# FIBREGLASS PUMP STATIONS: 10 YEARS EXPERIENCE IN NEW ZEALAND

Presented at the Water New Zealand Conference, Rotorua, November 2011

*Holyoake, K.M.; ARMATEC Environmental Ltd, and Guthrie, B.C; ITT Water & Wastewater NZ Ltd*

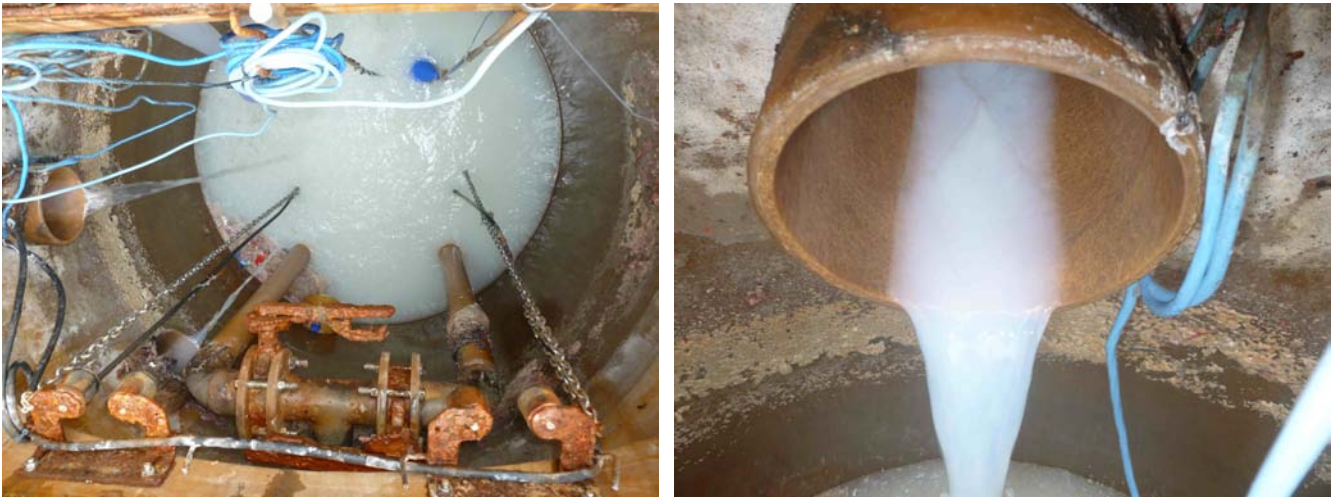
A fibreglass pump station was installed in a Dairy Factory in 2000. It was manufactured in vinyl ester resin, and handles CIP effluent including up to 5% nitric acid, up to 5% caustic, hot water, and milk wastes. Evaporator water has at times exceeded 95°C. The thermal shock from sudden changes in temperature has caused surface crazing on the internal surface of the fibreglass pipe (Photograph 10) that drains the evaporator to the pump station. This is superficial only, and has not led to failure. The resin rich interior surface of all fibreglass parts is reinforced and strengthened with a fine glass tissue, giving it improved physical characteristics to handle these thermal stresses. All parts of the pump station are contact moulded for the highest degree of chemical resistance, and this is especially needed in this application. The main laminate is reinforced with non-continuous glass fibre, and this limits the spread of any chemicals within the laminate should significant cracks develop.

Valve handles and other non-stainless steel metal parts within the pump station are being corroded (Photograph 9).

*Photographs 9 & 10. Fibreglass pump station at Dairy factory after 11 years service handling milk products and CIP chemicals at temperatures to 95°C. Internal surface of inlet pipe has crazed, but is still structurally sound.*

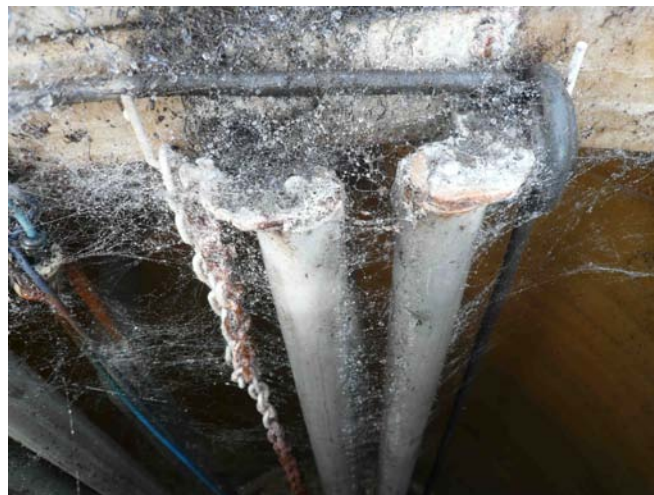
A fibreglass pump station was installed in the Mangaroa Prison in Hawkes Bay in 2005. After 6 years operation, it is in excellent condition. The load is intermittent, with low-level buildup of hydrogen sulphide gas. Non-stainless steel parts within the pump station have corroded, and will need maintenance in the future.

Site personnel advised that the pump station is hardly ever touched, other than being cleaned out every 3 to 4 months. Management of the prison changed in 2010, and servicing had possibly been neglected in the past. The spider webs present (Photograph 11) confirm there has been minimal servicing. The fibreglass pump station itself has not suffered as a result of infrequent service.

*Photographs 11. Fibreglass pump station at Hawkes Bay prison handling wastewater is in excellent condition, despite minimal servicing. Non-stainless steel metal parts are being corroded by hydrogen sulphide gas.*

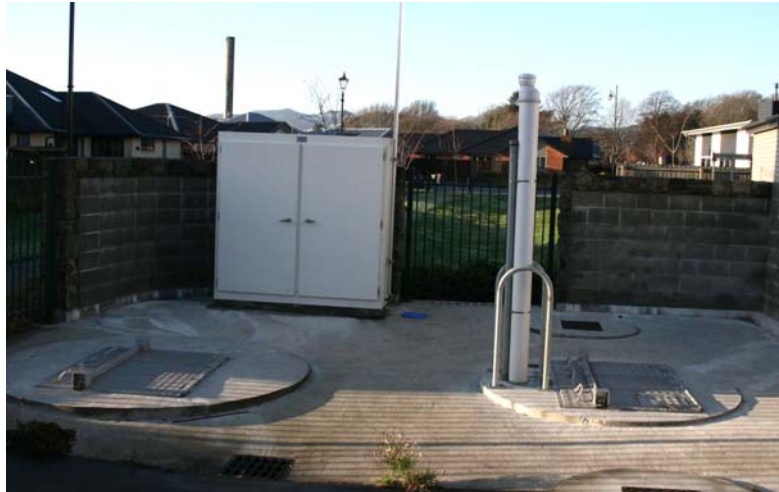
The Linden Grove Ave pump station (PS96) was installed in 2008. It is located about 4km southwest of the city centre, and has endured more than 6,000 earthquakes during 2010 and 2011, without damage. The pump station and valve chamber are located close together. They are connected by rigid ductile iron piping, and a reinforced concrete slab ties the two together. The lack of damage is likely due to the two being tied together, so that there is minimal differential movement during an earthquake.

*Photograph 12: Linden Grove Pump Station, Christchurch (PS96). No damage during earthquakes of 2010 and 2011. Pump station and valve chamber are close, and tied together with concrete slab.*

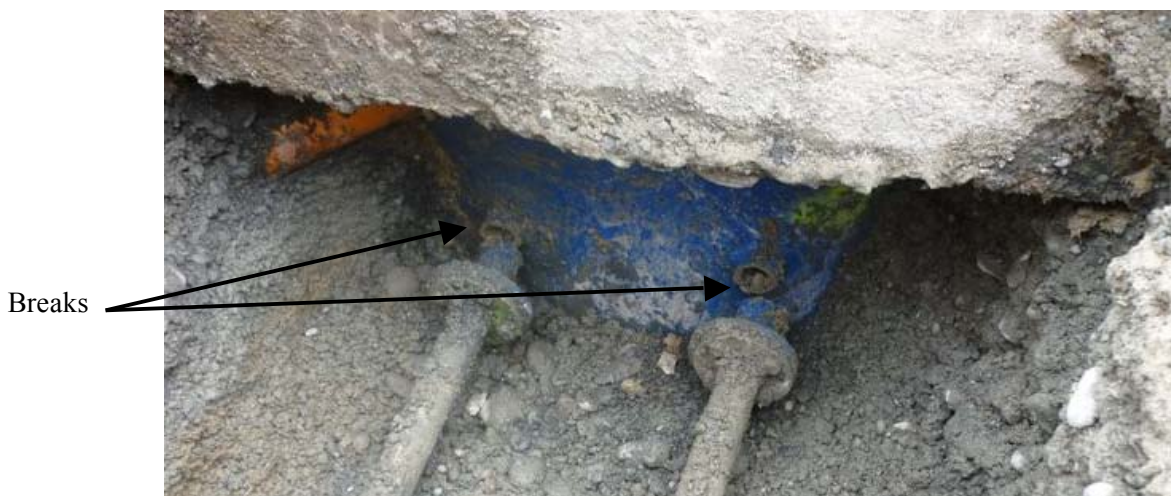
The Birchgrove pump station (PS97) was installed in 2009. It is located to the east of the city centre, closer to the area worst affected by the 2010 and 2011 earthquakes. The two 50mm diameter pump station discharge pipes include flanged fibreglass spools at the pump station wall, followed by a ductile iron pipe to the valve chamber. During the 22 February 2011 earthquake, both discharge pipes sheared immediately outside the pump station in the fibreglass spool section (Photograph 13). The liquid tight envelope of the fibreglass vessel itself was not broken.

When excavated, the pipes were found to be displaced both horizontally and vertically by 20mm to 50mm. It is likely the pump station and valve chamber moved during the earthquake, and that the backfill around the discharge pipes compacted downwards. As the discharge pipes were rigid ductile iron, there was no flexibility to take up any movement, and the breakage resulted.

*Photograph 13: Birchgrove Pump Station, Christchurch (PS97): Discharge pipes broke during 22 February 2011 earthquake at fibreglass spool just outside pump station wall.*

Repairing the breaks in these fibreglass pipe spools was relatively straight forward, as the break was outside the pump station. The rigid ductile iron pipes have been replaced with HDPE piping, and trial 'Carrier Pipes' were

installed. This provides more flexibility and room for movement of the pipe connecting the pump station and valve chamber. The 'Carrier Pipes' are fibreglass, with a diameter between 4 and 6 times the discharge pipe diameter. They also provide protection to the HDPE piping during any future excavation.

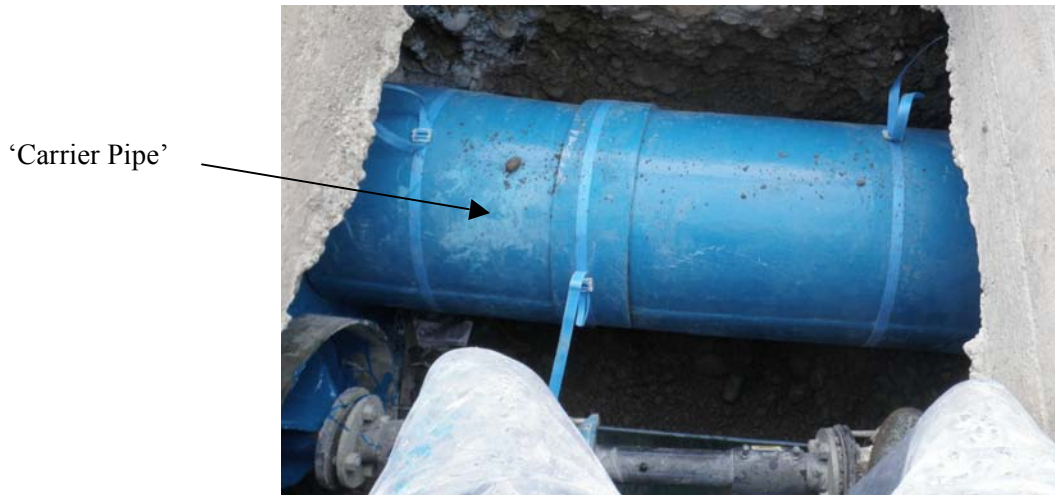
*Photograph 14: Birchgrove Pump Station, Christchurch (PS97) Earthquake Damage Repairs: (1) Fibreglass nozzles strengthened, HDPE pipe used, and 'Carrier Pipes' being installed to provide room for movement.*

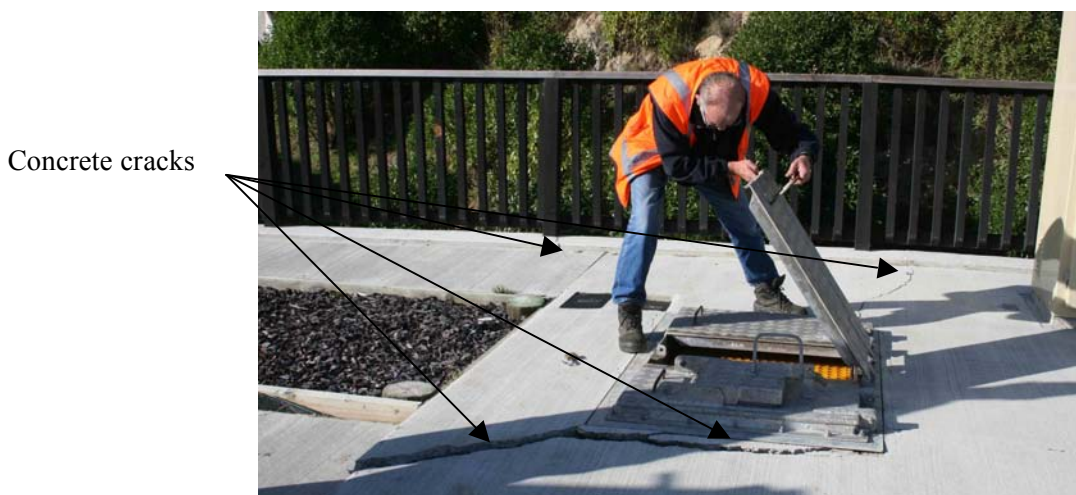
The earthquakes further consolidated the fill, resulting in significant cracks to the concrete and asphalt surrounds (Photograph 15). There was no damage to the pump station or discharge pipework.

*Photograph 15: Black Rock Pump Station, Lyttleton (PS625): Earthquakes cracked concrete surrounds.*

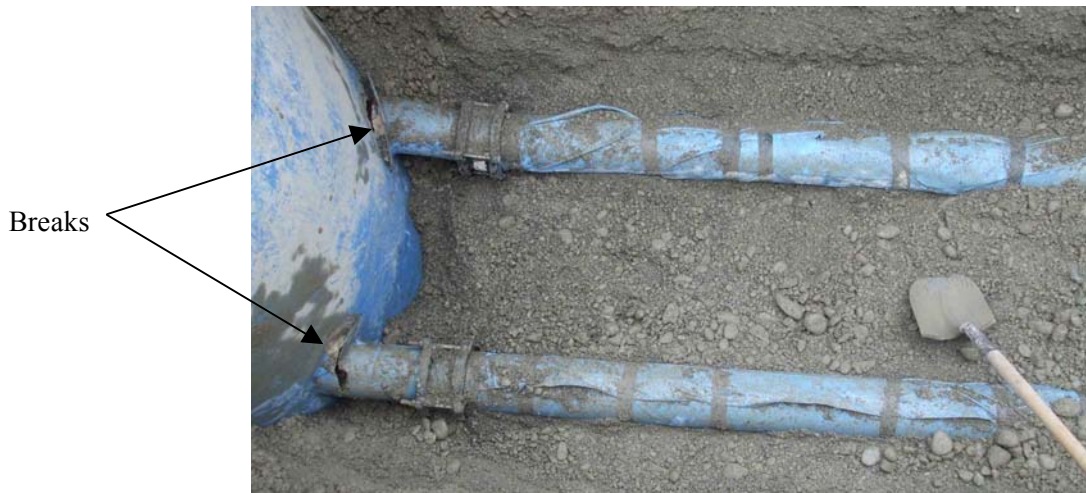
The Wigram pump station was installed in 2011 in a new subdivision. The pump station and valve chamber are 4 metres apart, and 150mm diameter ductile iron discharge pipes connect the two. The pump station was commissioned immediately prior to the series of earthquakes in June 2011. The earthquakes fractured the discharge piping just outside the pump station in the fibreglass spools (Photograph 16). The liquid tight envelope of the fibreglass vessel itself was not broken. Again, there was both vertical and horizontal displacement of the pipes; the maximum vertical displacement measured was 80mm downwards.

*Photograph 16: Wigram Pump Station, Christchurch (PS101): Both 150mm diameter discharge pipes to the valve chamber fractured in the fibreglass pipe spool at the pump station wall.*

It appeared that the ductile iron pipes (and not the pump station) were forced downwards by the earthquake, and as a result the fibreglass pipes fractured. The pump station and valve chamber were subsequently surveyed, but no significant movement vertically of either was found. It appears the earthquakes compacted the backfill around the pump station, forcing the discharge pipes downward, with the observed result.

The fibreglass spools were strengthened and gusseted (Photograph 17), so that the weakest point is further out from the pump station wall and more accessible if damaged in the future. HDPE discharge piping was installed, and is now the standard for this work in Christchurch. It is not possible to totally stop earthquakes causing damage, but the measures taken will minimize any future damage and make subsequent repairs easier.

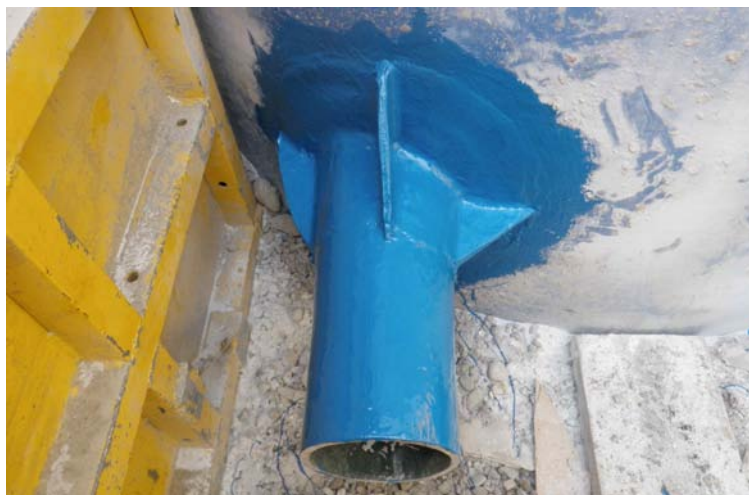
*Photograph 17: Wigram Pump Station, Christchurch (PS101): Strengthened and gusseted fibreglass outlet pipe.*
