INSPECTION REPORT

For the Property at:
SAMPLE ADDRESS
GRAYSLAKE, IL

Prepared for: SAMPLE REPORT
Inspection Date: Saturday, August 1, 2015
Prepared by: Lucas Weigle

Report No. 1029

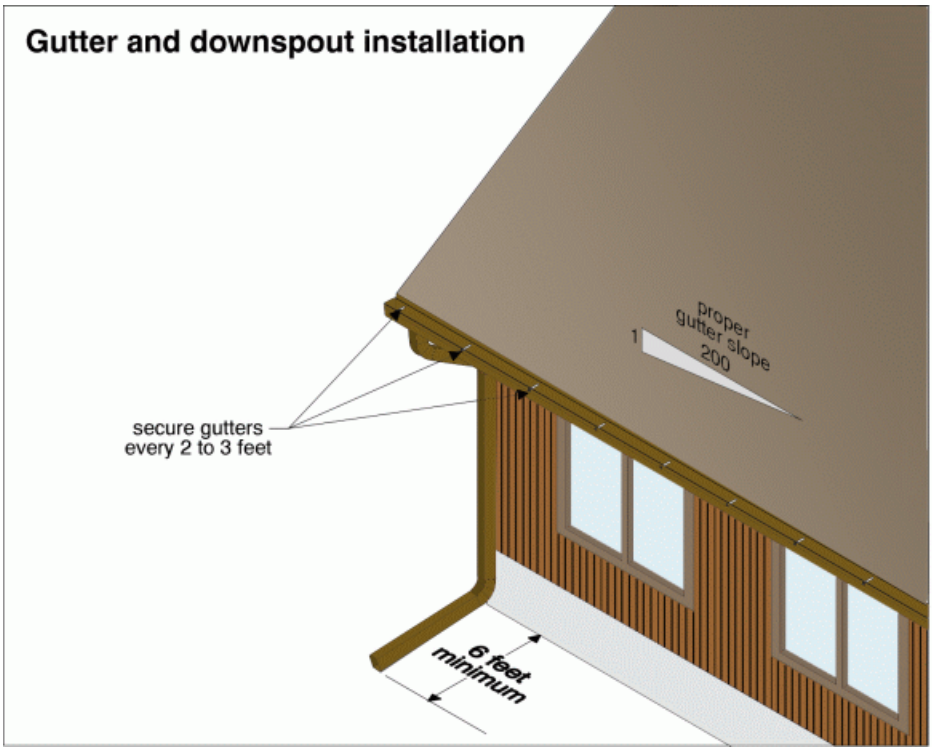
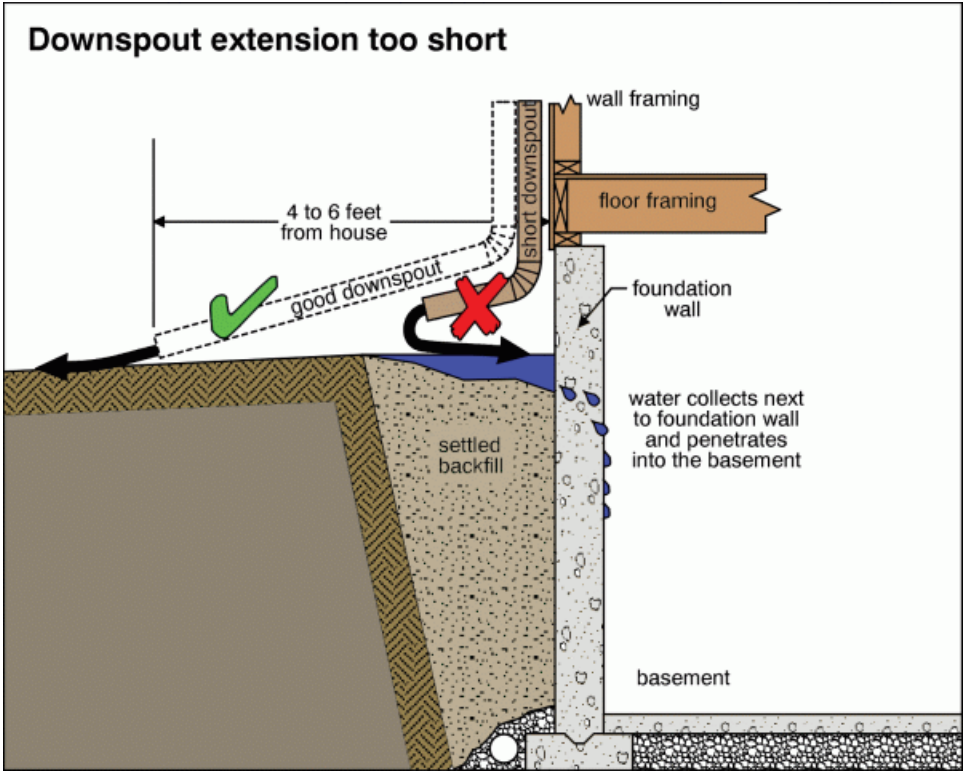
ROOF DRAINAGE \ Downspouts

1. Condition: • Downspouts end too close to building

Extend the downspouts 6 feet from property. Contact a licensed gutter professional.

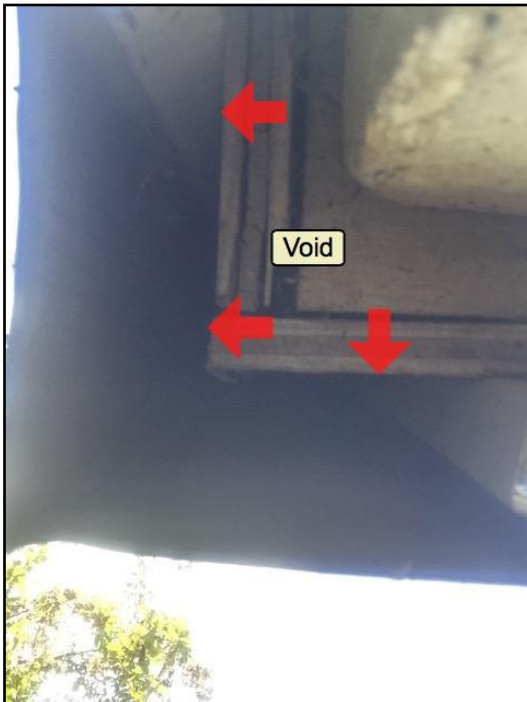
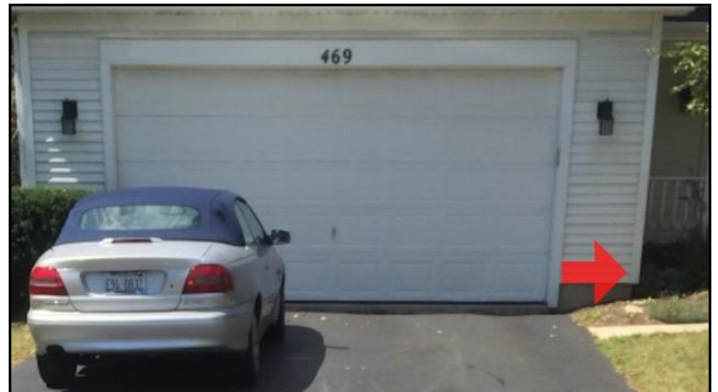
WALLS \ Trim

2. Condition: • Observed chipmunk running up the corner trim board. Close off the bottom void of the corner trim. Contact a licensed siding professional.

Location: Northeast First Floor Garage

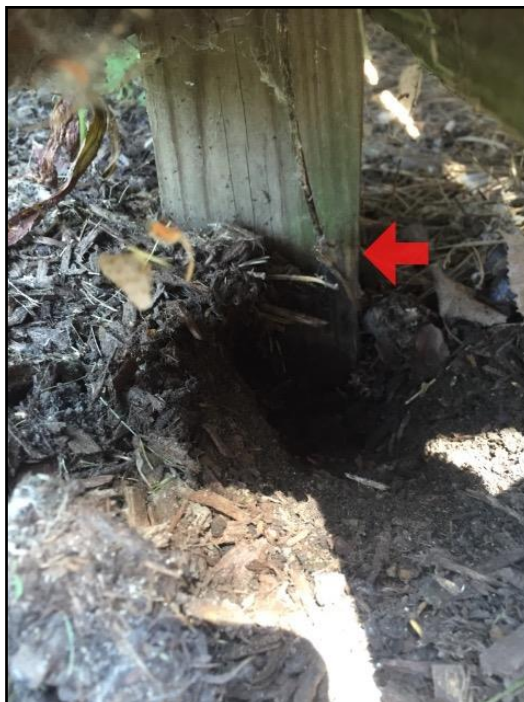
PORCHES, DECKS, STEPS, PATIOS AND BALCONIES \ Columns

3. Condition: • Wood/soil contact

Limited access under deck. Could not verify that every column was resting on a cement footing. Contact a licensed carpenter.

Implication(s): Weakened structure | Chance of movement | Rot | Insect damage

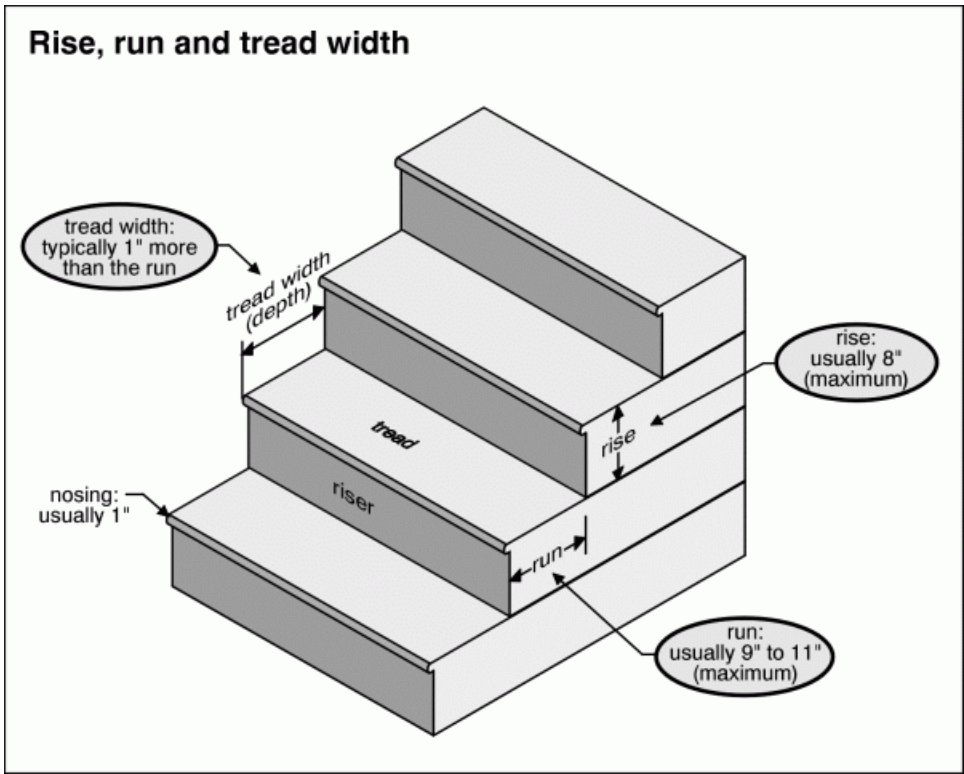
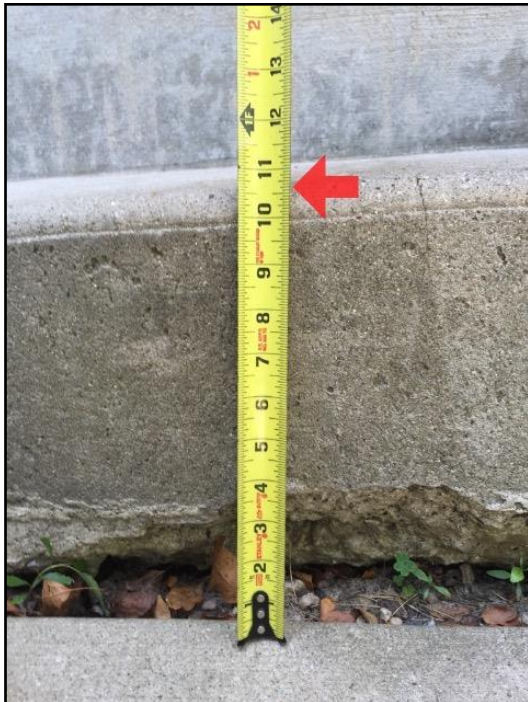
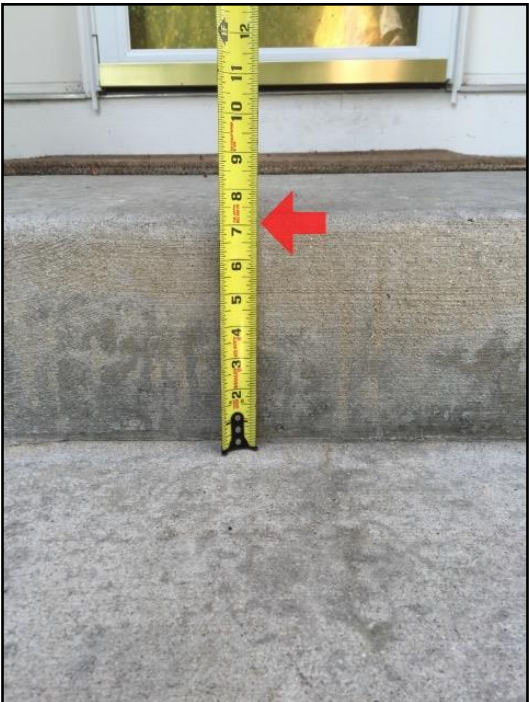
PORCHES, DECKS, STEPS, PATIOS AND BALCONIES \ Steps and landings

4. Condition: • Stair rise too big or not uniform

First step leading to the front door is a 10.75 inch rise, and the second stair's rise is 7 inches. Contact a licensed concrete professional to raise the walkway leading to the first step.

Implication(s): Trip or fall hazard

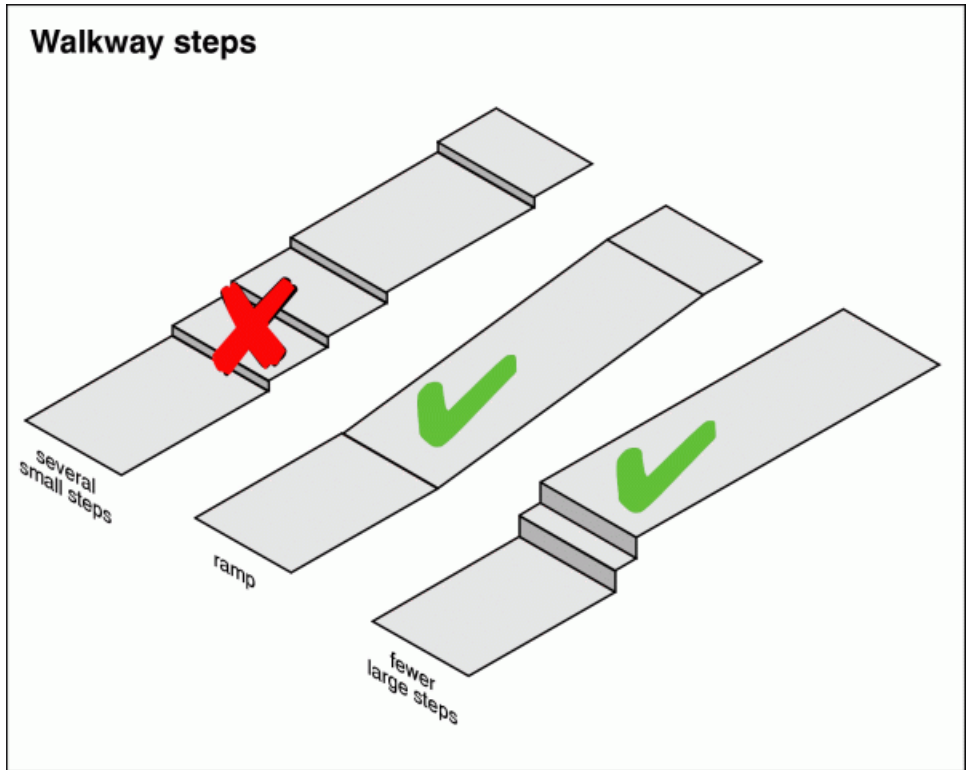
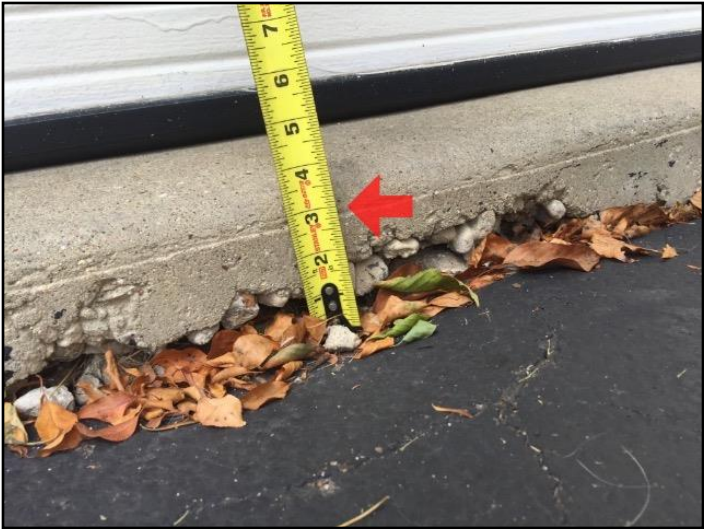
LANDSCAPING \ Driveway

5. Condition: • Uneven (trip hazard)
Contact a licensed asphalt professional

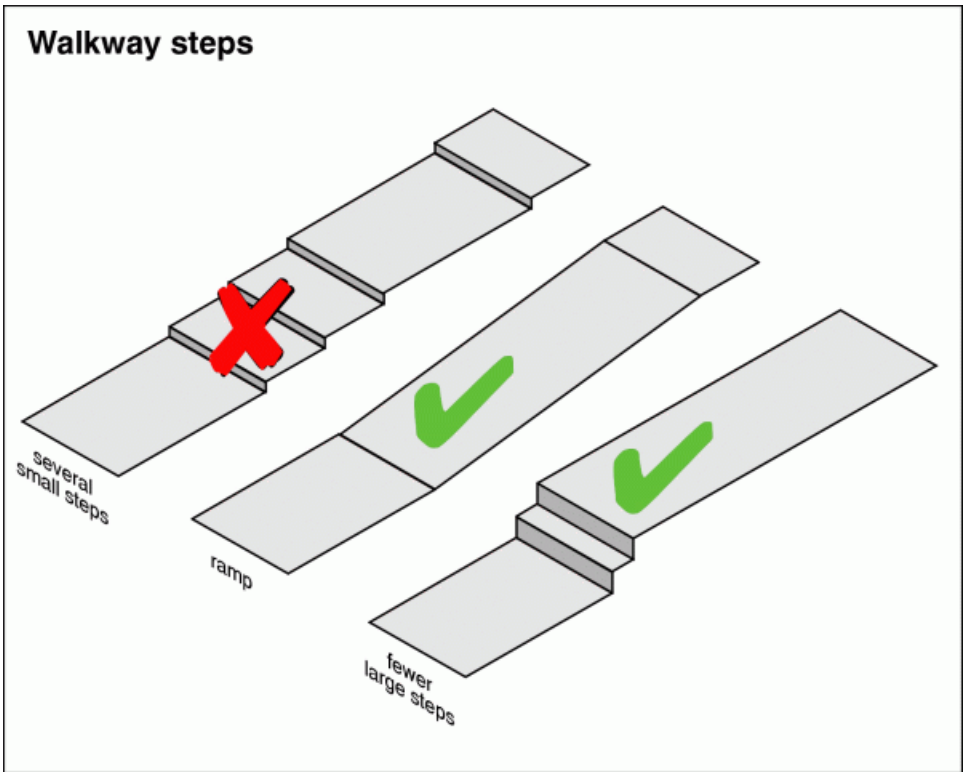
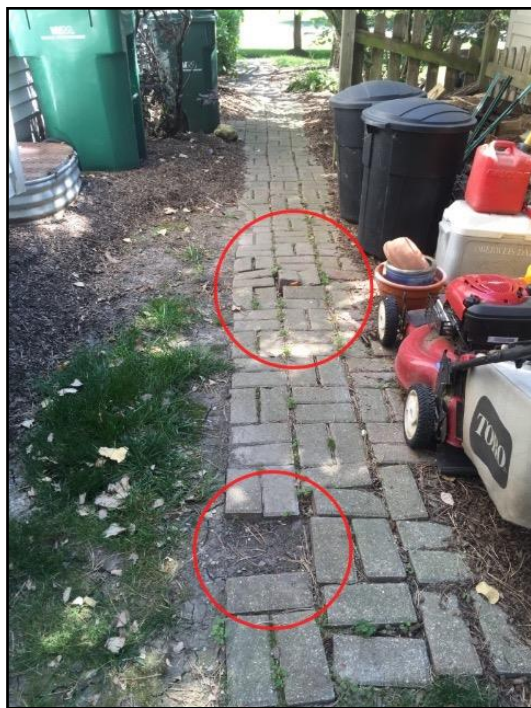
LANDSCAPING \ Walkway

6. Condition: • Uneven (trip hazard)
Contact a licensed paver professional.

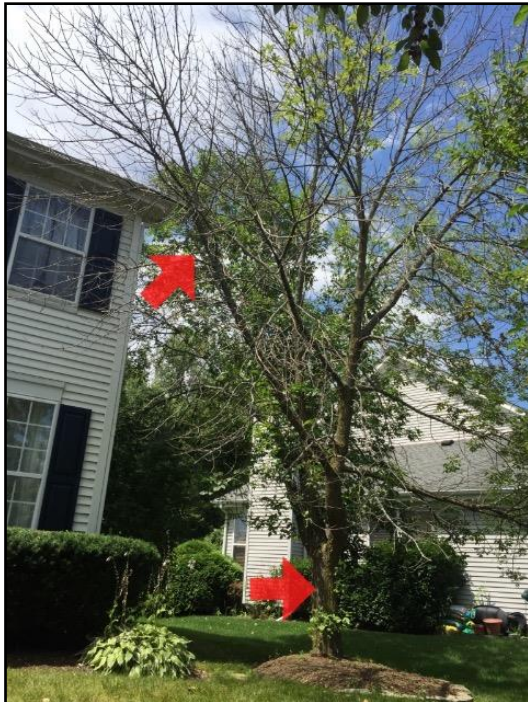
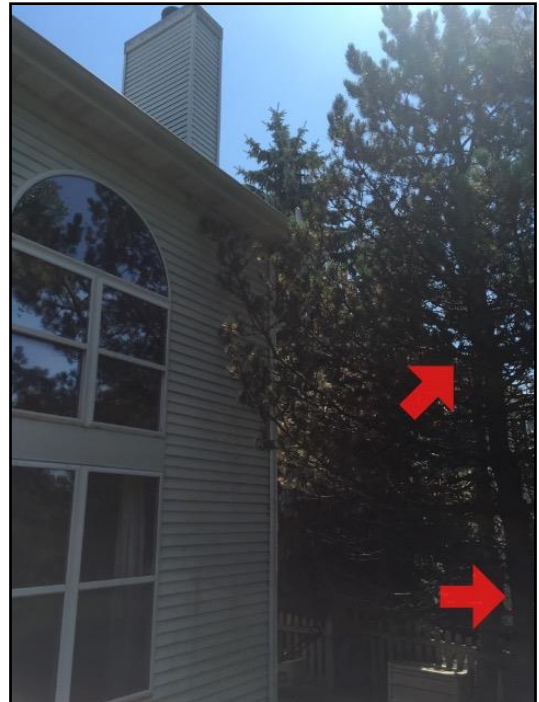
LANDSCAPING \ General

7. Condition: • Two trees appear to be dying (southwest side and northeast side of property). Contact a licensed Arborist to evaluate whether they need to be removed or if they can be saved.

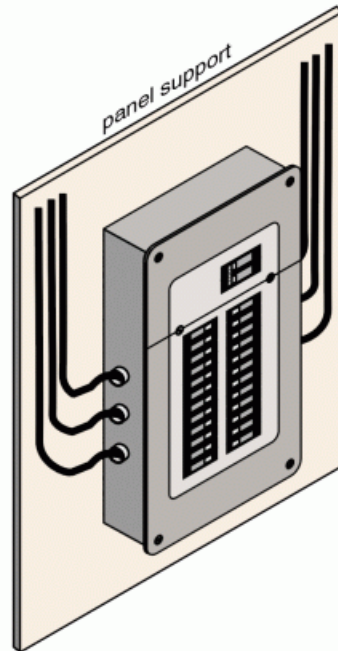
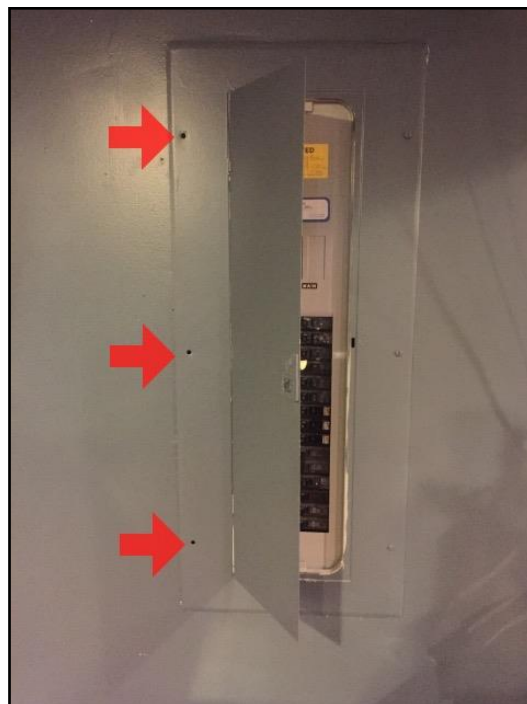
SERVICE BOX, GROUNDING AND PANEL \ Distribution panel

10. Condition: • Loose panel

Panel cover missing 3 screws. Obtain proper screws for installation via local hardware store or contact a licensed electrician if needed.

Implication(s): Electric shock | Fire hazard

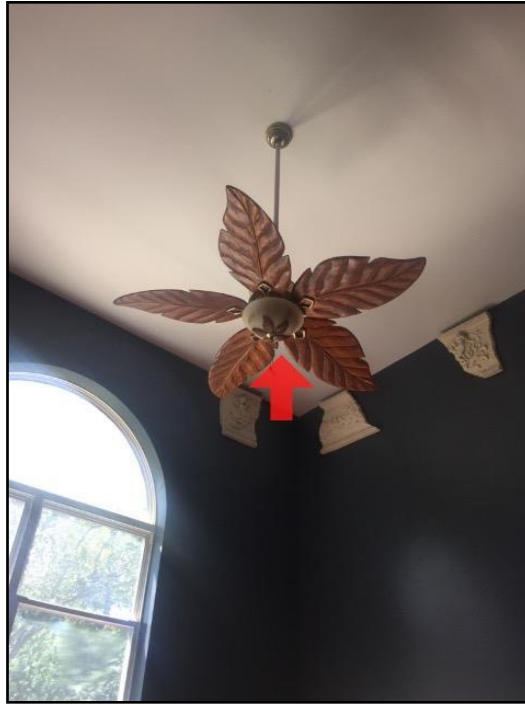
DISTRIBUTION SYSTEM \ Lights

11. Condition: • Ceiling fan problems

Could not get fan/light to operate from wall switches. Request demonstration from Seller(s). Contact a licensed electrician if needed.

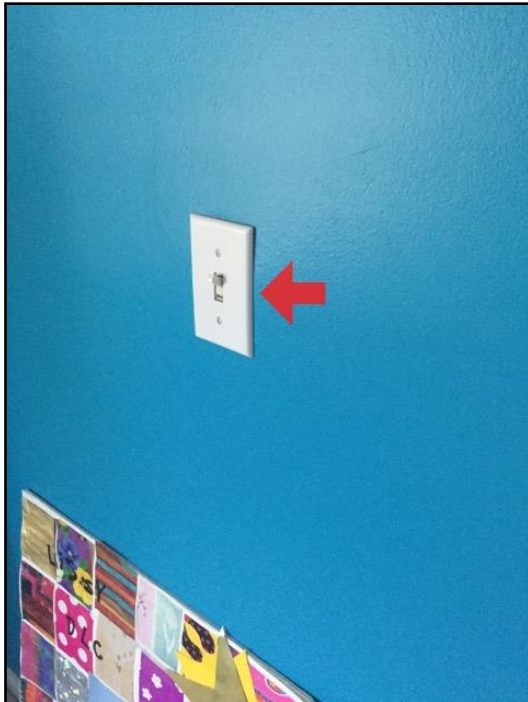
Bedroom

DISTRIBUTION SYSTEM \ Switches

12. Condition: • Inoperative

Request demonstration from Seller(s) to disclose the function of the following switches: family room, living room and bedrooms. Contact a licensed electrician if needed.

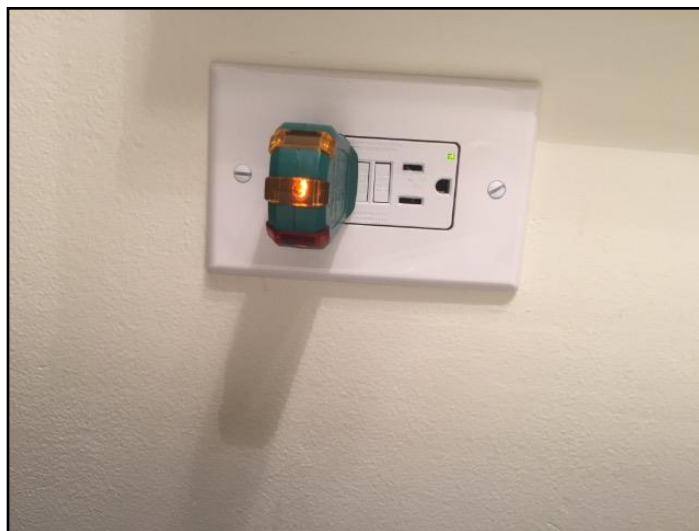
DISTRIBUTION SYSTEM \ Outlets (receptacles)

13. Condition: • GFI test faulty

Implication(s): Electric shock

Contact a licensed electrician

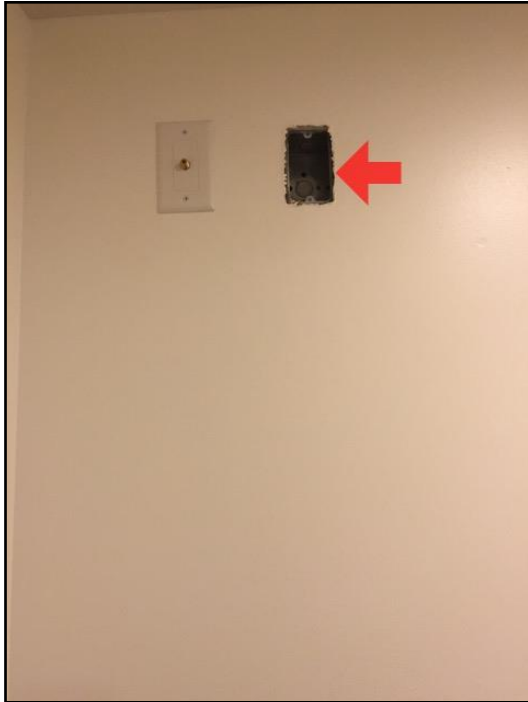
Laundry Room

DISTRIBUTION SYSTEM \ Cover plates

14. Condition: • Missing

Implication(s): Electric shock

Contact a licensed electrician

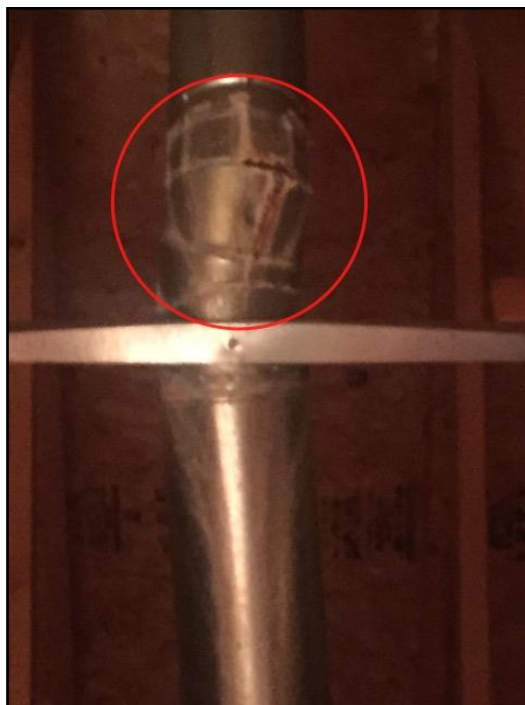
GAS FURNACE \ Venting system

19. **Condition:** • Rust, dirty, obstructed

Observed condensation on the attic section of the exhaust ducting. When replacing the furnace, also have the flu evaluated by a licensed HVAC professional.

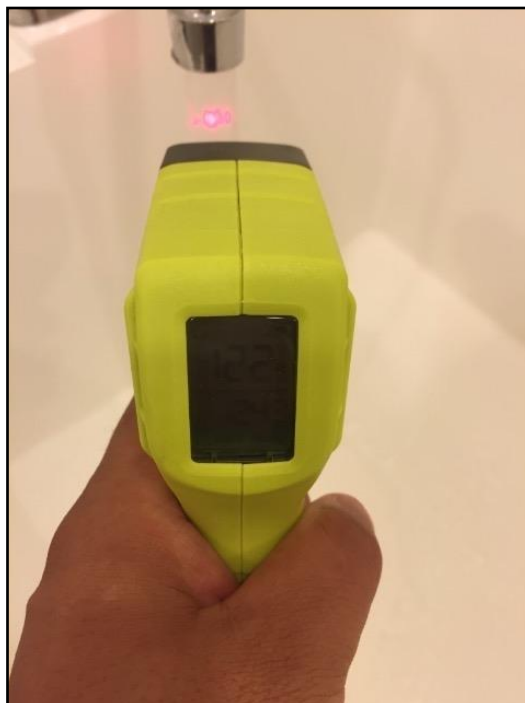
WATER HEATER \ Temperature/pressure relief valve

23. Condition: • Water temperature is currently 122 degrees. For child safety, set water temperature to 110 degrees.

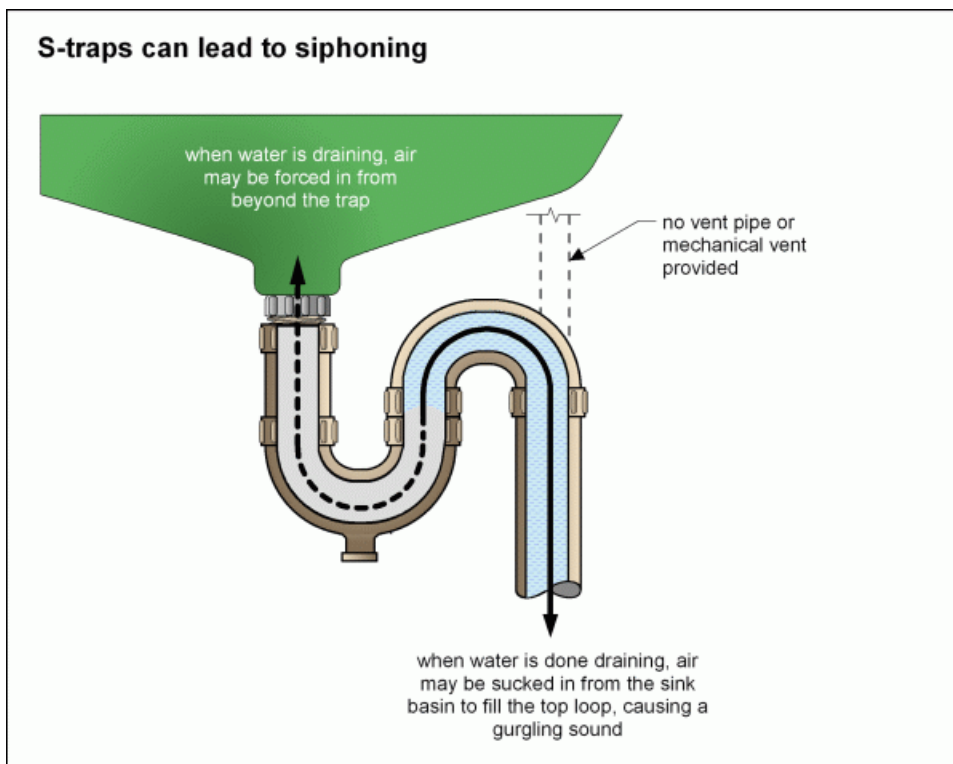
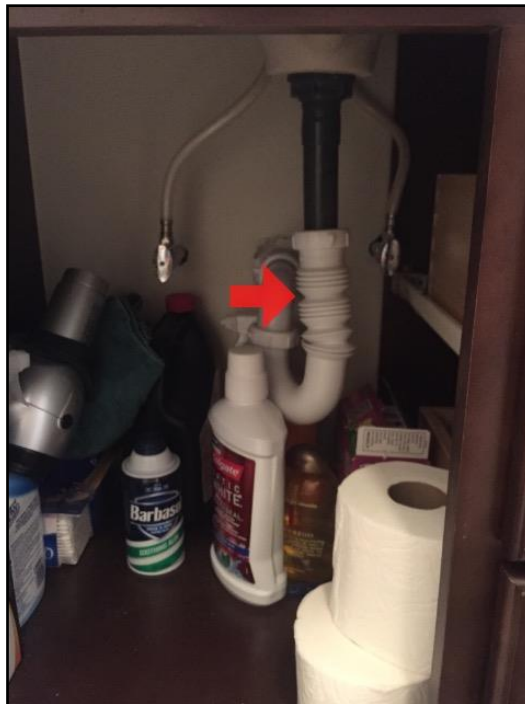
WASTE PLUMBING \ Traps - installation

24. Condition: • Nonstandard shape or material

Corrugated piping under bathroom sink is a breeding place for bacteria. Recommend upgrading to proper material. Contact licensed plumber.

Implication(s): Reduced operability | Fixtures slow to drain

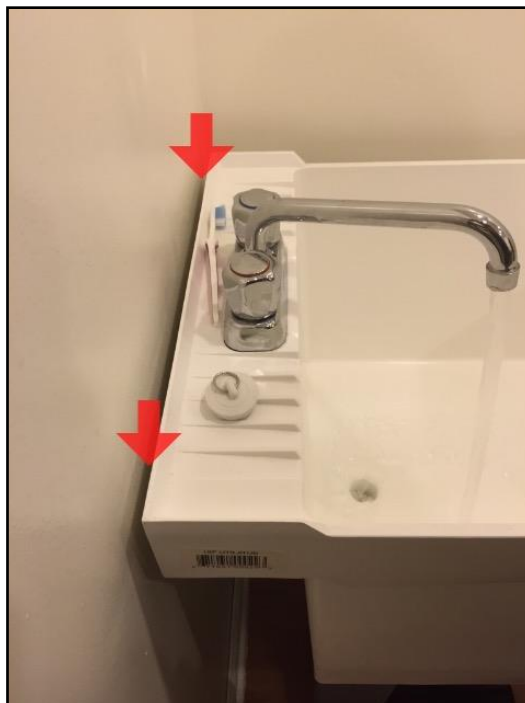
FIXTURES AND FAUCETS \ Basin, sink and laundry tub

25. Condition: • Loose

Implication(s): Chance of water damage to contents, finishes and/or structure | Damage or physical injury due to falling materials | Sewage entering the building

Contact a licensed plumber

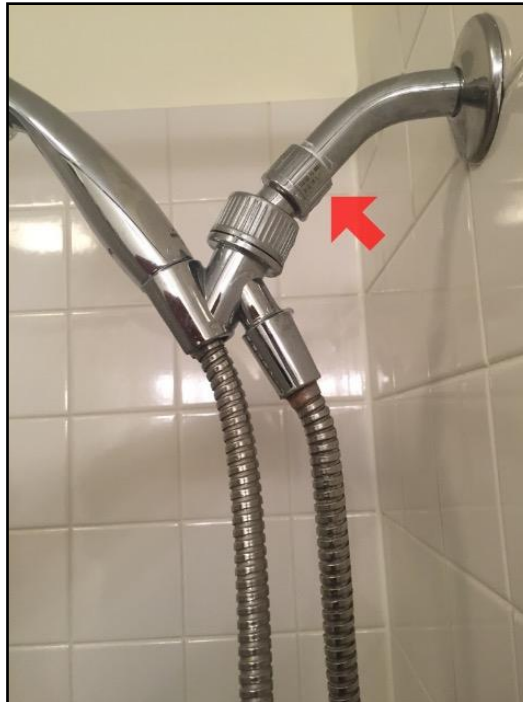
FIXTURES AND FAUCETS \ Faucet

26. Condition: • Drip, leak

Contact a licensed plumber

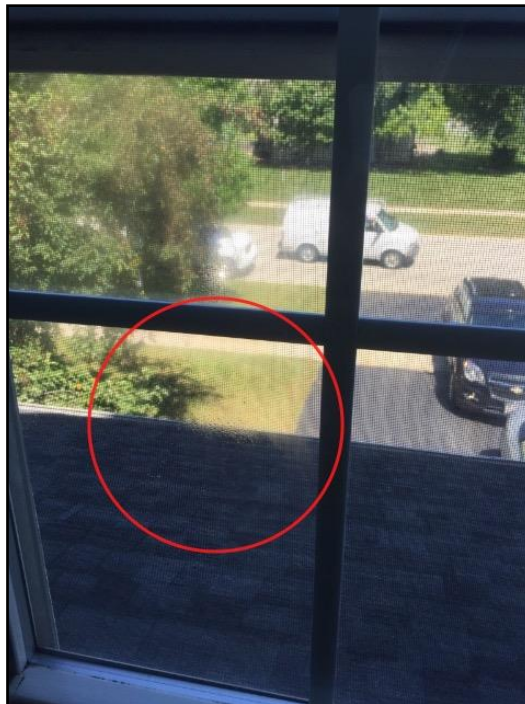
27. Condition: • Lost seal on double or triple glazing

Implication(s): Cosmetic defects

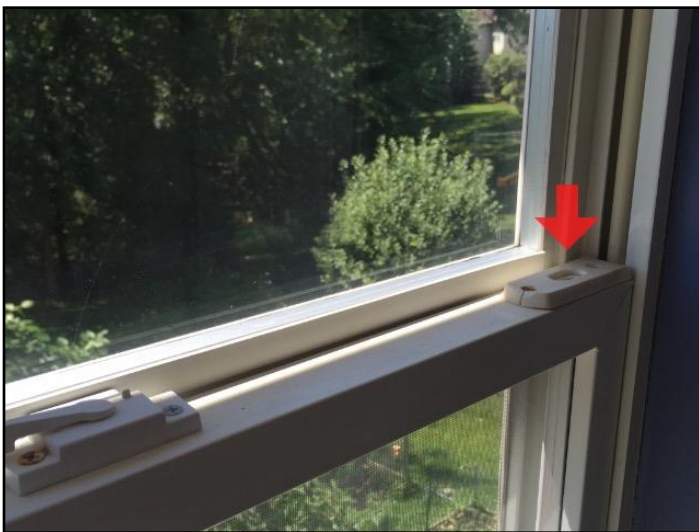
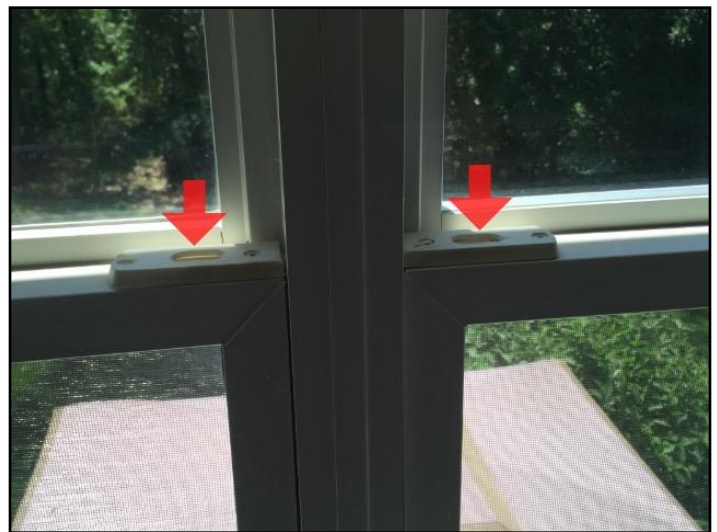
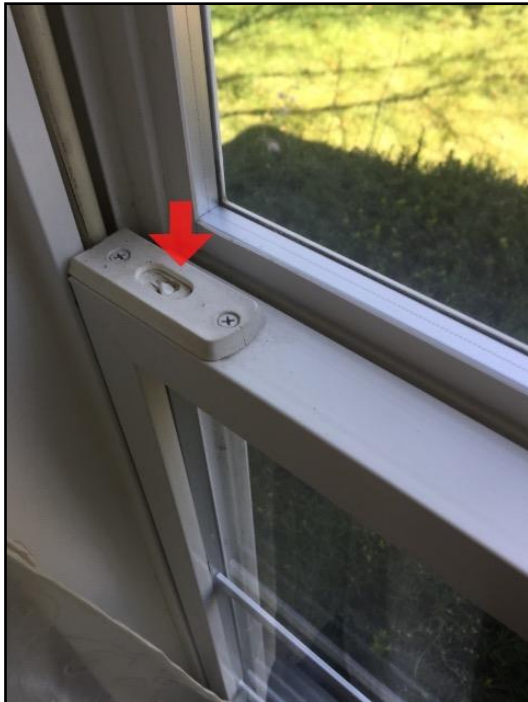
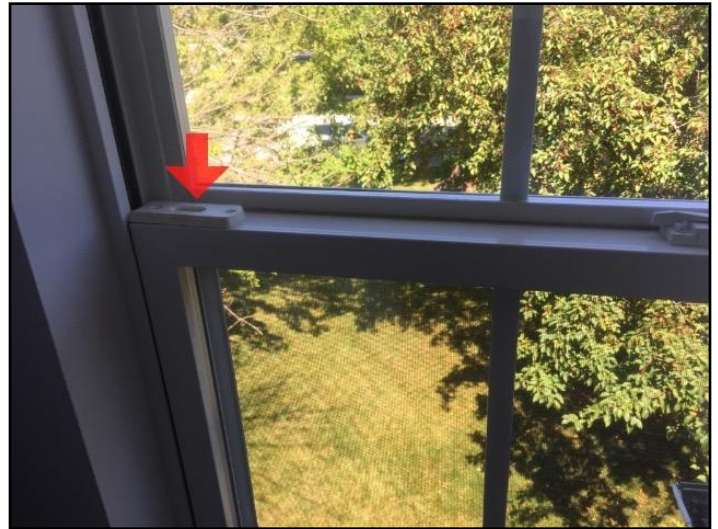
WINDOWS \ Hardware

28. Condition: • Broken

Window sash tilt latches are broken throughout (i.e., master bathroom, dining room, living room). Contact a licensed window professional.

Implication(s): Cosmetic defects | System inoperative or difficult to operate

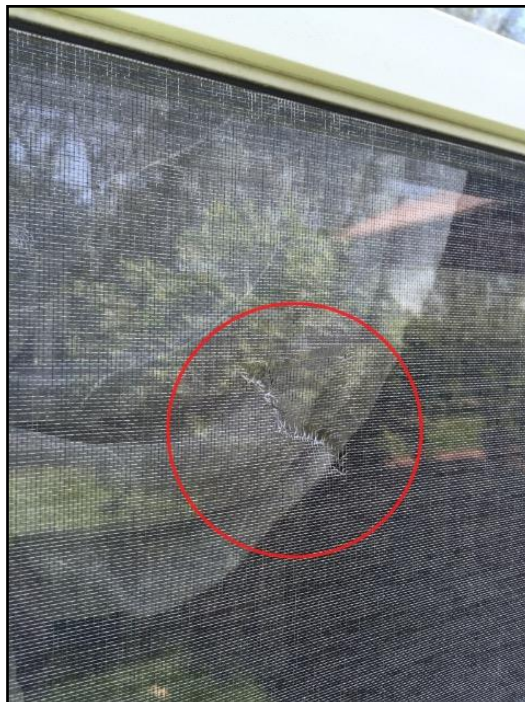
WINDOWS \ Storms and screens

29. Condition: • Holes

Implication(s): Cosmetic defects | Chance of pests entering building

Screens may be repaired at local hardware store, or contact a licensed window professional if needed

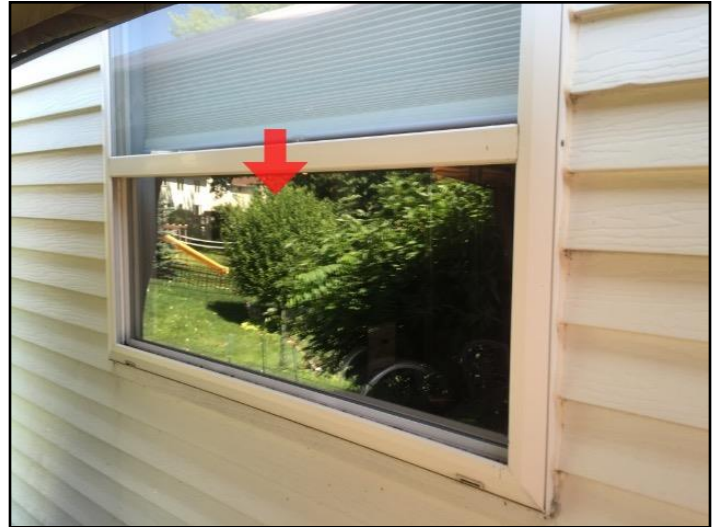
Kitchen

30. Condition: • Missing

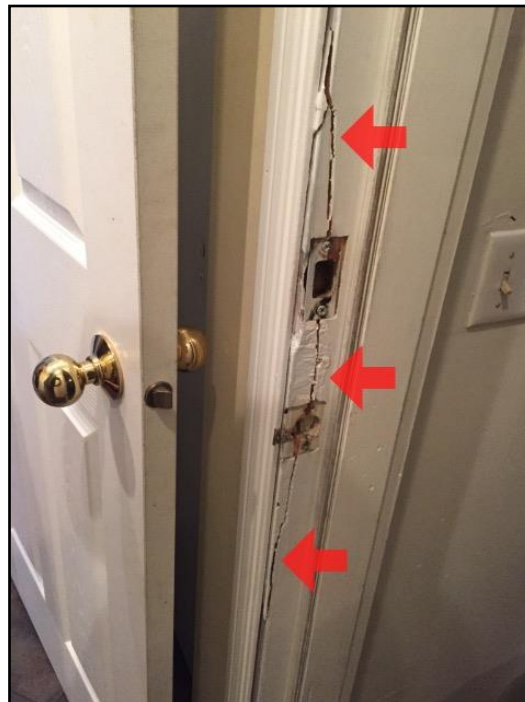
DOORS \ Doors and frames

31. Condition: • Damage

Implication(s): Cosmetic defects

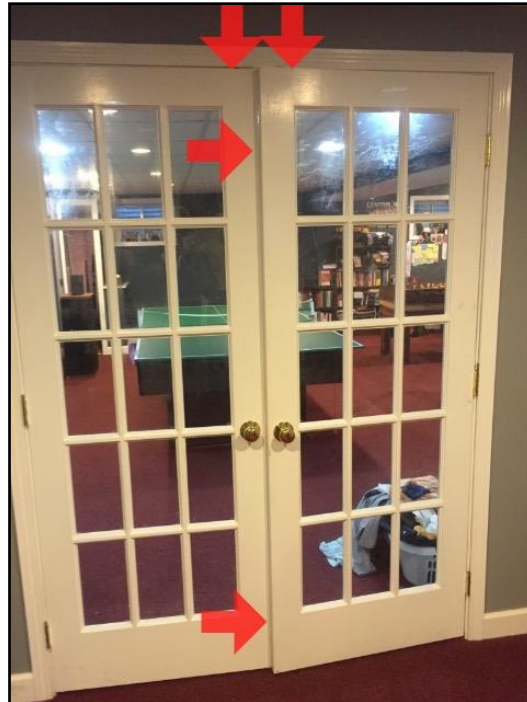
32. Condition: • Stiff

Contact a licensed carpenter

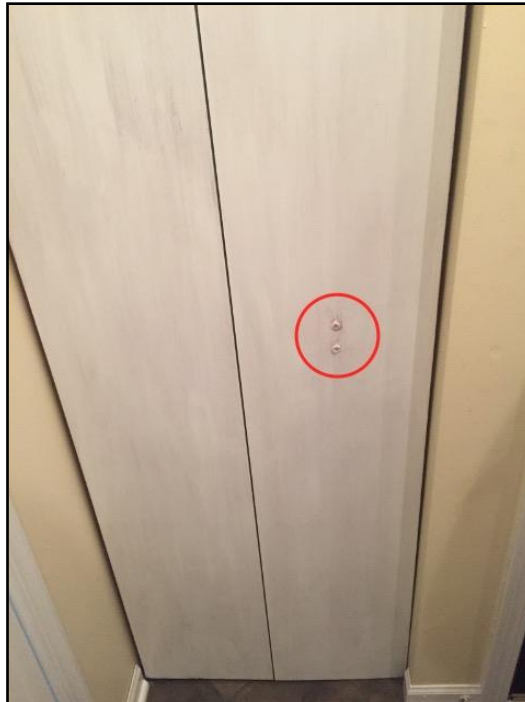
DOORS \ Hardware

33. Condition: • Missing

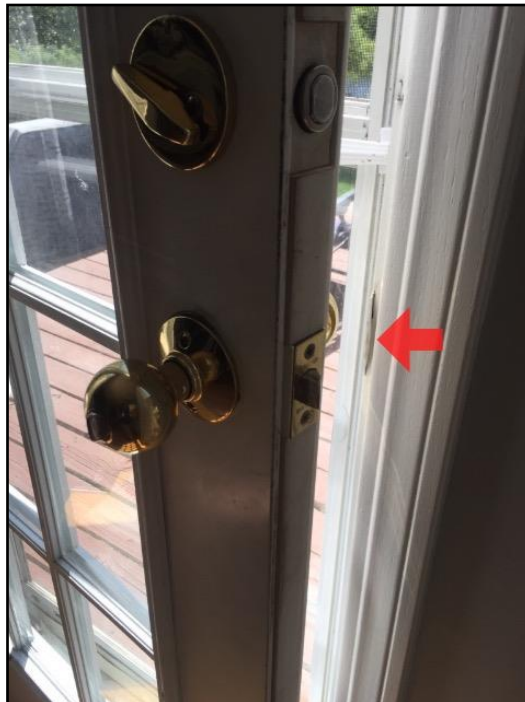
34. Condition: • Latch not effective on exterior door

Contact a licensed carpenter

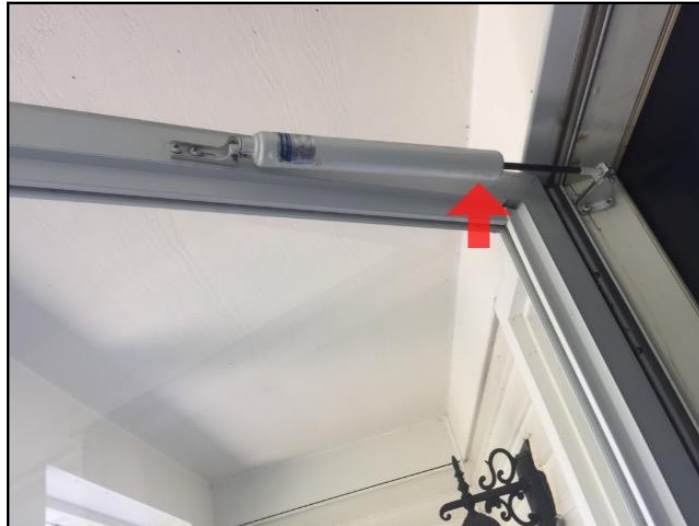
DOORS \ Storms and screens

35. Condition: • Loose

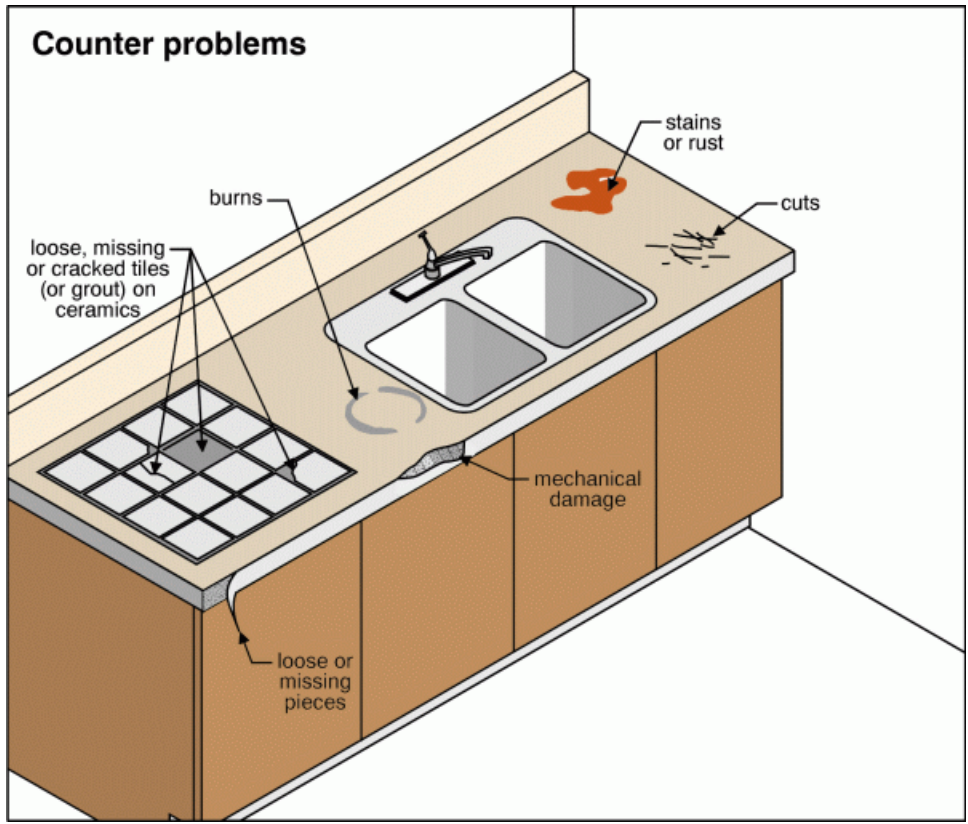
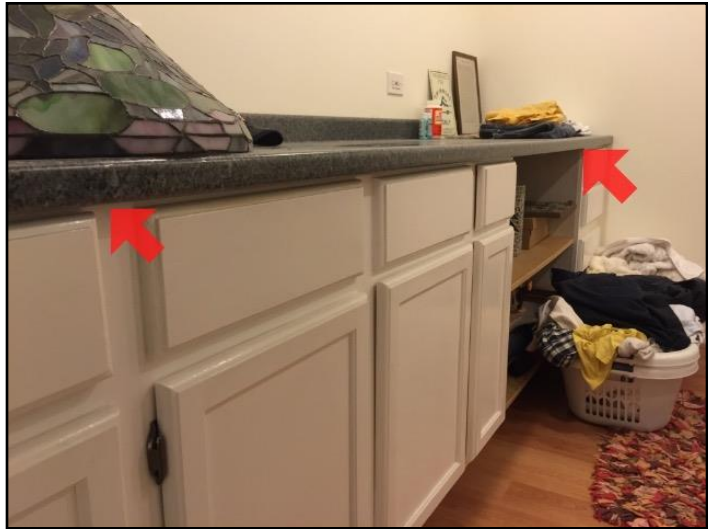
CARPENTRY \ Countertops

36. Condition: • Entire top loose

Implication(s): Cosmetic defects

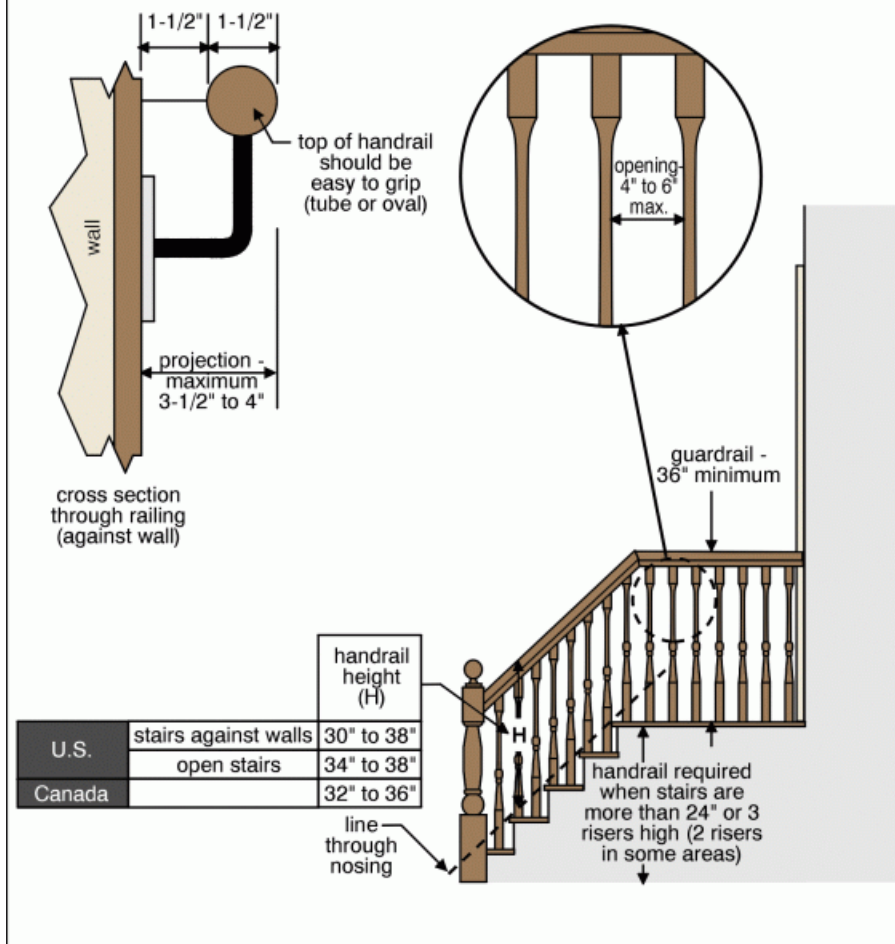
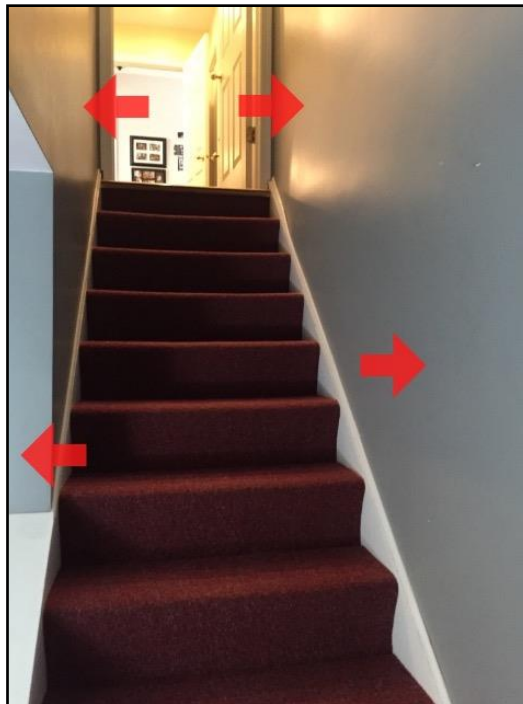
STAIRS \ Handrails

37. Condition: • Missing

Implication(s): Fall hazard

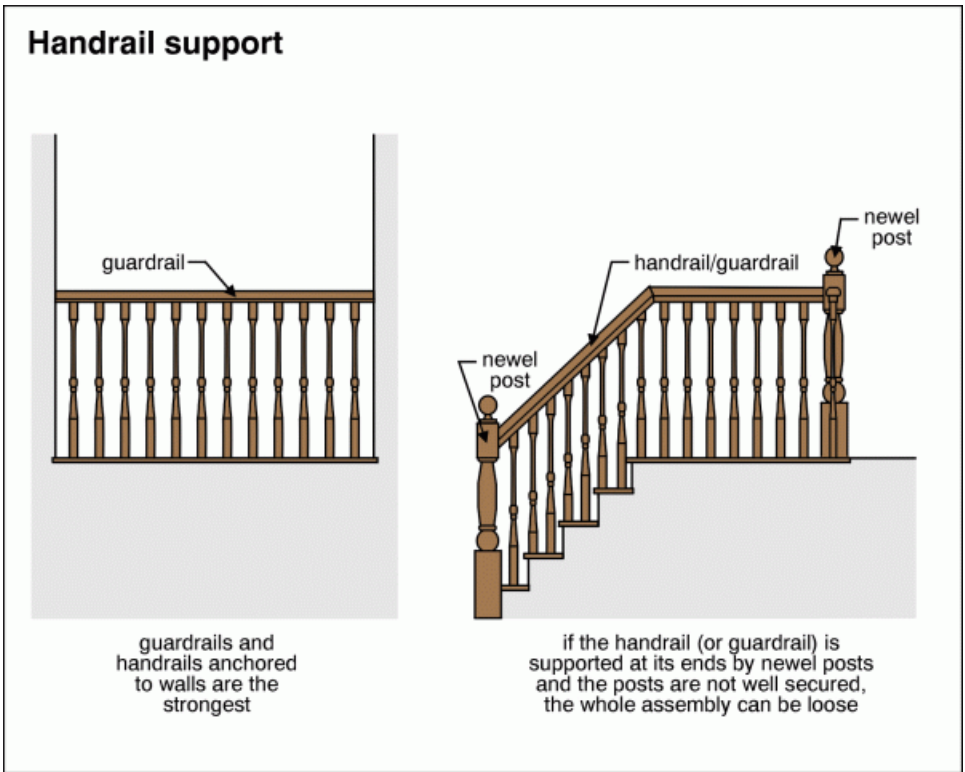
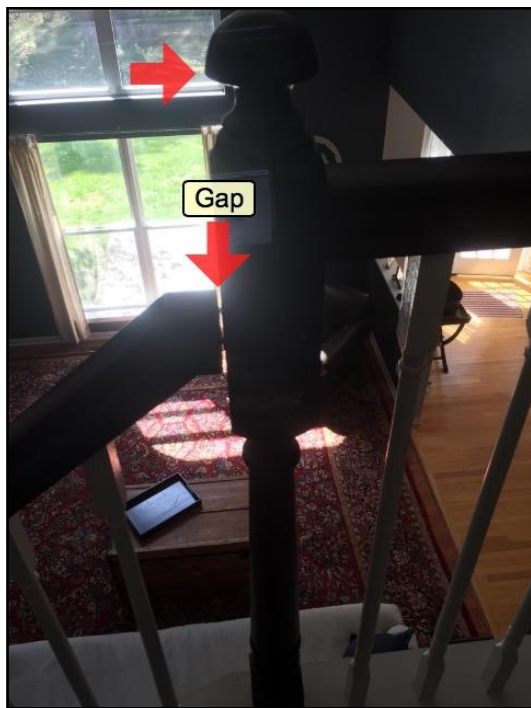
STAIRS \ Guardrails

38. Condition: • Loose

Implication(s): Fall hazard

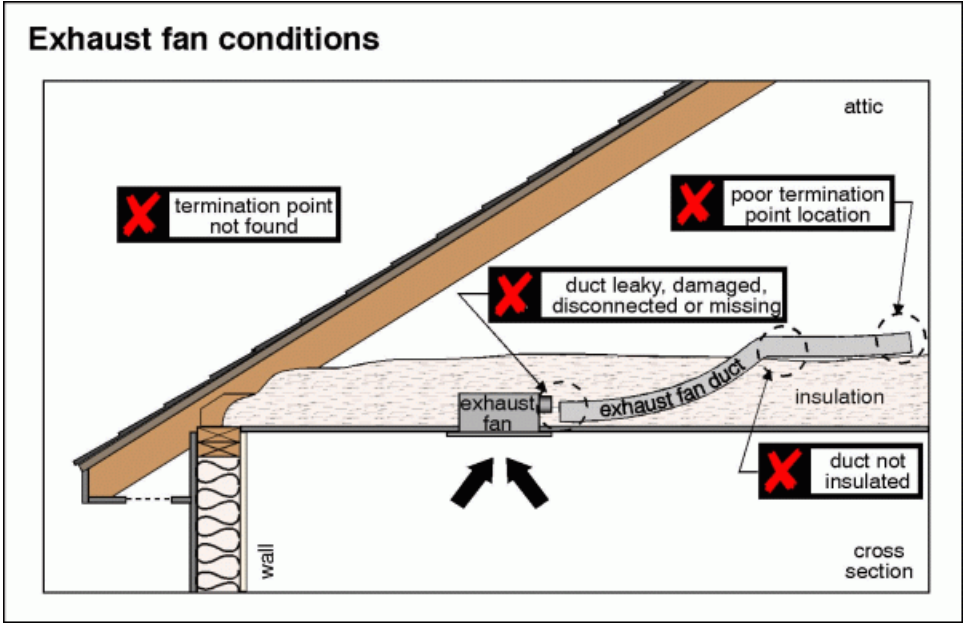
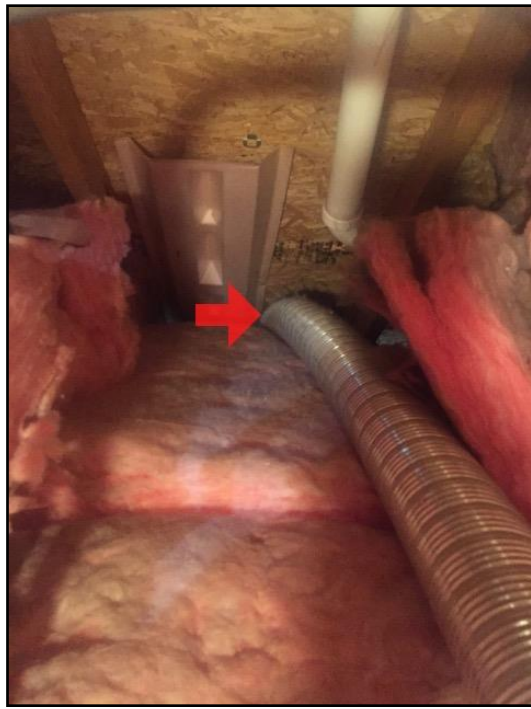
EXHAUST FANS \ Exhaust duct

39. Condition: • Poor termination location

Implication(s): Chance of condensation damage to finishes and/or structure

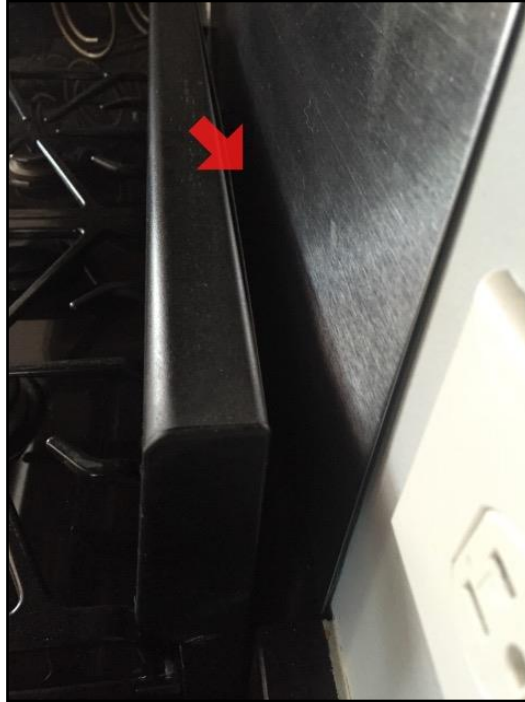
APPLIANCES \ Oven

40. Condition: • Anti-tipping device missing
 Safety hazard for children. Contact a licensed appliance professional.

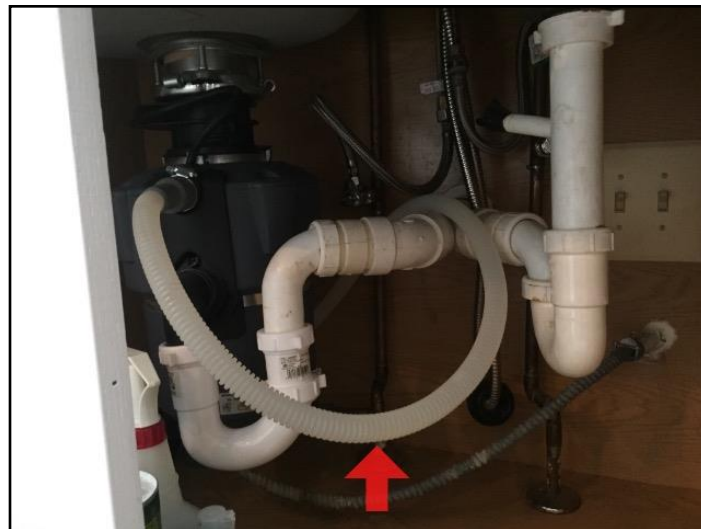
APPLIANCES \ Dishwasher

41. Condition: • Backflow prevention missing
