YOUR INSPECTION REPORT

213 Jewel Ct.
Fort Collins, CO 80525

Saturday, June 13, 2015

RE: Report No. 1005
213 Jewel Ct.
Fort Collins, CO
80525

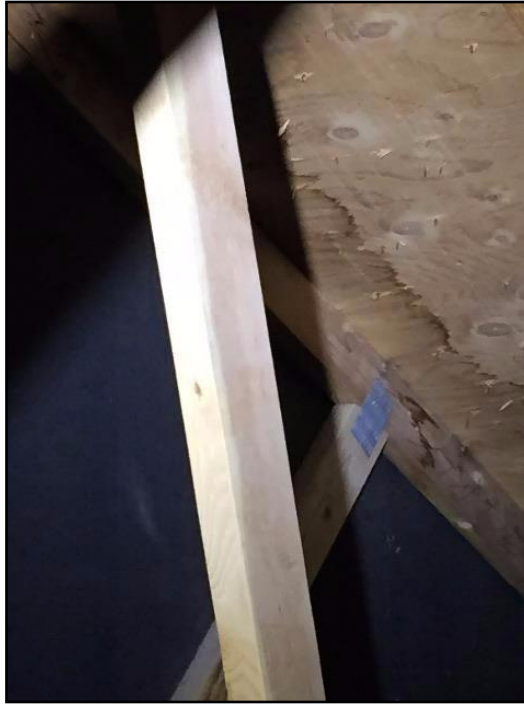
2. Leak

Roof Decking (sheathing) at junction point where the roof above the garage meets the second story exterior wall showed evidence of significant moisture damage. Discoloration of sheathing and evidence of leaking was present at time of inspection. Lack of flashing is the probable cause of this condition. Recommend repair of roof sheathing and the installation of a proper flashing as soon as possible by a licensed, qualified ROOFING CONTRACTOR. Failure to do so will lead to major damage and costly repairs.

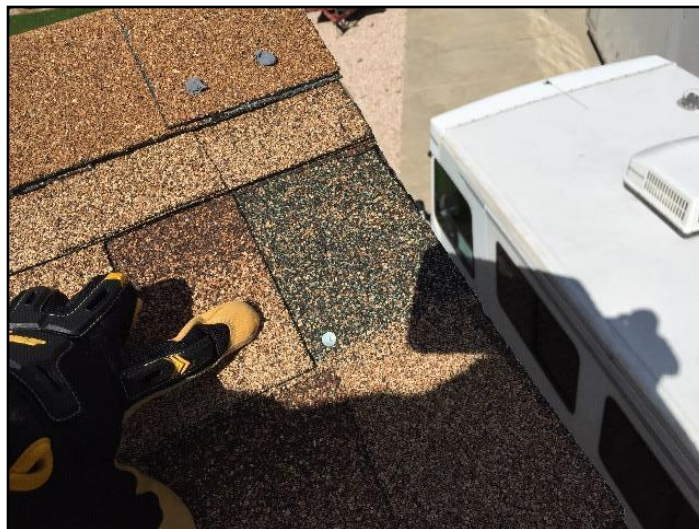
3. Missing, loose or torn

2. Condition: • [Missing, loose or torn](#)

Location: Northwest Roof

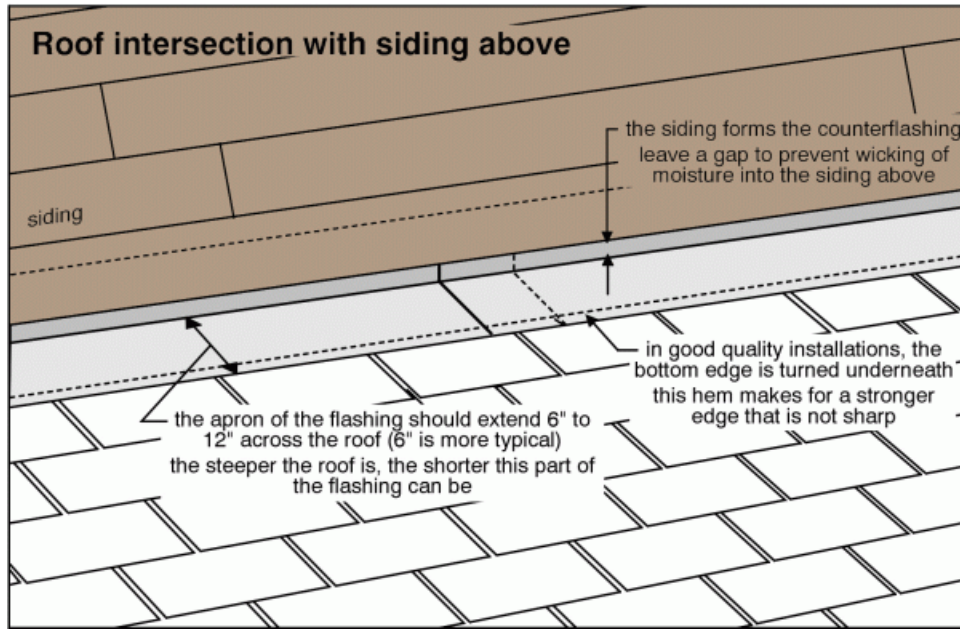
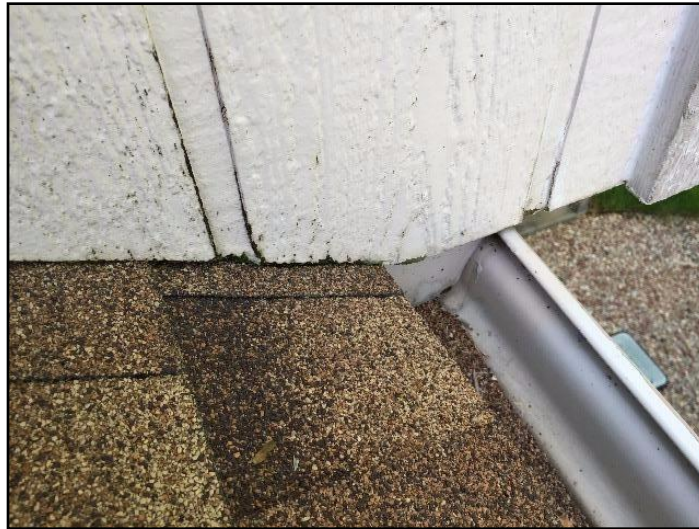
4. Siding not cut back

3. Condition: • [Siding not cut back](#)

Signs of rotting on siding above roof covering. Recommend further evaluation by a professional roofing contractor.

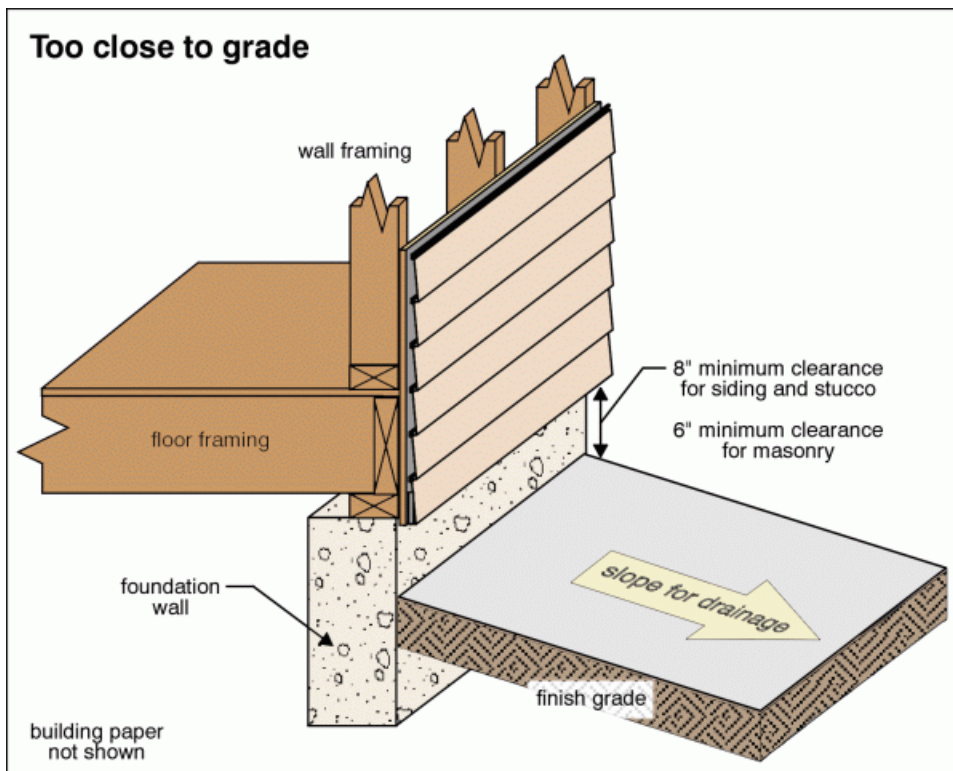
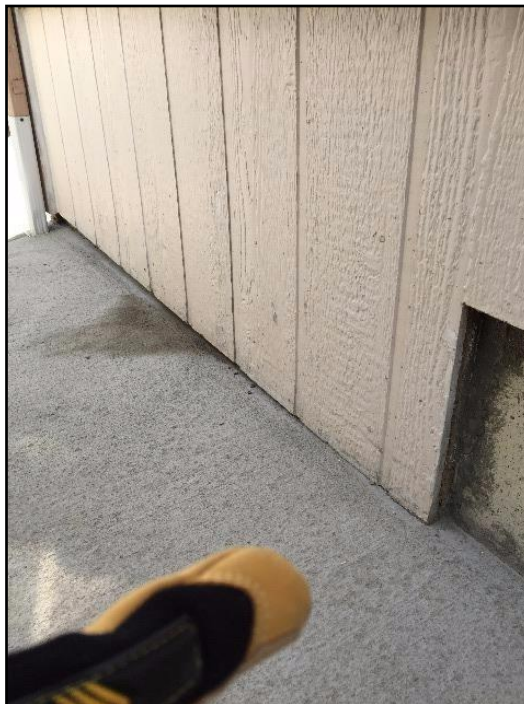
10. Too close to grade

4. Condition: • [Too close to grade](#)

Siding on north side of home is in direct contact with newer portion of driveway. Recommend a qualified contractor make repairs and replacements to prevent further damage to siding.

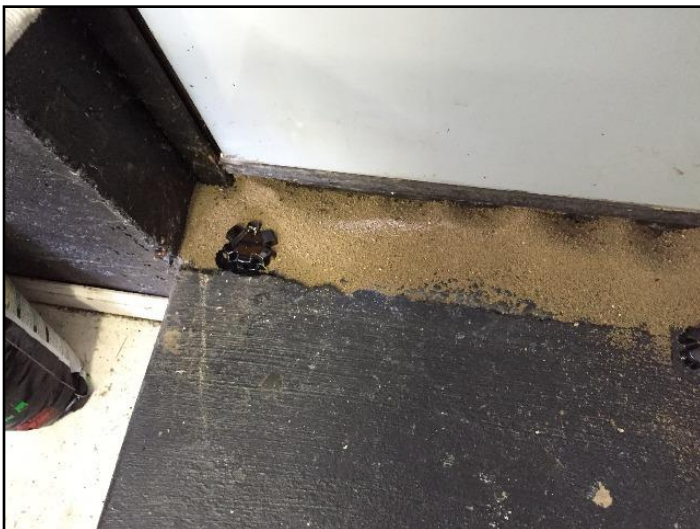
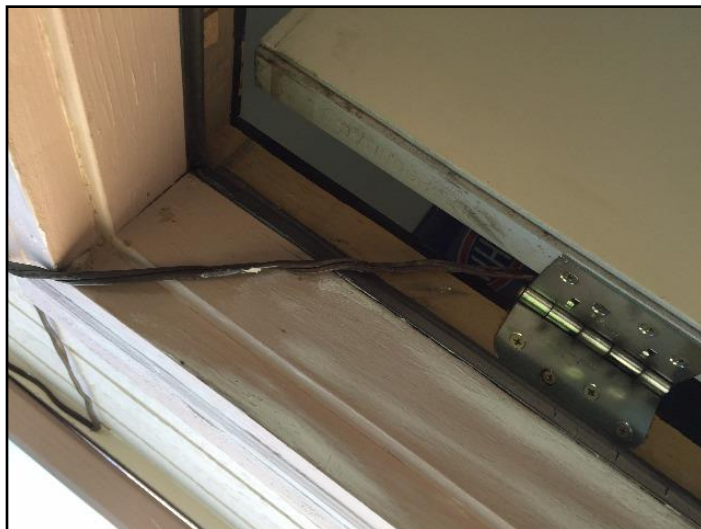
5. Condition: • Weather stripping on exterior door leading into garage is deteriorating and cable found improperly leading through door. Also, ants have entered the garage at the base of the door. Recommend a qualified contractor replace the weather stripping or entire door.

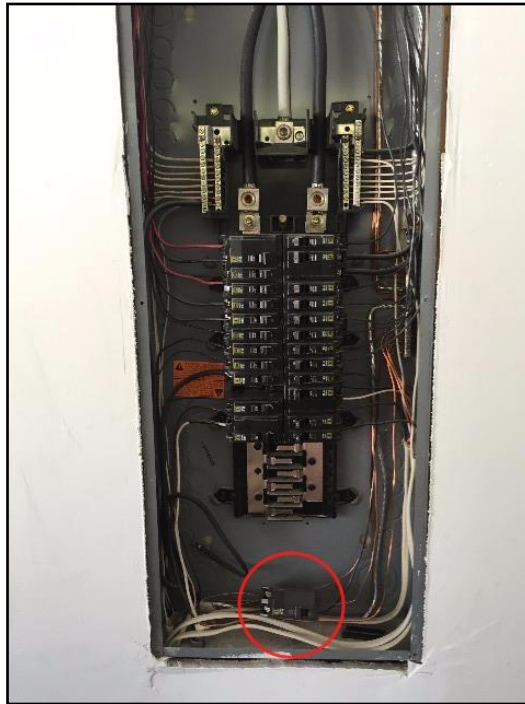
16. Loose breakers or fuses

6. Condition: • [Loose breakers or fuses](#)

Extra breaker found resting at bottom of panel. Recommend further evaluation by a licensed and qualified electrician.

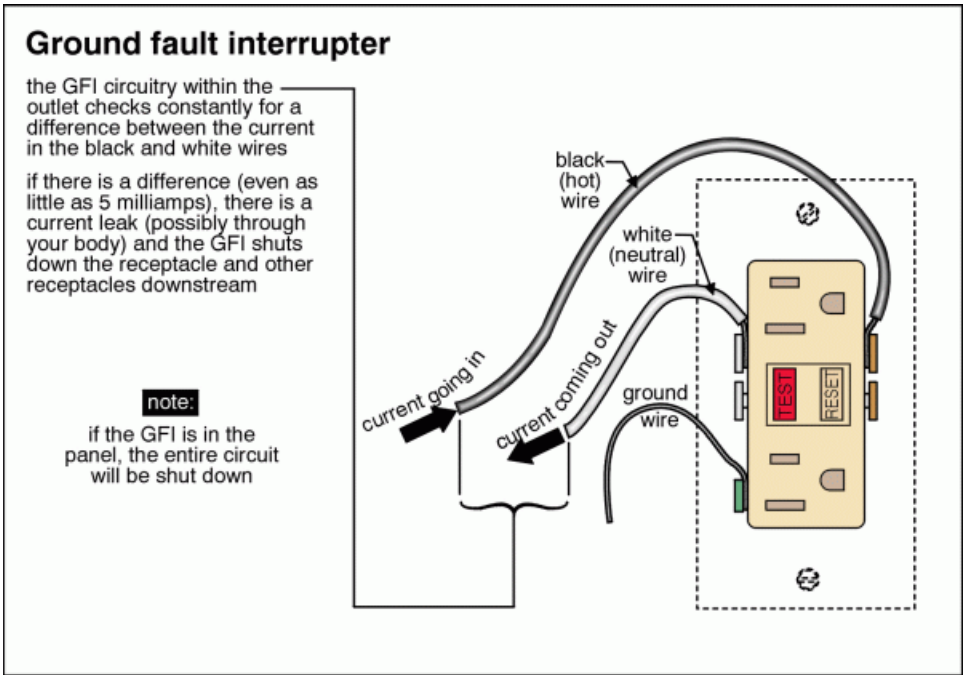
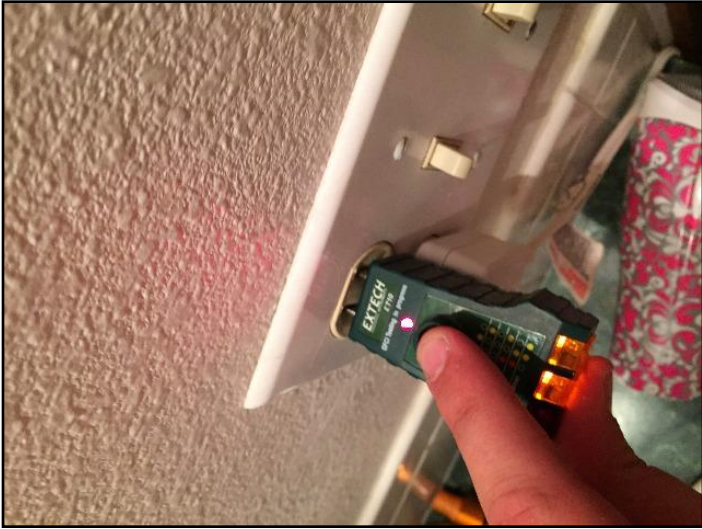
17. No GFI (Ground Fault Interrupter)

7. Condition: • [No GFI \(Ground Fault Interrupter\)](#)

Current standards call for GFCI protected outlets in bathrooms. Outlet near sind in basement bathroom was not GFCI protected. Recommend replacement by a licensed electrician.

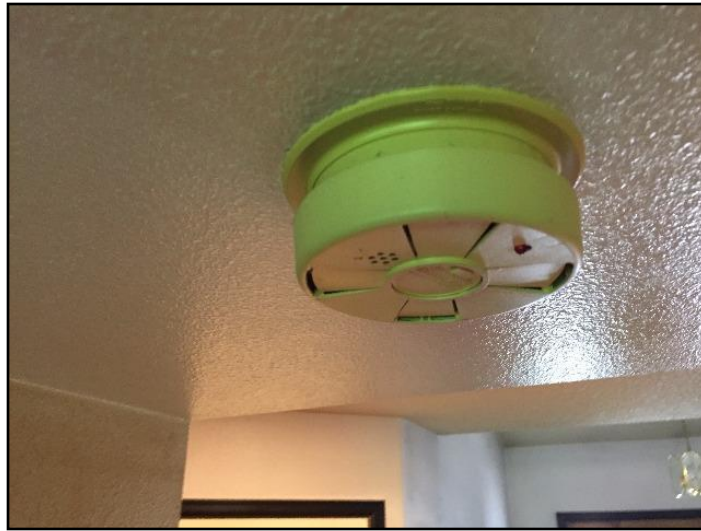
18.

8. Condition: • Smoke detector near end of life expectancy.

Implication(s): When smoke detector plastic turns yellow it is a sign that they are at the end of life and should be replaced.

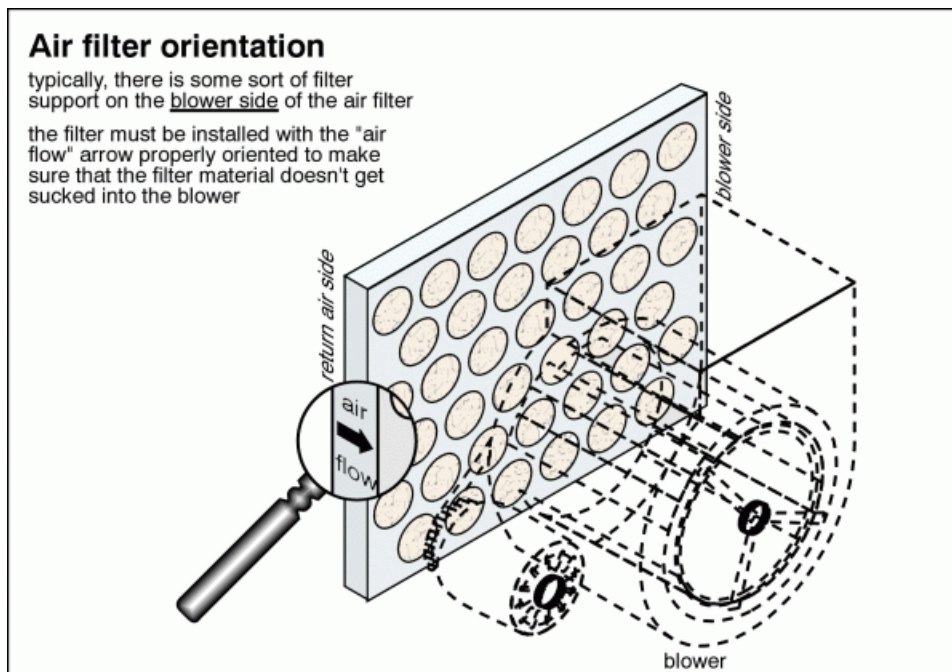
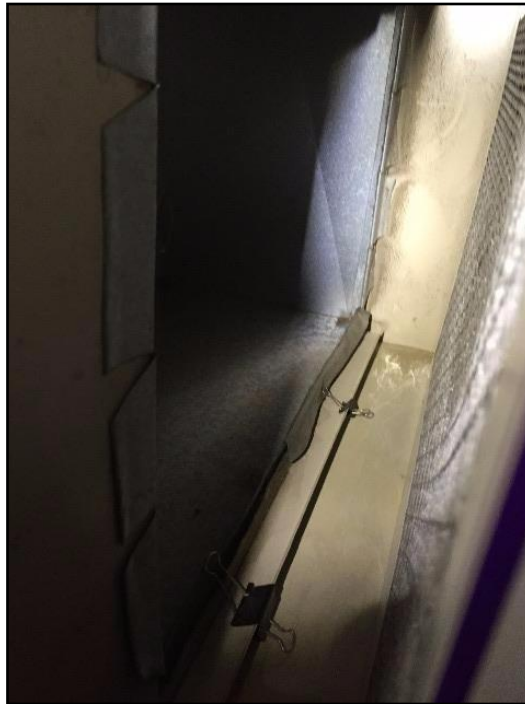
20. *Loose or collapsed*

10. Condition: • [Loose or collapsed](#)

Air filter not installed correctly. Recommend correctly installing filter in channel provided up against the return air supply.

Monitor monthly and replace when dirty

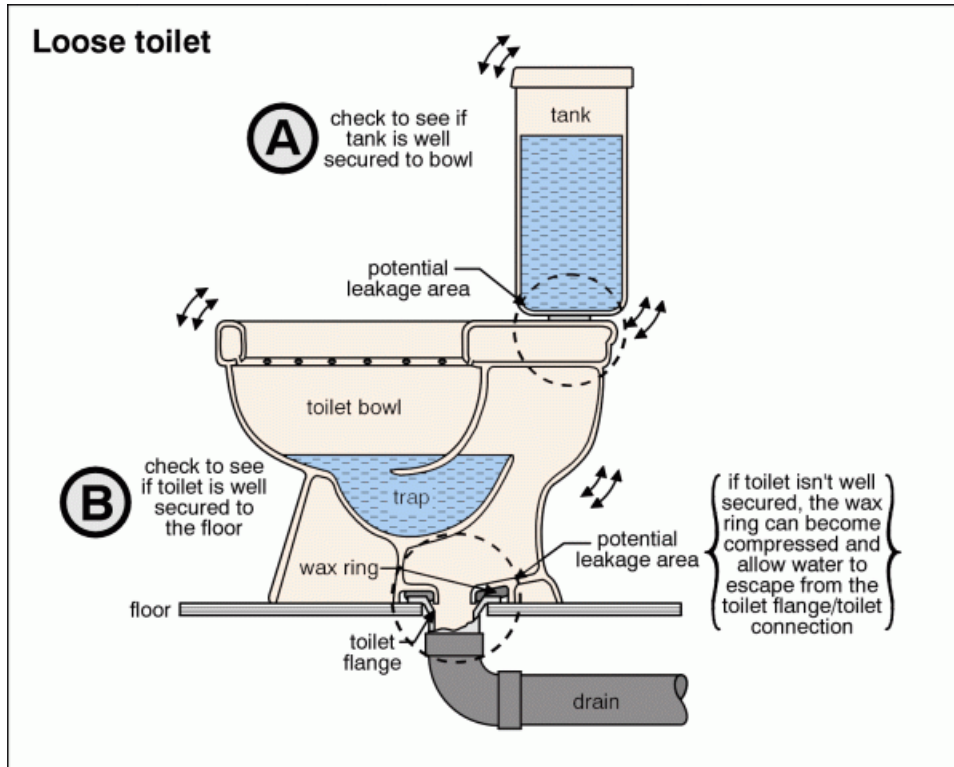
25. Loose

12. Condition: • Loose

Location: Basement Bathroom

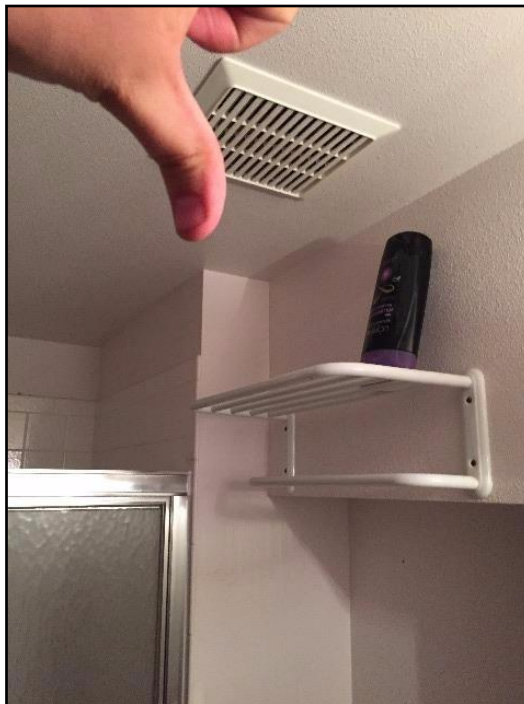
28. Inoperative

13. Condition: • [Inoperative](#)

Ventilation fan in basement bathroom was inoperative at the time of inspection. Recommend repair or replacement by a qualified professional.

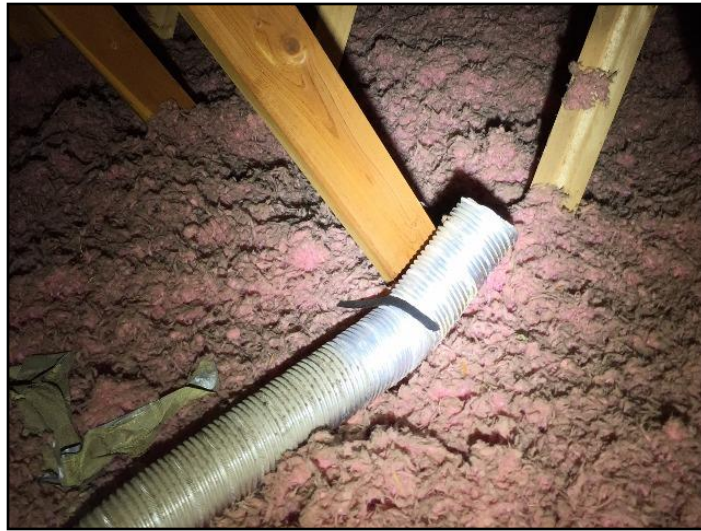
29. *Not well secured*

14. Condition: • Not well secured

The bathroom fan was observed to exhaust into the attic, which is an improper INSTALLATION. The fan should be vented to the exterior, either through the roof or through an outside wall, rather than to the soffit vent at the eaves of the roof. The present installation permits the bathroom fan to vent moisture into the attic space, which can reduce the R-value of the insulation, and promote mildew and mold growth on the underside of the roof sheathing. Recommend correction of the bathroom fan vent so that it exhausts to the exterior.
