Common Construction

by Pete Fowler

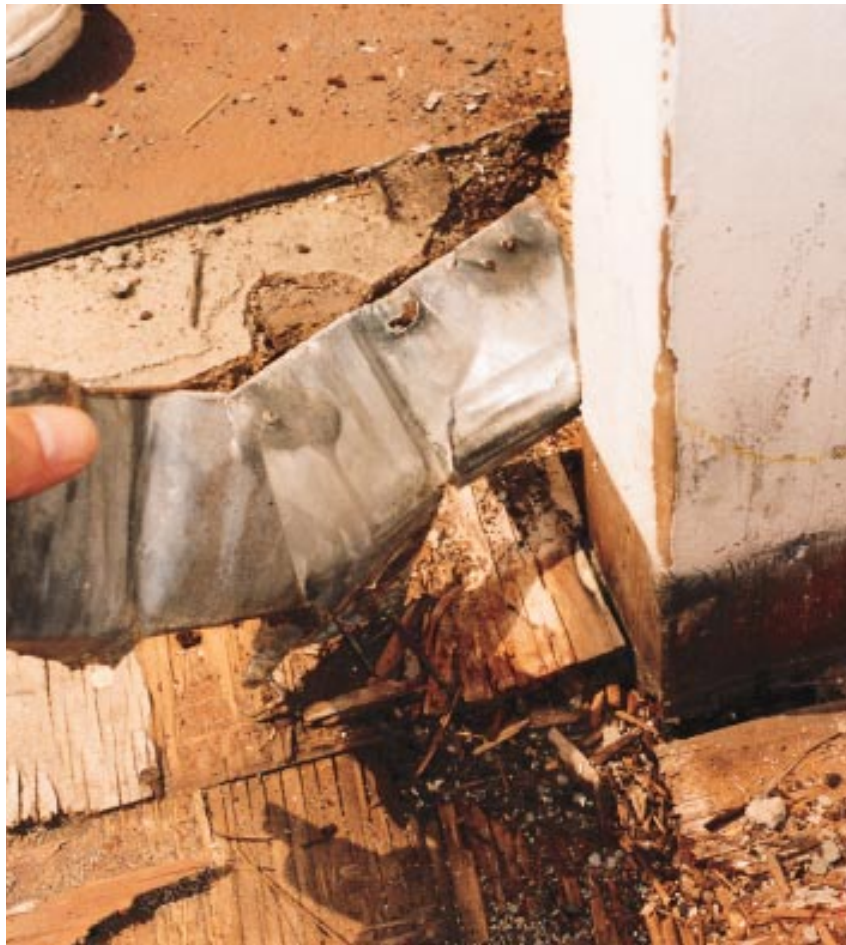
Since the early 1990s, the Southern California building industry has been engulfed in a bitter fight. Spawned by sub-standard construction during the region's 1980s building boom, construction defect litigation has become a full-

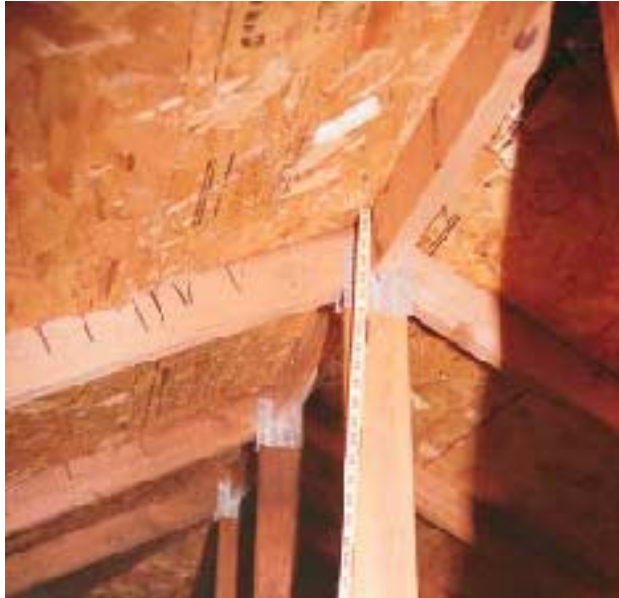
been so thoroughly scrutinized.

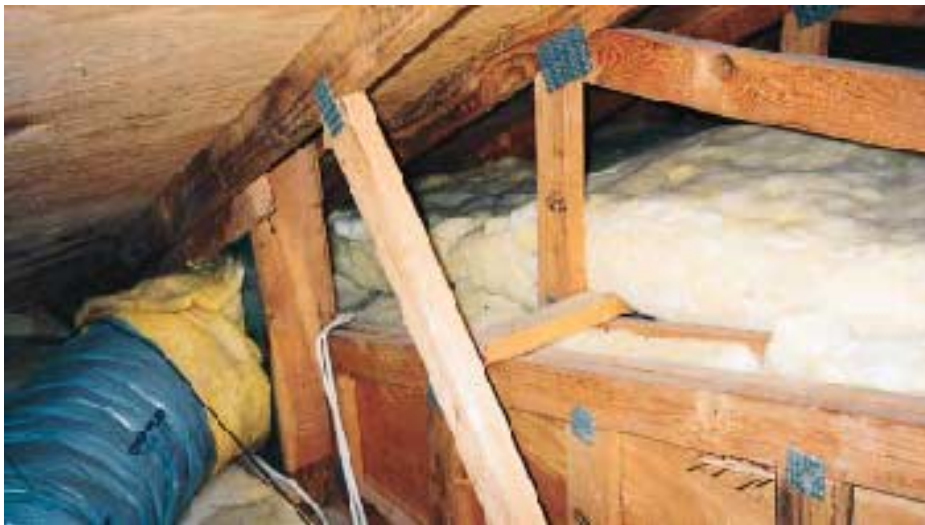
Figure 2. The plywood on this interior shear wall should have been carried all the way to the roof diaphragm.

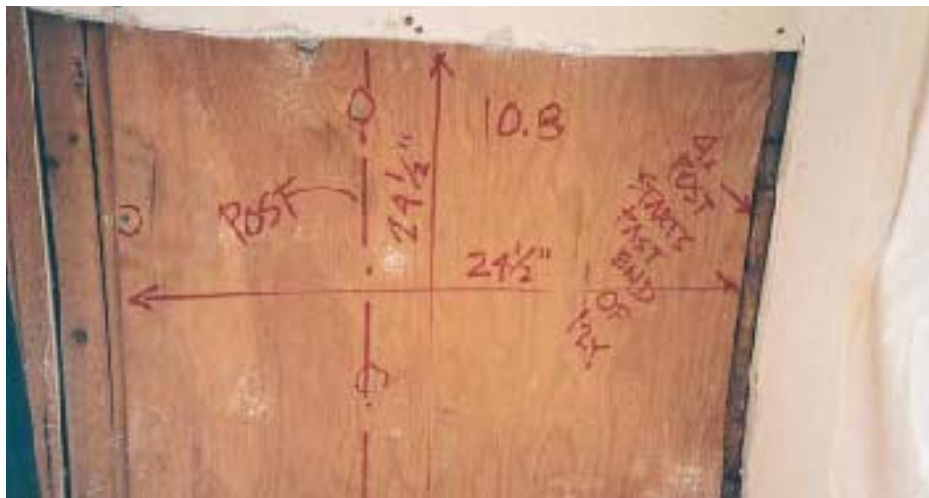
Figure 3. This shear plywood falls short of the shear wall posts on the right and left, and is attached with too few nails.

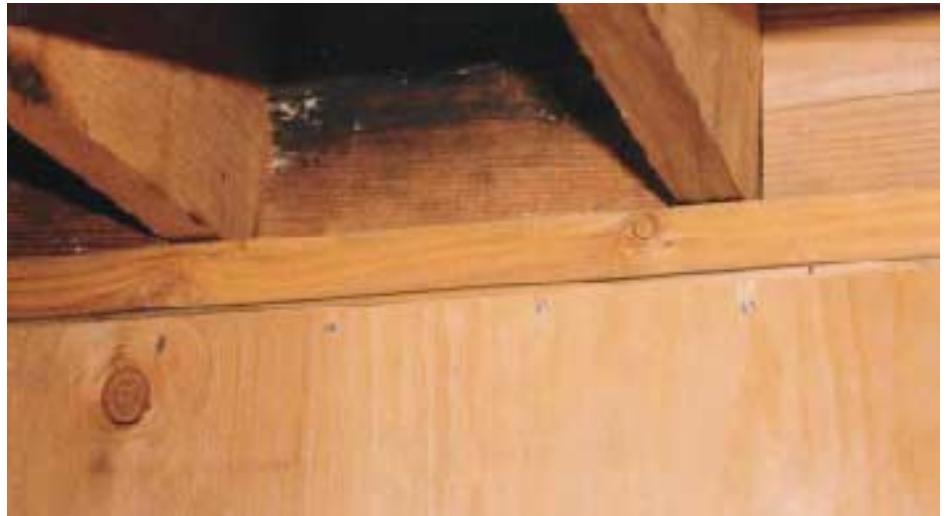
Figure 4. This shear plywood should have extended to the top of the double top plate — a mistake that can be remedied with the addition of metal connectors across the two plates.

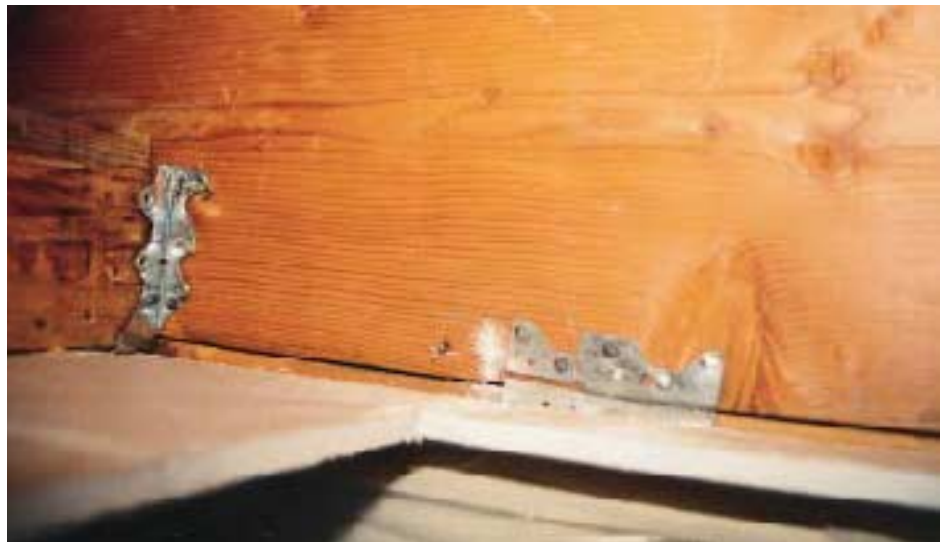
Figure 6. An inspection made through a hole cut in the ceiling reveals that the joist hanger at left is bent and missing nails.

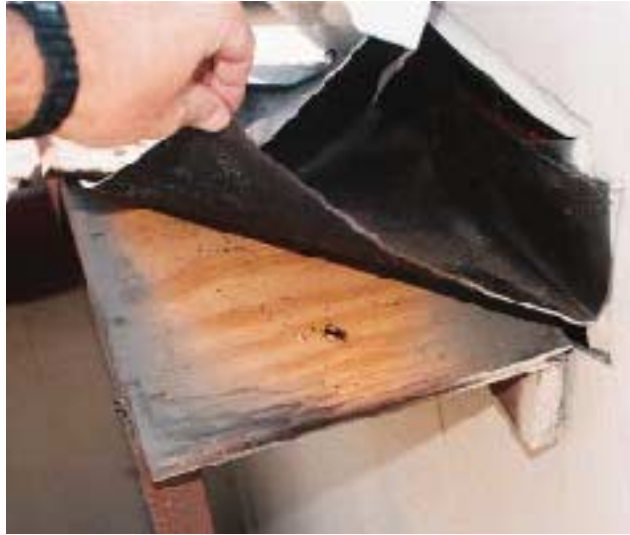
Figure 8. A raised fascia board (illustration) requires a heavy metal flashing or cant strip to ensure that runoff passes over the edge. Otherwise, water will pond, as in the photo, resulting in leaks and rot in the eaves.

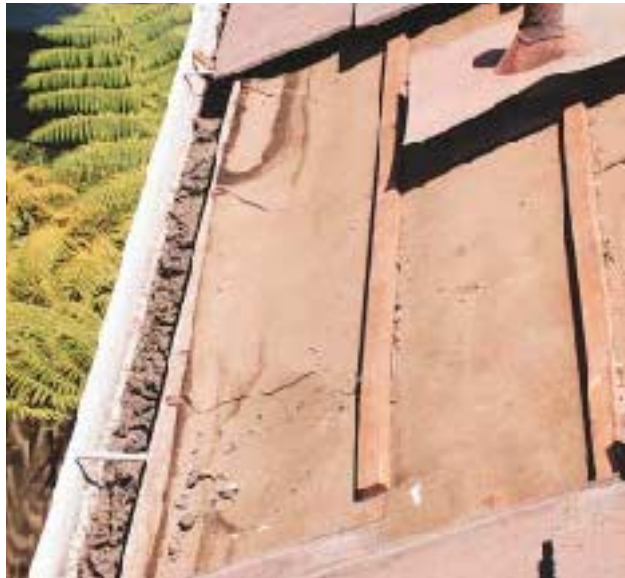
Raised Fascia Flashing

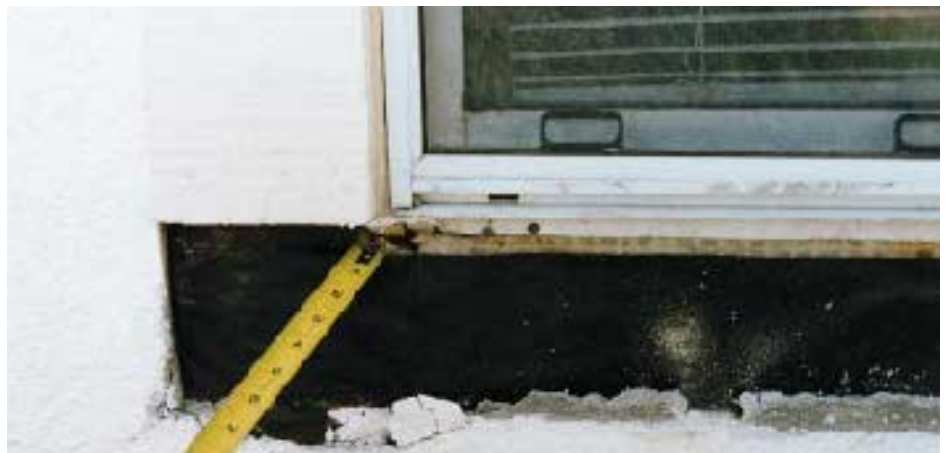
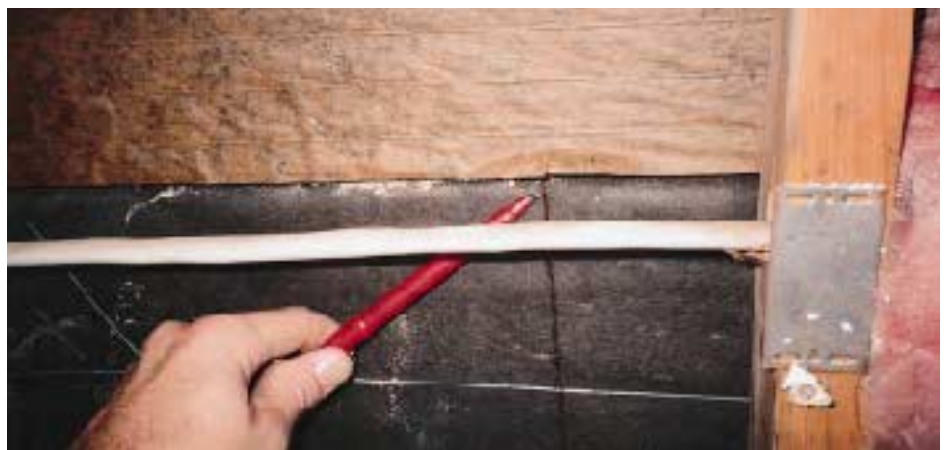
Figure 9. The building paper below a window must be tucked below the flashing paper — a detail often botched, as in the top photo. Above is a reverse lap seen from the inside of the wall cavity.

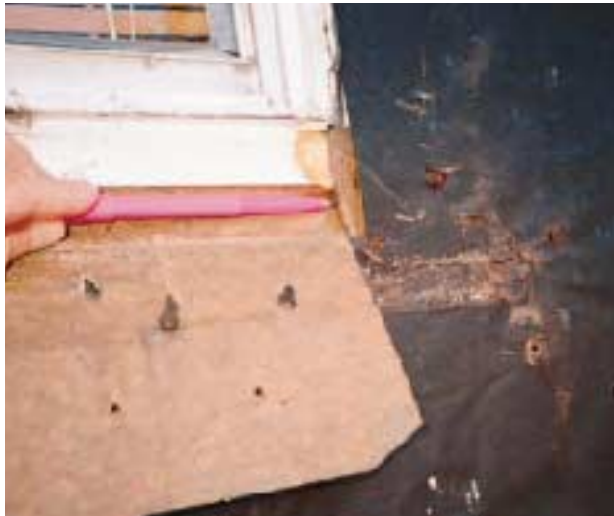
There is a remarkable shortage of detailed information regarding the flashing and intersection details that cause so many of the problems encountered in construction defect litigation. Most installation specifications and code documents make general statements about the application of plaster or proper cement mixes but do not make detailed recommendations for waterproofing penetrations other than windows, even though they plainly state that “stucco plaster should not be considered waterproof.”

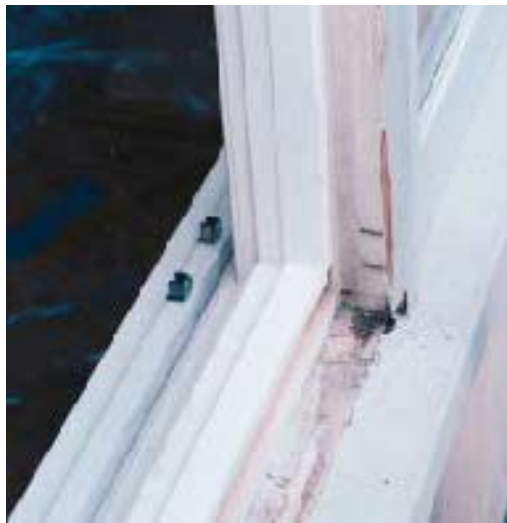
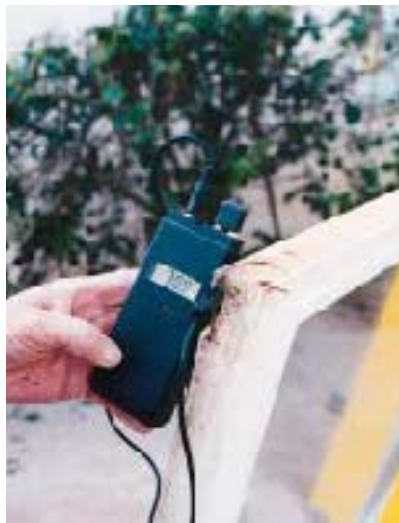
Figure 11. Wood windows should be painted on all raw wood surfaces. Otherwise, they will pick up excessive moisture (as the moisture meter reading in the photo at right shows), causing them to swell or even rot.

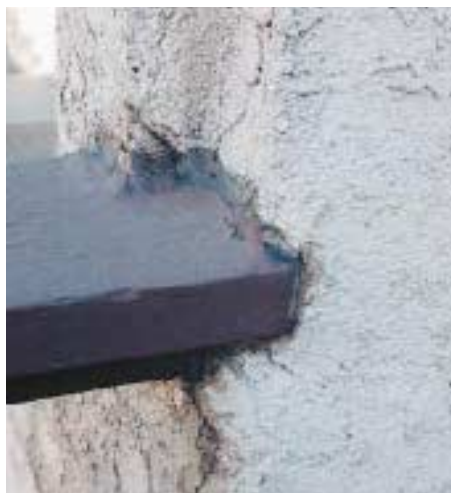
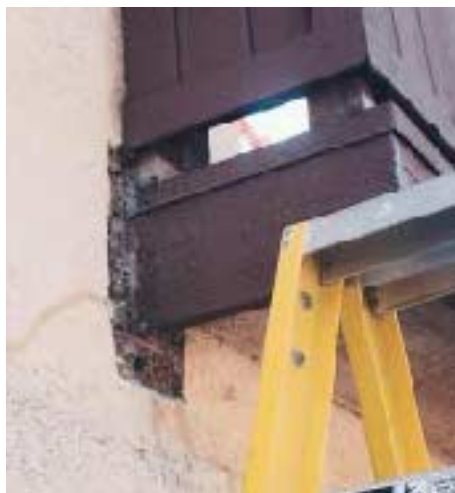
Figure 12. Framing protrusions, such as handrails (left) and cantilevered joists (right), are difficult to flash properly, inevitably leading to moisture intrusion, cracked stucco, and decay in the structure below.

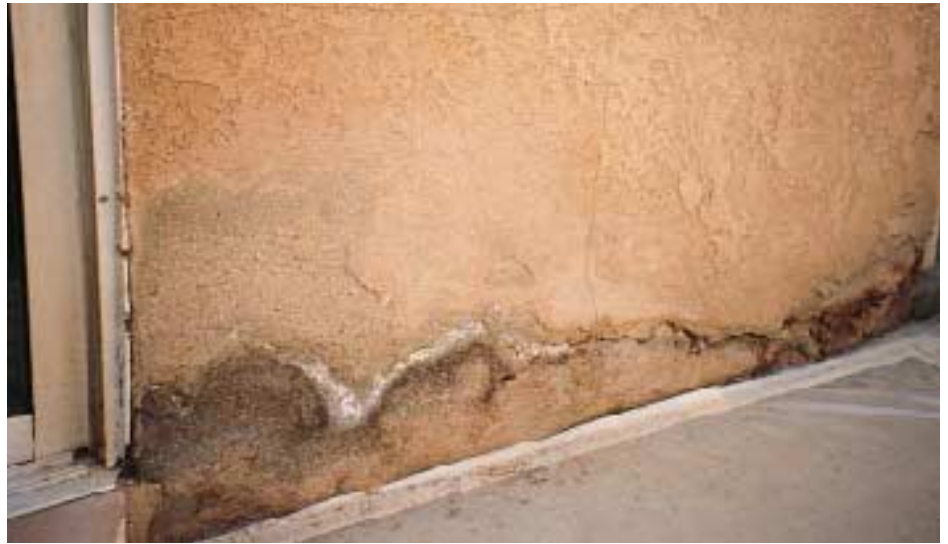
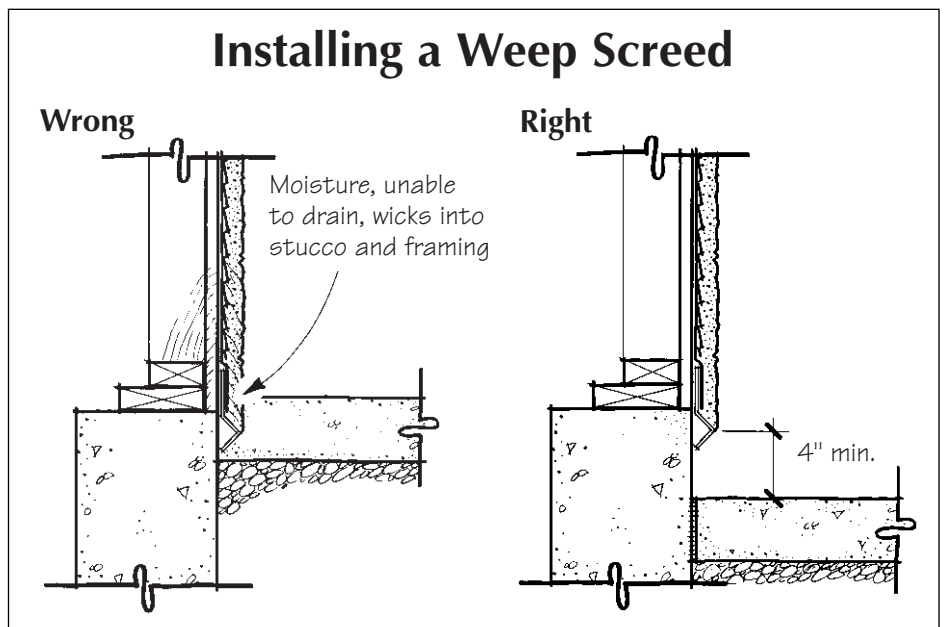
Figure 13. The stucco at the bottom of this wall (photo, top) should have terminated with a weep screed above grade rather than being buried behind an outdoor patio slab.

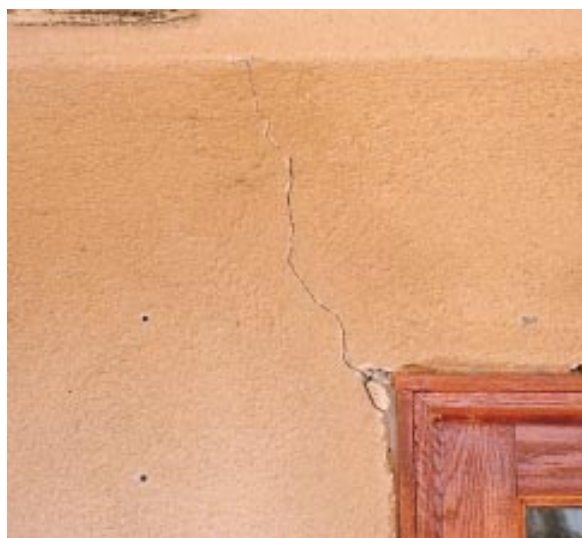
Figure 14. Stucco cracking is one of the most common customer complaints. Tight surface cracks are normal in stucco and can usually be repaired. With quality workmanship, larger cracks can be avoided.

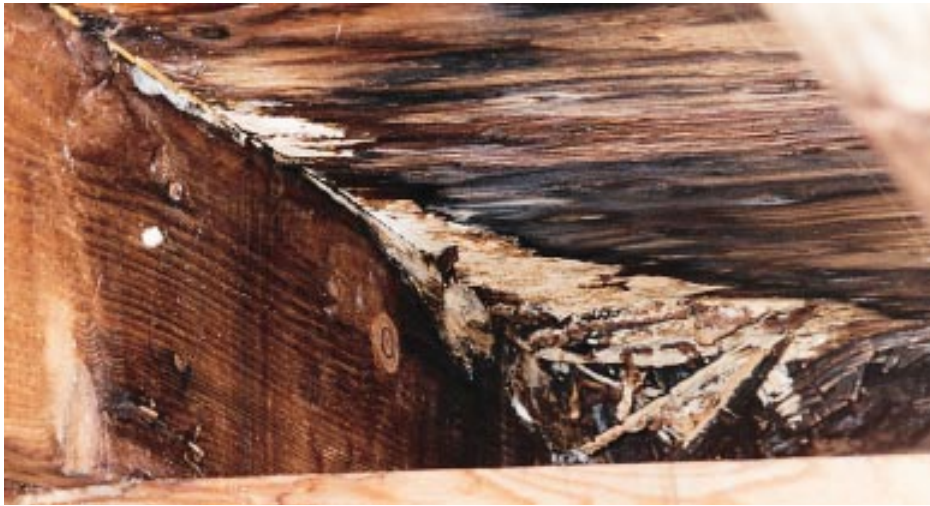
Figure 15. Because waterproof decks are difficult to detail properly, rotting substructure is a common defect.

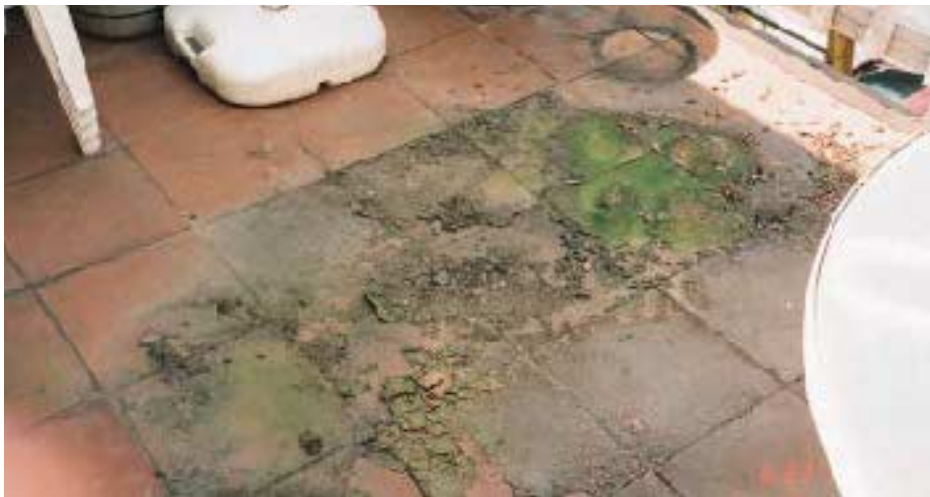
Figure 16. Besides ruining the finish surface, ponding on waterproof decks also leads to deterioration of the framing below.

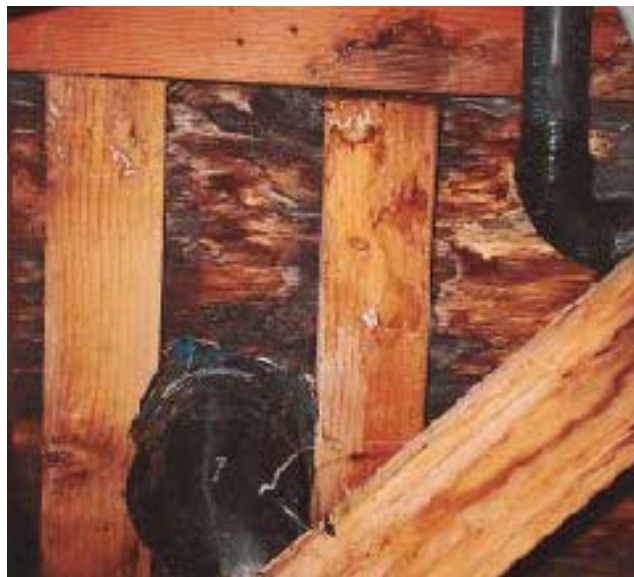
Figure 17. If hidden by finish surfaces, a leaky toilet connection can go undetected until structural decay sets in.

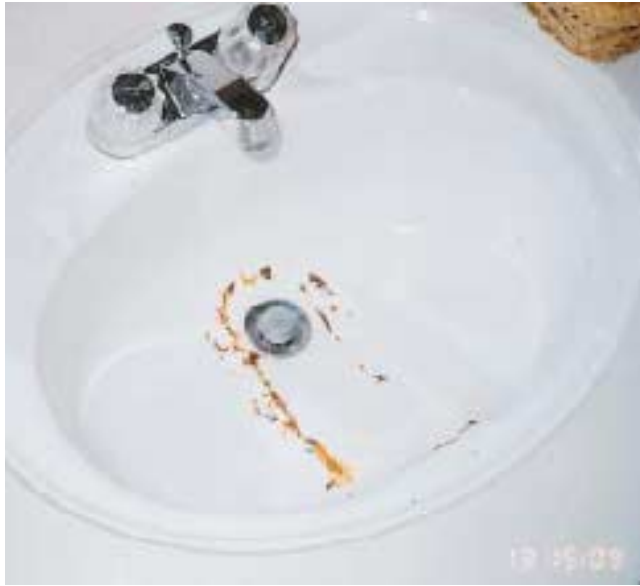
Figure 18. The chipped enamel in this cheap lavatory sink is the kind of defect that will send condo or tract homeowners ballistic — especially when they see it in every home on the block.

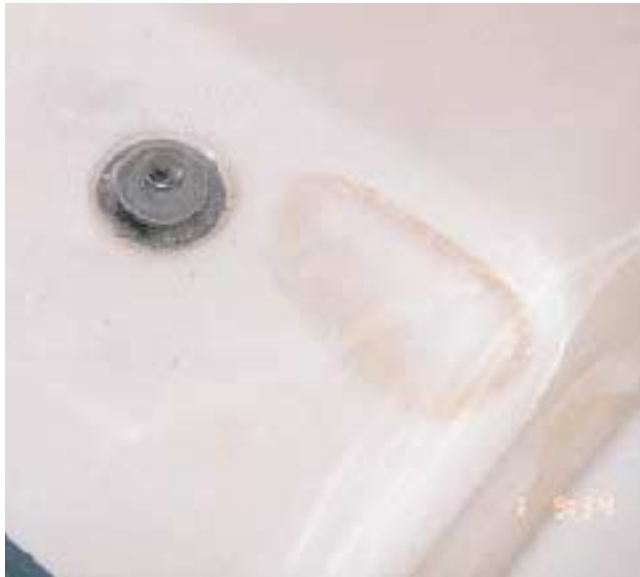
Figure 19. Ponding in the bottom of a tub unit — the result of an out-of-level installation — is not structurally serious but is obvious to any homeowner.

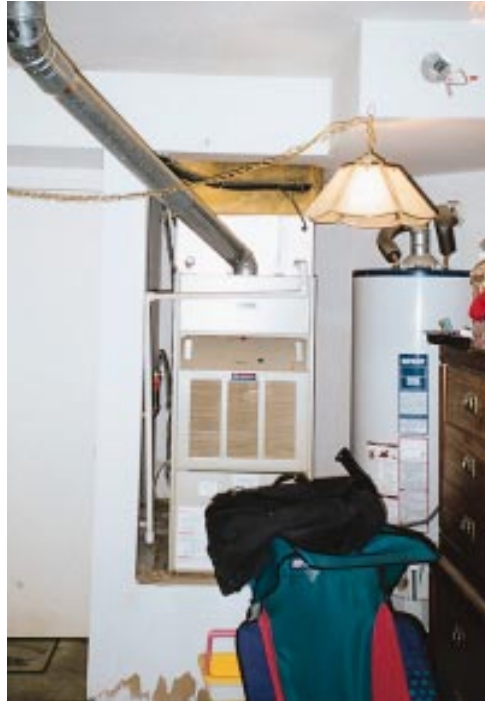
bustible materials and to follow the manufacturer's installation instructions, which will usually state this requirement very clearly. If you purchase the device and the flue separately, always use the flue recommended by the manufacturer of the appliance.

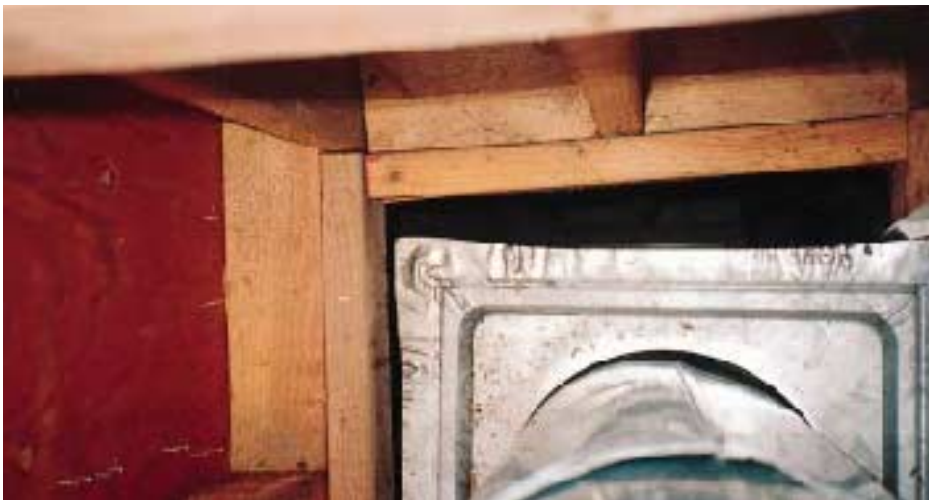
Figure 22. Firestops are an important safety requirement. Unfortunately, if a gap is missed by the inspector, all too often it will be permanently concealed from view.

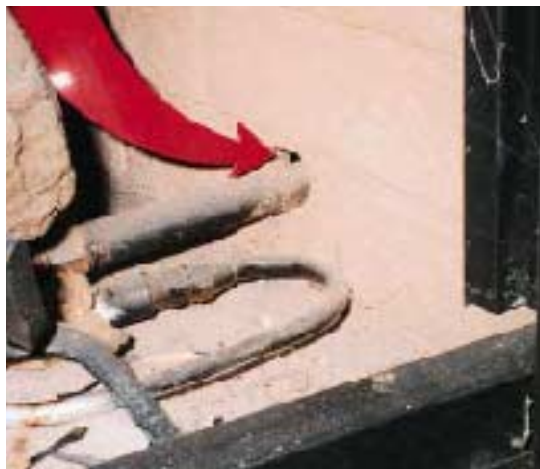
Figure 23. The pipe penetration into a gas fireplace must be properly sealed with a firestop material — a defect that's easy to spot and easy to fix with fireproof grout.
