SEISMIC RETROFIT  
OF UNREINFORCED  
MASONRY HERITAGE  
CHURCHES IN THE  
PHILIPPINES

JANUARY 13 – 14, 2016

# Global Seismic Responses of Unreinforced Heritage Masonry Construction

prof. eng. Claudio Modena

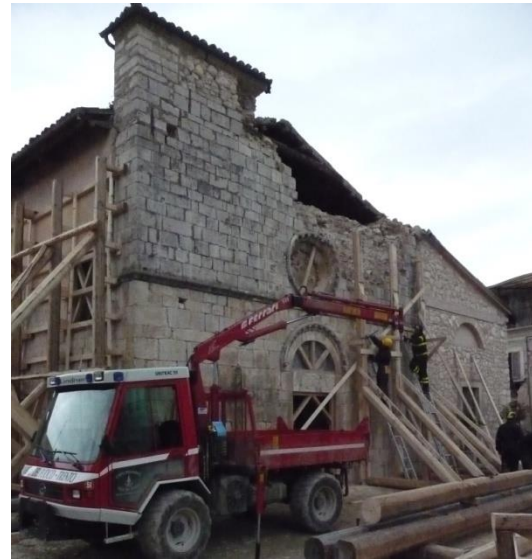
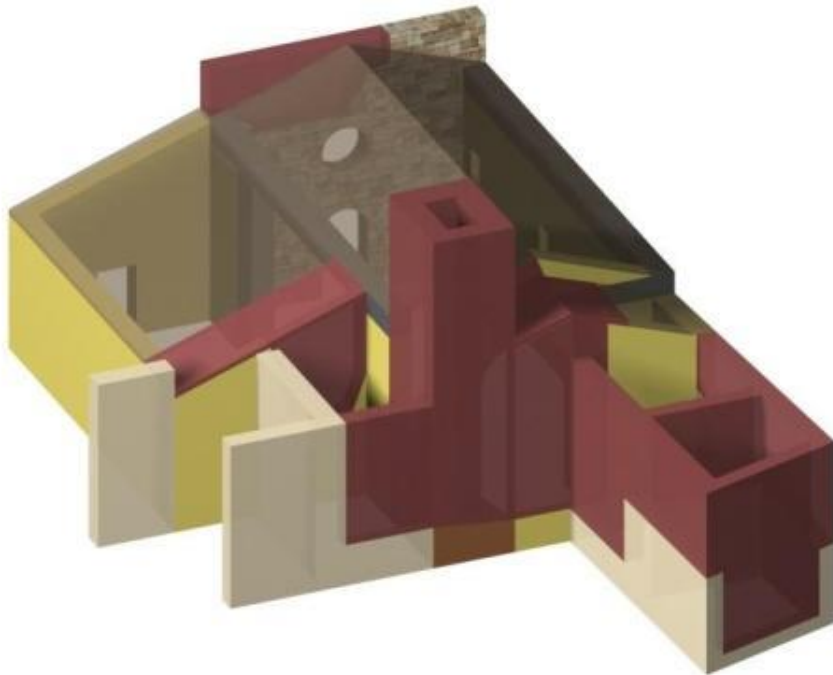
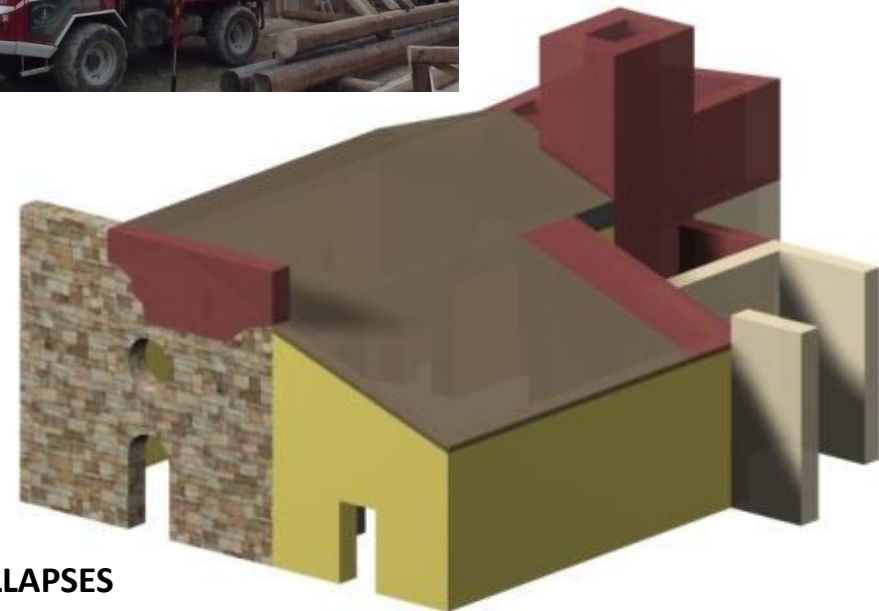
**SCHEMATIZATION OF THE MAIN COLLAPSES**

The damage survey was performed to define the structural faults that, among the structural features, caused the collapses and the severe damages.

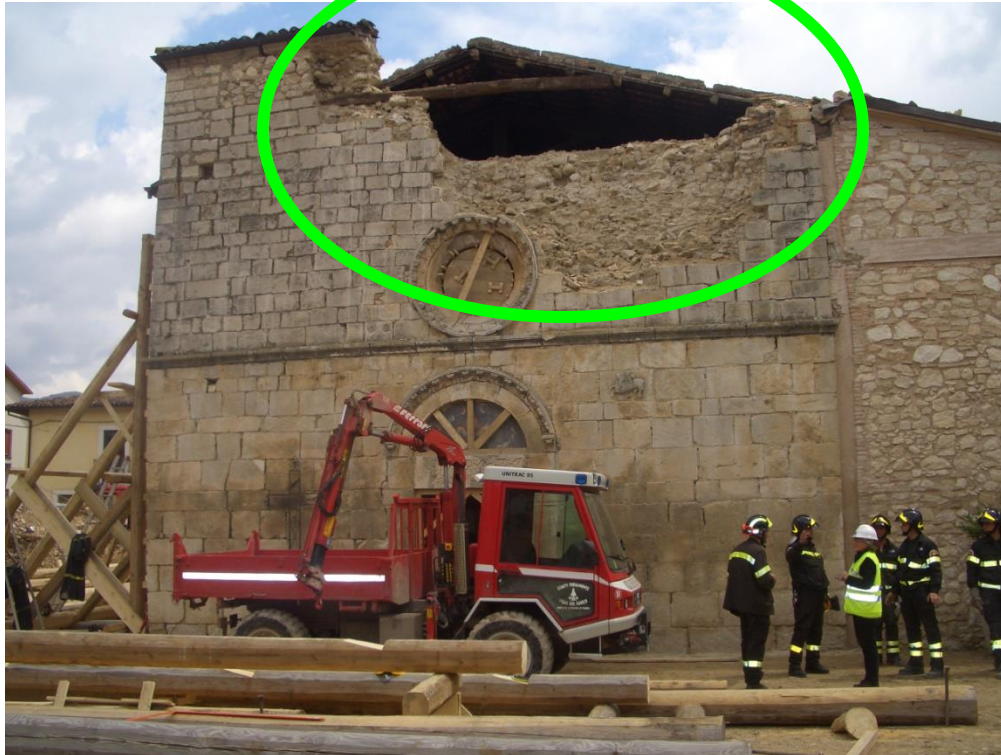
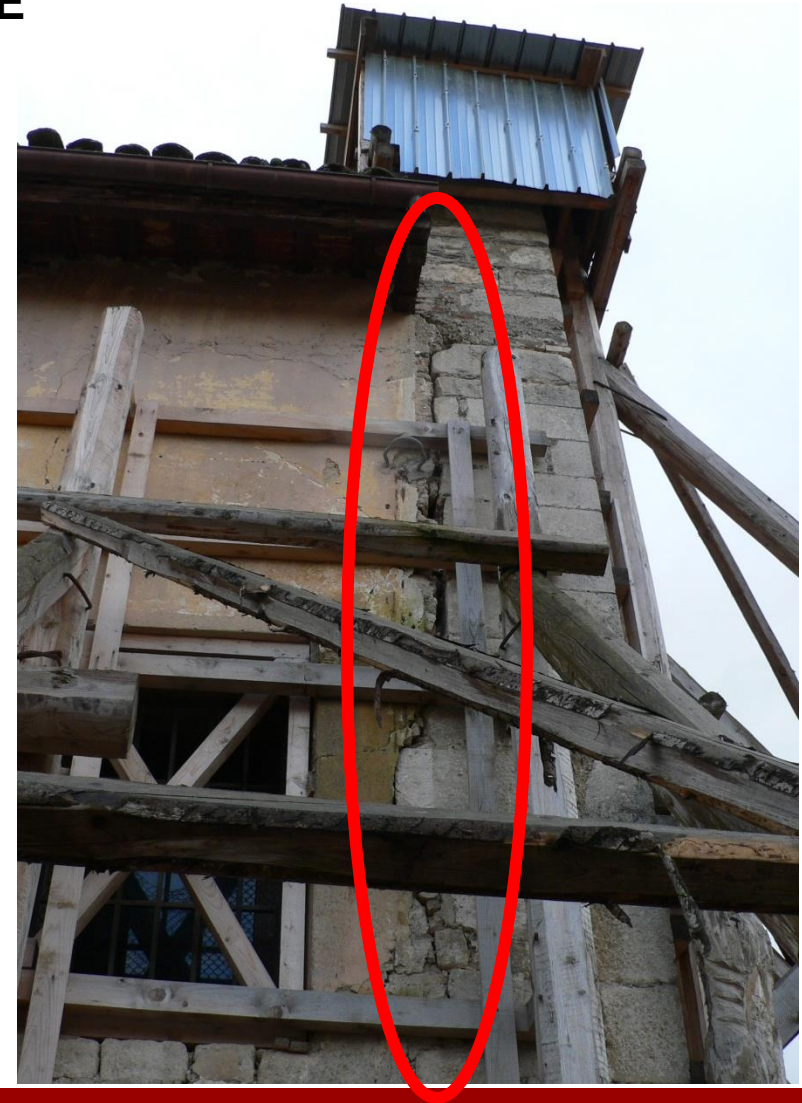
### St. Pietro Apostolo – Onna, L'Aquila: FAÇADE

The façade showed a double damage mechanism:

-the global overturning:

-the overturning of the upper part (that collapsed).

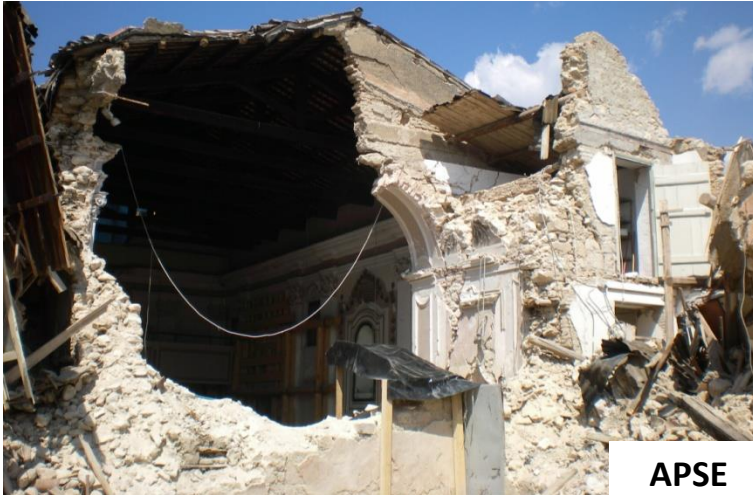
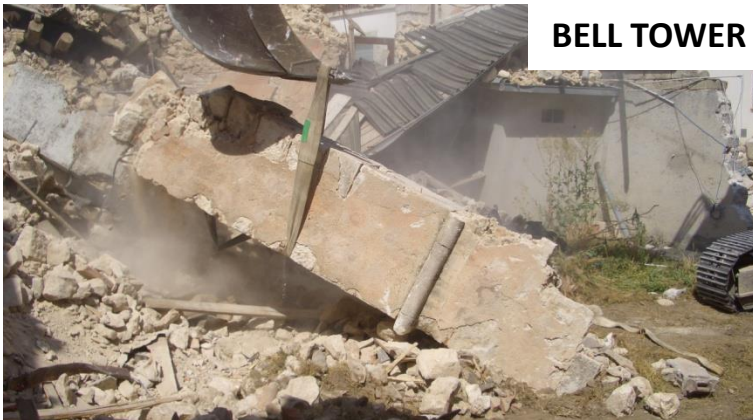
### St. Pietro Apostolo – Onna, L’Aquila: APSE AND BELL TOWER

The most severe damages are concentrated into the apse and bell tower, both totally collapsed; only a portion of about 1,5 m height survived.

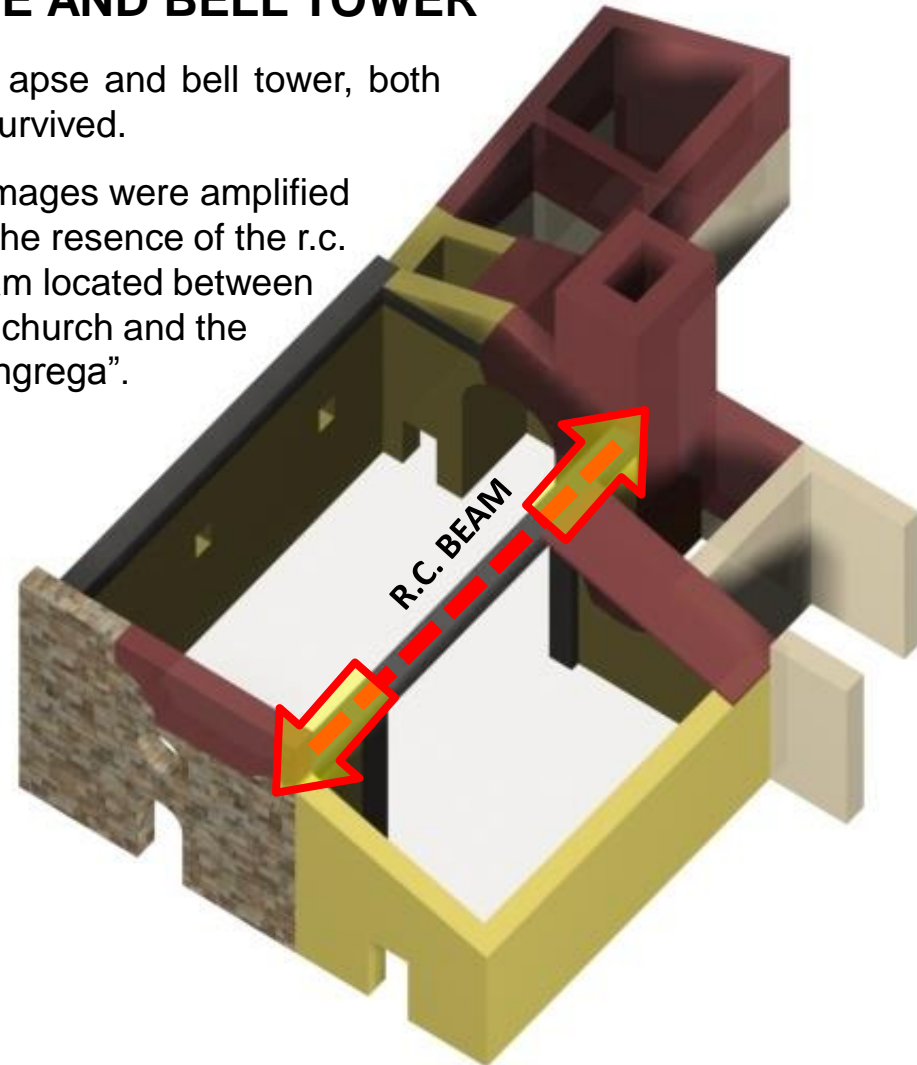
Damages were amplified by the presence of the r.c. beam located between the church and the “congrega”.

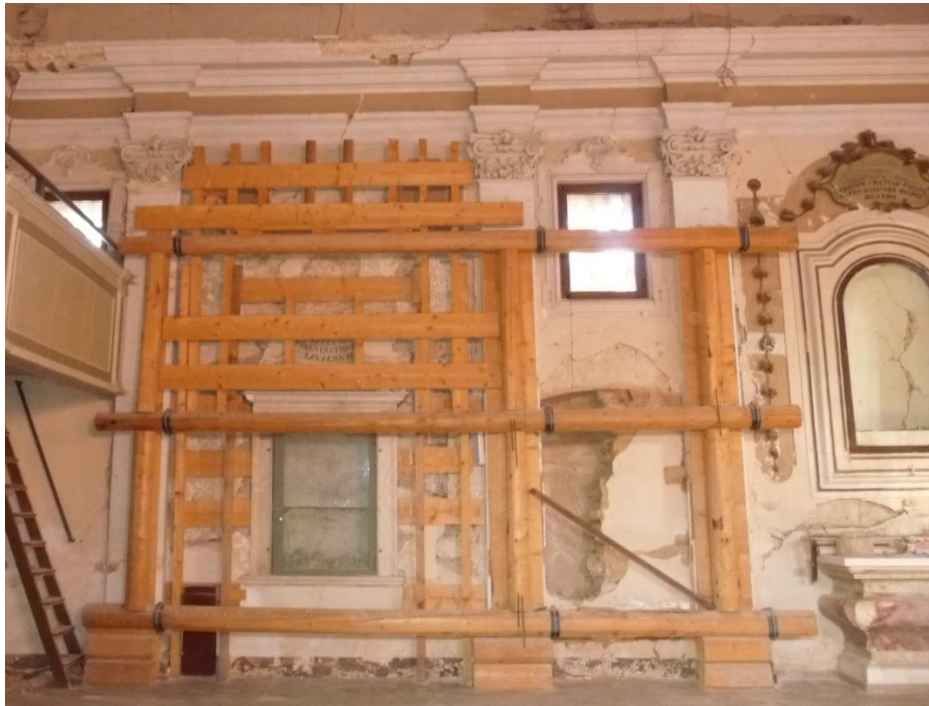
LEFT LONGITUDINAL WALL – PRESENCE OF OPENINGS AND NICHES

The longitudinal walls show the damages due to their in plane behaviour. The presence of several niches and openings worsen the wall property.

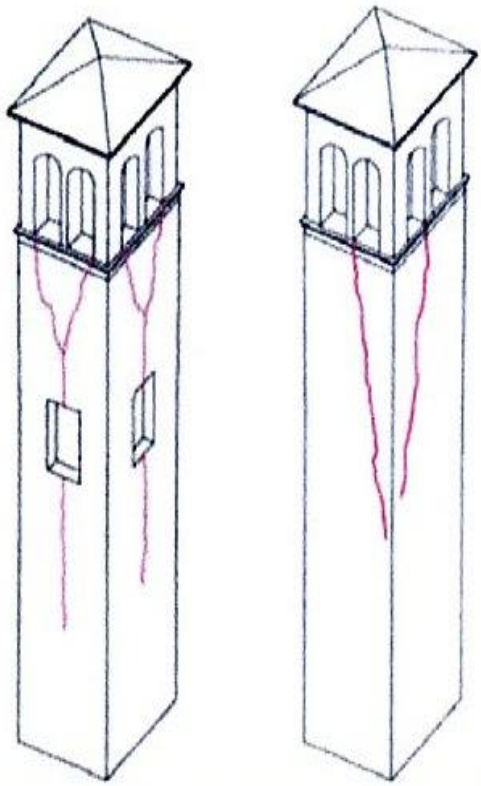
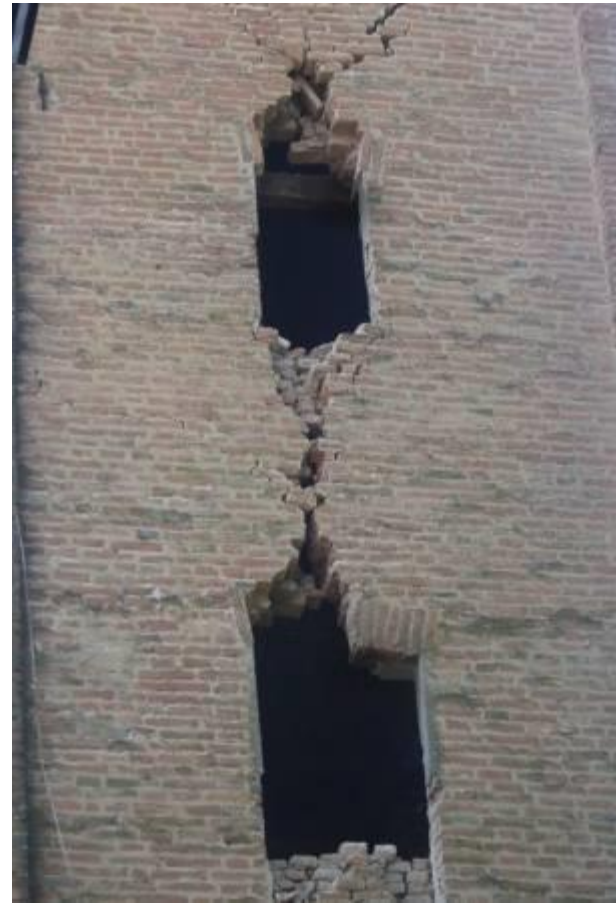
S. Michele - Novi

### Isolated bell towers

vertical cracks

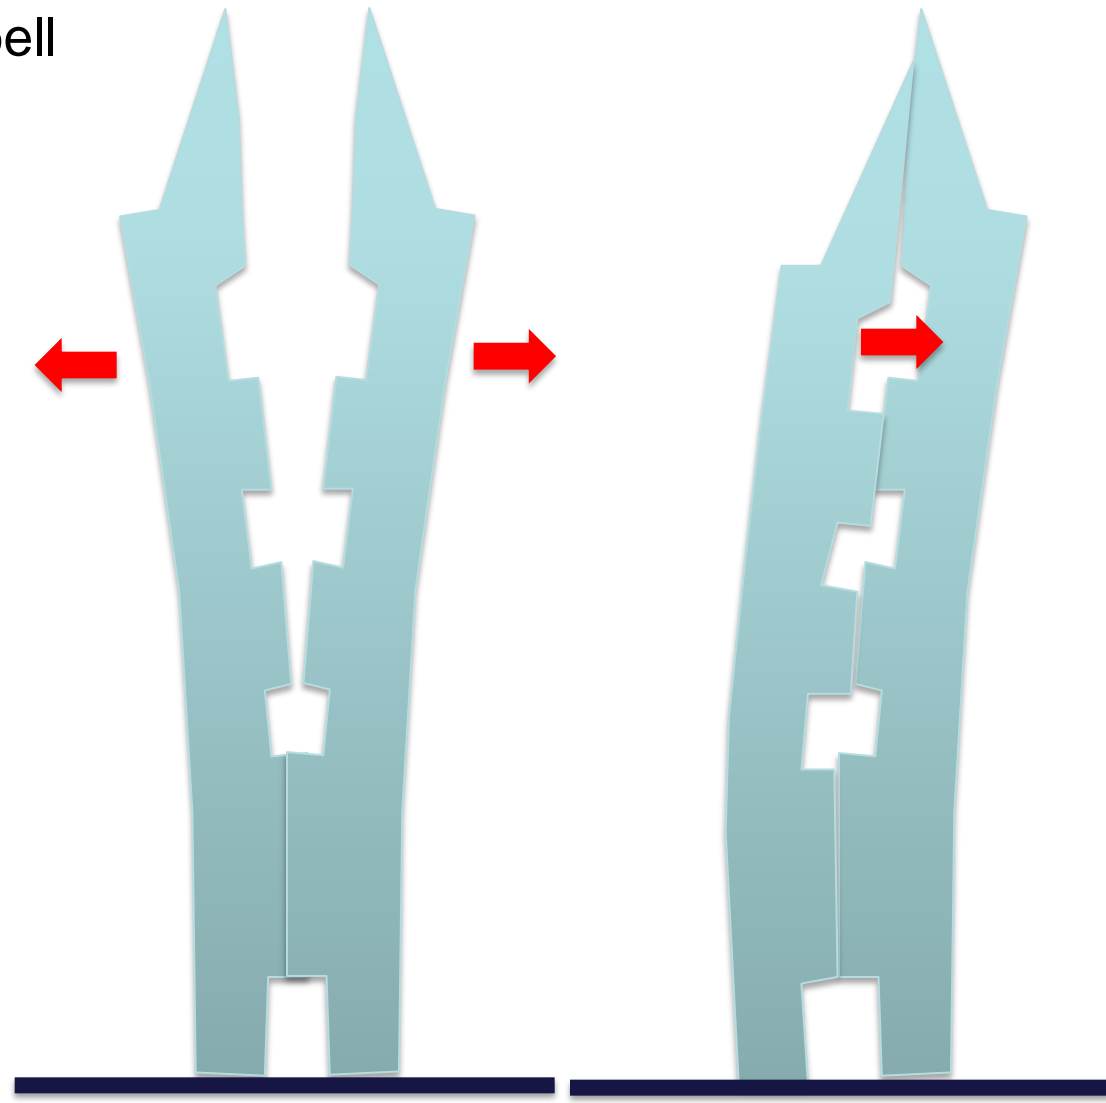
S. Michele - Novi

Isolated bell towers  
vertical cracks

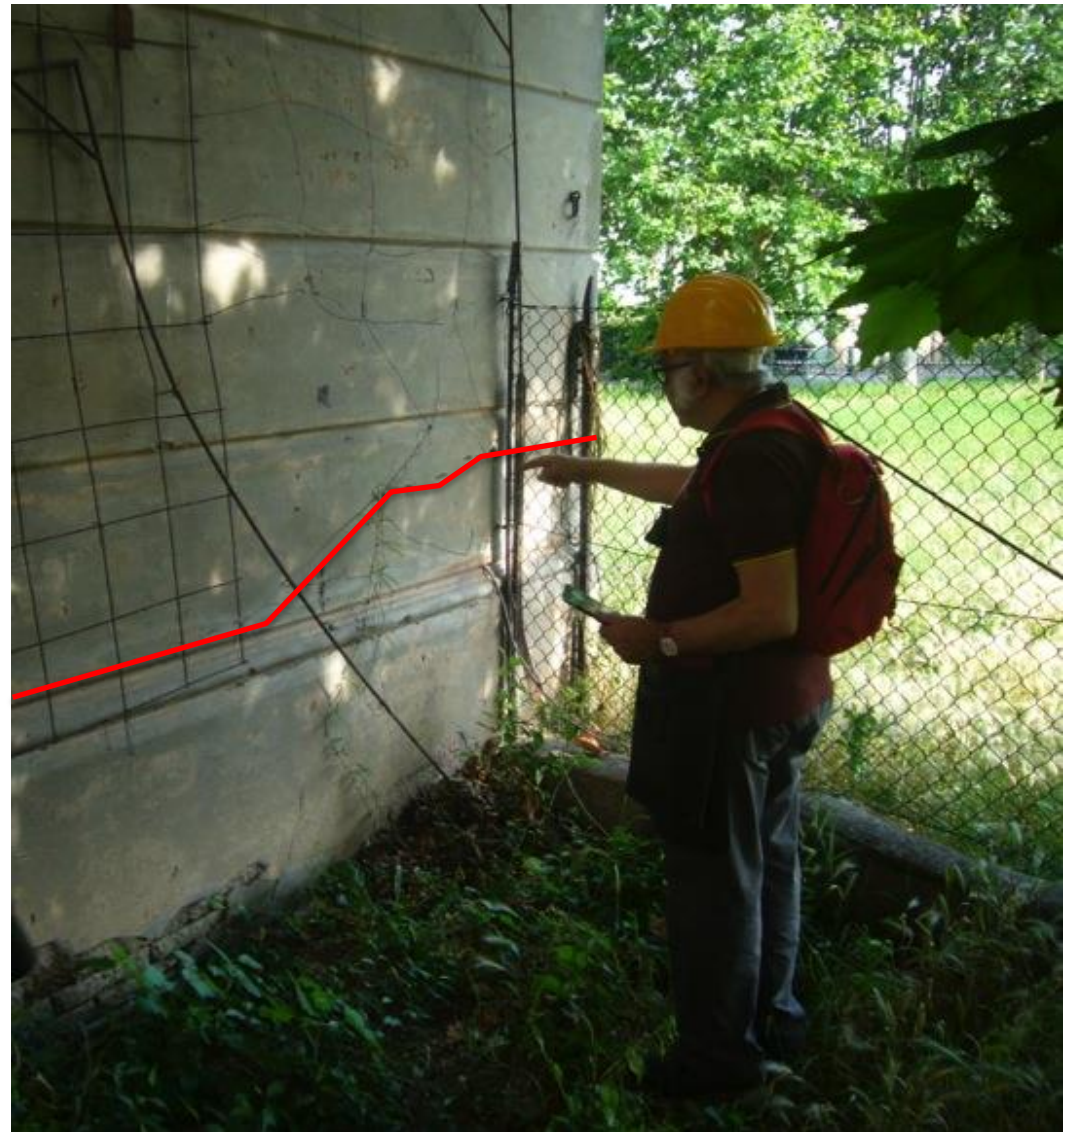
San Giacomo a Roncole

Isolated bell towers  
horizontal cracks
