BOHOL HERITAGE CHURCHES

Summary of Findings & Recommendations - STRUCTURAL

The JV Digiscript and EM2A Partners & Co was commissioned by the National Museum to undertake a detailed investigation of the causative mechanisms, environmental factors (Geology and Geotechnical considerations) to come up with General Conclusions and recommendations on the directions for Repair, remediation and reconstruction for each of the specific 9 Heritage Structures assigned to the JV.

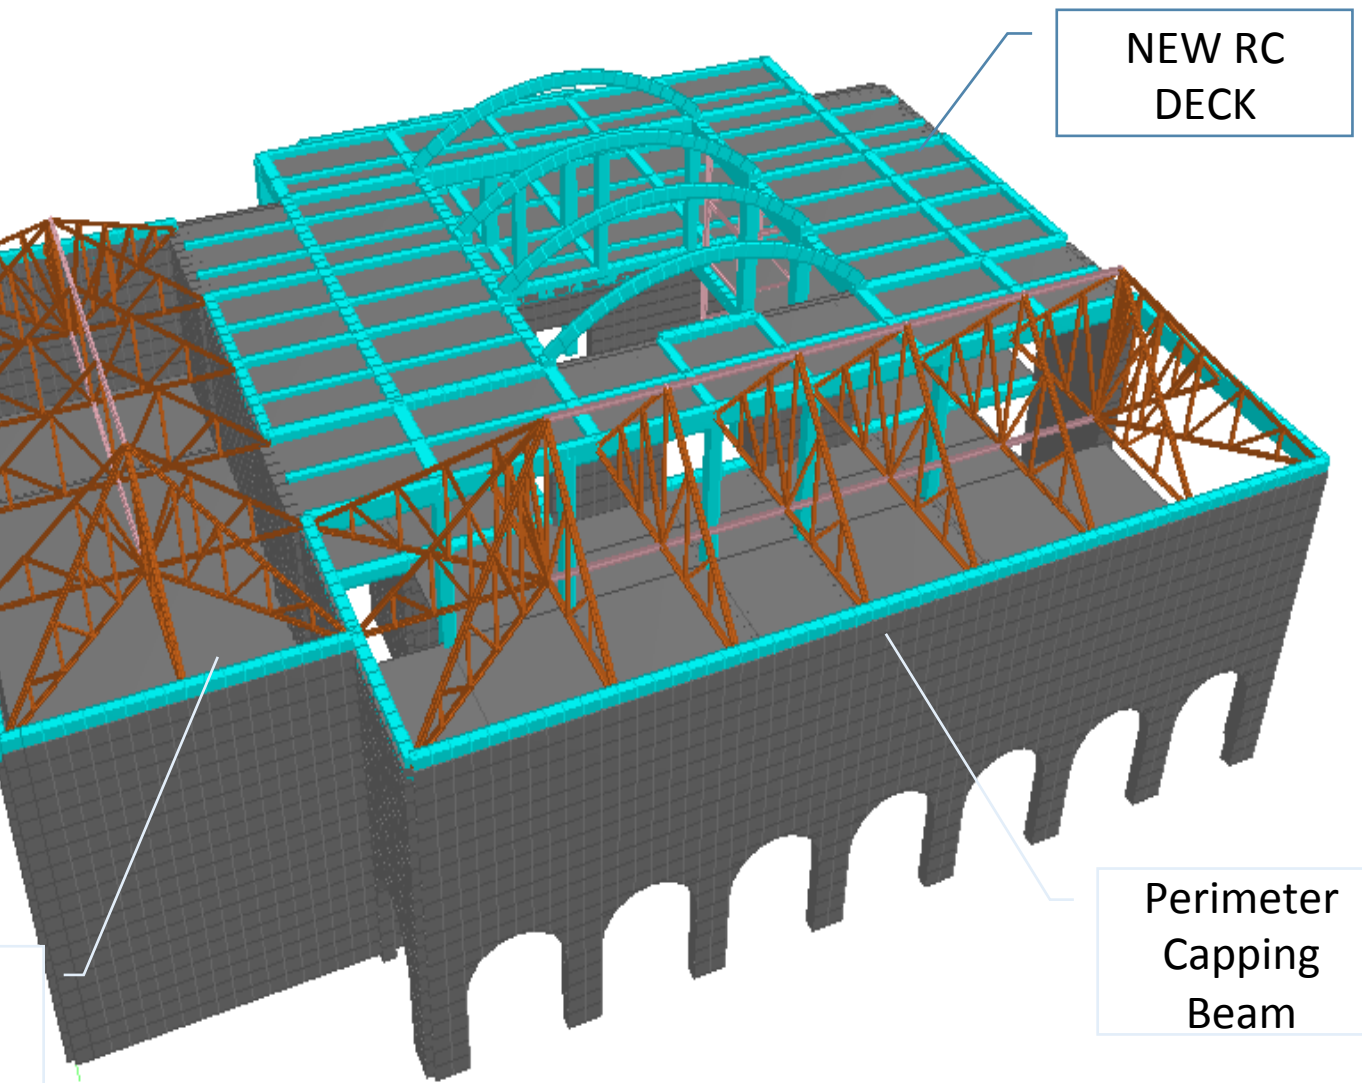
Due to the addition of an RC concrete deck at the 2nd Floor Level, lateral loads have aggravated the already Damaged Structure.

To the left is the rendered view of the modified FEA of the Capitol building. Proposed alterations in the design made by the NM Mani are incorporated in the analysis. In order to support the new loads applied to the building, additional structural members are provided. This includes additional transfer beams and columns to support the new roof. Portions of the existing masonry walls are also used and reinforced to act as Shear walls by using steel rebars and shotcrete to make it more rigid to carry the additional loads and also to resist the lateral loads from earthquake or wind. This reinforced masonry walls will serve as rigid shear walls.

The solution is to beef up interior walls and convert these as shear walls by providing a continuous Reinforced *Boxed* shotcrete wall to provide confinement as well as Structural Rigidity.

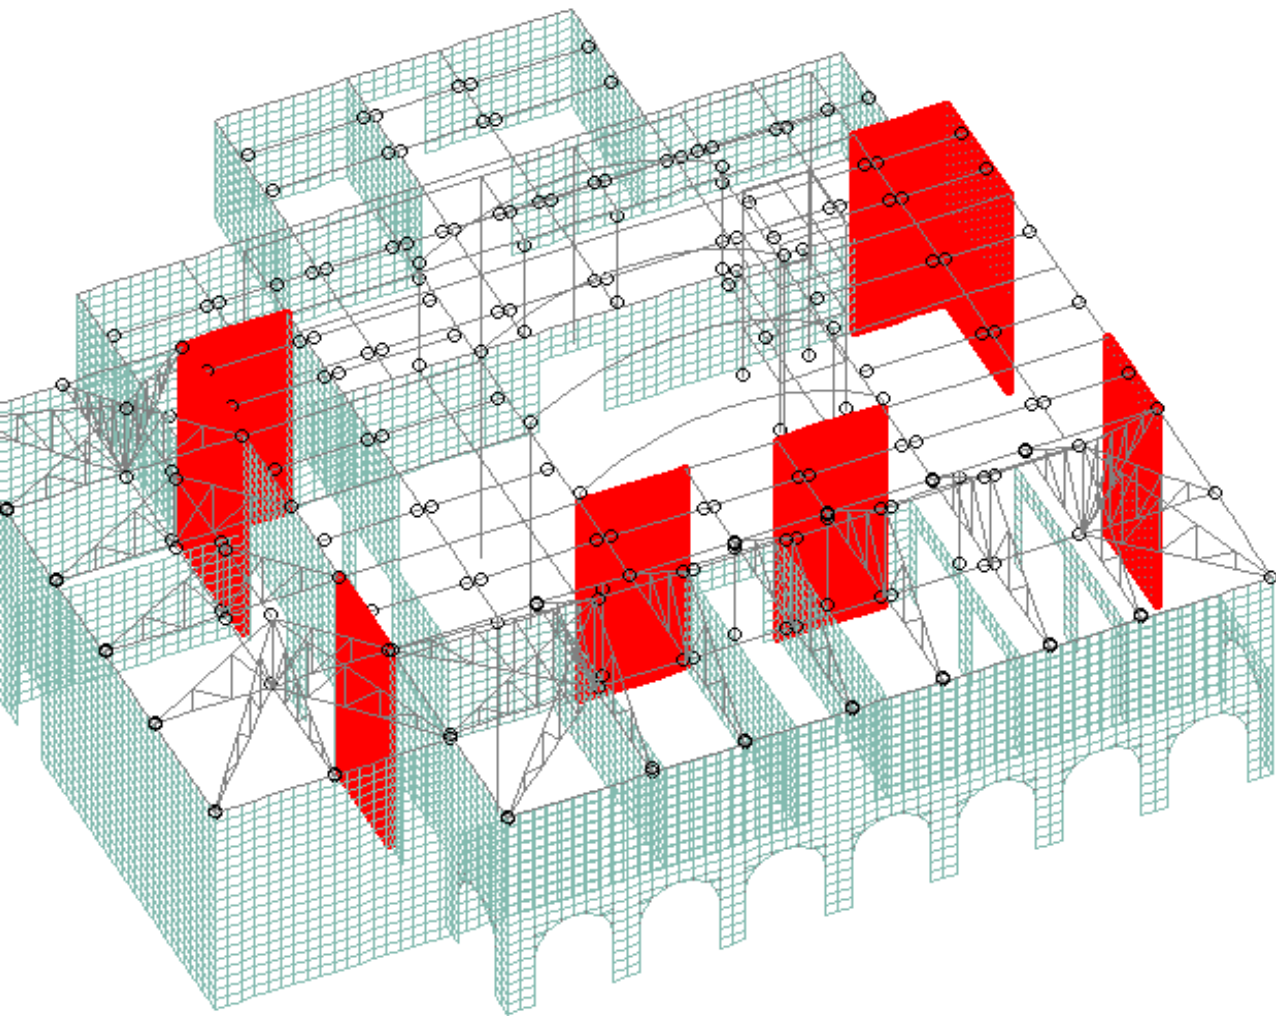
Highlighted in Red are proposed shear wall locations. These shear walls start from subgrade up to the roof beam level. The confinement effect of Reinforced Shotcrete Make upgraded walls rigid without unravelling.

Additional beams/girders attached to these walls serves as horizontal Transverse Girders..

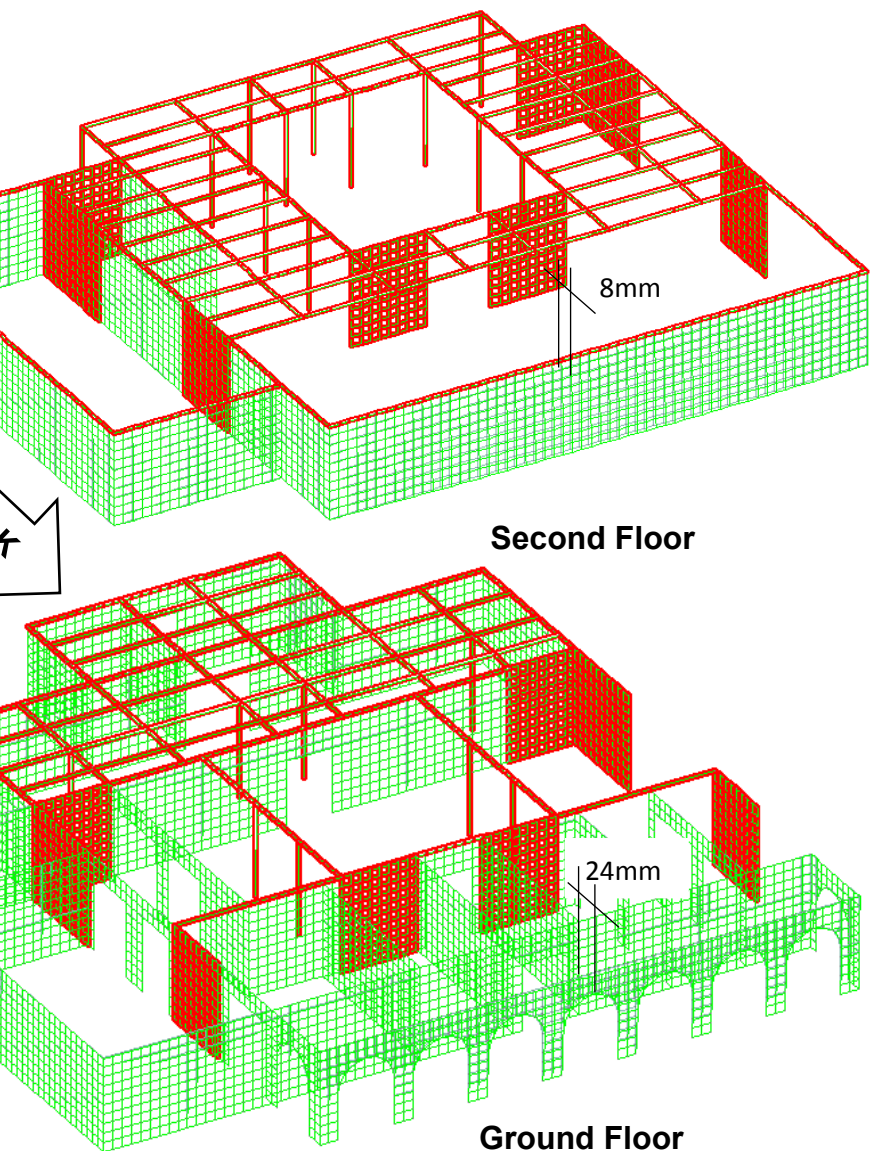
To the Left are the lateral deflections of the existing masonry walls when retrofitting is applied using Horizontal Diaphragms and Shear Walls. The highlighted lines are the additional structural framing used to carry the new loads. These structural framing are also supported by the shear walls (highlighted plates). It is observed that theoretical lateral deflections have been greatly reduced from 589 mm to 8 mm on the middle top of the façade wall. This proves that horizontal diaphragms play a big contribution in distributing the lateral stresses on the walls..

**DEFLECTIONS AFTER REMEDIATION IS CA
OUT WITH SHEAR WALLS**

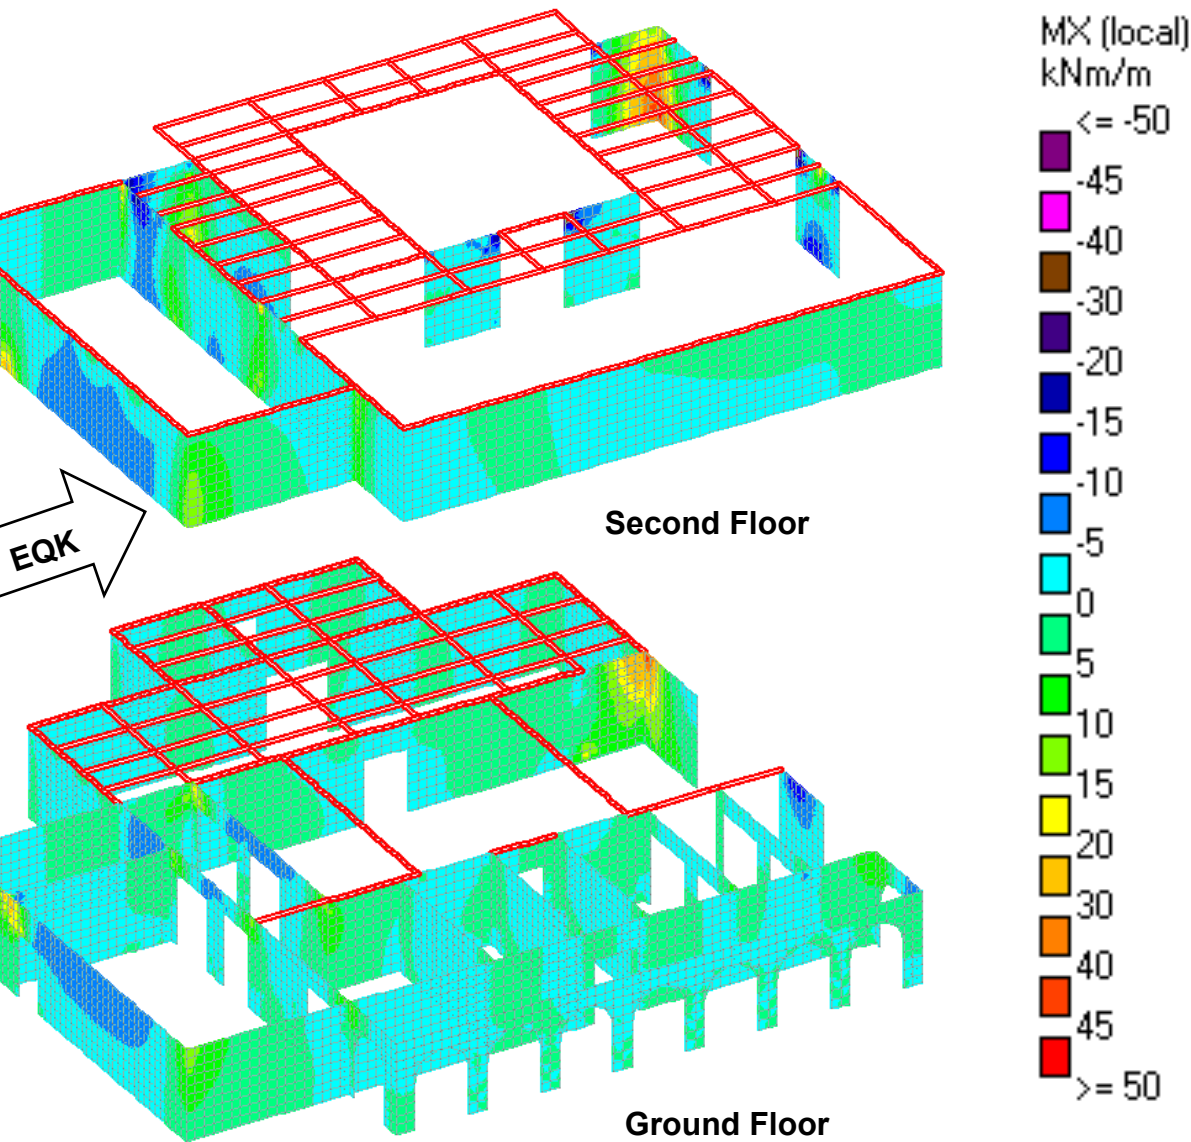
Flexural stress contour of the walls when subjected to a lateral earthquake load in the +X direction.

Observed magnitude of the stresses are greatly reduced and most of the stresses occurred on the plates where shear walls are located.

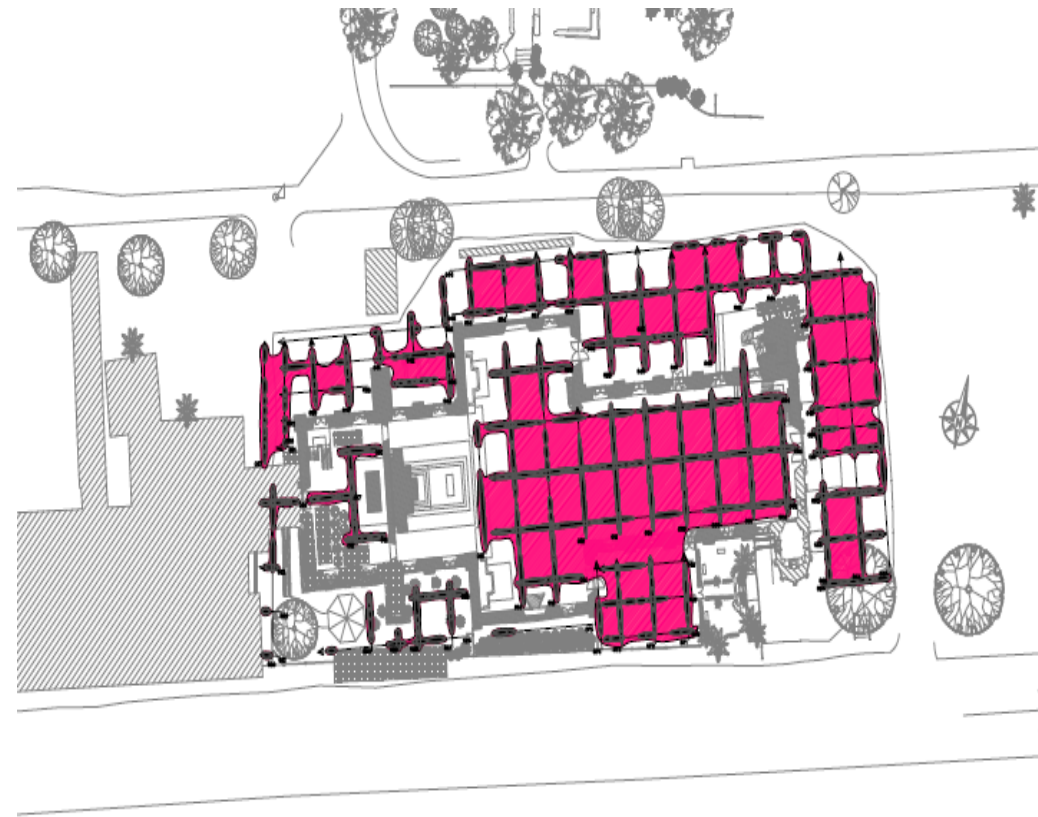
Significant Cavities detected under the footprint. It is recommended that the depth and volume of cavities be determined by additional exploration and sealed before any reconstruction.

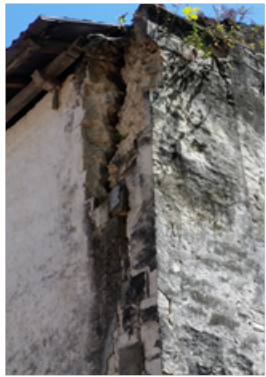
Large delamination of wall at corner requires anchoring and repair to prevent falling hazard

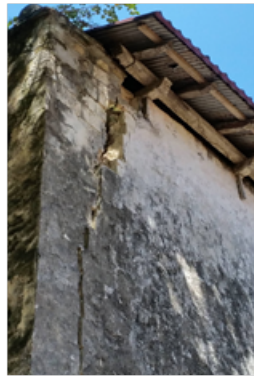
Walls separation at corners needs repair to prevent accidents.

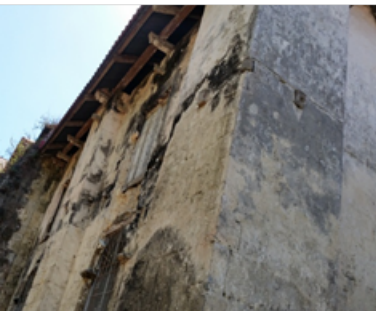
Extend to the corner. Reinforcement

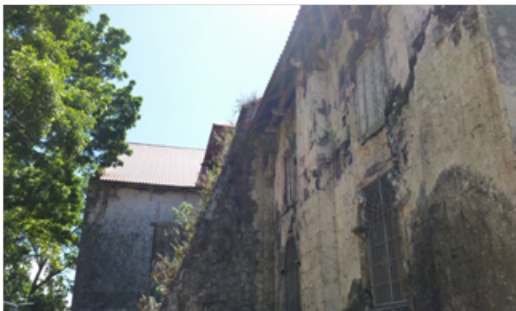
Exterior wall cracks with growth of moss requires repair, strengthening and sealing.

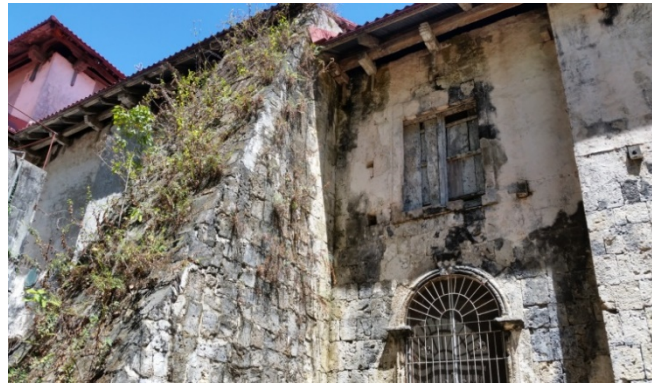
Cracked walls above arched doorway needs repair and strengthening.

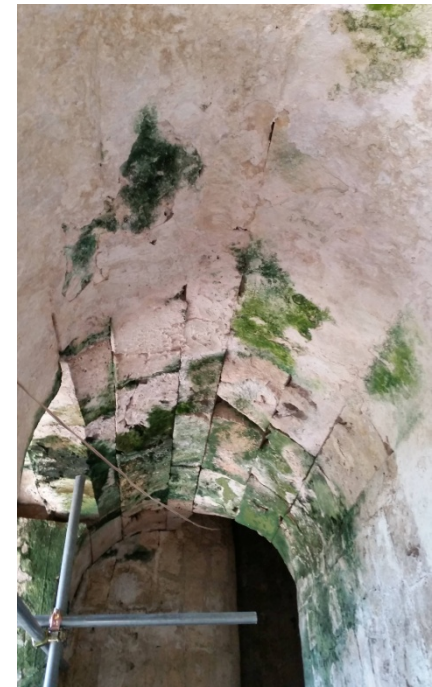
Arch shows movement of Voussoirs. Repair required.

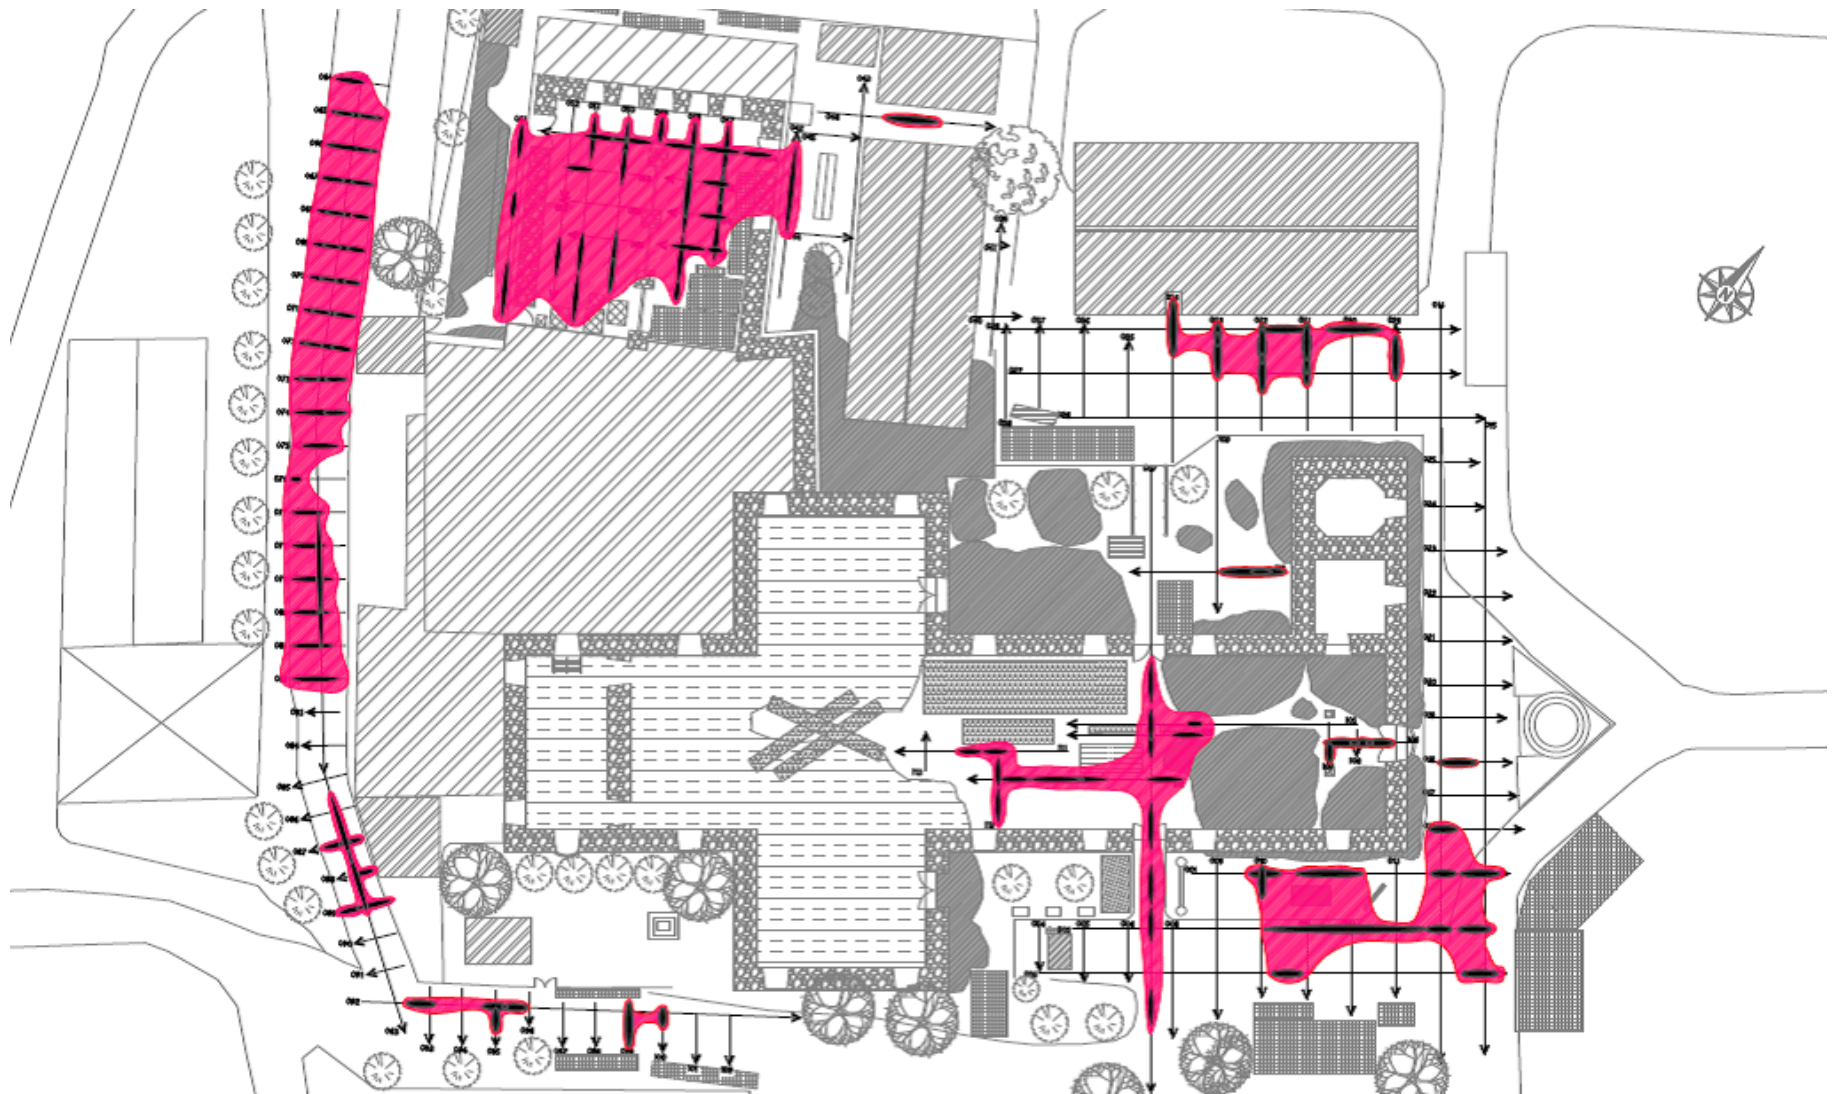
Maribojoc Church PARTIAL CAVITIES MAP

However, there is still the concern of the occurrence of interconnected cavities within the church footprint and elsewhere. These would have to be verified and addressed before reconstruction plans are even contemplated.

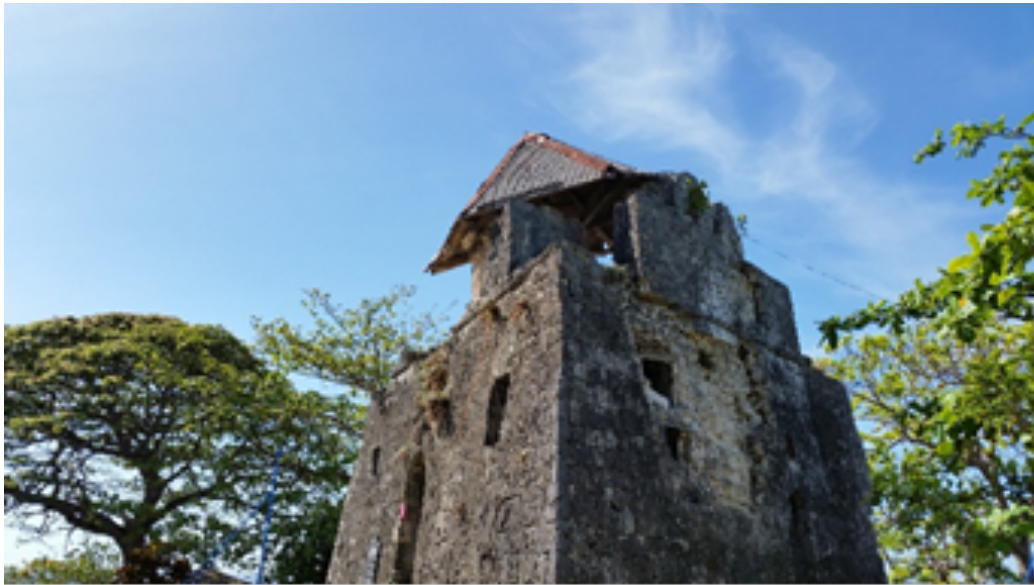
Close up of Tower showing extent of delamination

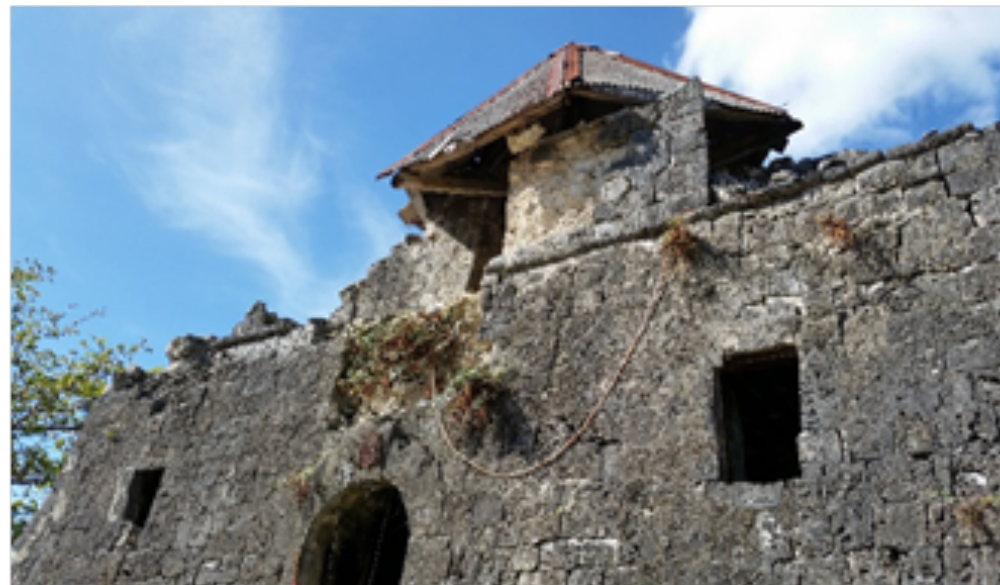
Top portion of Tower showing extent of damage

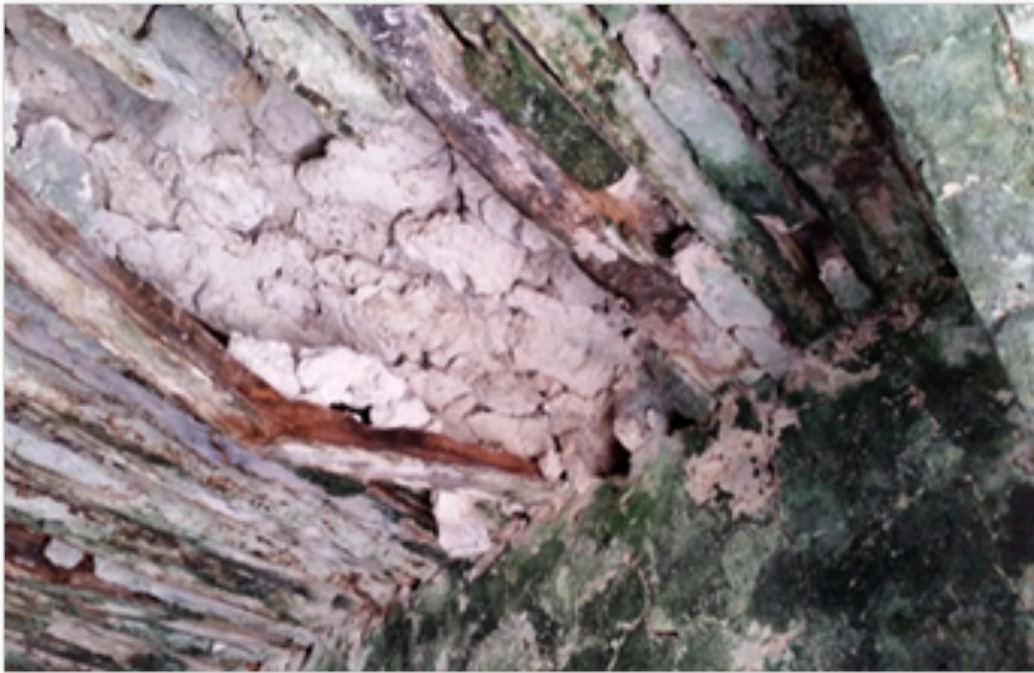
Damaged or missing Timbers require replacement

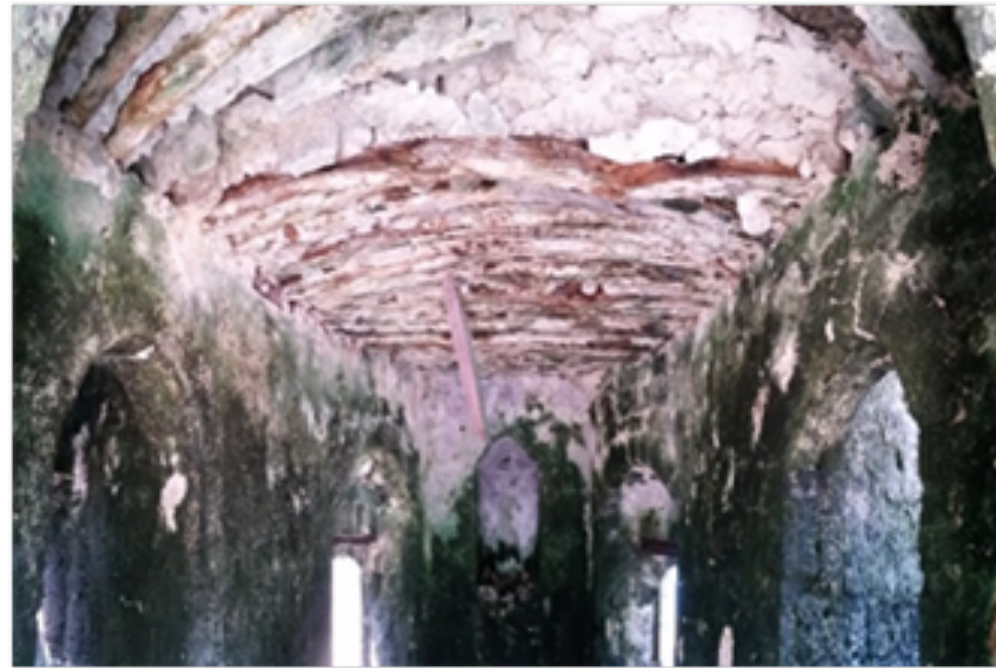
View of interior Floor Support show damaged

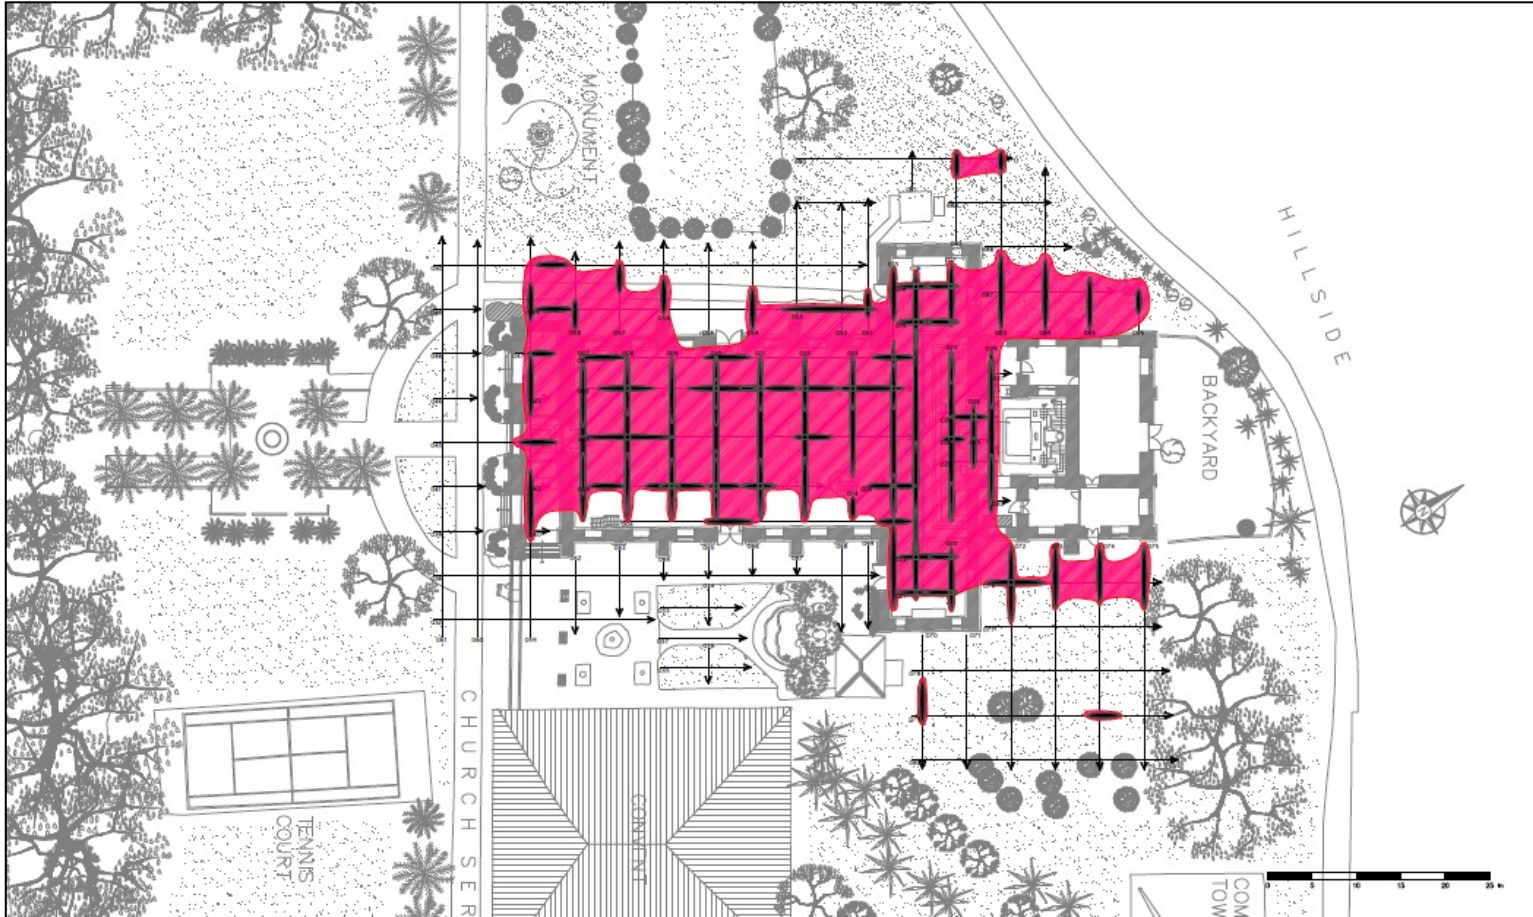
GPR MAPPING OF CAVITIES

The underlying soils in general are comparatively competent strata of Sands and are not Limestone bedrock which may be the basis of discounting the possibility of occurrence of cavities. However, traces of weathered coralline limestone are present in the sand layers making it also susceptible to dissolution. Supplementing geophysical method conducted on site as presented in the ensuing discussions indicates the extent of cavities underneath the areas not influenced by the point locations of boreholes.

Verification of the presence of the suspected cavities underlying the church must be done first. This could be done by drilling additional boreholes at the areas where cavities have been identified.

In case of the occurrence of interconnected cavities within the church footprint and elsewhere are confirmed, these are to be injected with grout to seal the voids. The grouting must be done by a specialist company to ensure that no damage is caused by the grouting pressure in case grouting will be required.
