Dam decisions: past experiences, future challenges

The use of innovative groundwater seepage detection techniques

Dr Andy Hughes, Atkins

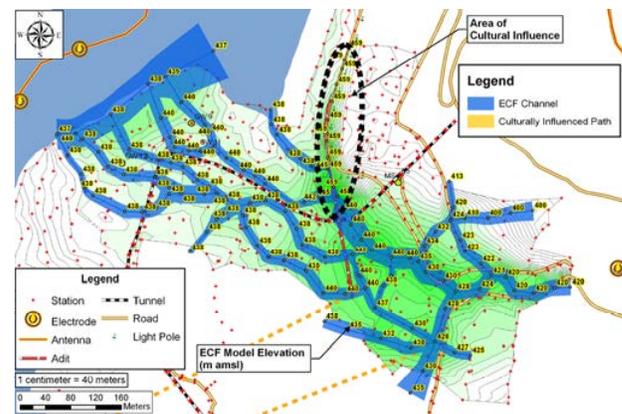
Figure 4 - Electric Current Flow Model with Posted Elevations

Figure 4 presents an interpretation of Survey 1 results. This figure 4 shows the positions of the modelled flow paths (vertical and horizontal alignment).

The model suggests that seepage north of the tunnel occurs above the tunnel and finds an opening in the adit's grout curtain very near the 440m elevation.

In conclusion the results of the investigation suggest that there are a series of braided seepage flow paths north and south of the tunnel that run beneath the right abutment study area. Seepage appears to concentrate around the right side of the dam rather than underneath or through the dam's earthen embankment. There is some seepage occurring along the right rim grout curtain, but not to the extent that it is flowing through the right abutment study area. It has been recommended any seepage through karst topography needs to be carefully characterised, monitored and possibly remediated to ensure the integrity of the reservoir as well as the safety of those residing downstream of the dam.

The Willowstick survey has confirmed two main areas where the cut-off is compromised – one on the bend of the tunnel and the other where the original cut-off crosses the tunnel. Having identified the location of what we believed to be the two largest sources of leakage through the right abutment area, it is possible to undertake cost effective remedial works at Samanalawewa Dam to ensure the safety and integrity and to bring the reservoir back to its proposed top water level and retain its ability to generate energy.

- 1) to close 2 significant gaps in the existing supplementary grout curtain
- 2) to locate and fill major karstic features at approximate elevation of 438m.
