SCHOOL ZONE INFRASTRUCTURE AUDIT

DEL NORTE LOCAL TRANSPORTATION COMMISSION

JANUARY, 2014

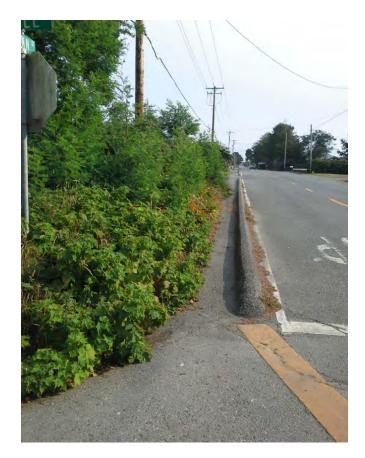
Vegetation blocking walkway

o Maintain vegetation and debris east side of Glenn St. in pedestrian area.

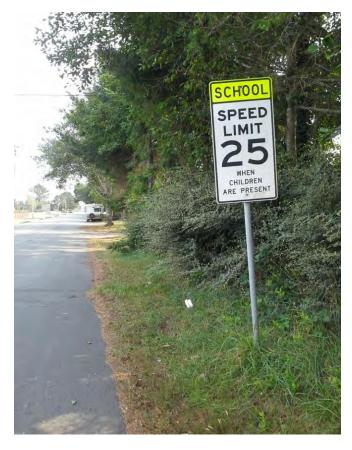
No walkway or bikeway along road

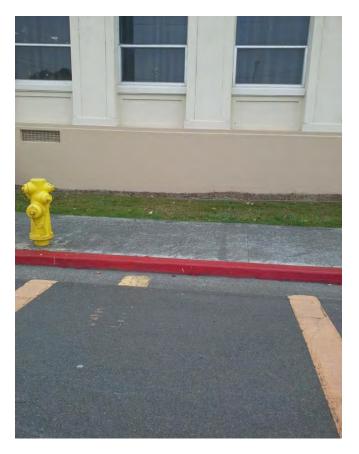
Crosswalk lacks curb ramp

- o Replace thermoplastic school zone marking.
- o Install new curb ramps on both sides of G St. crosswalks.

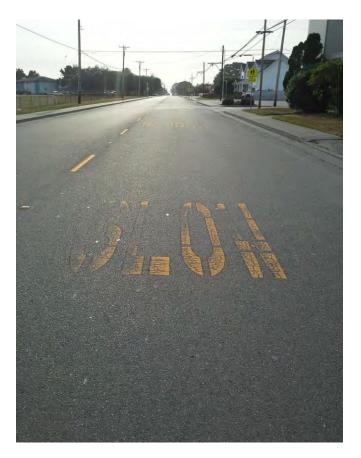
Pavement marking needs repainting

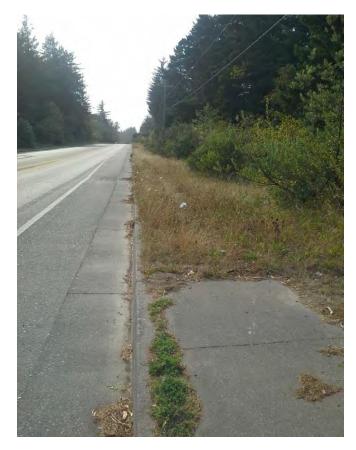
Sidewalk ends

o Install sidewalk along El Dorado, from north parking lot to intersection of Washington.

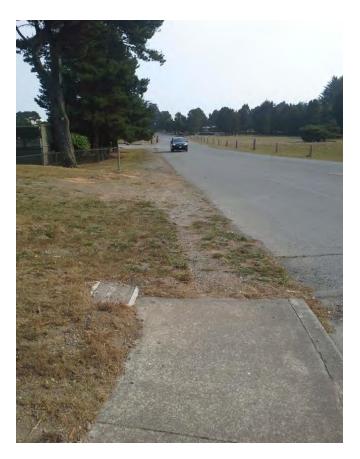
No sidewalk or bike lane along El Dorado St

o Install bike lane along east side of El Dorado St. (Hamilton to High School parking lots).

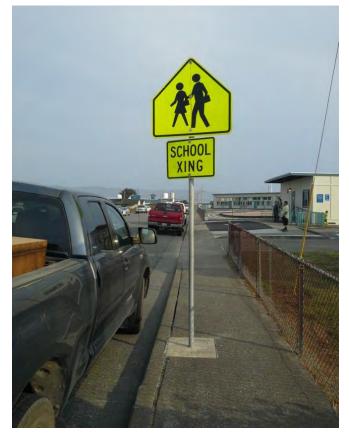
Signage is important to warn drivers, but the location of this sign makes the sidewalk too narrow for ADA compliance

- o Trim vegetation encroaching onto sidewalks.
- Relocate School Xing sign at north end of E St. sidewalk for ADA compliance.
- o Install curb ramps at 10th and E St. crosswalks.

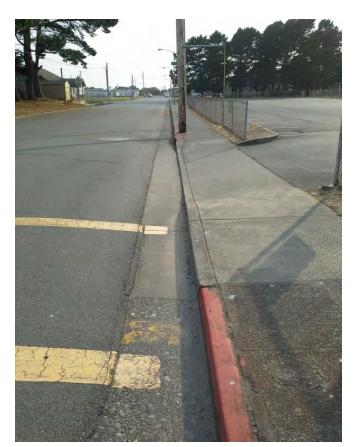
Sidewalk ends in front of school on 10th St between C and D St.

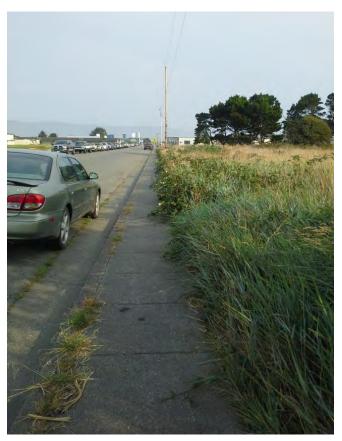
Overgrown vegetation is blocking access to the walkway

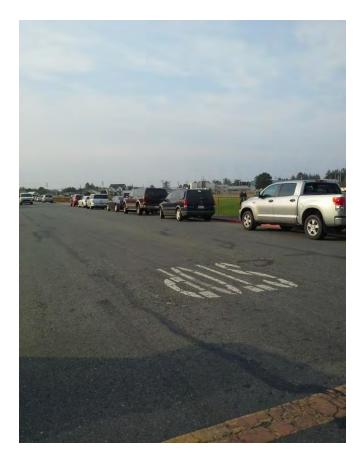
Illegal parking in red zone

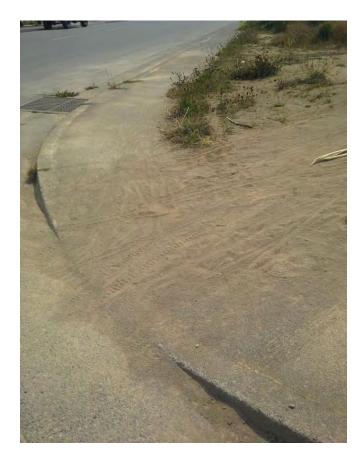
Dirt covering sidewalk

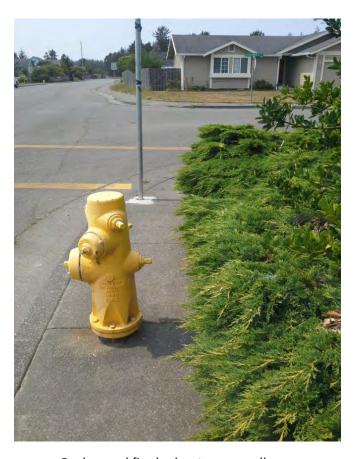
Bushes and fire hydrant cover walkway

- o Install new thermoplastic roadway markings at intersect in front of school.
- o Trim bushes encroaching on sidewalks along Madison Ave.
- o Install curb ramp at Madison Ave. and Arlington Dr. intersection.

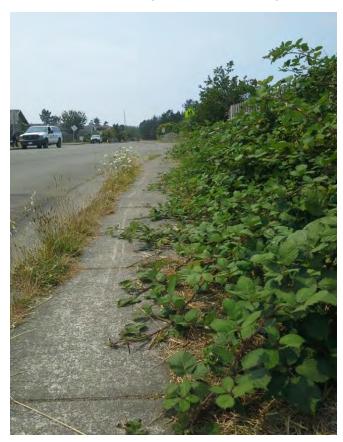
Vegetation needs to be trimmed

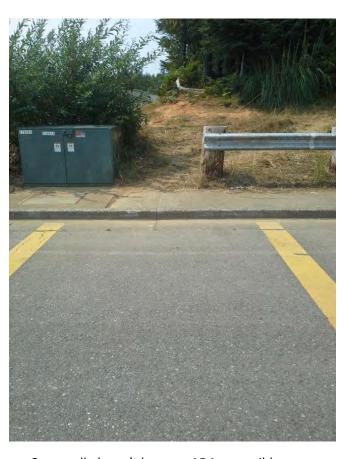
Crosswalk doesn't have an ADA accessible ramp

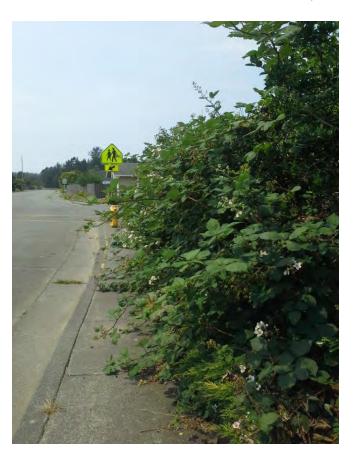
Overgrown bushes covering the sidewalk

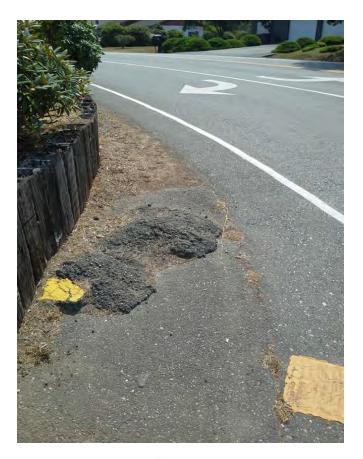
Asphalt left in the bike lane

o Remove excess asphalt mound in bike lane and general sweeping.

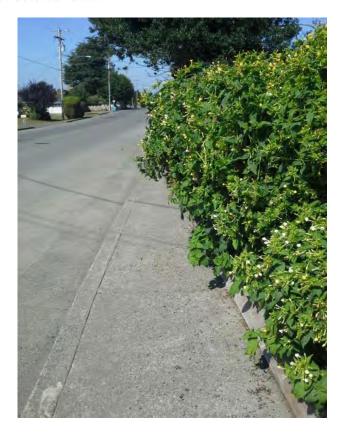
Overgrown vegetation blocking pedestrian access along 1st St between Brookings and Wallace

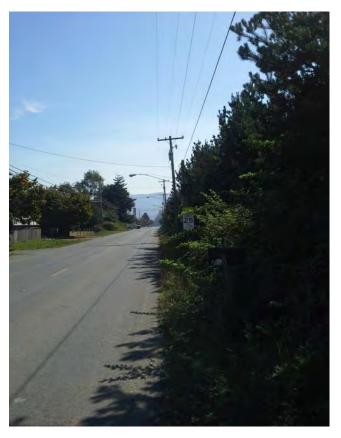
Vegetation is obscuring speed and school zone signs

- o Remove vegetation blocking school zone and speed limit signs.
- o Replace thermoplastic at crosswalk and school zone marking.

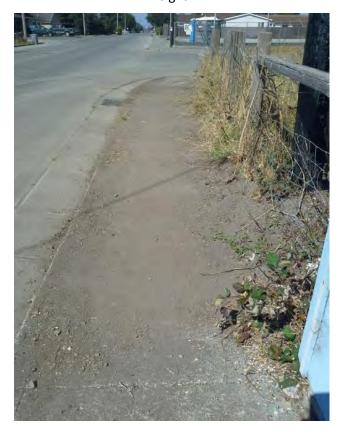
Dirt covering the sidewalk should be removed

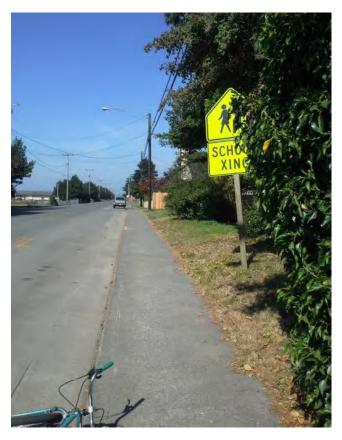
School crossing sign is being blocked by trees and bushes

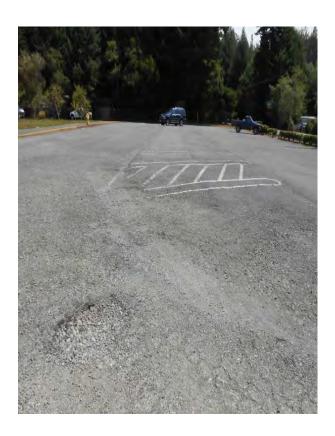
Parking area in need of repair/resurfacing

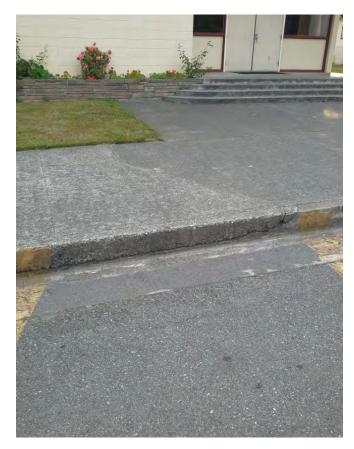
No curb ramp

o Remove vegetation growing up through sidewalk and pavement. o Install curb ramps at crosswalks adjacent to school grounds.

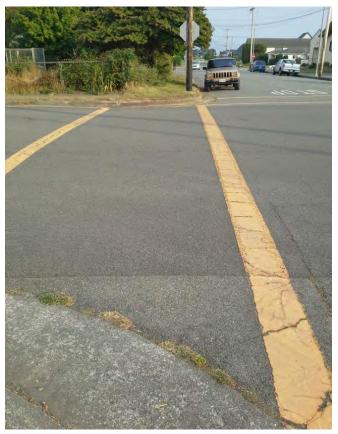
Crosswalks lack curb ramps and sidewalks on opposite side

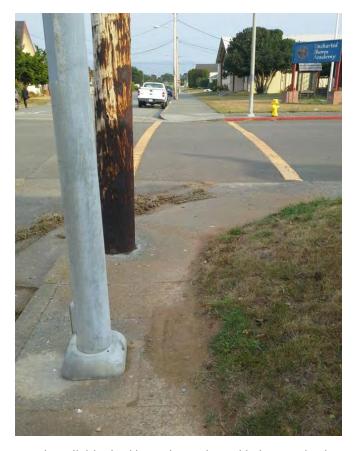
Sidewalk blocked by utility pole and light standard

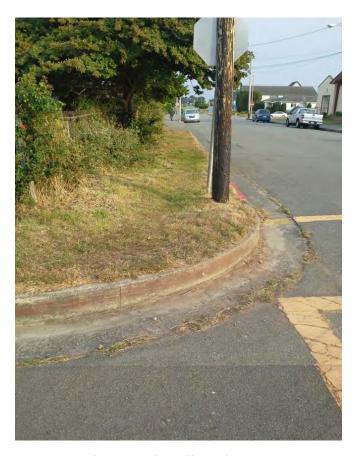
Absent Sidewalk and Ramp

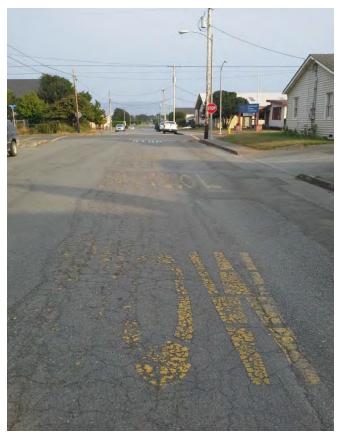
Pavement markings need to be repainted
