FINAL REPORT

HIGH LEVEL BRIDGE PEDESTRIAN AND CYCLING SAFETY REVIEW

AUGUST 2016

PREPARED FOR
CITY OF EDMONTON

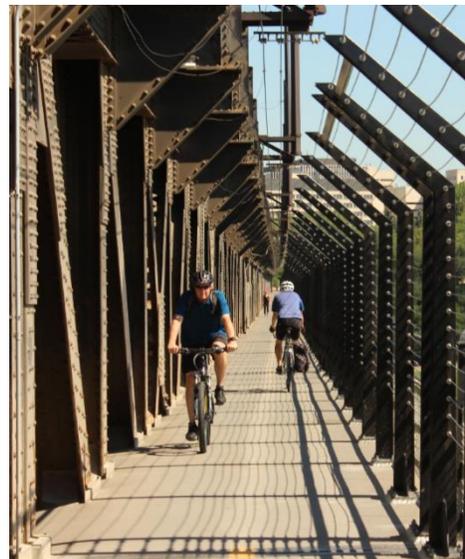
Figure 9: East Side Pathway

On-site observations indicated that these widths resulted in some conflicts (near collisions) between users of the pathways on both sides of the bridge. In particular, the most significant conflicts were observed along the east pathway due to limited width and the pathway being used as a two-way facility shared between pedestrians and bicycle users. There were minimal separations between road users, especially between cyclists, travelling in opposite directions on the east pathway due to the narrow width. Issues were observed when cyclists engaged in a passing maneuver and crossed to the opposite of the pathway, which created conflicts with pedestrians who may not be aware of the passing, as well as oncoming bicycle users. Similar issues were observed on the west side pathway. Although the west side pathway is wider, similar issues were experienced due to the higher pedestrian and cycling volumes on this side of the bridge.

Given the existing conditions, to ensure the safe operation of the pathways, it is suggested that the pathway operations be modified, and it would be desirable that the resulting operations and widths would be in accordance with the Guide, i.e. meeting minimum design guidelines.

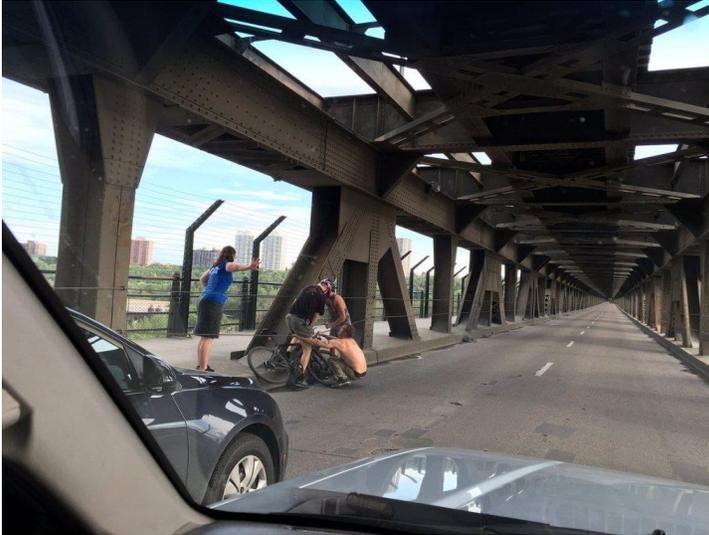
Figure 10: Witnessed Safety Issue
 Source: @edmontonbicycle twitter account, posted June 30, 2016.

The gaps between the truss members along the bridge deck on both pathways present a potential safety risk particularly for people cycling if they were to lose control of their bicycle or fall from it. In addition, the crossfall is greater in the areas of the truss members, and the deck slopes towards the roadway, which could present a further safety risk. A recent incident was noted on social media (not observed during the site visit) of a bicycle user falling into the motor vehicle carriageway (as shown in **Figure 10**).

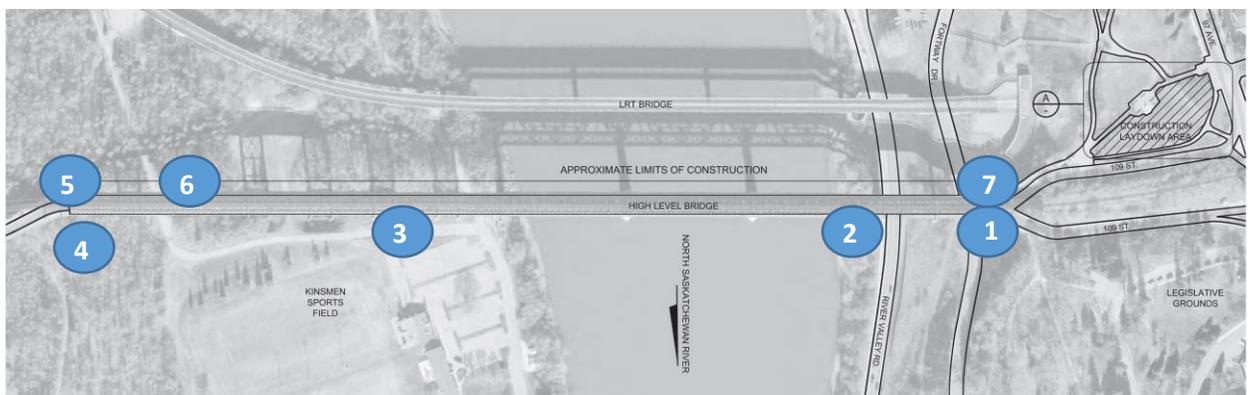
Figure 11: Location of Obstructions and Pinch Points

As noted previously, the typical width of the pathways are 2.8 metres on the west side and 2.3 metres on the east side based on the cross-section drawings provided. However, there are several pinch points along the pathways which have constrained widths. The location of these obstructions and pinch points can be seen in **Figure 11** and are illustrated in photos below. At each of these locations the pathway narrows, creates an obstruction for pathway users, and is a potential safety hazard.

- Install reflective hazard markings on all obstructions.
- Consider the installation of obstruction pavement markings as outlined in TAC guidelines.
- Consider installing additional warning signage at pinch points, ensuring the location of the signage does not create an additional obstruction but informs users that pathway narrows and to slow down and use caution.
- Consider adding advance warning signs for pinch points.
- Consider removing where applicable the metal barrier located on the southeast approach pathway to provide some additional width (as seen in the photos for **Location 4**).

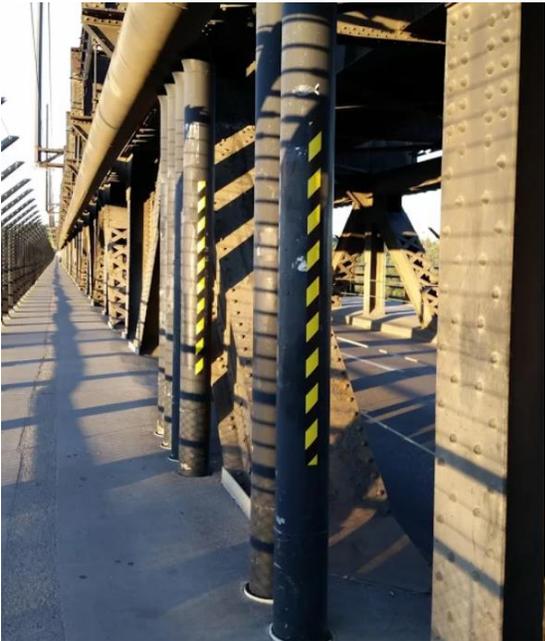
Location 2: East Side – Waterfall Piping

Width: 1.8 metre (Source: City of Edmonton)

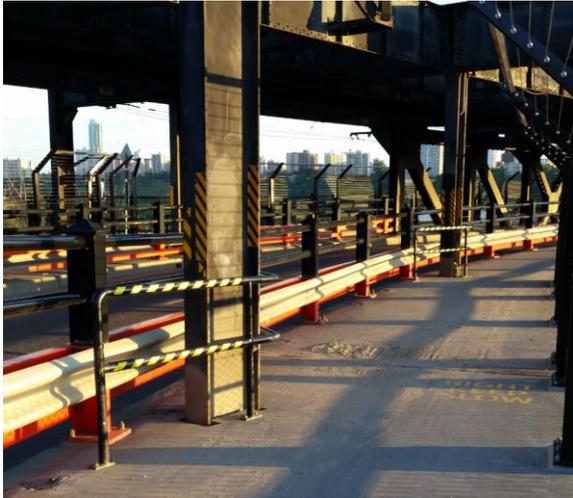
Location 3: East Side - Bridge Column

Width: 2.0 metres hand rail to face of the new post
(Source: City of Edmonton)

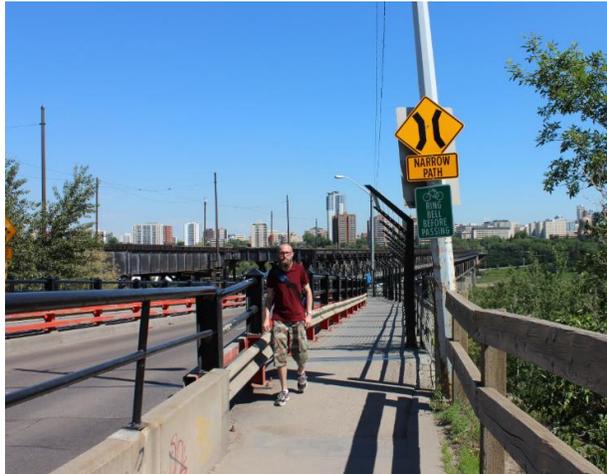
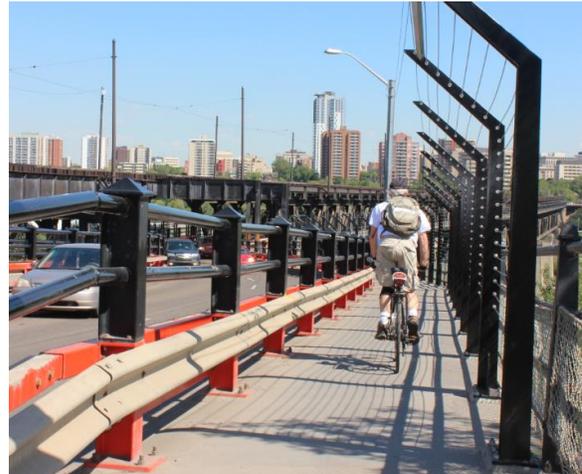
Location 4: East Side – South Bridge Entry/Exit

Width: 2.0 metres (Source: City of Edmonton)

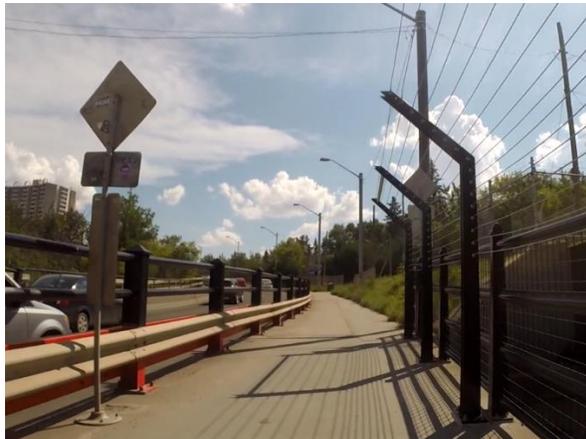
Location 5: West Side – South Entry/ Exit

Width: 2.9 m at the narrowest

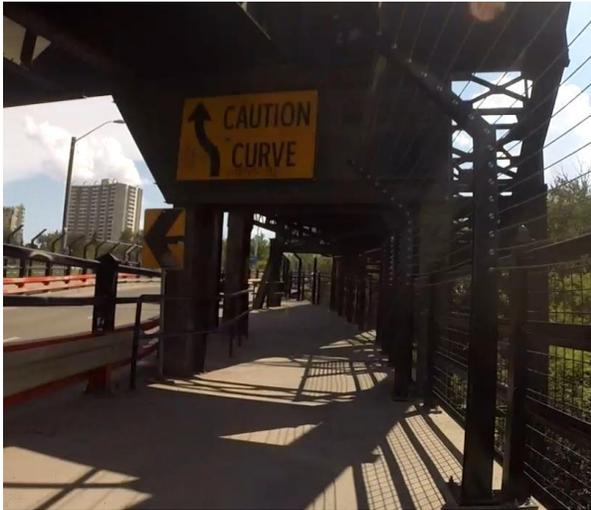
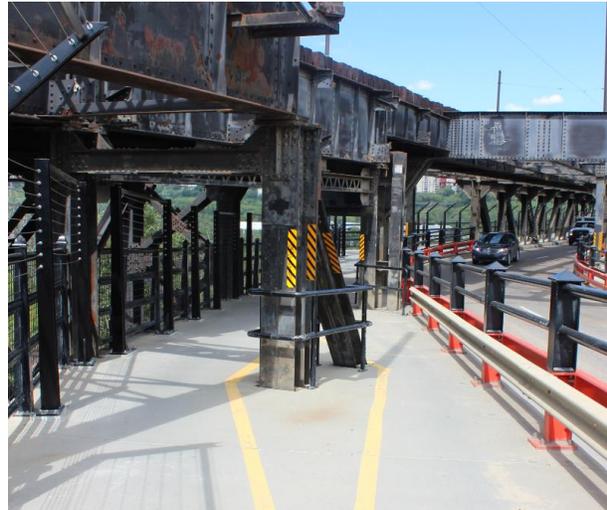
Location 6: West Side - Bridge Column and Vertical Obstructions

Vertical Height - 2.3 metres

Pathway width on either side of the bridge columns - 1.2 metres and 1.7 metres

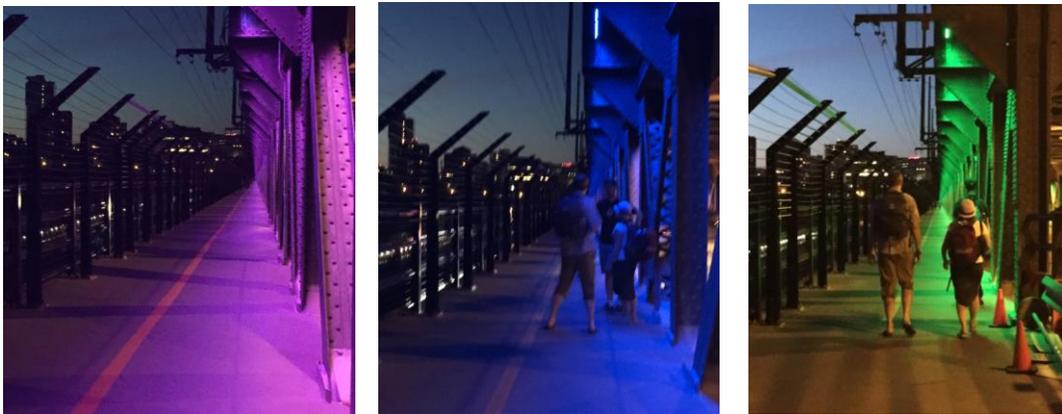
Figure 12: High Level Bridge at Night (West Side)

Like speeding, lighting and personal safety concerns were identified in the incident reports collected through the Edmonton Bicycle Commuters Survey. Lighting of the pathway specifically could help to illuminate obstructions and jogs in the pathway itself. Additional lighting could also help enhance personal safety and visibility in the evening. At the time of the evening site visit the lighting on the bridge deck was rotating colours and thus brightness. While this was visually appealing, it was found that depending on the colour of the lights being used pathway visibility varied (**Figure 12**).

- Consider installing additional pedestrian scale overhead lighting where feasible on the bridge pathway itself ensuring that any additional light does not obstruct the pathway itself.

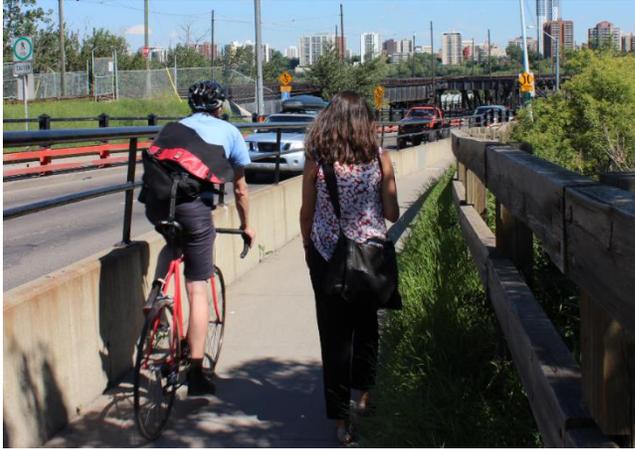
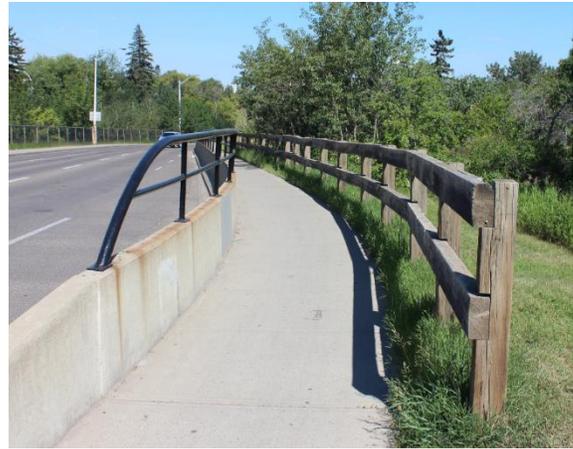
Figure 14: South End/East Side Bridge Deck Approach

The pathway on the south end of the bridge on the east side currently operates as a shared use pathway with two-way operations (**Figure 14** and **Figure 13**). The current width of this pathway does not meet TAC's minimum width guidelines. Further, the pathway is constrained by vertical obstacles on both sides, including a wooden fence on one side and a retaining wall with a black guard rail on the other side (separating the pathway from motor vehicle drivers) which creates a confined space. The presence of the fence and the guard rail could potentially result in people cycling getting their handlebars caught in the railing.

- Consider adding a rub rail on the existing railing on the approach to the east side of the bridge or consider replacing the type of separation currently being used.
- “Narrow pathway” signage should be placed early at the start of the approach to the bridge to advise users of the constrained conditions.
- Consider installing signage advising users that tandem riding and walking is not permitted through this narrow stretch.

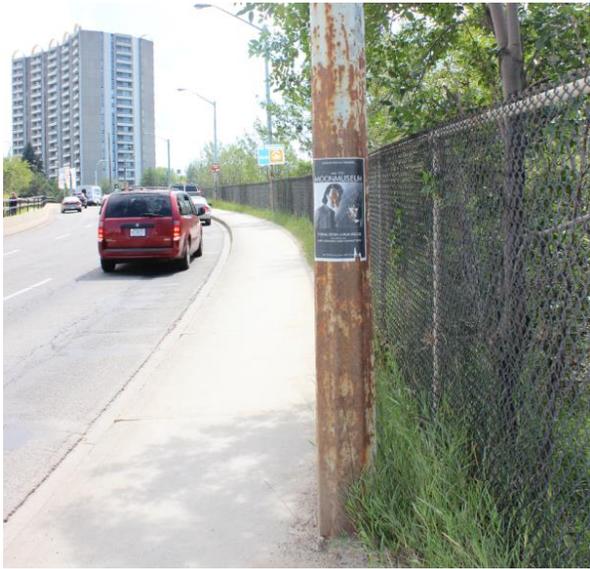
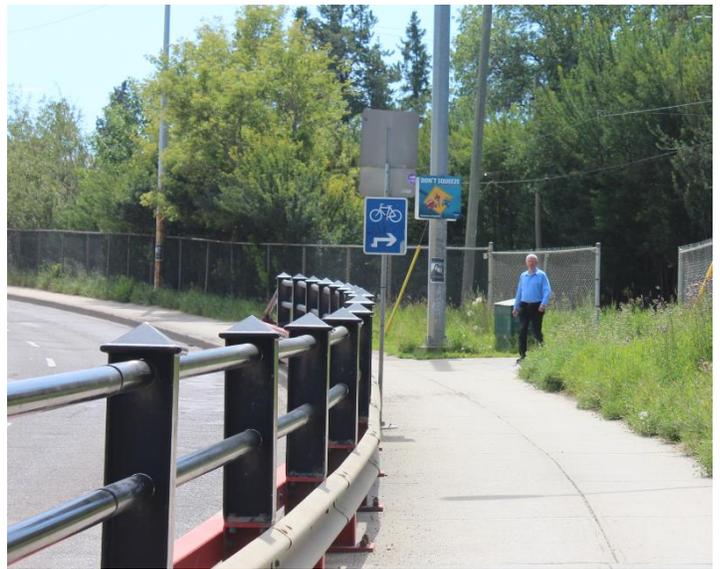
Figure 16: South End/West Side Bridge Deck Approach

The safety issues at both ends of the bridge approach are exacerbated by the vertical profiles, which creates distinct issues in the uphill and downhill directions as follows:

- **Downhill:** high speeds could strike other users same and opposite directions, potentially resulting in significant injury
- **Uphill:** Cycling uphill needs more width due to the "wobble" factor. May result in more conflicts with other users.

- Consider widening the west side pathway, subject to structural, geotechnical and/or property constraints. This may require working with other stakeholders to acquire additional space from the rail right-of-way if required.
- Consider installing a guard rail to prevent pedestrians and cyclists that fall from being struck by moving motor vehicles (**Figure 18**)
- Consider providing more lighting and additional vegetation maintenance on the designated multi-use pathway that runs parallel to the roadway on the west side of the bridge.

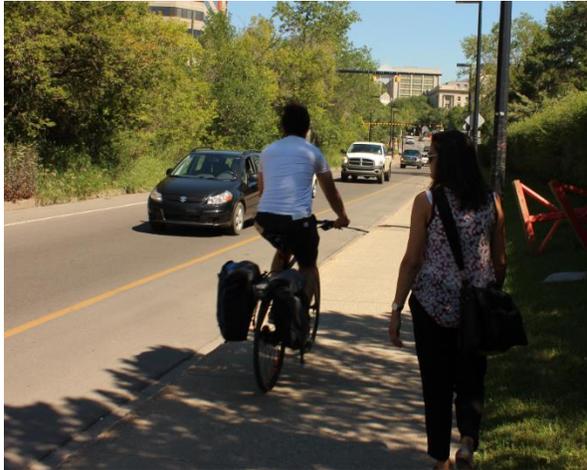
Figure 19: North End / East Side

On the north end of the High Level Bridge on both the east and the west sides, sidewalks provide people walking access to the bridge crossing adjacent to the motor vehicle lane (**Figure 19** and **Figure 20**). These sidewalks were observed to be used by people cycling as well as people walking, and are operating as shared use facilities. On the west side of the bridge, there is an additional multi-use pathway that runs parallel through the park, although it should be noted that this pathway was closed during the time of the site observations. On both sides, aside from a curb, there is no physical separation between the pathway and motorized vehicles. Similar to the potential safety issue identified on the south/west approach, this lack of separation could create a situation where if a person walking or cycling were to lose control and fall off of the pathway they may fall into the carriageway. There is a shoulder in the carriageway, which could minimize the risk of collision with a motor vehicle; however, the narrow sidewalk combined with lack of physical protection and two-way operation by both cyclists and pedestrians increases the risk of collision.

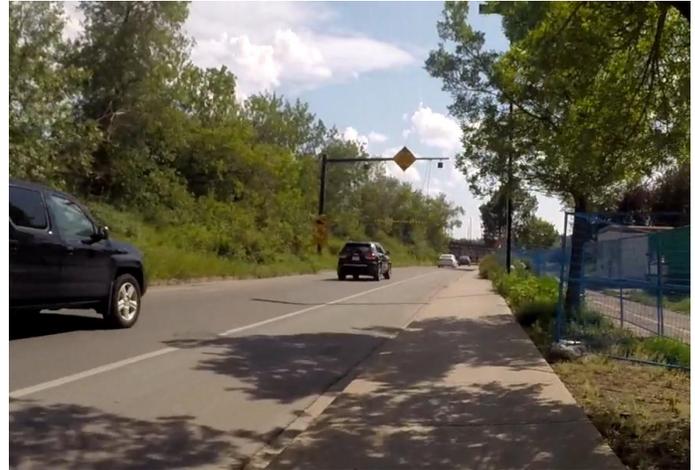
Figure 20: North End / West Side

As noted, during the RSA team’s site visit, the parallel existing multi-use pathway on the west side was closed as it is currently being used as the construction laydown area. As a result all users travelling on the

west side were using the pathway adjacent to the road which made conditions feel constrained. However, upon the reopening the pathway these issues will likely be alleviated. On both the east and the west approach there is a wide shoulder between the motor vehicle lane and the pathway.

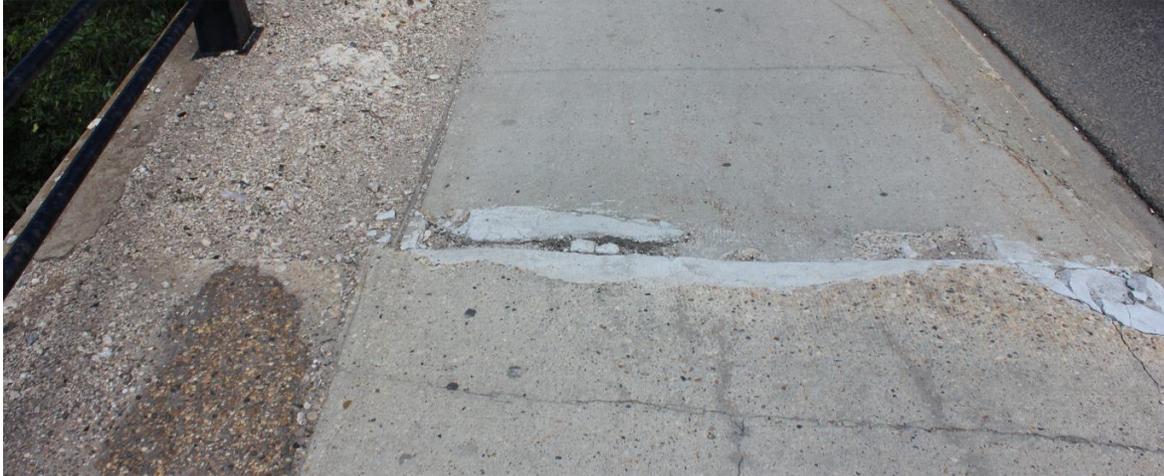
Figure 22: Example of Debris, Cracks and Uneven Pavement on the Pathway

There were some locations along the pathways where poor pavement quality was observed, including cracks in the pavement and uneven seams between the pathway and the bridge joints, which could be tripping hazards (**Figure 22** and **Figure 23**). There was also the presence of debris from cracked concrete. Debris, hazards and poor pavement quality presents a safety hazard for both people walking and cycling.
