Railway Investigation Report R11T0161

Employee fatality

VIA Rail Inc.
Train VIA 051
Mile 314.4 Kingston Subdivision
Durham Junction, Ontario
14 July 2011

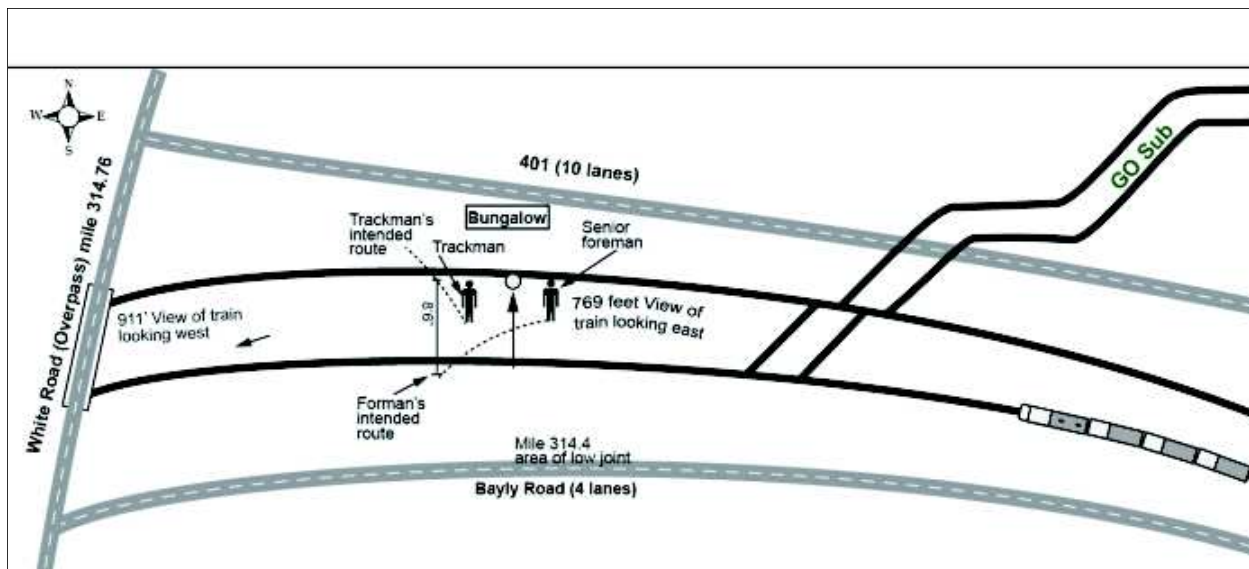
Figure 2. Accident Site Diagram (diagram not to scale) ↑

The accident occurred just east of the White Road overpass (Mile 314.76). Highway 401 is situated to the north and Bayly Road is situated to the south ([Figure 2](#)).

As westbound VIA 51 traversed a long, sweeping 1° left-hand curve on the south track approaching Mile 314.4, the train crew observed 2 track workers performing maintenance on the south rail of the north track immediately ahead. The accident occurred when the track foreman attempted to clear to the south and inadvertently moved into the path of VIA 51.
