National Transportation Safety Board

Railroad Accident Brief

Accident No.: DCA-11-FR-001
Location: Kelso, Washington (Longview Yard)
Date: March 23, 2011
Time: 4:25 p.m., Pacific daylight time¹
Railroad/Property: Burlington Northern Santa Fe Railway
Property Damage: \$32,000
Injuries: 1 serious
Fatalities: 3
Type of Accident: Private grade crossing

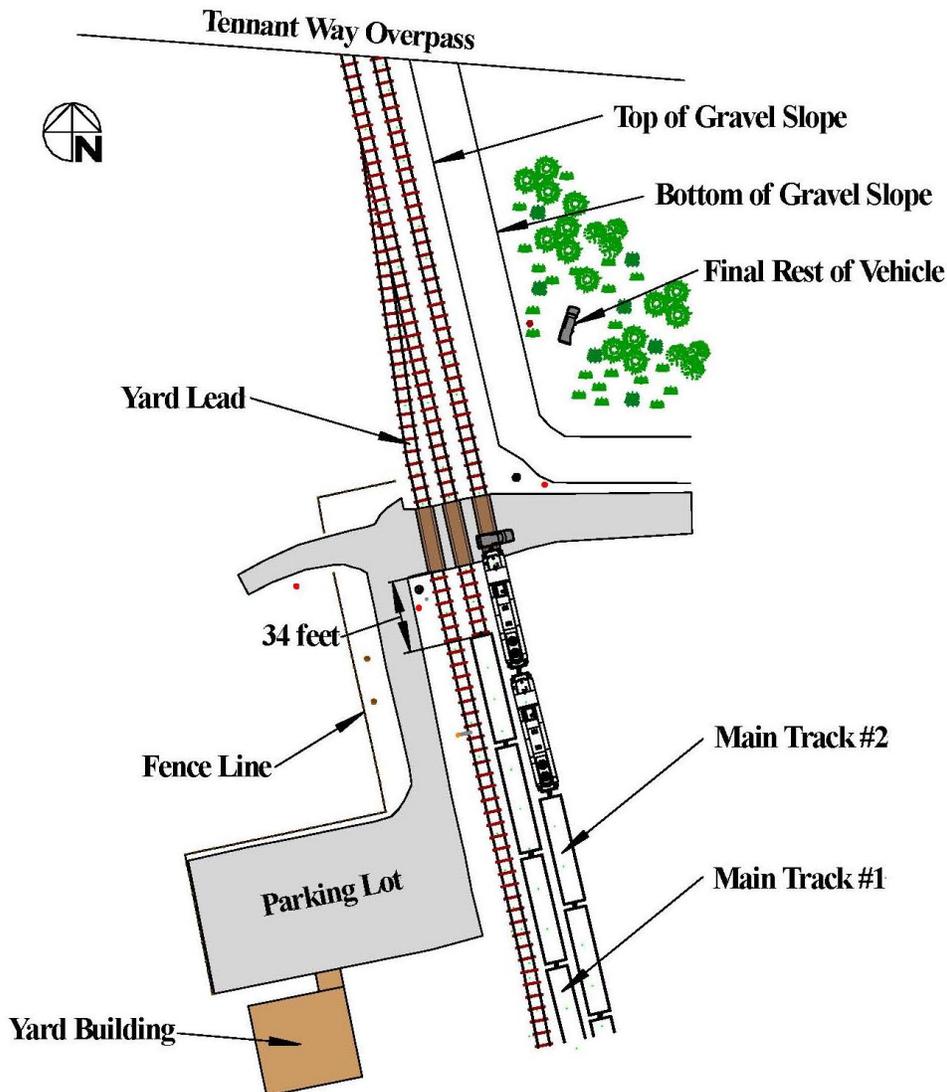
track #2. Main track #1 had railroad cars placed on it. The railroad cars obscured the view of main track #2, south of the private grade crossing that ran parallel to main track #1. (See figure 1.) When the driver reached the “T” intersection with the private grade crossing road, he hesitated slightly at the stop sign and railroad warning crossbuck sign without stopping, swung wide to the left and then turned right onto the first set of tracks, the yard lead. (See figure 2.) He continued driving across main track #1,² which was occupied by the stationary railroad cars that were 34 feet south of the private grade crossing. He then continued across main track #2 at an estimated 11 mph and was directly on the track when the northbound freight train collided with the passenger side of the Suburban at 47 mph.

Figure 1. Diagram of accident location.

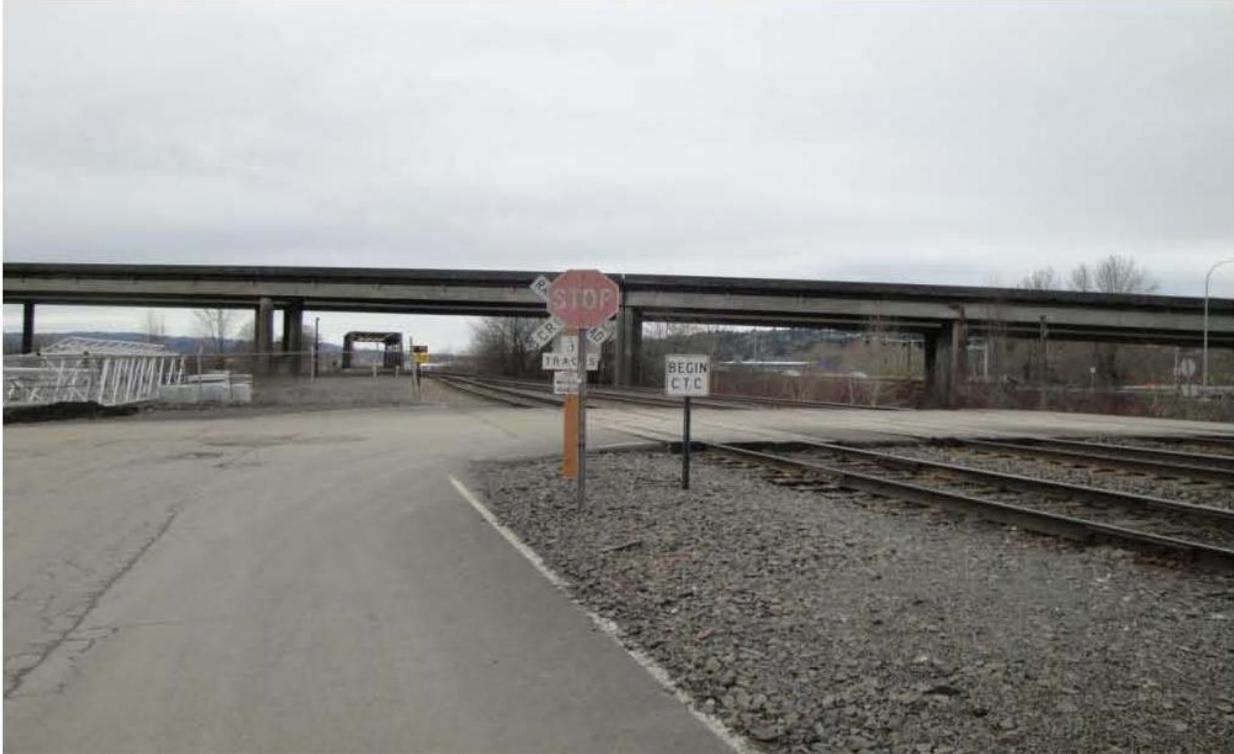
Figure 2. Stop sign and railroad warning crossbuck sign as seen by approaching accident driver.

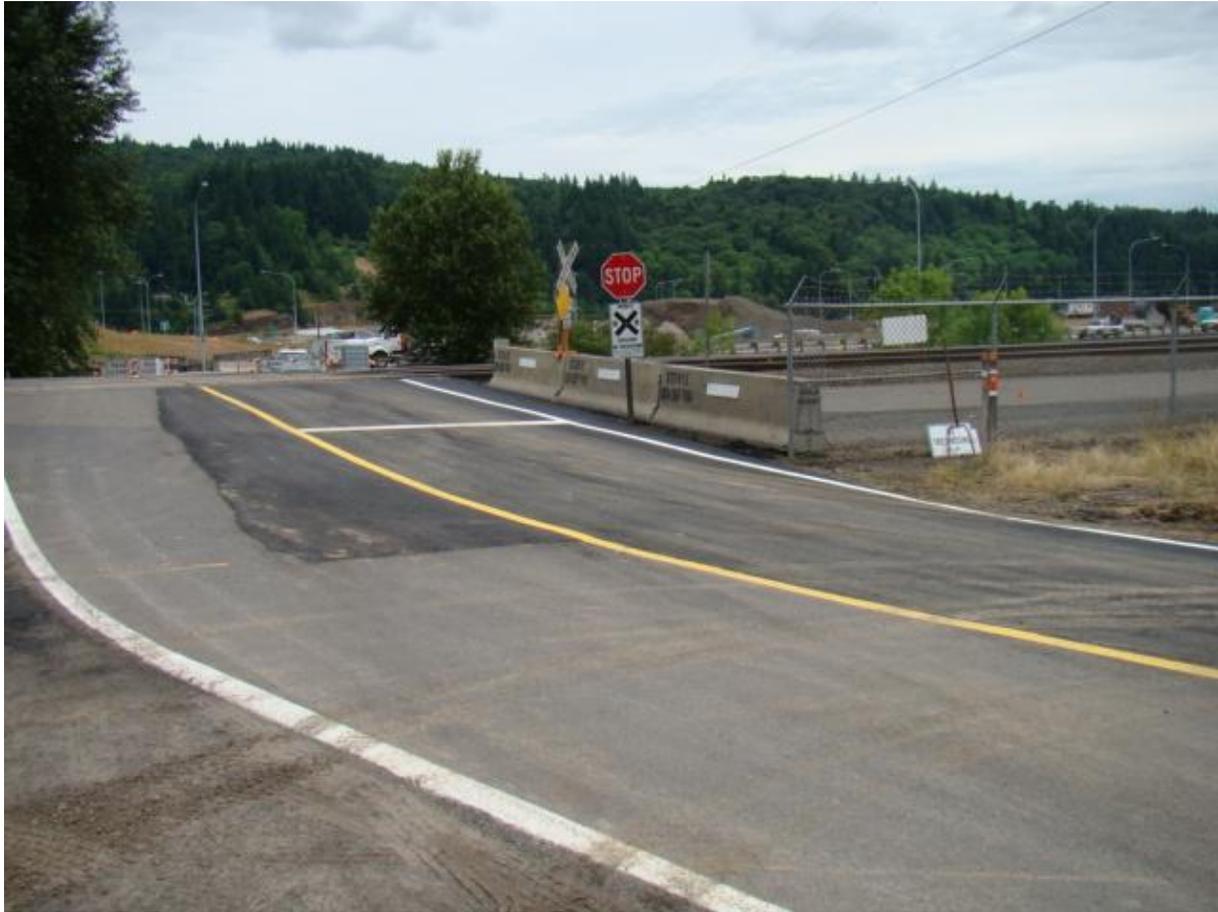
The first step taken by the BNSF was to restrict the routes approaching the crossing. In this accident, the Suburban was traveling parallel to the tracks and then made a right hand turn onto the crossing. This configuration allowed drivers to observe southbound trains but hindered

their ability to see the northbound train traffic. With the crossing perpendicular to the tracks, drivers can more easily look to the left and right for approaching trains before crossing. (See figure 3.)

Figure 3. First improvement to grade crossing was to block entry from road parallel to tracks with cement barricades.
