National Transportation Safety Board
Washington, D.C. 20594

Railroad Accident Brief

Accident No.: DCA-09-FR-005
Location: Selkirk, New York
Date: May 10, 2009
Time: 6:38 PM, Eastern daylight time¹
Railroad: CSX Transportation
Fatalities: 1
Type of Accident: Remote control locomotive switching operation

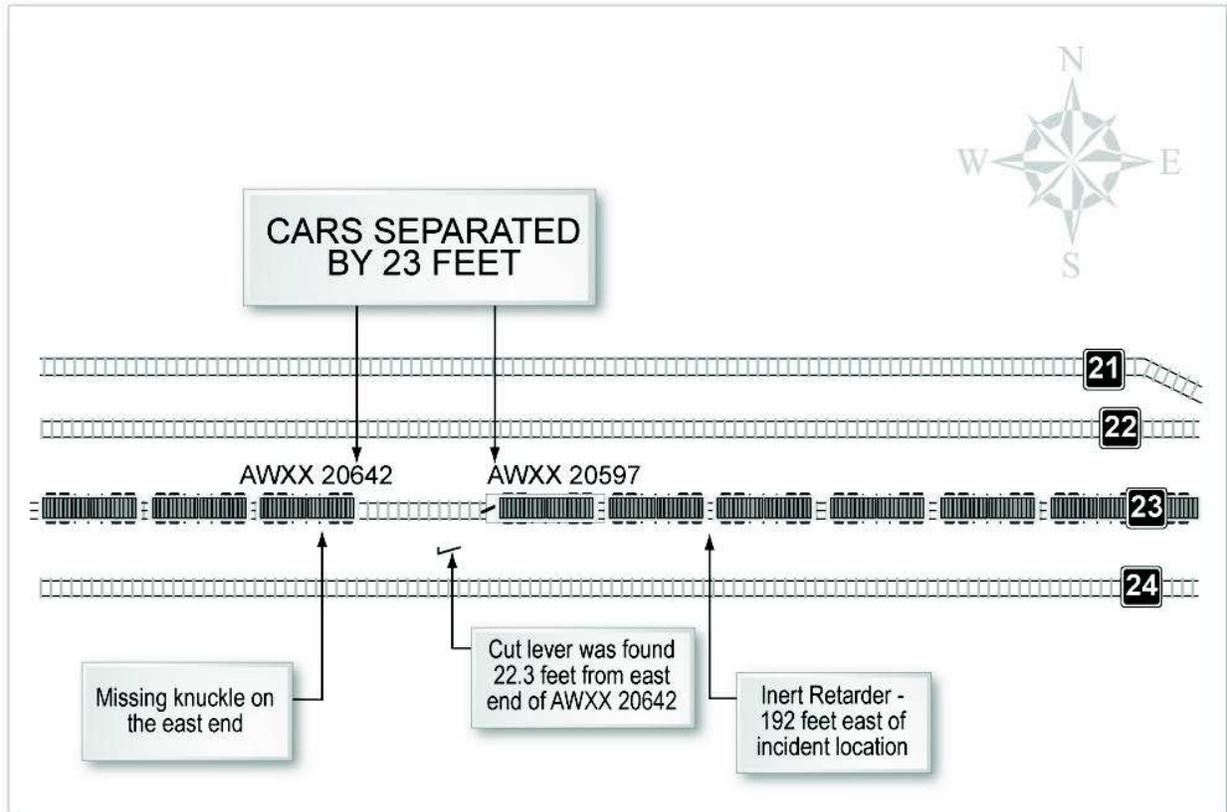
Several other CSX employees in the area heard the emergency announcement and went to the accident site. The RCO was found between tracks 23 and 24, with his OCU on the ground between the seventh and eighth cars. The RCO had worn the OCU on a large Velcro belt. There were marks in the coupler pocket¹⁰ of the seventh car and on the OCU consistent with one having been struck by the other. One of the responding CSX employees had received training in remote control operation and used the OCU to move the equipment. He left a gap between the seventh and eighth cars of about 23 feet to provide access room for EMS personnel. (See figure 1.)

Figure 1. Accident site on track 23.

Postaccident observations by witnesses indicated that the knuckle of the eighth car was hanging from the east end coupler and was tilted outward from the top about 3 inches. The knuckle pin, which would normally have been inserted in the coupler and knuckle as a hinge, was found on the ground next to the RCO. One of the witnesses stated that he picked it up and placed it between the wheel and rail of the eighth car to act as a stop. The coupler of the west end of the seventh car was found skewed to the south with the knuckle closed.

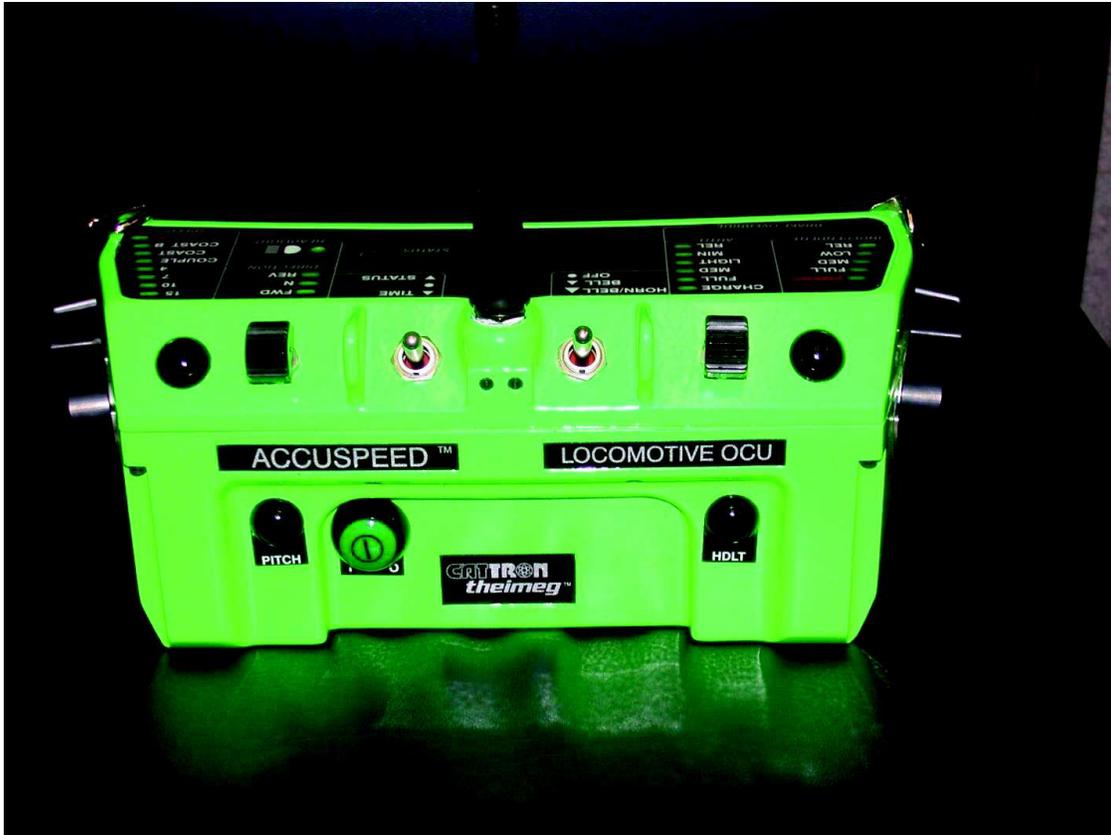
The RCO was using the Cattron OCU shown in figure 2. Cattron tested the recovered unit onsite and again later at the Cattron facilities in Sharon, Pennsylvania. No operational anomalies were found. Onsite testing showed no differences between the simulated recorded operations of the unit from the event recorder when compared with the use of another OCU.

Figure 2. Cattron operating control unit.

The testing determined that the operation of the OCU was consistent with FRA Safety Advisory 2001-01 and that no inadvertent operation of the locomotive could be initiated from the OCU.
