National Transportation Safety Board

Railroad Accident Brief

Accident No.: DCA-09-FR-008
Location: Lake Buena Vista, Florida
Date: July 5, 2009
Time: 2:00 a.m., eastern daylight time¹
Railroad/Property: Walt Disney World Resort
Property Damage: \$24 million
Injuries: 0
Fatalities: 1
Type of Accident: Collision

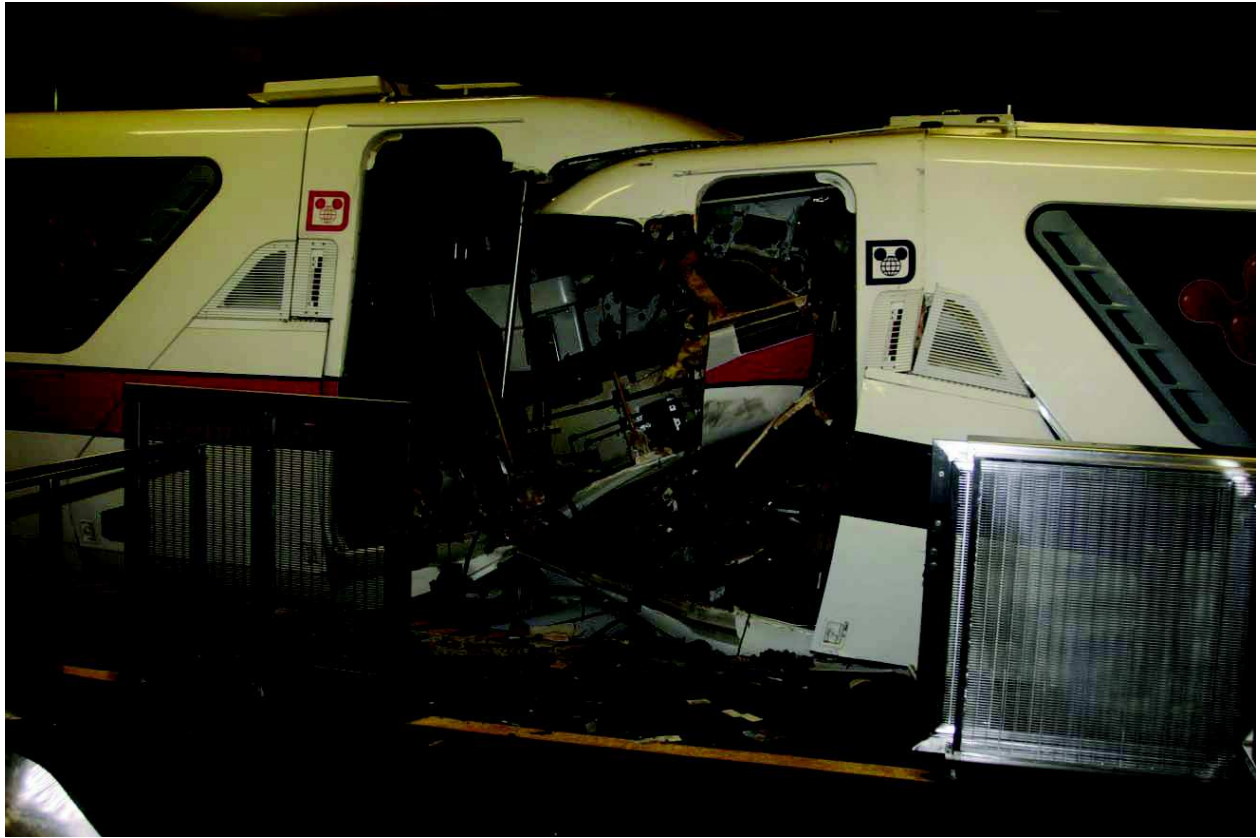
About 2:00 a.m. on Sunday, July 5, 2009, two monorails² collided on a fixed guideway system³ referred to as the Epcot beam⁴ near the Concourse station within Walt Disney World Resort in Lake Buena Vista, Florida. The accident occurred when the Pink monorail backed through an improperly aligned switch-beam⁵ and struck the Purple monorail. An operator and six passengers were on board the Purple monorail at the time of the collision. The operator was fatally injured; the passengers were not injured. The only occupant of the Pink monorail, the operator, was taken to a nearby hospital and treated and released. At the time of the accident, weather conditions were clear with light winds and a temperature of 76° Fahrenheit. One operating cab from each of the monorails was destroyed.⁶ (See figure 1.) Total damages were estimated at \$24 million.

Figure 1. The accident monorails after the collision. The rear operating cab of the Pink monorail (unoccupied at the time of the accident) is on the left, and the front operating cab of the Purple monorail is on the right.

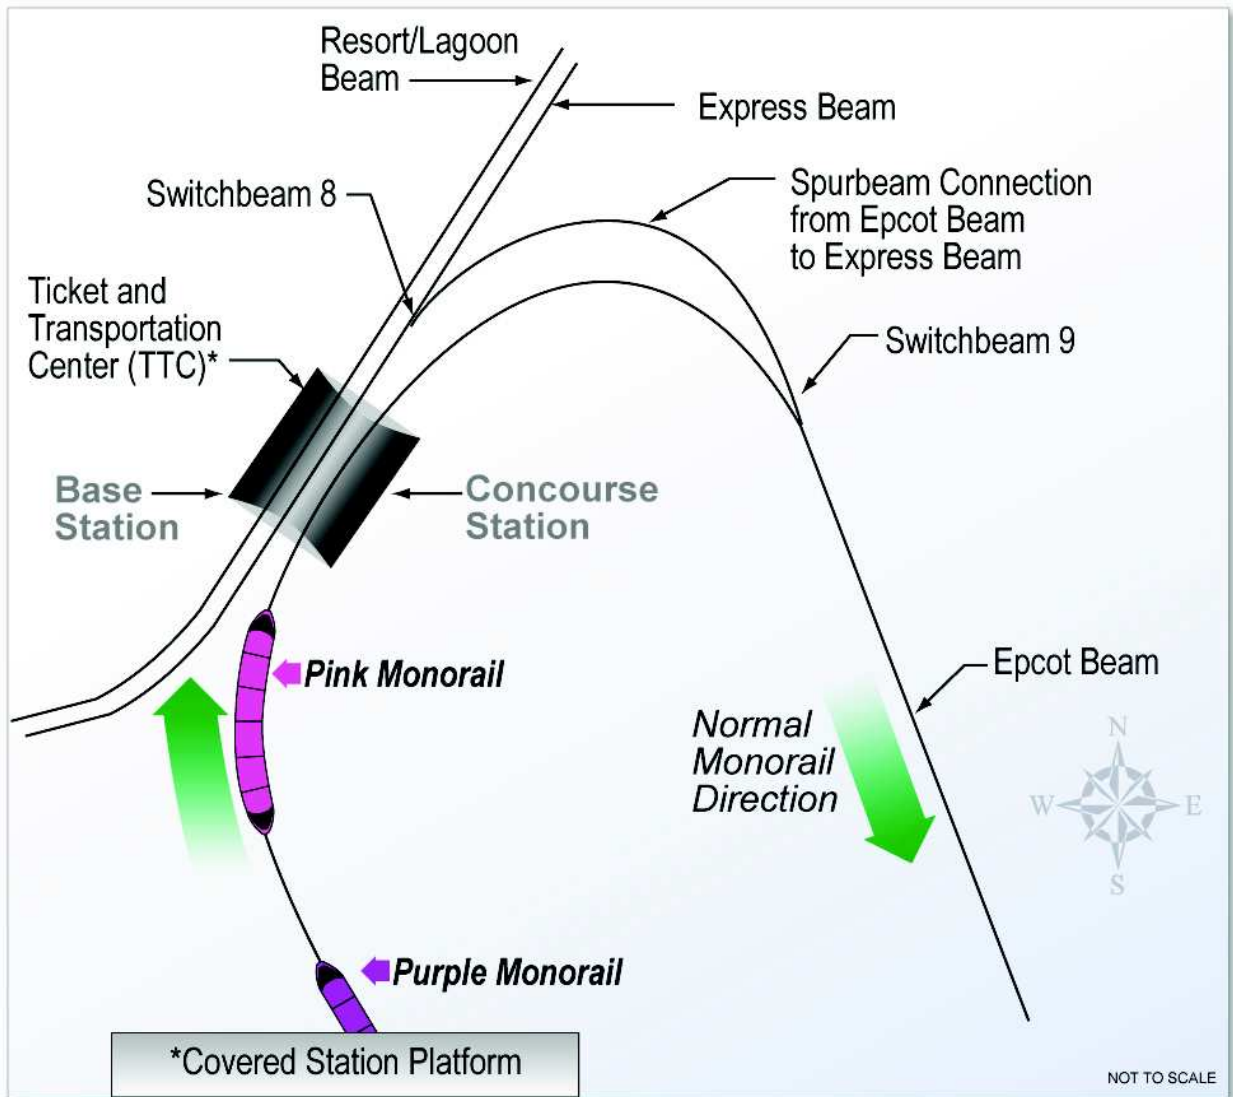
The Epcot beam is located to the south of the Magic Kingdom Park beam system. The Epcot beam is connected to the Magic Kingdom Express beam through a spur-beam. Switch-beams 8 and 9 at either end of the spur-beam⁷ can be repositioned to allow a monorail access from the Epcot beam to the Express beam or vice versa. (See figure 2.)

Figure 2. Junction of the Epcot beam with the Resort/Lagoon beam and the Express beam near the Ticket and Transportation Center. Normal direction of monorail travel on the Epcot beam is indicated by green arrows.

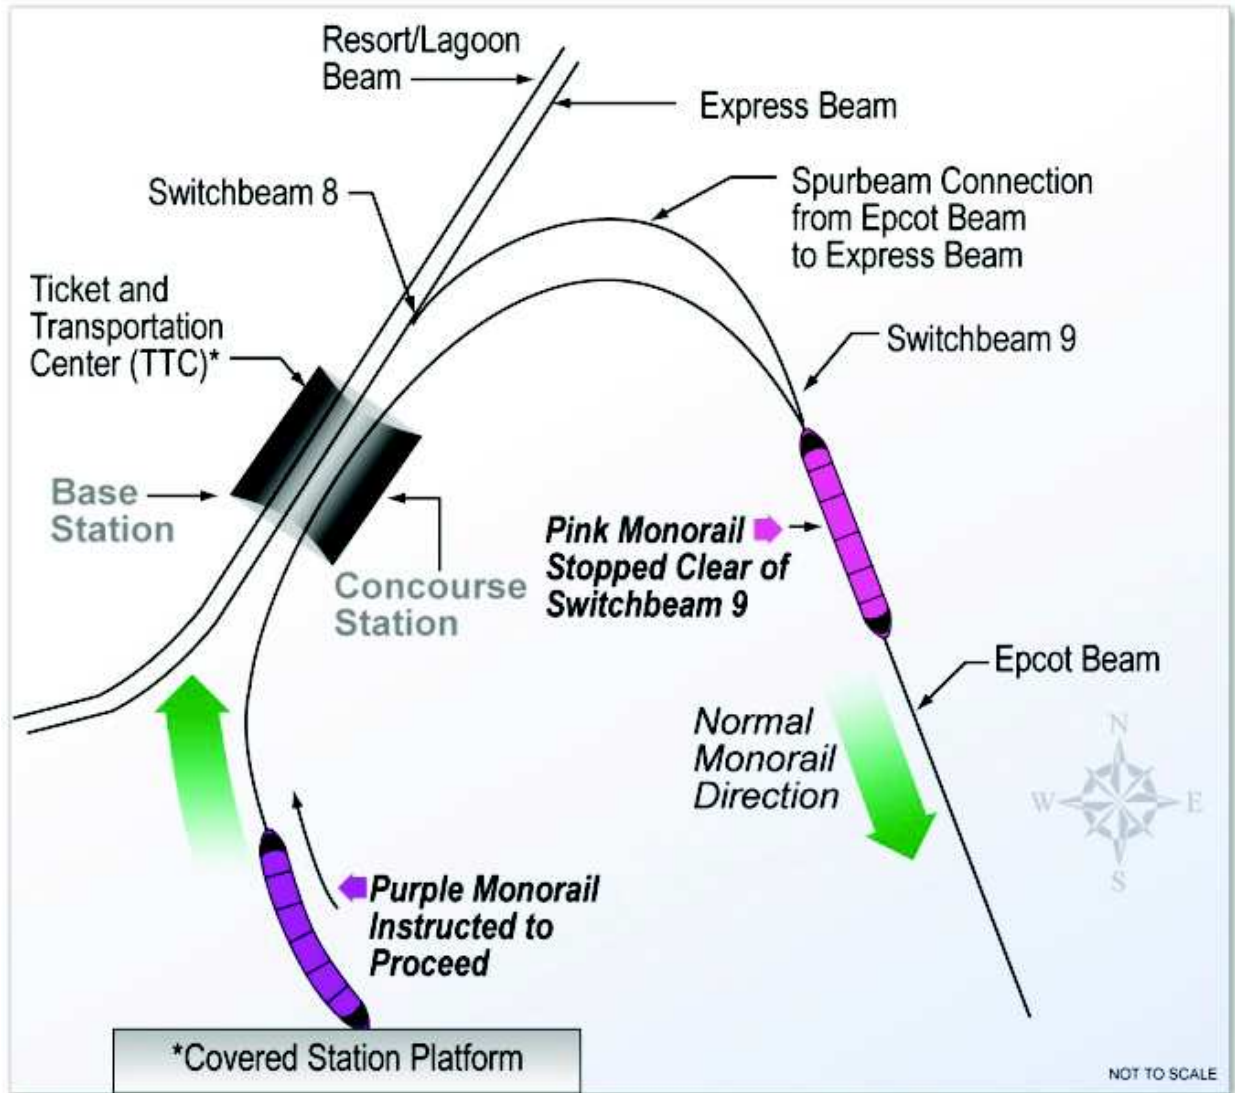
which is accessible via the Express beam. About 1:53 a.m., the monorail central coordinator transmitted the following instruction to the operator of the Pink monorail: “Normal visual to pylon 30,^[8] hold and notify.” This was a routine instruction intended to move the Pink monorail past switch-beam 9 on the Epcot beam so that, after switch-beams 8 and 9 were aligned for the spur-beam, it could back onto the spur-beam and then onto the Express beam for return to the mechanical facility. The operator of the Pink monorail stopped the monorail beyond switch-beam 9. He then notified the central coordinator that he had cleared switch-beam 9 and was awaiting further instructions. (See figure 3.)

Figure 3. The Pink monorail has cleared switch-beam 9 and is awaiting further instructions.

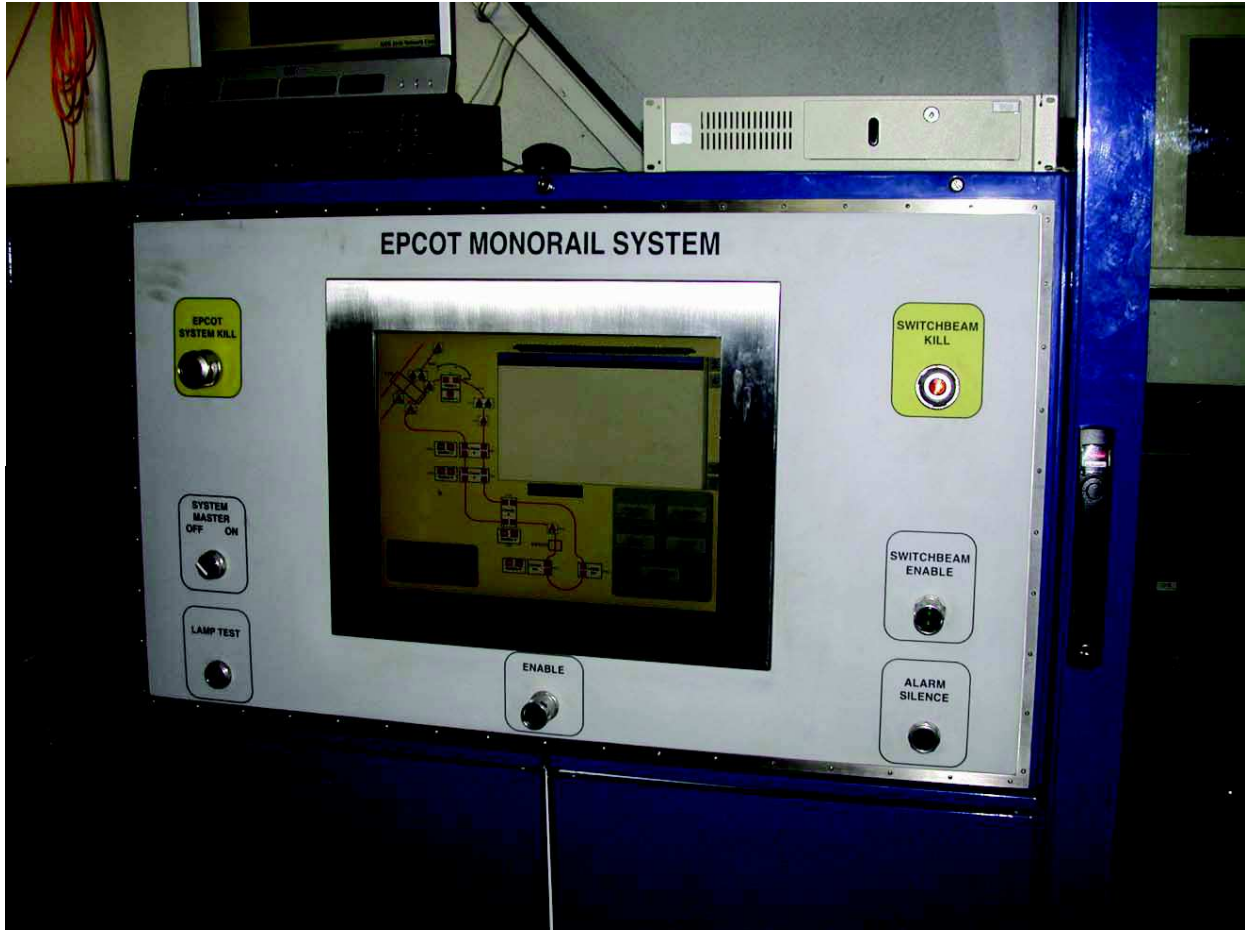
The central coordinator contacted the shop panel operator⁹ and instructed him to line “switch-beams 8 and 9 to the spur-line with power.” At 1:54 a.m., the shop panel operator confirmed that the central coordinator had requested that switch-beams 8 and 9 be aligned for the spur-beam. The operator then removed power from that section of the Epcot beam in preparation for the switch-beam realignment. Under normal operating conditions, graphical prompts appear on the Power Distribution and Monitor System (PDMS) screen that permit the switch-beams to be realigned. (See figure 4.) Without operator input, the system will “time out,” and the prompts for changing the switch-beam alignment will disappear.

Figure 4. Power Distribution and Monitor System switch panel for controlling switch-beams 8 and 9.

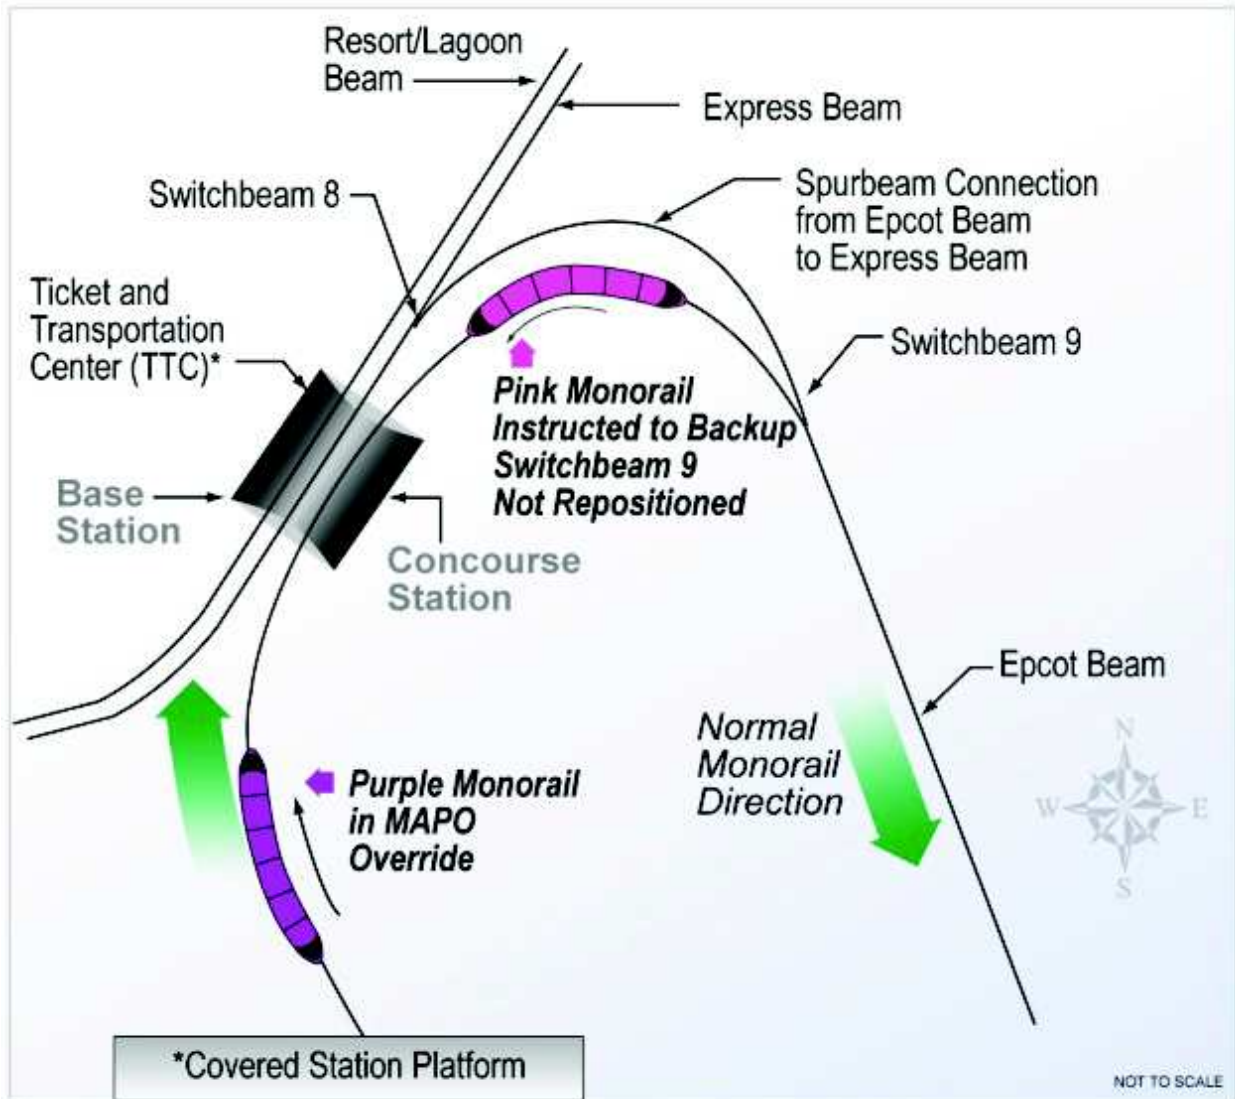
The operator of the Pink monorail began backing up the monorail. However, switch-beams 8 and 9 had not been repositioned. This resulted in the Pink monorail backing up on the Epcot beam, the same beam on which it had just been traveling and the same beam on which the Purple was following.

At 1:59 a.m., the central coordinator gave the operator of the Purple monorail (the monorail following the Pink monorail on the Epcot beam loop) the following instruction: “Normal visual 385, MAPO override into Concourse^[13]....” The MAPO system had to be placed in override to allow the Purple monorail to enter the station while the Pink monorail should have been backing through the spur-beam just beyond the station. (See figure 5.)

Figure 5. The Pink monorail is backing up on the same beam as the incoming Purple monorail, instead of on the spur-beam.

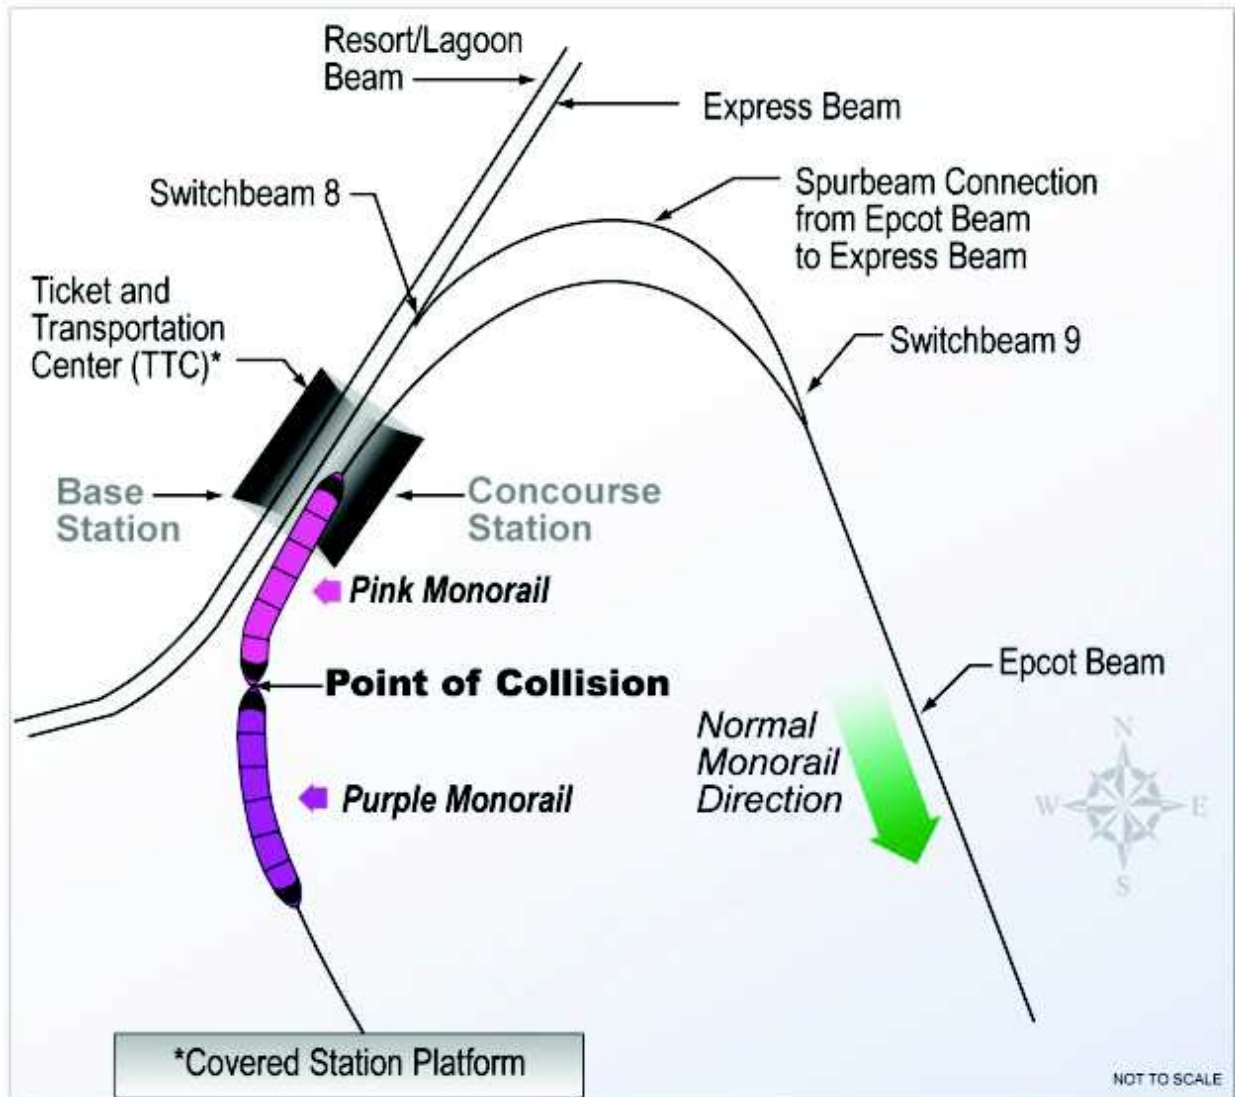
The Purple monorail proceeded toward the Concourse station within the Ticket and Transportation Center. According to the onboard Local Monitoring and Control Unit, which captures and logs data during operations, the operator of the Purple monorail stopped the monorail and placed the controls in reverse, but before the Purple monorail could be moved, it was struck by the Pink monorail (See figure 6.). The occupied operating cab of the Purple monorail was crushed, and the operator was fatally injured.

Figure 6. The unoccupied rear operating cab of the Pink monorail strikes the occupied operating cab of the Purple monorail.

The National Transportation Safety Board determines that the probable cause of the July 5, 2009, collision between two monorails at Walt Disney World Resort in Lake Buena Vista, Florida, was the shop panel operator's failure to properly position switch-beam 9 and the failure of the monorail manager acting as the central coordinator to verify the position of switch-beam 9 before authorizing the reverse movement of the Pink monorail. Contributing to the accident was Walt Disney World Resort's lack of standard operating procedures leading to an unsafe practice when reversing trains on its monorail system.
