Collision Between Two Massachusetts Bay
Transportation Authority Green Line Trains
Newton, Massachusetts
May 28, 2008

NTSB/RAR-09/02
PB2009-916302

Railroad Accident Report

Collision Between Two Massachusetts Bay Transportation
Authority Green Line Trains
Newton, Massachusetts
May 28, 2008

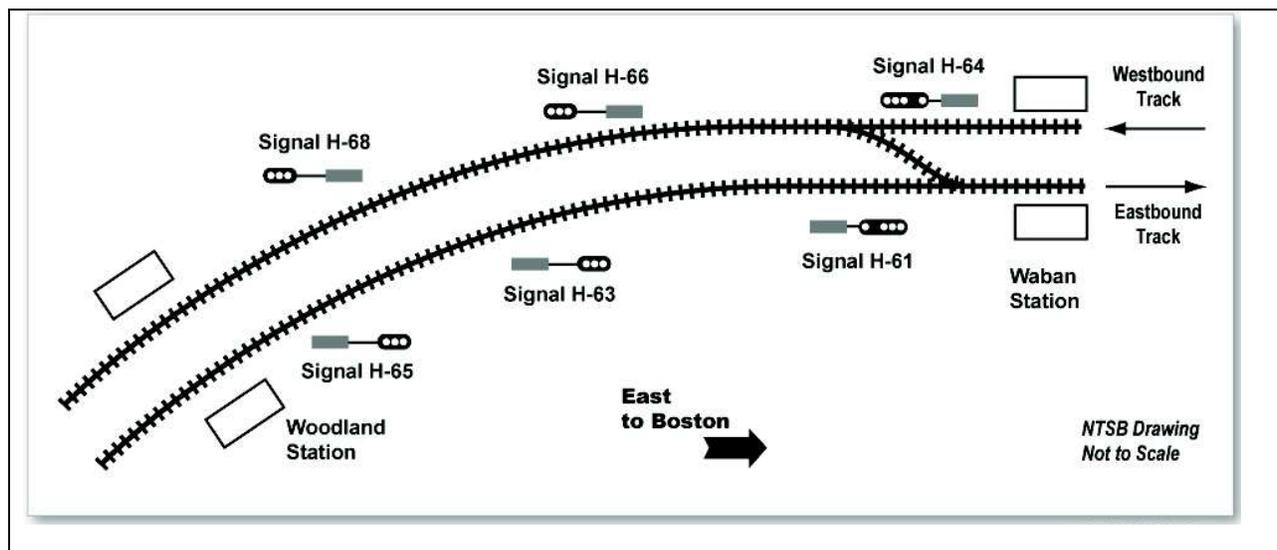
Figure 3. Signal layout between Waban and Woodland stations on D Branch of MBTA Green Line.

Crewmembers of the struck train reported nothing out of the ordinary during their afternoon run until about 5:50 p.m., when the train operator observed that signal H-66, about 1,666 feet west of Waban station, was displaying a single red aspect. (See figure 3.) MBTA rules state that a train encountering such a signal must stop and hold short of the signal for 1 minute before proceeding at restricted speed not to exceed 10 mph while being prepared to stop short of a car, train, or other obstruction. The operator of the struck train stated that he held his train for the specified time even though the track ahead was clear and he saw no reason for the red signal. The operator told National Transportation Safety Board (NTSB) investigators that he had encountered a red aspect at signal H-66 with the track ahead clear on one of his morning runs on the day of the accident. He stated that at that time he reported the red signal to the Operations Control Center and was told that it had been previously reported; however, there was no MBTA record of a trouble report being filed for the signal at this location.

The presence of stopped train 3681 at signal H-66 just ahead caused signal H-64, at the west end of Waban station, to also show a single red aspect. The trail operator of train 3667 stated that he remained on the train while it served Waban station and that, from his position in the operator's compartment of the rear car, he could not see the aspect of signal H-64.

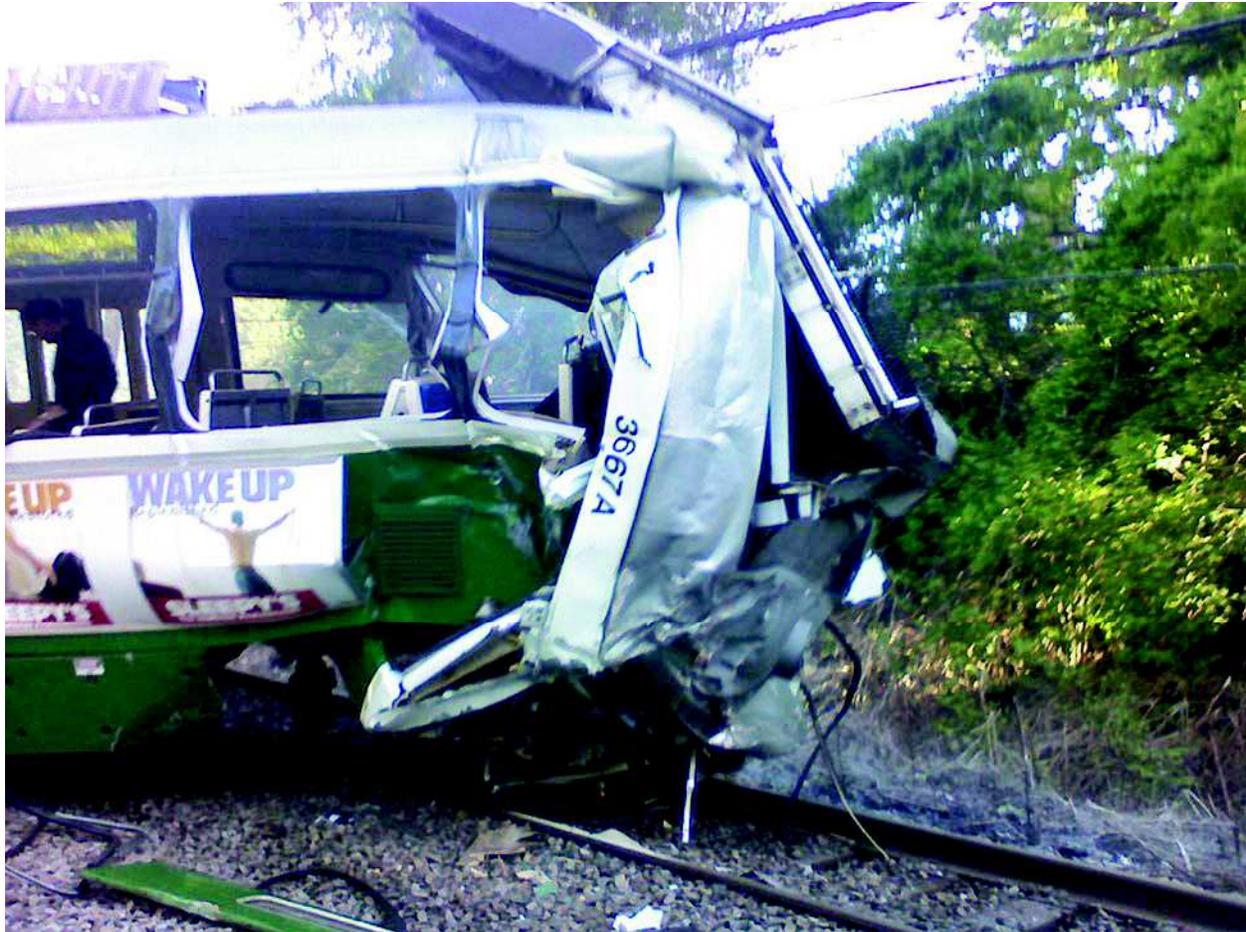
Figure 4. Crushed lead car of striking train.

MBTA car 3667, the lead car of the striking train, was destroyed in the accident. It sustained substantial crush damage and also derailed as a result of the collision. (See figure 4.) The second car of the striking train, 3706, sustained minor damage. MBTA car 3703, the second car of the struck train, was severely damaged. The lead car of the struck train, 3681, was derailed with minor damage. The total damage was estimated to be about \$8.6 million.

10. The failure of the structure of the trolley cars resulted in the catastrophic loss of survivable space.
