National Transportation Safety Board

Railroad Accident Brief

Accident No.: DCA-08-FR-004
Location: Providence, Rhode Island
Date: March 13, 2008
Time: 1:11 p.m., eastern daylight time¹
Railroad: Amtrak (National Railroad Passenger Corporation)
Property Damage: None
Fatalities: 1
Injuries: 2
Type of Accident: Employee fatality

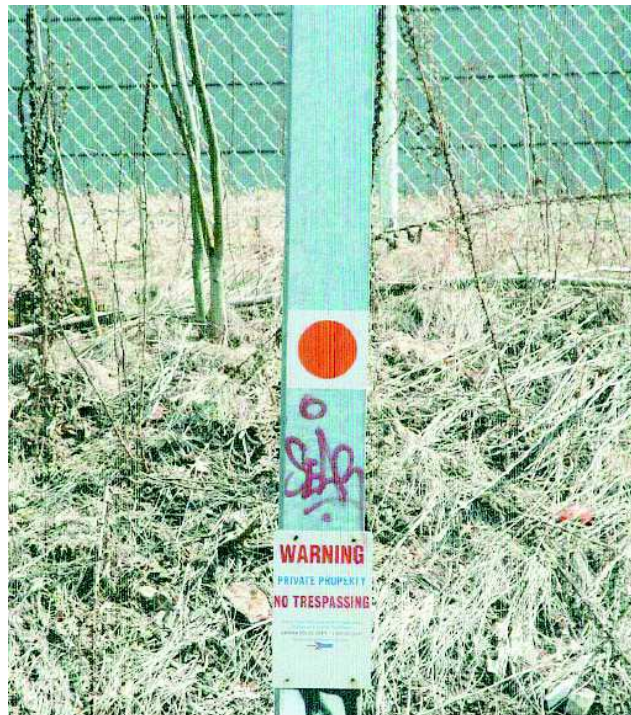
The accident occurred in a 4° 23' curve under a bridge—a hot spot, visually designated as such by orange decals on catenary poles (see figure 1) between MP 181.1 and MP 187. The HNTB inspector was walking in the gage of track 2 and the foreman was walking behind the inspector outside of the gage, but still on the ties, when Amtrak Acela train 2154 struck the inspector and the foreman. The watchman was on the field side of track 2, on the inside of the curve. During postaccident interviews, the watchman recalled looking up, seeing the Amtrak train right in front of him, and jumping. (See figure 2.) The train stopped 564 feet past the point of impact.

Figure 1. Orange decal posted on a catenary pole indicating a hot spot.

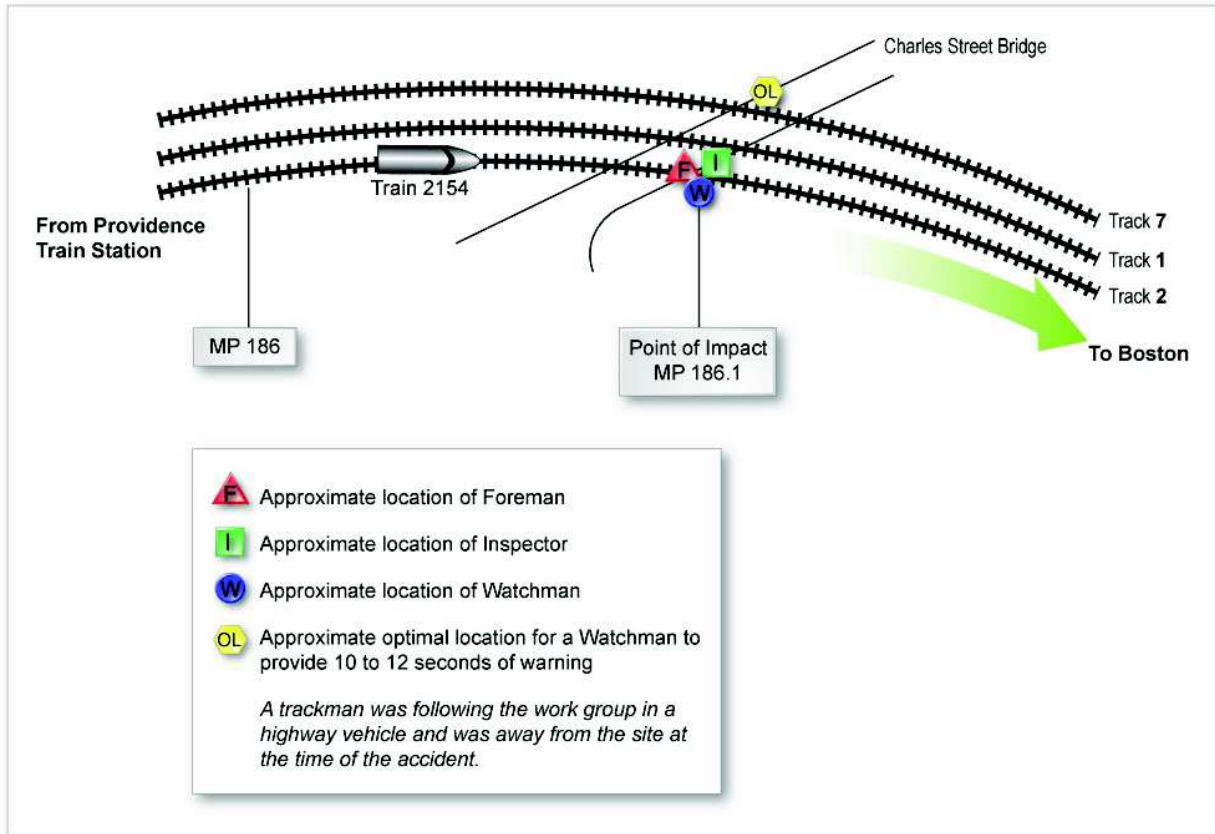
Figure 2. Accident site layout and locations of roadway workers.

Postaccident sight-distance observations determined that the optimal location for positioning a watchman was on the outside of the curve on the field side of track 7, approximately 53 feet from the center of track 2. (See figure 2.) From the optimal location, a watchman could see about 765 feet looking west and about 862 feet looking east where he would have had between 10 and 12 seconds to provide a warning of an approaching train.¹⁰ The watchman's actual location allowed him about 1 second of time to warn the work group of a train approaching from either direction at 51 mph. Regardless of the type of on-track protection in place when the accident occurred, the watchman was positioned in a spot that afforded him the least amount of visibility of approaching trains in either direction. Although directed to stand close to the work group, the watchman did not recognize that he was poorly positioned to perform his duties and he did not exercise his right to challenge¹¹ the foreman's instructions.

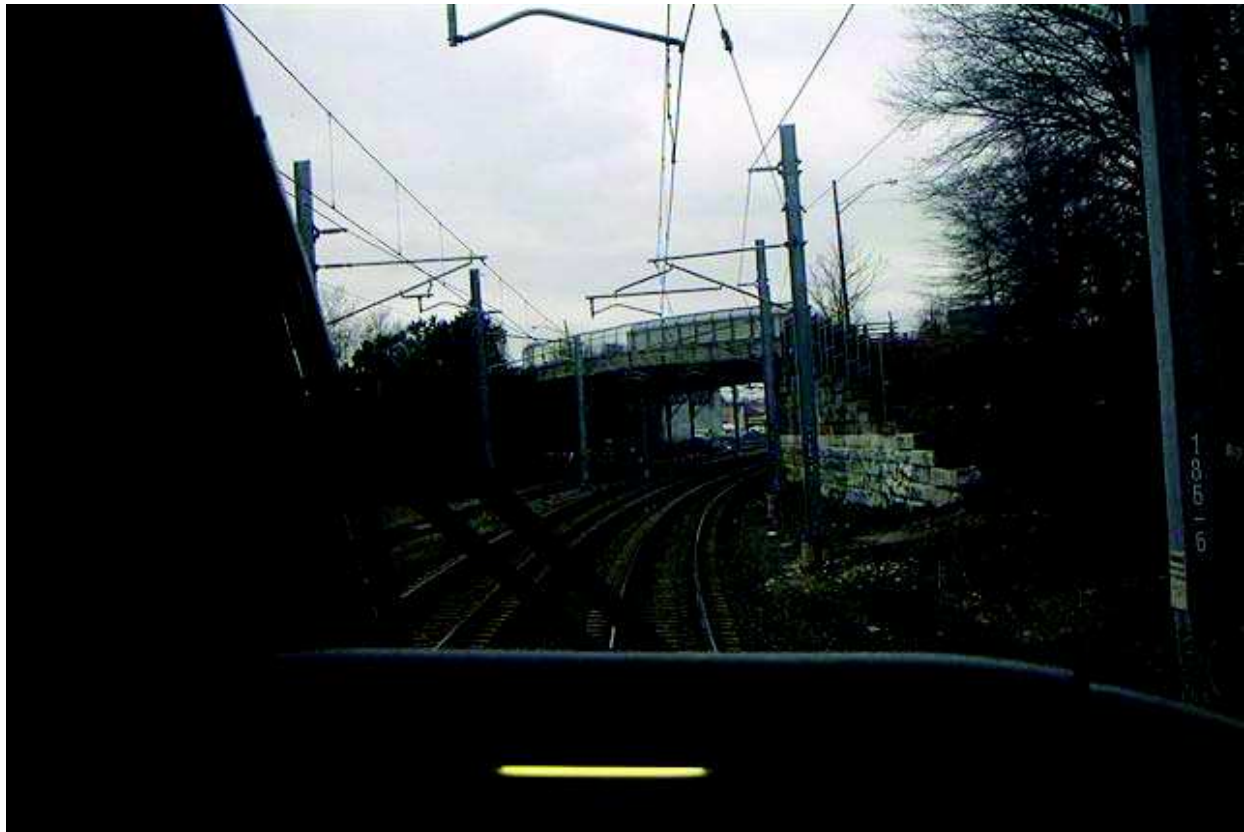
On the day of the accident, Amtrak Acela train 2154 departed from Penn Station in New York City, New York, shortly after 10:00 a.m. and arrived at Providence train station about 1:05 p.m. It departed Providence train station about 1:09 p.m.; at that time, there were four people in the locomotive cab: the engineer, a Federal Railroad Administration (FRA) deputy regional administrator, an Amtrak assistant superintendent of road operations, and a Massachusetts Bay Commuter Railroad road foreman. The train was traveling between 20 and 25 mph through the first curve out of the station, and its speed increased to about 51 mph at MP 186 as it approached the Charles Street Bridge. (See figure 3.)

Figure 3. Engineer’s view eastbound on track 2, approaching the Charles Street Bridge. Point of impact was located under the bridge.
