Derailment and Collision

Canadian National

Train No. U-783-21-30 and Train No. M-306-31-30

Mont-Saint-Hilaire, Quebec

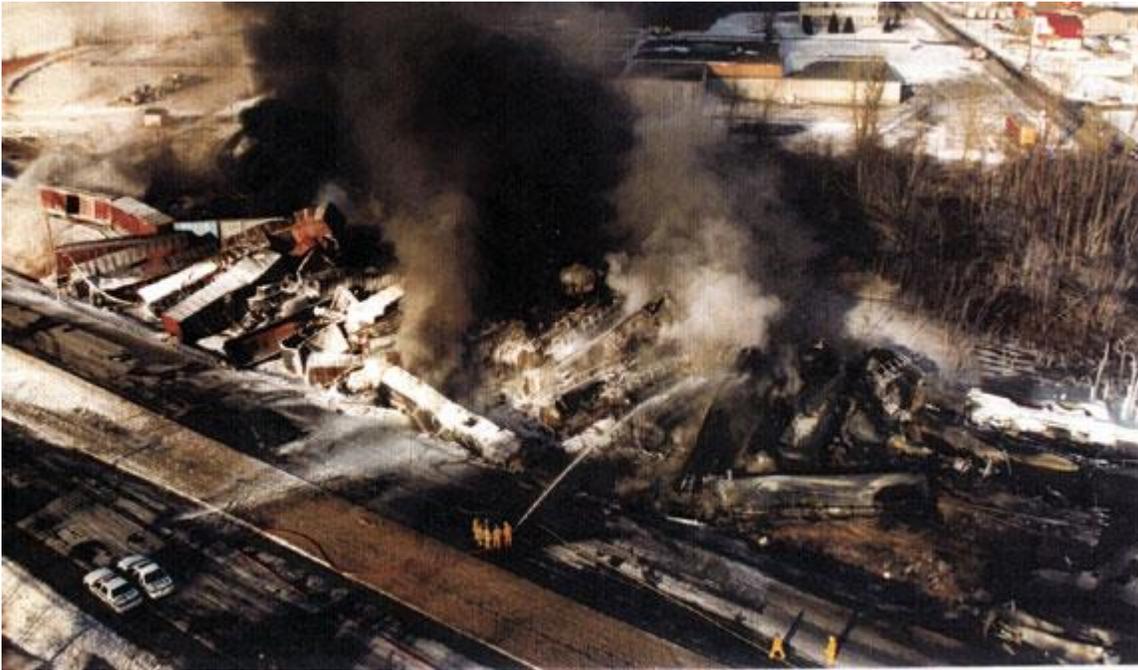
Figure 2 - Overview of scattered cars

The cars were scattered across both tracks and in the ditches on either side of the tracks (see Figure 2). The locomotives from train 306 were engulfed in flames and lay on the south side of the track, in the ditch between the railway tracks and Laurier Boulevard (Highway 116). The tank cars loaded with hydrocarbons from train 783 were punctured, and almost all rolling stock in the derailment area was on fire. The fire was isolated and brought under control during the night of 30 to 31 December, but continued to burn for four days.

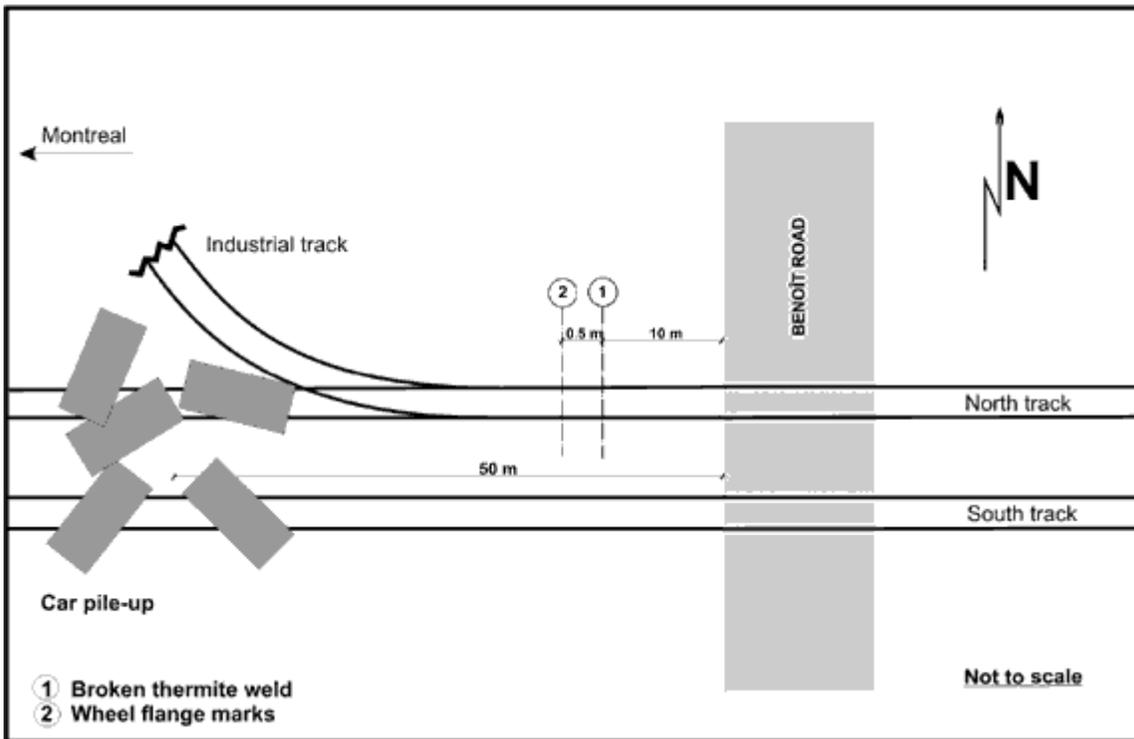
Figure 3 - Location of broken weld

The south rail of the north track broke at a thermite weld located 10 m west of the end of the crossing and 1.5 m east of the switch point for the industrial turnout (see Figure 3).

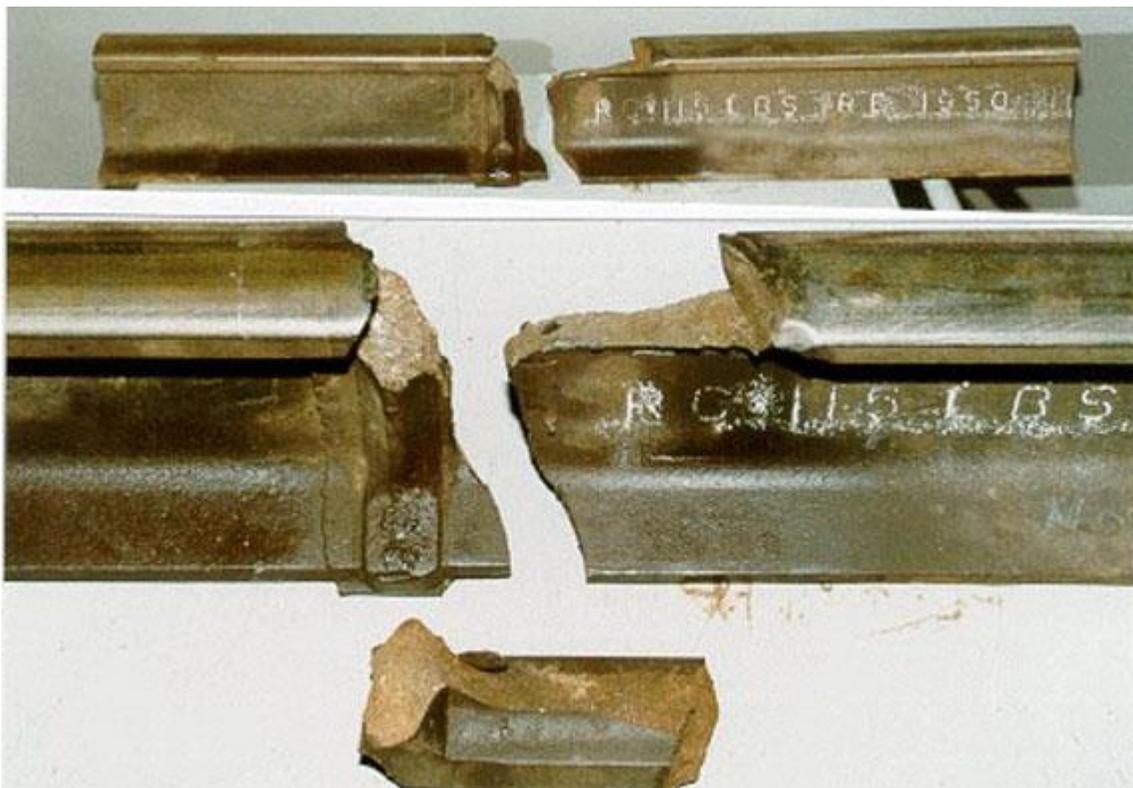
Figure 4 - Rail fracture

The rail was displaced laterally and the east rail end was rolled over. The break had the form of a T; it was vertical in the base and web, separated into two horizontal branches at the junction of the web and the head of the rail, and then continued vertically again in the head (see Figure 4). A rail head section, 150 mm in length, separated from the rail and was found on the ground beside the south rail, a few feet east of the weld.

The south rail of the north track broke at a thermite weld. No wheel flange marks or scrape marks were found east of the broken weld; consequently, it may be concluded that the derailment did not occur to the east of the weld. The shape of the first scrape observed on the field side of the rail head, immediately west of the weld, indicates that the wheel flange climbed the rail at that point; this is also consistent with the wheel flange marks seen on the turnout gauge plate and the tie plate west of the weld.

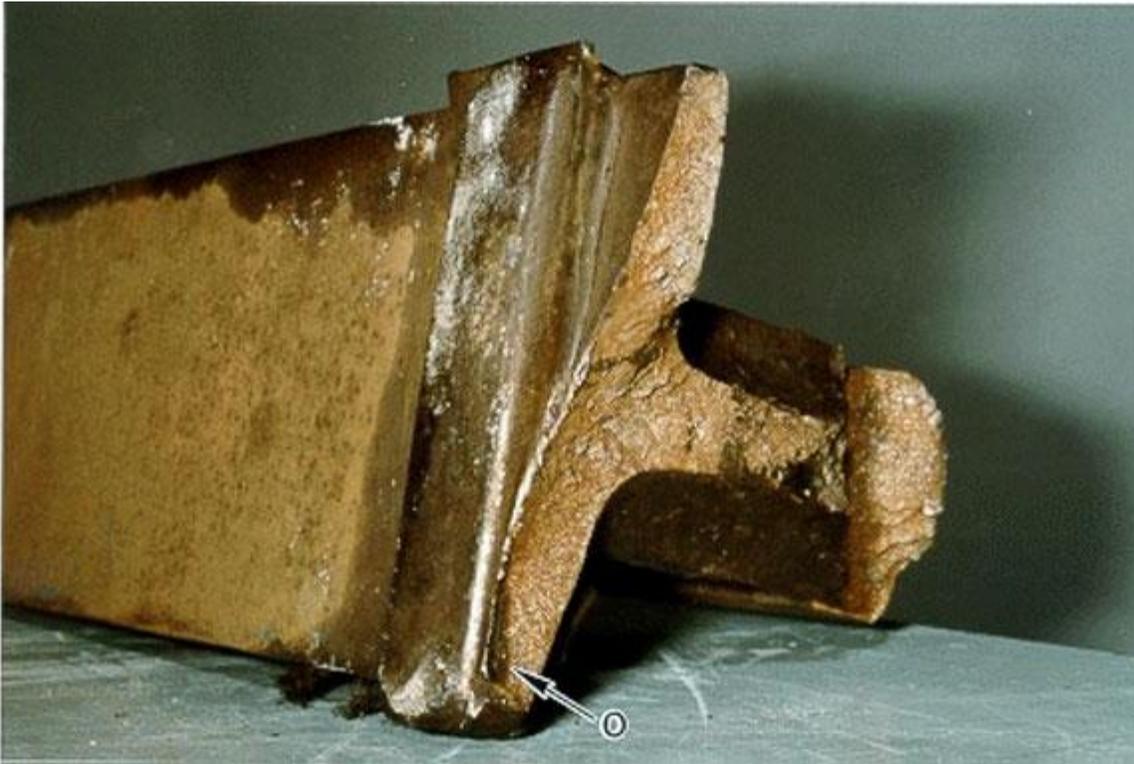
Figure 5 - Location of pre-crack (O)

A semi-circular dark area containing a pre-crack was located on the field side of the weld fracture surface, on the lower corner of the rail base (see Figure 5). It was 29 mm wide and 6 mm high and was located 22 mm from the weld axis. The pre-crack was located in the heat-affected zone of the weld, near a sudden change in the cross-section. The surface of the pre-crack was highly oxidized and showed no signs of recent growth.

The two surfaces of the pre-crack were cut out of the east and west rail sections. Analysis of these pieces with a scanning electron microscope and a metallurgical microscope confirmed that the pre-crack had begun in an area of acicular ferrite, a microstructure that has less resistance to fracture and impact, and that there was no recent extension of the pre-crack.

The chevron markings observed on the fracture surfaces are consistent with a rapid overstress fracture. The direction of these markings indicates that the break originated in the pre-crack area located in the lower corner of the rail base. Once initiated, the fracture occurred quickly, with the head of the rail breaking last. The pre-crack showed no signs of recent growth. It lacked the black colouration, which is usually associated with oxidation at high temperature, indicating that it formed after the weld was made, probably as a result of residual stresses created during welding. The thickness of the oxide layer indicates that the pre-crack was at least nine months old.

Fracture mechanics calculations based on the results of Charpy impact tests and tensile tests showed that, at the ambient temperature at the time of the accident, the pre-crack had actually reduced the rail's strength to approximately 33 per cent of the initial yield strength. Mismatch between the rail ends and use of a straight base plate⁽¹³⁾ created a notch effect conducive to the development and propagation of cracks. A sloped base plate would have allowed a more gradual transition between the two rails, lessening this effect.
