Derailment/Collision

VIA Rail Canada Inc.

Passenger Train No. 74

Mile 46.7, Canadian National Chatham Subdivision

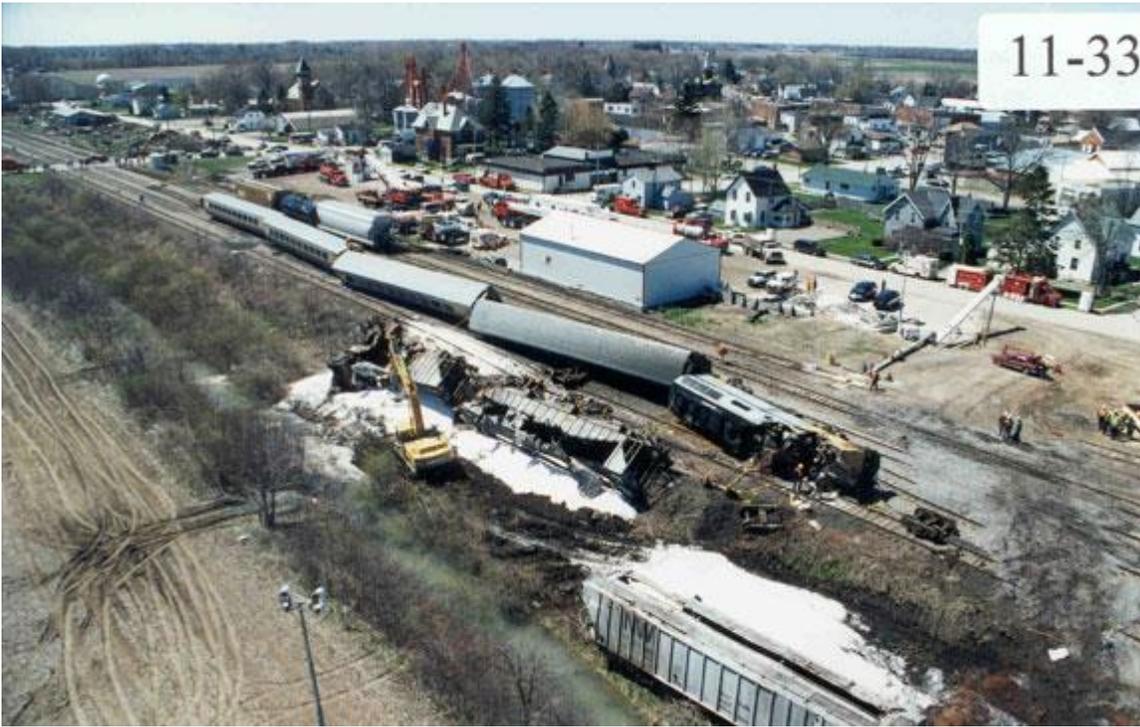
Figure 1 - Overhead photograph of accident site looking north-west

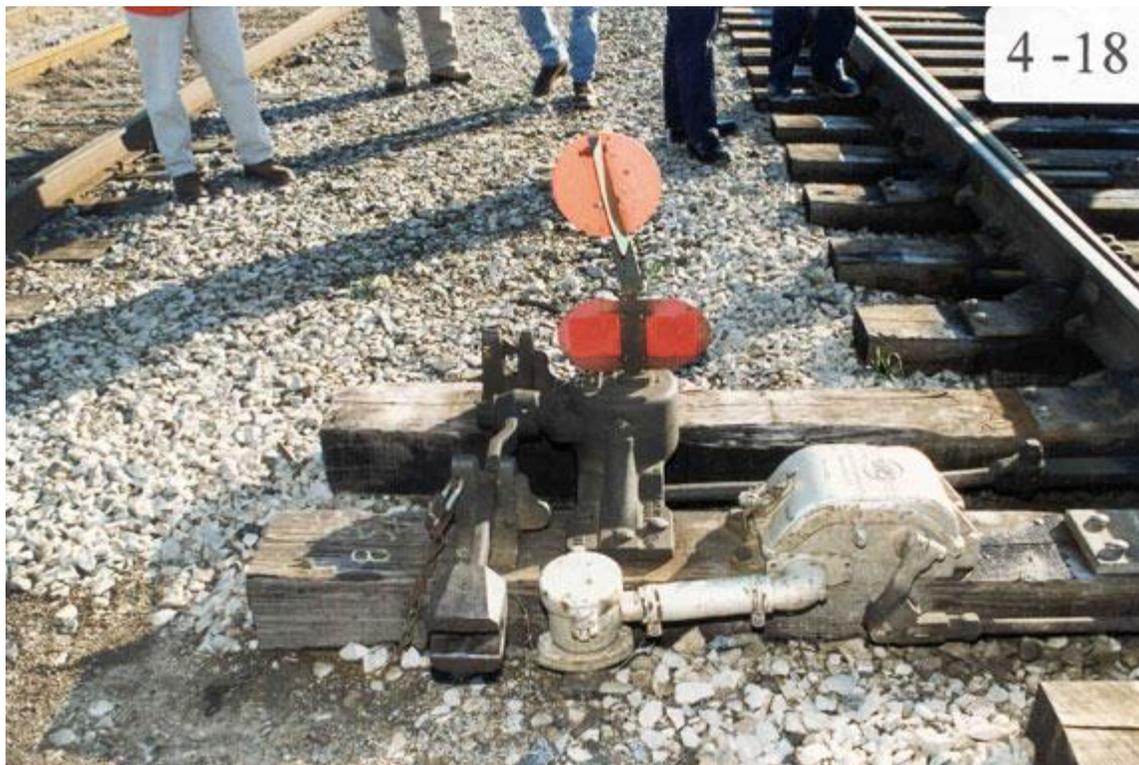
Figure 3 - West crossover switch, Mile 46.72, lined and locked in the reversed position

Each crossover switch was equipped with two targets displaying red for the reversed position and one target displaying green for the normal position (see Figure 3). Affixed to a square steel mast that ascended straight up out of the centre of the switch mechanism was an oval-shaped target 30.5 cm long by 15 cm high. This target had been painted red and had two rectangular pieces of high-intensity reflective material on its surface, one on each side of the centre line. Both the paint and reflective material were soiled and had experienced considerable surface degradation. The bottom of the oval target was about level with the top of the rail. An additional length of square steel rod extended from the top of the mast fastened by a sleeve and securing bolt. Affixed to this extension were two additional targets at 90 degrees to each other, one round and one square. The round target faced the same way as the oval target and was also painted red. The paint was faded and no additional reflective material had been applied. The square target, facing away from the train movement, was painted green. The round target was 20 cm in diameter and the square target was 20 cm by 20 cm. The bottom of these targets was approximately 27 cm above the top of the rail.

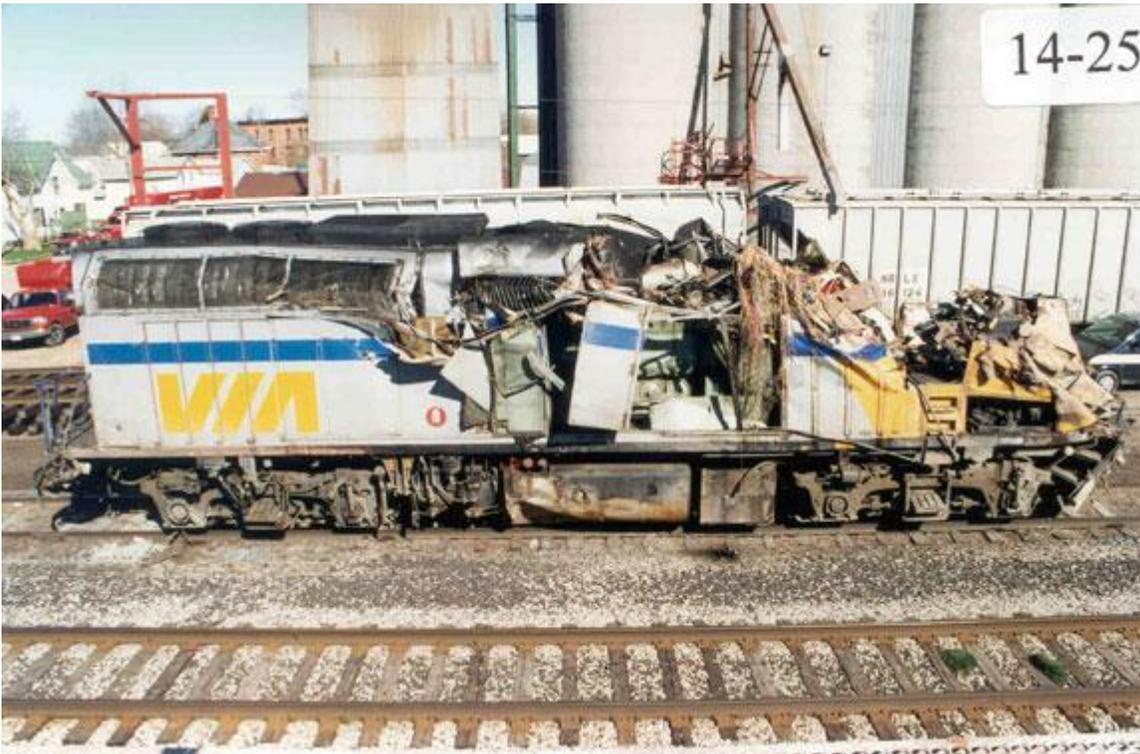
Figure 4 - Right side shown after locomotive was righted.
Damage is more extensive at the front right and along the right side of the locomotive.

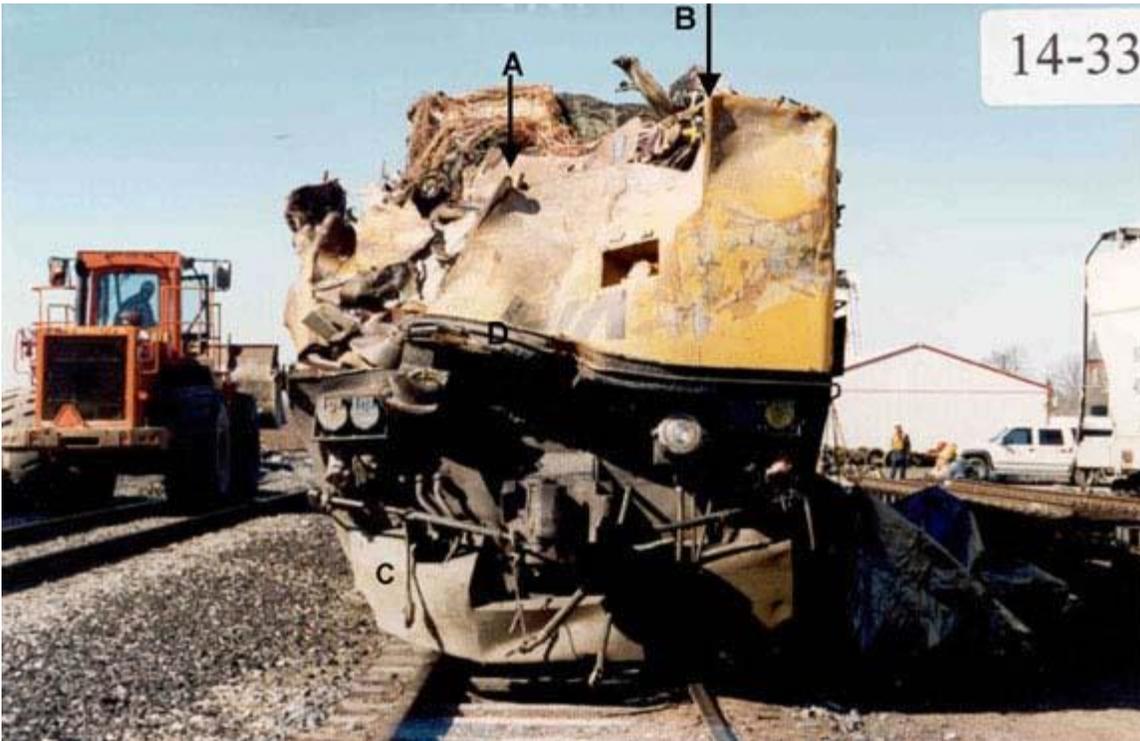
Figure 5 - View of locomotive from front after having been righted.
A - Right collision post B - Left collision post C - Pilot D - Anti-climber

near the top of the post was dented and sheared away. The right collision post was not bent along its length; however, the top of it was pushed aft. The structure which supports it at the bottom of the underframe was fractured. Close examination of the left collision post found similar damage to its underframe support structure, but which had not progressed to the same extent.

- Pilot and Vicinity - The right end of the pilot was pushed aft, while its left side was comparatively undamaged. The left ditch light was not broken. A large number of fine scratches on the surface of the right end of the pilot were consistent with having been caused by contact with the roadbed. The pilot or its surrounding area beneath the underframe did not contain deep gouges or severe structural damage as seen on the upper surfaces of the short hood that were consistent with contact with the hopper cars.

- Anti-Climber - The right end of the anti-climber was bent upwards. One gouge was observed on the underside of the anti-climber consistent with impact with the hopper cars. It is considered that much of this upwards bending likely resulted from damage to the underframe when the right collision post was forced aft.

- Short Hood - The short hood on the right was pushed back along with the right collision post. The short hood on the left was dented and sheared near the top of the left collision post. The left side of the short hood at the base of the collision post did not show any significant impact damage. The right side of the short hood contained numerous deep gouges in the metal where it contacted the loaded covered hopper cars.

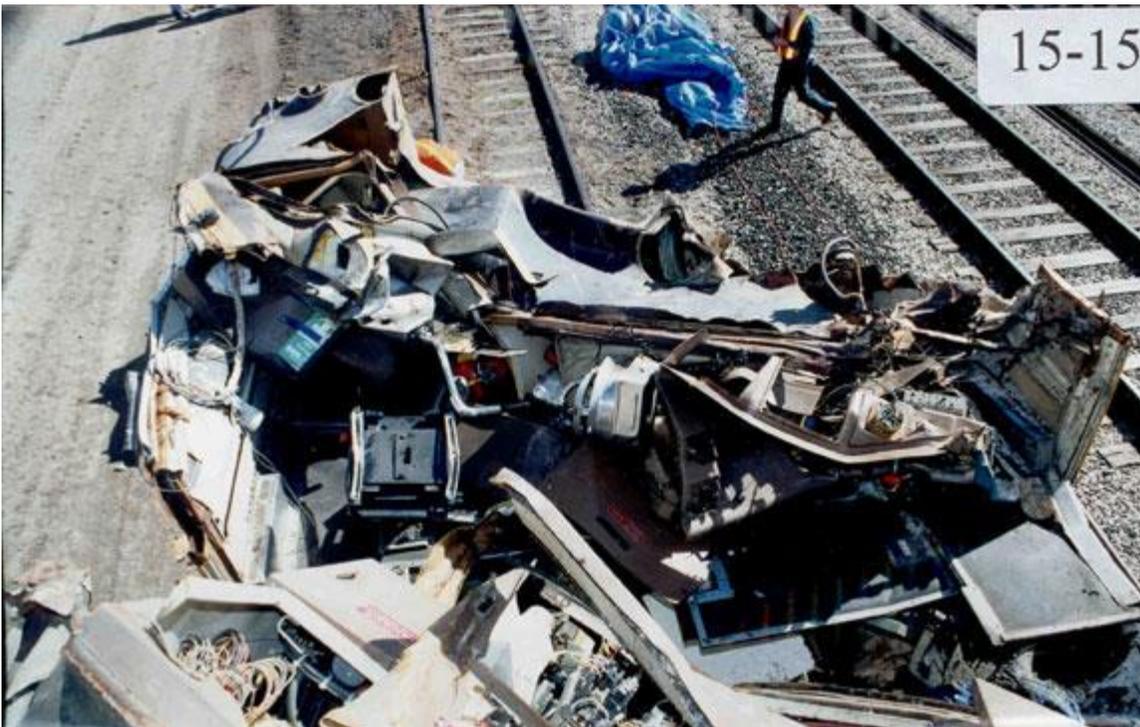
Figure 6 - Interior of cabin looking forward from top of locomotive

- Control Cabin - The roof of the cabin was found separately, and was considered to have been torn away by the collision. The electrical cabinet, located behind the operators, was pushed towards the rear, more on the right than on the left. On the right side, the control console and short hood were pushed back beyond the operator's seat and downwards almost level with the cabin floor. On the left side, the operator's seat pedestal was still securely fastened to the floor, was visibly deformed towards the rear, and was not covered by the short hood or console. No buckling was observed in the cabin floor.
