Railway Investigation Report R97V0063

Derailment

Canadian National
Train No. Q-102-51-26
Mile 106.15, Ashcroft Subdivision
Conrad, British Columbia
26 March 1997

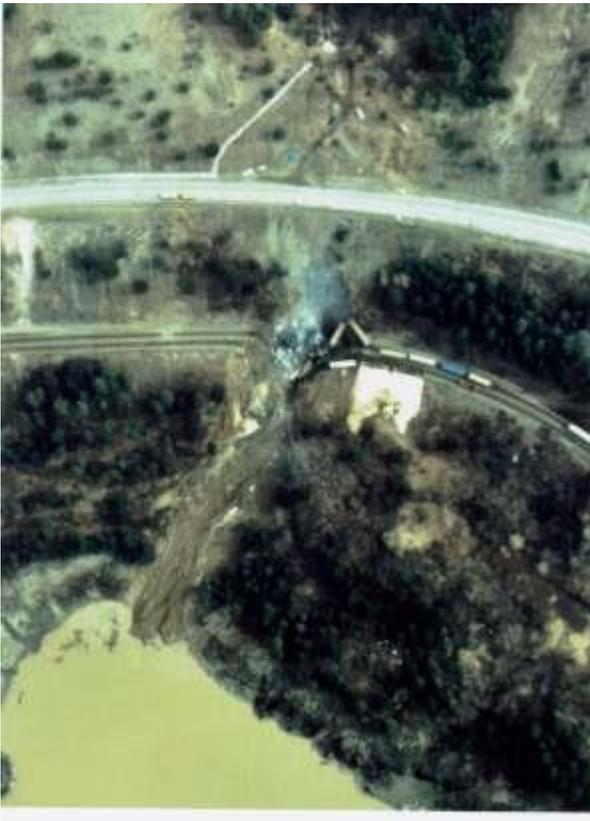
Figure 1

In the area of the derailment, the single main track and siding (west of the main track) run between the Trans-Canada Highway, approximately 60 m (197 feet) to the east and 34 m (112 feet) above, and the Fraser River, approximately 150 m (492 feet) to the west, and 50 m (164 feet) below. The railway embankment and toe of the highway fills had slipped away, leaving a void approximately 60 m (197 feet) long and 12 m (40 feet) deep, stretching up into the highway fills. The mud-like fill had flowed west, trailing into the Fraser River. The locomotive consist and first three cars of train 711 were standing upright and railed on the siding south of the depression. The fourth car was derailed and leaning, the fifth and sixth cars had rolled onto their sides and spilled their lading, while the seventh car was lying partially down the embankment. The eighth, ninth and tenth cars were near the bottom of the embankment on the westerly edge of the pile-up of equipment at the bottom of the depression, while the eleventh car was derailed and upright north of the slide area. The tenth car had come to rest approximately 46 m (150 feet) west of the siding track. The pile of equipment included the locomotive consist and the first six cars from train 102. The seventh and eighth cars were upright, but derailed, on the south edge of the depression (See Figure 1).

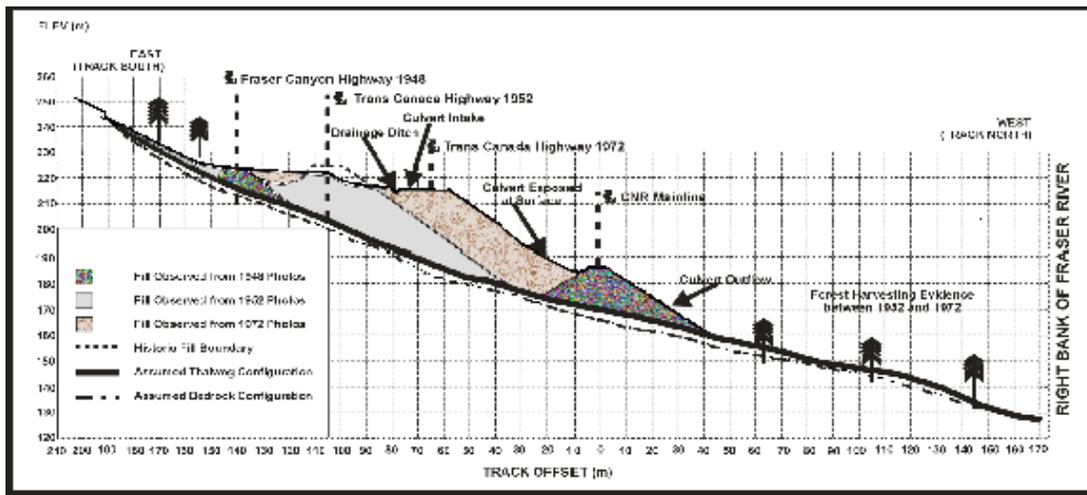
Figure 2

The terrain is mountainous and heavily forested. The highway, originally built in 1948, had been realigned in 1952 and 1960. Each realignment resulted in the highway being moved closer to the railway right-of-way (See Figure 2). The highway subgrade and embankment consist of local fill materials laid over original ground. The highway embankment is at an approximate 1 to 1.5 slope. A service road, 3 m (10 feet) wide, runs between the railway subgrade and the toe of the highway fill.
