PRELIMINARY REPORT

HIGHWAY

HWY15MH006

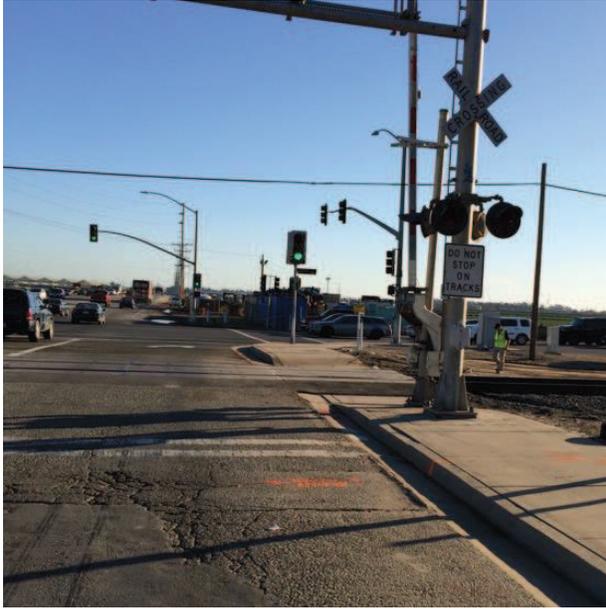
Driver's forward view of crossing.

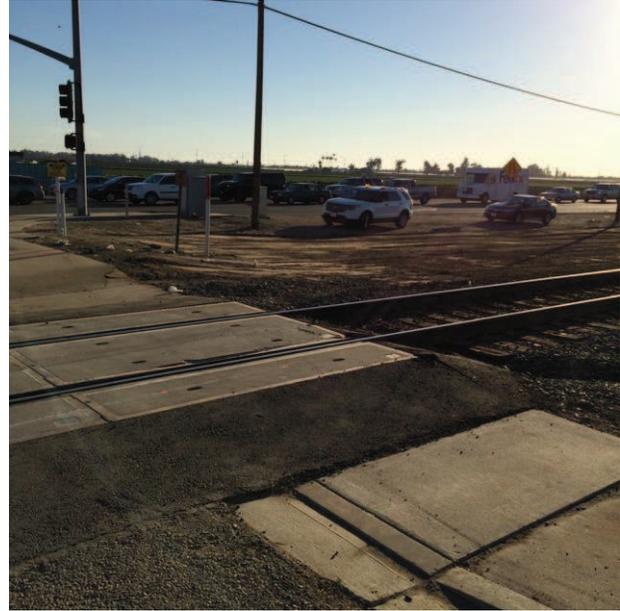
Driver's view to the right, looking at tracks.

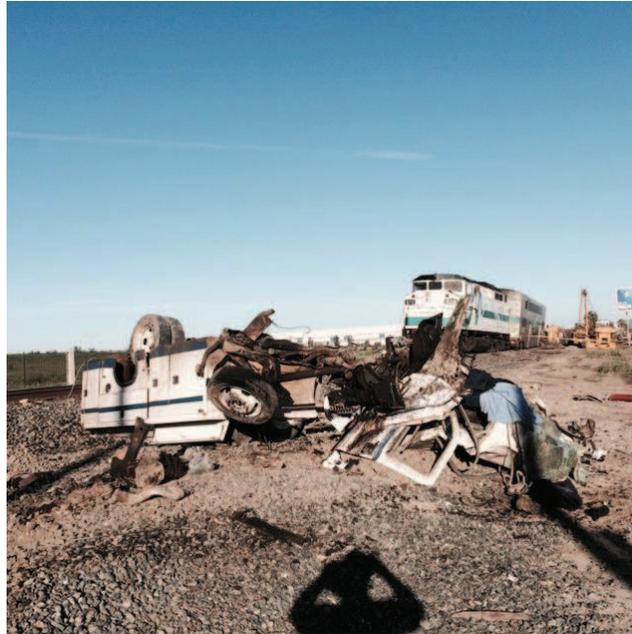
⁹ Emergency responders determined that the truck cab, which was found in a severely crushed condition, had been unoccupied.

Ford F-450 truck at final rest.
