**RAILWAY INVESTIGATION REPORT
R13W0260**

EMPLOYEE FATALITY

**CANADIAN NATIONAL RAILWAY
TRAIN L586 41-18
MILE 61.0, TISDALE SUBDIVISION
TISDALE, SASKATCHEWAN
18 NOVEMBER 2013**

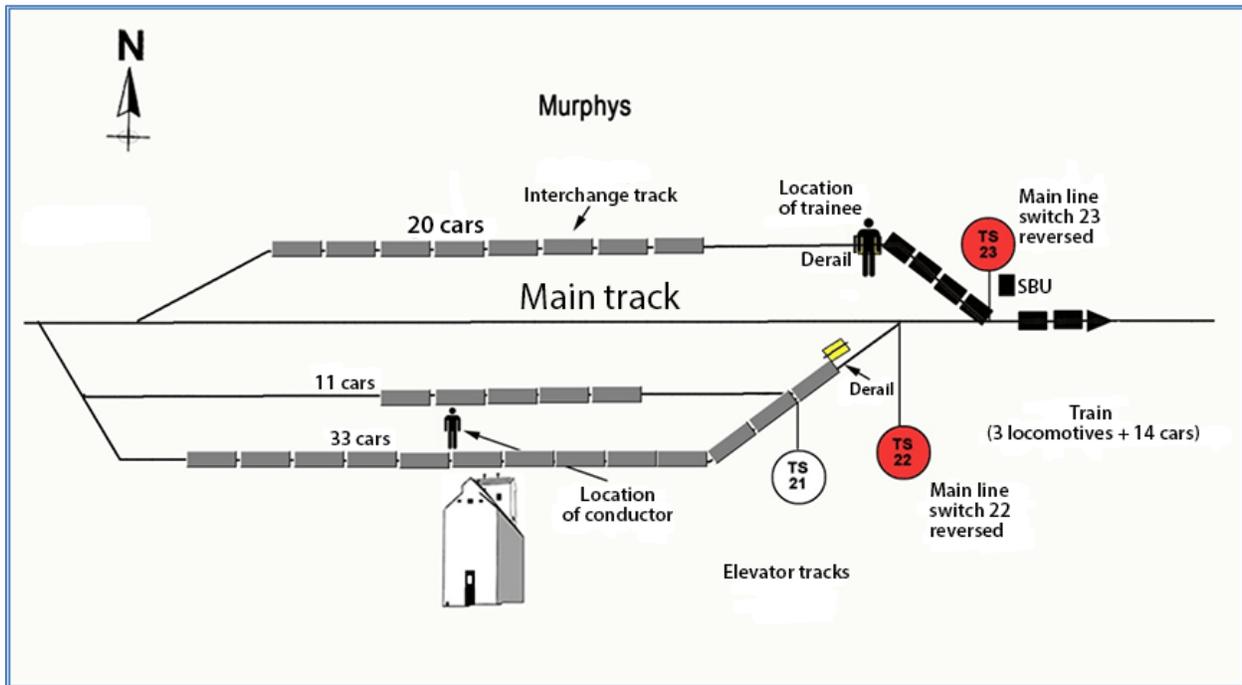
Figure 2. Diagram of the accident site, showing locations of the conductor, the trainee, and the train components and derrails.

Upon arrival at Murphys (Mile 61.0), the following events occurred² (Figure 2):

1817: Instead of lining TS 22, the trainee inadvertently reversed switch TS 23, which lined it for the interchange track, and then reported (on the radio) that the mainline switch had been lined and locked in the normal position for the main track. The crew acknowledged the radio transmission as required. However, the entire crew was unaware that the train was being routed into the wrong track.

1818: With switch TS 23 set in the reverse position, the train reversed into the interchange track instead of reversing westward on the main track.

The trainee was positioned between the rails of the interchange track (i.e., track TS 23) with his back to the train as he worked to secure the derail, which was located between

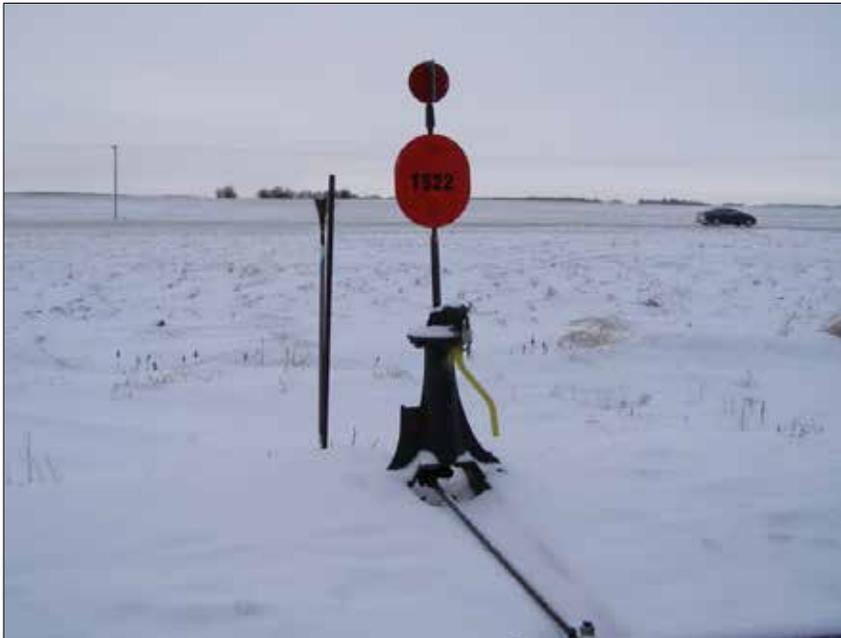
- 1757: The conductor reversed mainline track switch TS 22⁵ (switch TS 22) and removed the derail for the elevator tracks (i.e., track TS 21 and track TS 22 [Photo 1], located south of the main track) in preparation for spotting 44 empty grain cars onto the elevator tracks. The conductor was positioned at the east end of track TS 21 to make the cut after the first 11 cars were set off in track TS 21, and in preparation for setting off the remaining 33 cars in track 22.

Photo 1. Mainline track switch TS 22 in the normal position
