**RAILWAY INVESTIGATION REPORT
R14Q0045**

MAIN-TRACK DERAILMENT

**QUEBEC NORTH SHORE AND LABRADOR RAILWAY
ORE TRAIN BNL-212J
MILE 14.65, WACOUNA SUBDIVISION
NEAR TELLIER, QUEBEC
06 NOVEMBER 2014**

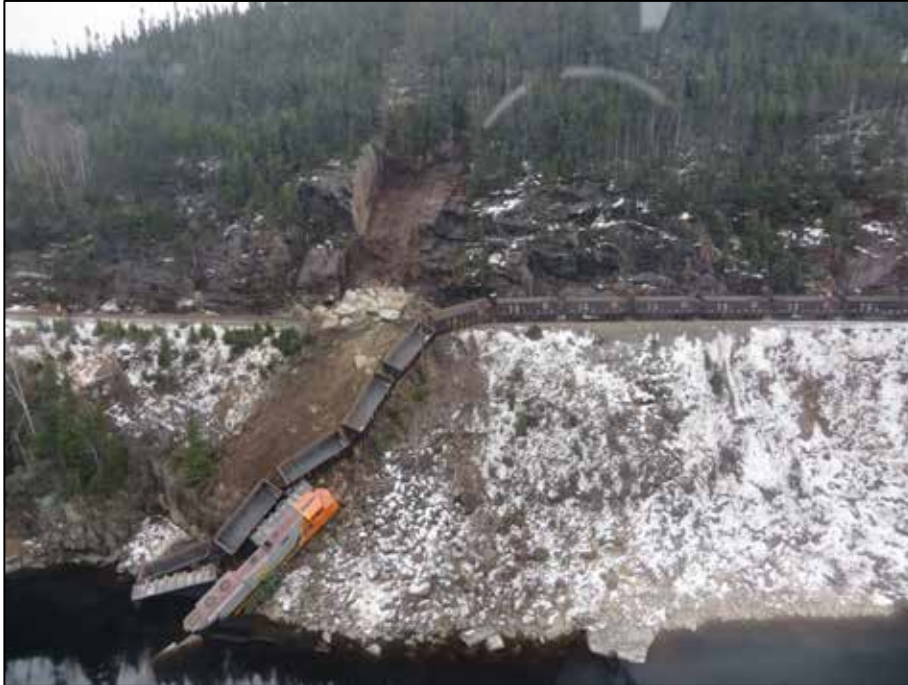
Photo 1. Accident site

The track was covered with boulders and gravel that had slid from the east-side rock face that runs along the track. The rock pile was about 10 feet tall, 50 feet long and 20 feet wide, for a total of about 350 cubic yards.

The wooden ties under the boulders were displaced. The rails near the pile-up of rocks and derailed cars were broken into several pieces. The surfaces of the rails showed signs of having been subjected to excessive lateral force. About 100 feet of track was completely destroyed.

In way of the pile-up, the rock face was vertically split and water from the top of the mountain was seeping down a smooth, sharply sloped surface. About 70 feet of the ditch on the east side of the track was blocked.

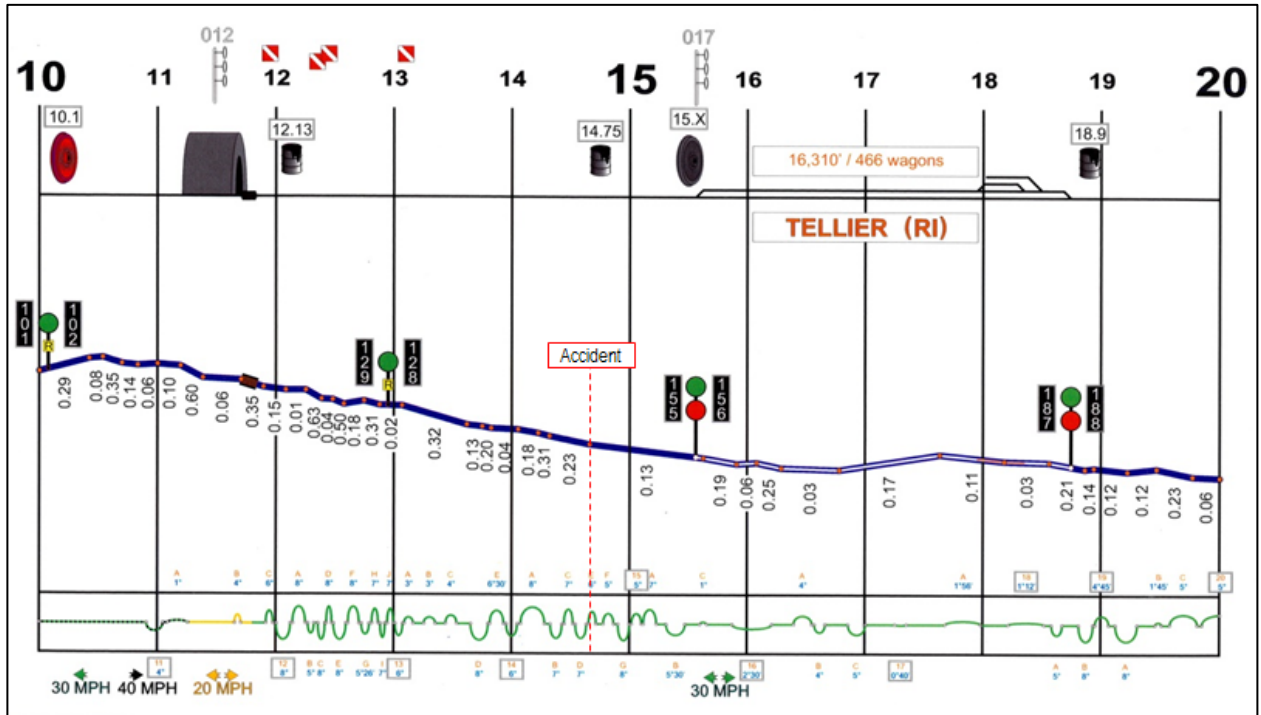
Figure 2. Track profile and signal layout near Tellier (Source: *Profil de la voie ferrée* (track profile), QNS&L, 2013, with TSB annotation)

There is a tunnel of about 2200 feet between Mile 11.3 and Mile 11.7. Radio communications are interrupted when rolling stock is inside the tunnel.

At Mile 12.9, when a train passes the dragging equipment detector in either direction, a “talker system” transmits an automated voice message. LEs must not use the radio system while their trains pass through detectors and they must wait until they hear the detector’s report on the results of the inspection.
