National Transportation Safety Board

Railroad Accident Brief

Metro-North Railroad Employee Fatality

Accident No.:	DCA13FR005
Location:	West Haven, Connecticut
Date:	May 28, 2013
Time:	11:57 a.m. eastern daylight time
Railroad:	Metro-North Railroad
Property damage:	Negligible
Injuries:	0
Fatalities:	1
Type of accident:	Employee fatality

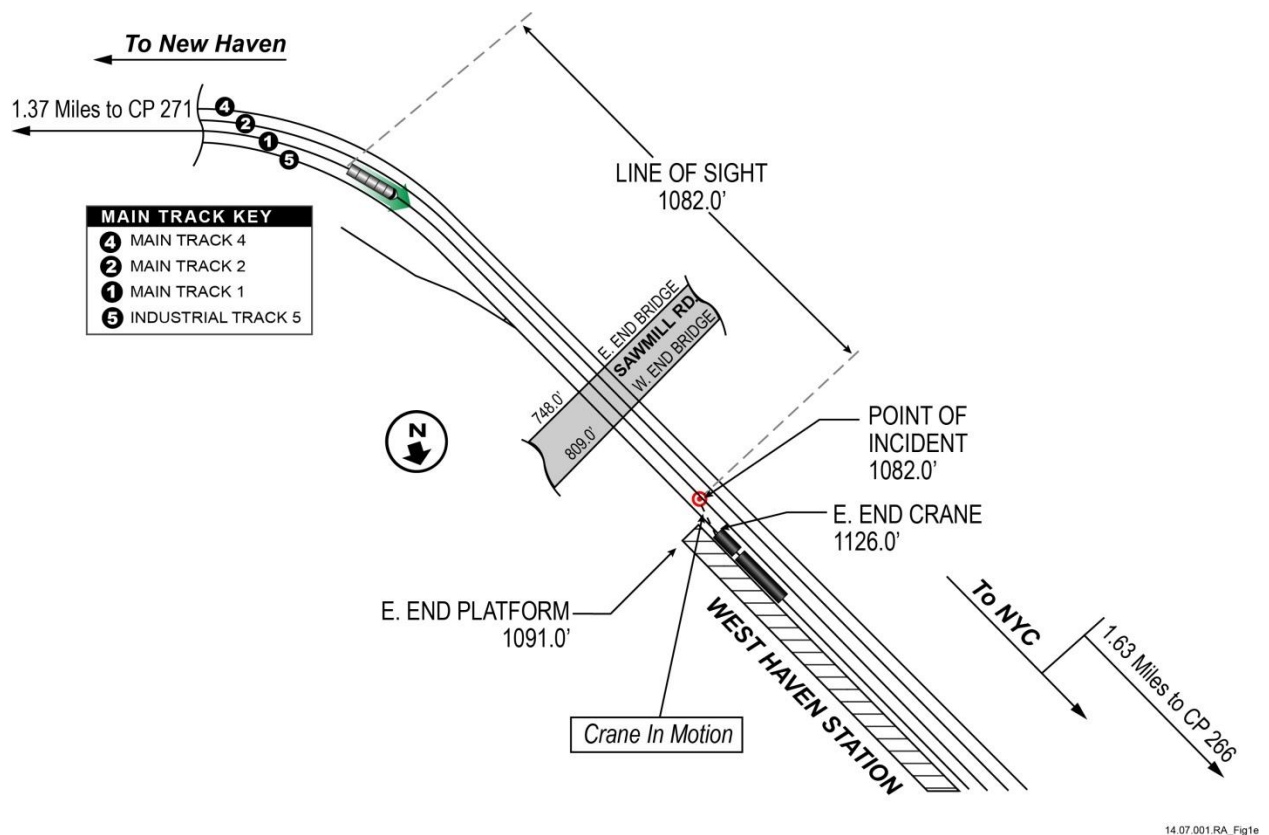
Figure 1. Accident area track diagram.

The foreman requested permission from the RTC to proceed into the interlocking to move the crane from main track 2 west to main track 1 and then east into the exclusive work area. After the authority was granted, the foreman moved the crane. By 11:45 a.m., the crane cleared CP 271 and was positioned on industrial track 5. (See figure 1.)

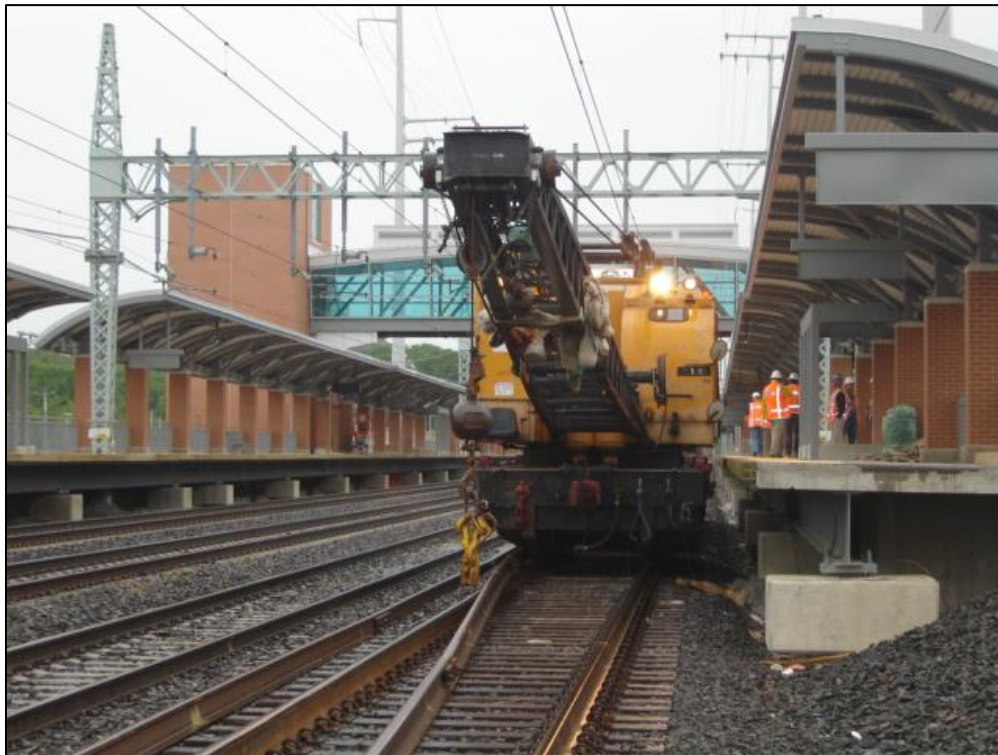
Figure 2. Westward view of work location and crane.

power from the overhead catenary wires above the main tracks.⁴ After they verified that the crane could swing without contacting the station platform, they began moving rail from main track 1 to industrial track 5. This effort required the foreman to manually attach rail tongs to the rail on track 1. The crane would pick up the rail and move the rail onto industrial track 5. The crew worked in a westerly direction with the crane facing east and the foreman facing west. (See figure 2.)

As the crane operator began moving rail from main track 1 to industrial track 5, the crane operator heard the horn of a train approaching from the east. The crane operator and the track foreman continued to look to the east and observe the approaching train. The crane operator told investigators that he could not tell which track the train was on due to a curve in the tracks. He said that he returned his attention to his work because main track 1 was out of service. However, as the train neared, he realized that the train was on main track 1. He tried to warn the track foreman by yelling for him to run. The operator moved the boom clear of main track 1 just before the train arrived, thus minimizing the hazard to the train and its passengers. However, the track foreman did not clear the track. The train struck and killed the foreman, and it struck the rail that was draped over the north rail of main track 1; this collision with the rail knocked the remainder of the rail into the center ditch between main track 1 and industrial track 5.
