# National Transportation Safety Board

## Railroad Accident Brief

### Employee Switching Fatality

**Accident No.:** DCA15FR001  
**Location:** Colorado Springs, Colorado  
**Date:** October 8, 2014  
**Time:** 12:30 p.m. mountain daylight time  
**Train:** L-PWR0223-8 I (Engine BNSF 1923)  
**Railroad:** BNSF Railway  
**Property Damage:** None  
**Injuries:** 0  
**Fatalities:** 1  
**Type of Accident:** Employee Fatality

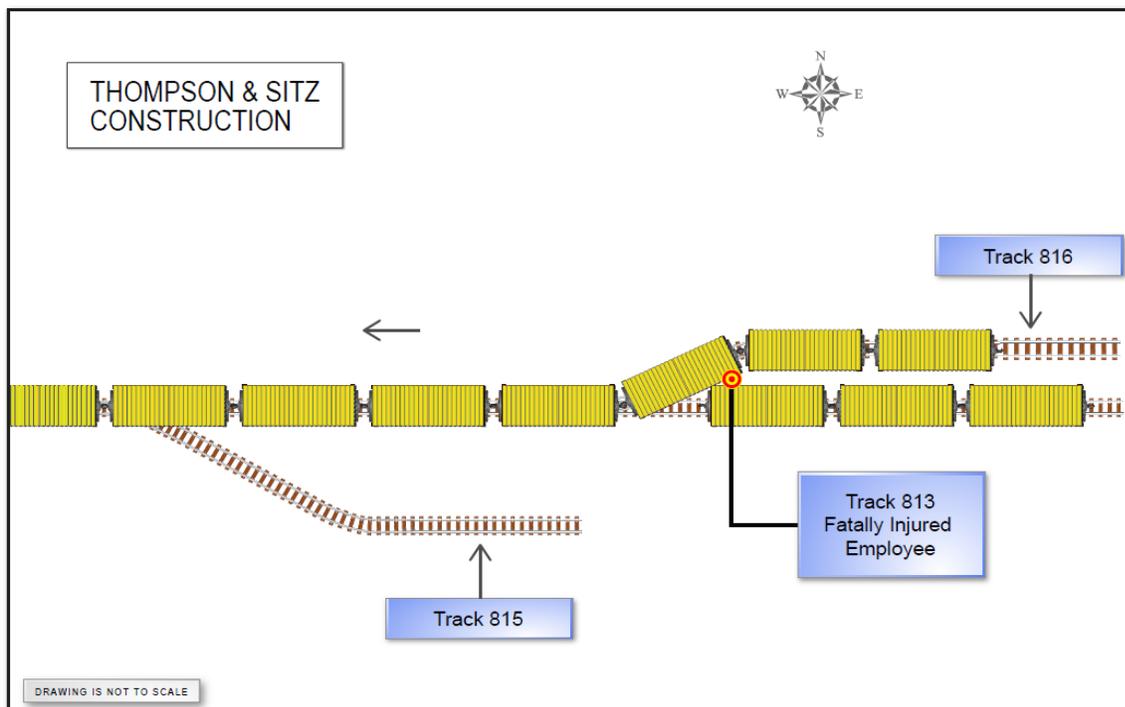
**Figure 1.** Track Diagram and Accident Site.

The conductor coupled the four loaded railroad cars and two locomotives of the local train to six empty flat railroad cars that were on track 813 and track 815, which were connected by a switch. (See figure 1.) The conductor then moved these railroad cars off track 815 and lined the switch for movement to track 813. The railroad cars were then moved to the end of track 813. The conductor separated three of the railroad cars and had the engineer pull forward, leaving the three railroad cars on track 813. According to the brakeman, the handbrakes were applied on these railroad cars before the switching move was made and the handbrakes were never released.<sup>5</sup>

There were three tracks in the Thompson and Sitz property. Track 813 was straight and ended at the company’s back fence. It was used for unloading lumber from railroad flat cars. Short stub track 815 diverted from track 813 in the middle of the property on the south side of track 813. Track 815 was used for unloading wood chips from railroad cars. Track 816 diverted from track 813 on the north side and was parallel to track 813 up to the company’s back fence.

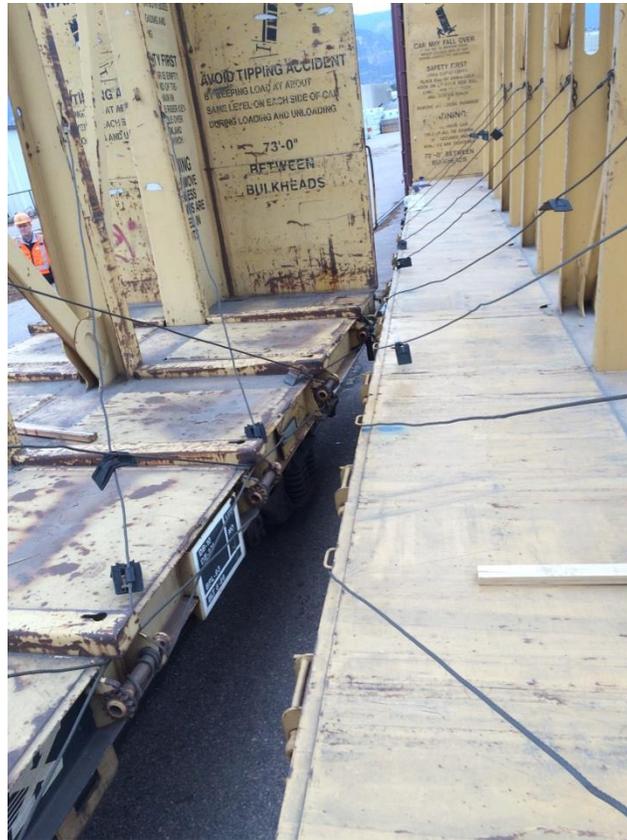
**Figure 2.** Railroad Cars Making Contact.

The postaccident examination showed that the standing railroad cars on track 813 had insufficient clearance from the railroad cars moving on track 816 to avoid a collision. During a re-enactment, the cars on track 816 were moved in the same direction as during the accident. When the 80-foot railroad car negotiated the curvature in the track to pass through the switch to enter track 813, the distance between the railroad car on track 813 and the moving railroad cars narrowed dramatically. NTSB investigators confirmed that if the railroad cars were in the same position as the day of the accident, the railroad cars would have made contact. (See figure 2.)

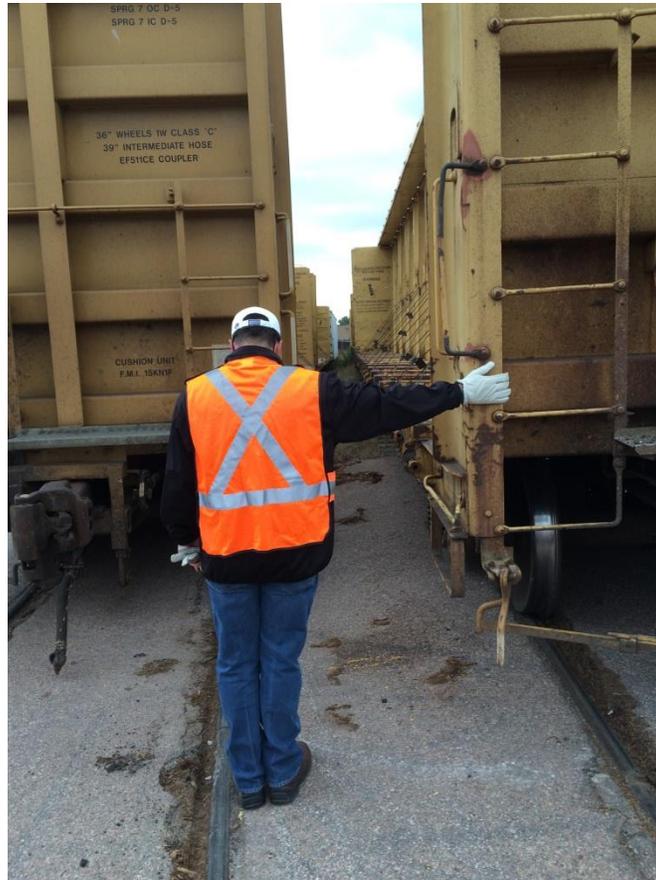
**Figure 3.** Checking Railroad Car Clearance.

Railroad car clearance from an adjacent track can be checked manually. If a person can stand with one foot against the rail and the hand of their outstretched arm cannot touch the side of the standing railroad car, the car would be in the clear, in other words, not fouling the adjacent track.<sup>8</sup> When this was done during the postaccident examination, with the standing railroad cars in their original position on track 813, the railroad car could be touched with an individual's hand and, therefore, not clear of moving railroad cars on track 816. (See figure 3.)

The National Transportation Safety Board determines that the probable cause of the accident was the conductor leaving cars on track 813 with insufficient clearance to the adjacent track and then instructing the engineer to move the railroad cars on track 816 before stepping clear of the moving cars. The conductor's focus on successfully coupling the railroad cars on track 816 likely contributed to the accident.
