National Transportation Safety Board

Railroad Accident Brief

Norfolk Southern Employee Fatality During Switching Operations

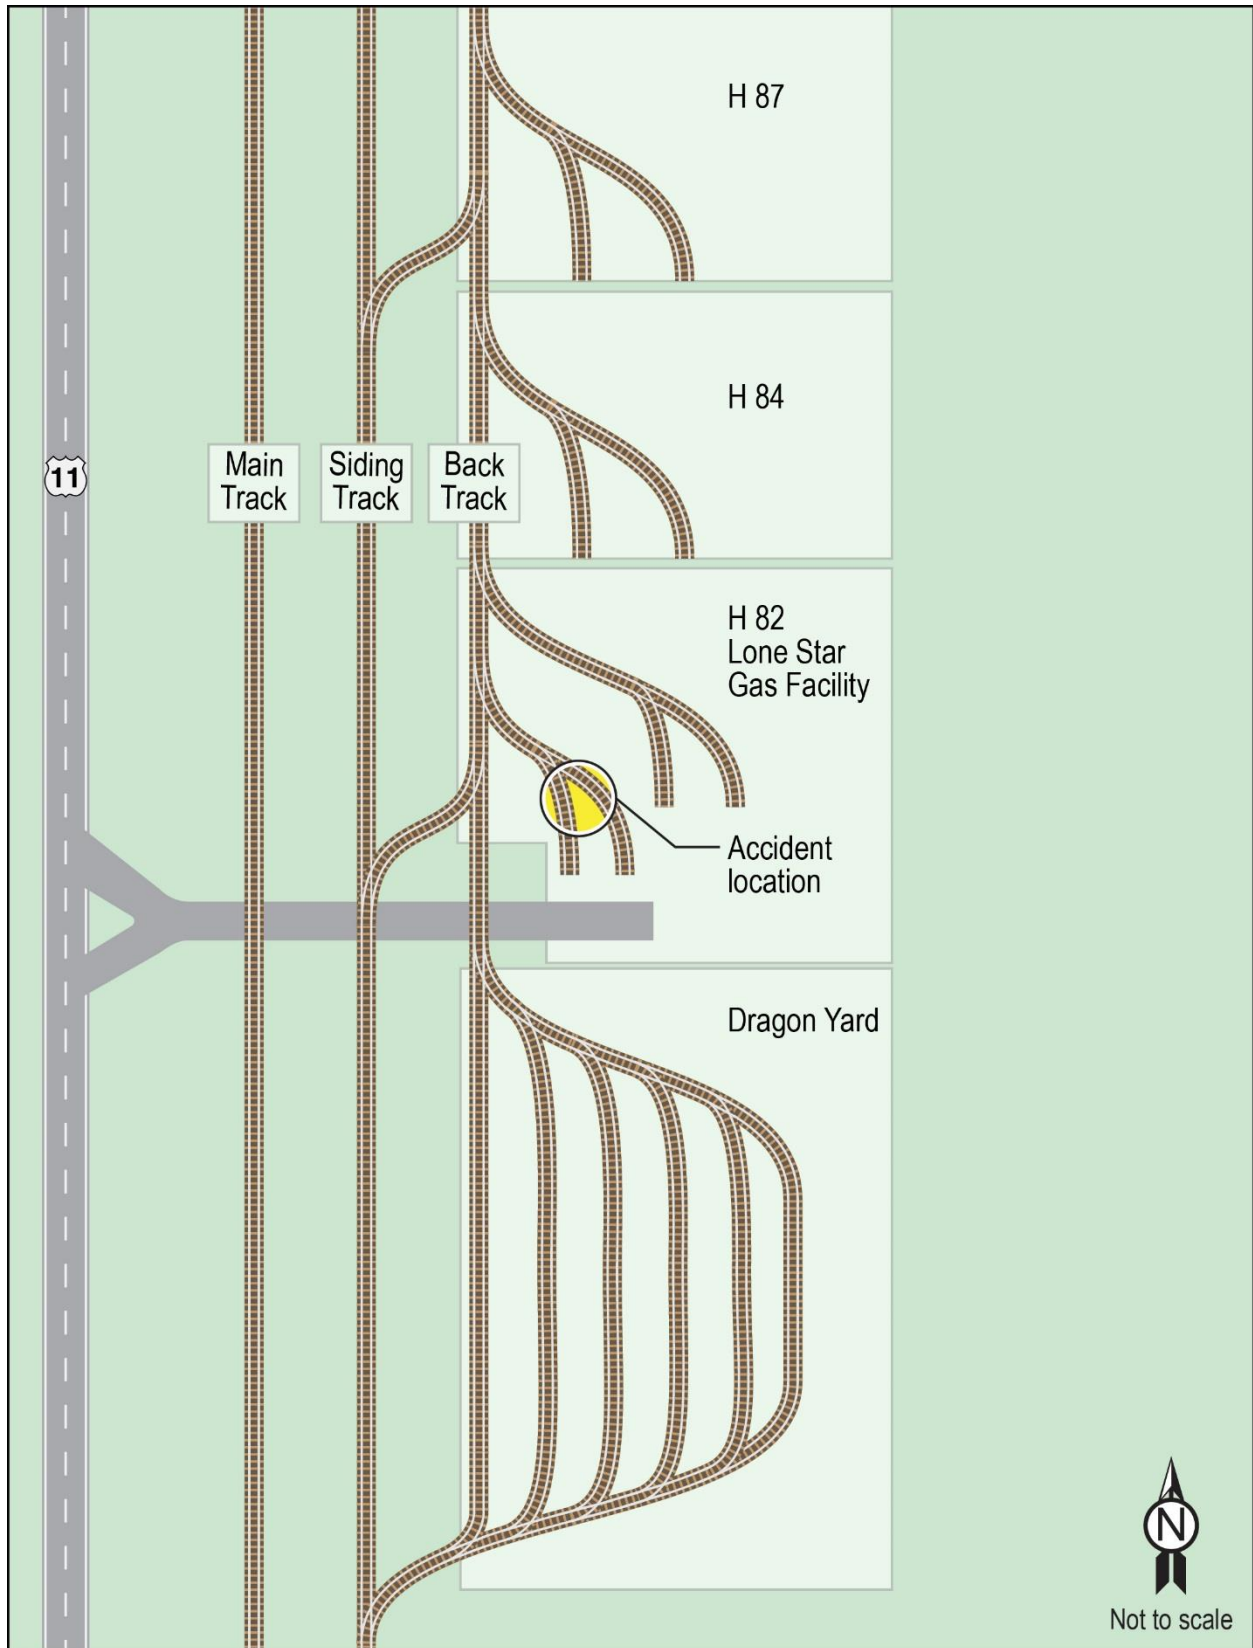
Figure 1. Accident location.

The accident occurred inside the Lone Star liquefied petroleum gas (LPG) transloading facility in Petal, Mississippi, about 5 miles east of Hattiesburg. H 82 was east of the NS main track, a siding track, and a back track. Train movements on the main track were authorized by track warrants and governed by operating rules, general orders, timetable instructions, and the signal indications of an absolute block system.² Figure 1 is a diagram of the incident location.

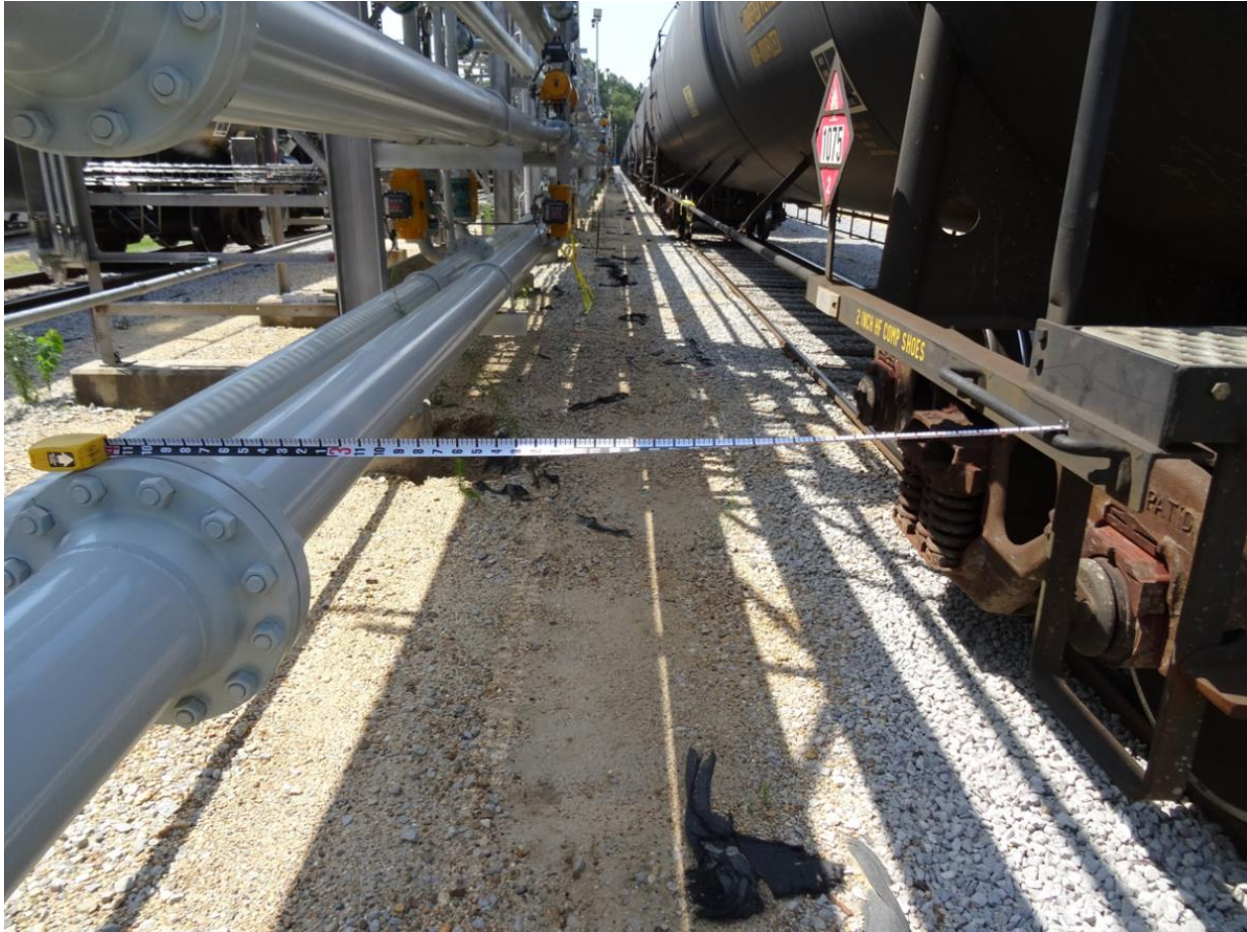
Inside the facility were two tracks separated by a pipe rack. The pipe rack was an elevated structure with a walkway and a series of pipes and valves used in transloading LPG from railroad tank cars. The pipe rack was 1,100 feet long, with 11 spots for tank cars on each side of the rack. (See figure 2.)

Figure 2. Path between the tank cars and unloading rack in the H 82 gas plant.
