National Transportation Safety Board

Railroad Accident Brief

BNSF Railway Employee Fatality Minneapolis, Minnesota

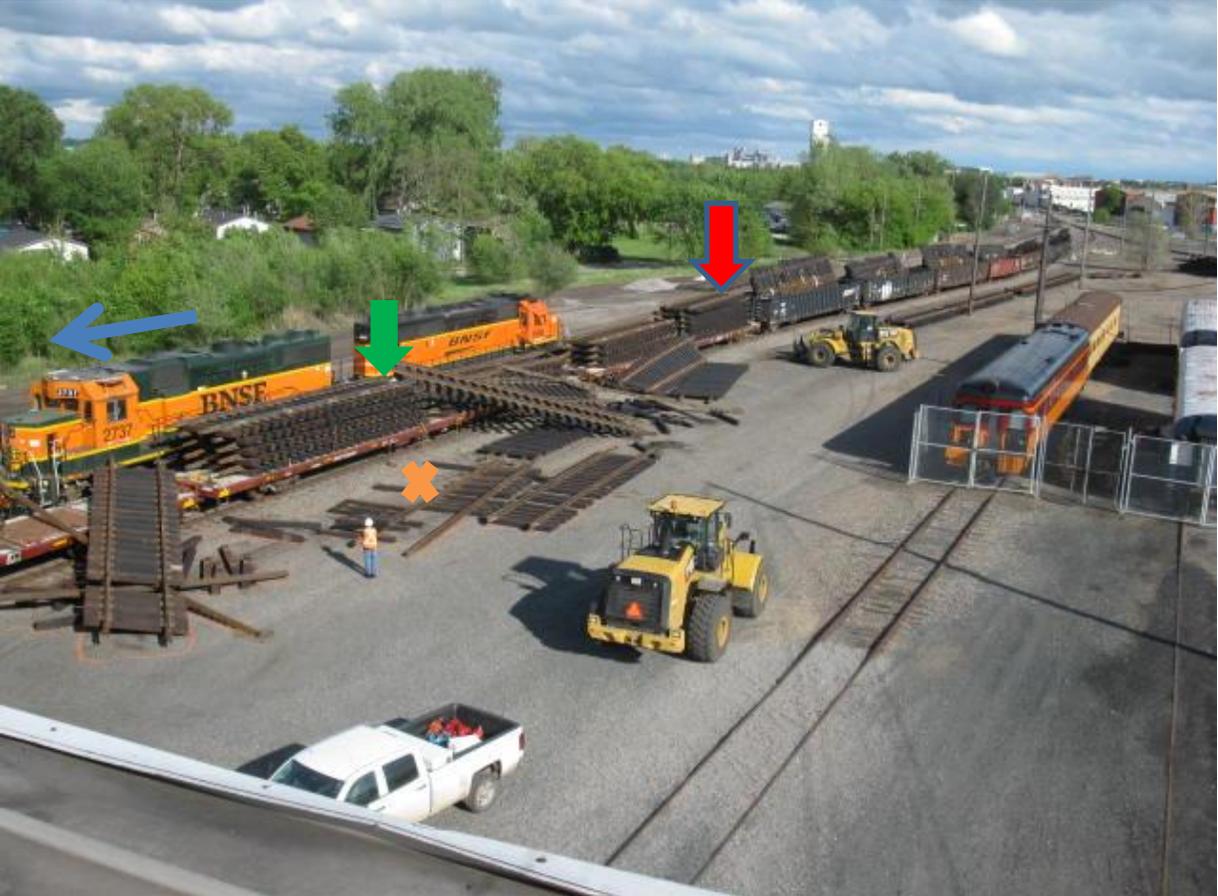
Figure 1. In this postaccident photo, the red arrow shows the fork lift operator’s position when he tried to lift two track panels. The green arrow shows the foreman’s likely position. The blue arrow indicates the direction of the train; “X” shows the location of the deceased. (Photo: BNSF Railway)

The machine operator said he had trouble seeing where the forks fit under the top track panel and decided to lift the top two track panels. (See figure 1.) Meanwhile, the foreman remained

During a postaccident interview, the machine operator said he thought he had time to finish lifting the panels because he could not see the approaching train. He also said he believed the fork lift bumped the top track panel, which caused it to slide off of the track panel underneath it and into the side of the first locomotive moving past on the adjacent main track. The machine operator said he thought the taper of the forks added to the slant of the load he was lifting.

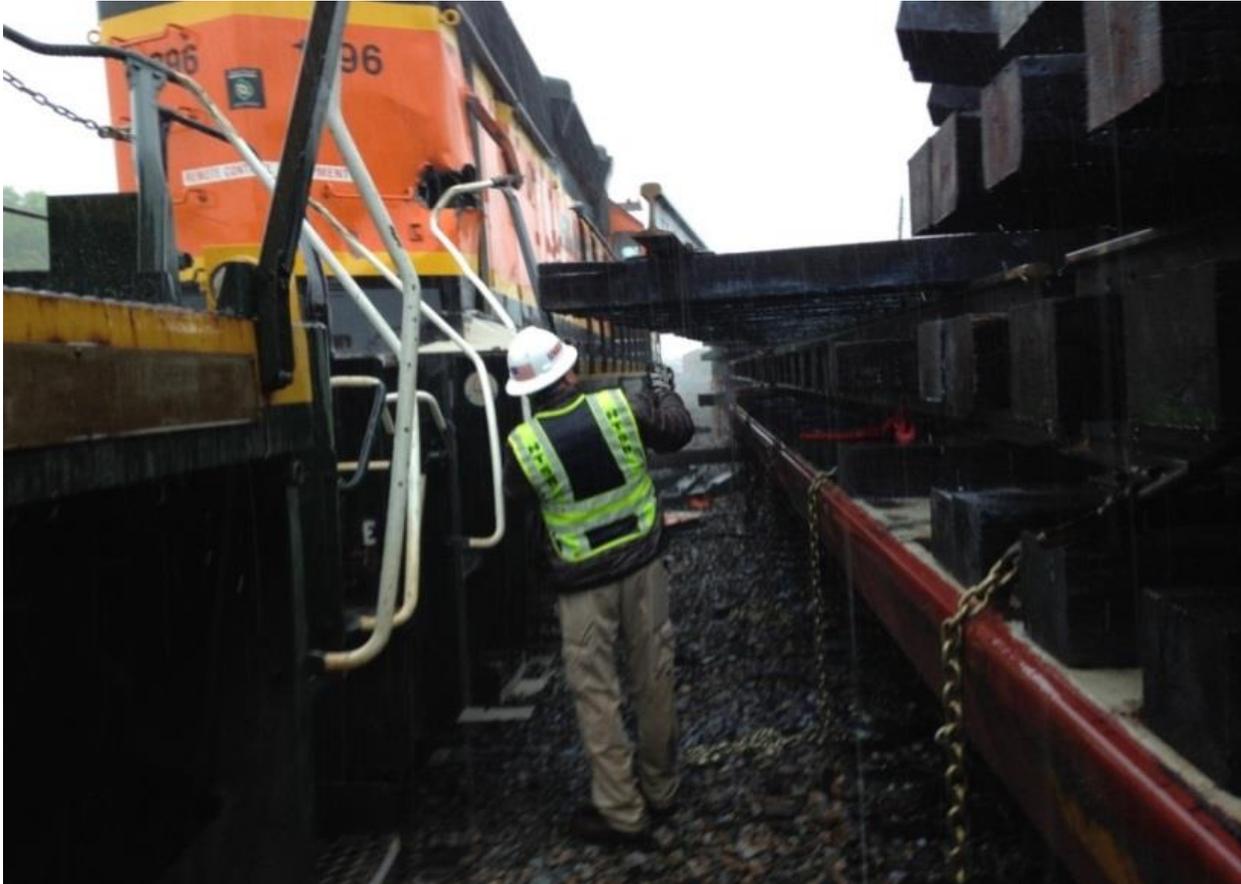
cars. To release the securements, employees had to climb on top of the stacks of track panel and work at ground level on the side track next to the main track. (See figure 2.) According to the Federal Railroad Administration's Roadway Worker Protection regulation, when an employee is within 4 feet of an adjacent track, protection must be provided. The workers who were releasing the securement on the main track side of the flat cars should have had protection.⁶

Figure 2. Dislodged track panel and damage to the BNSF train. (Photo: Federal Railroad Administration)

When the track panel hit the locomotive, the panel struck other unsecured track panels forcing them off the flat car. (See figure 2.)

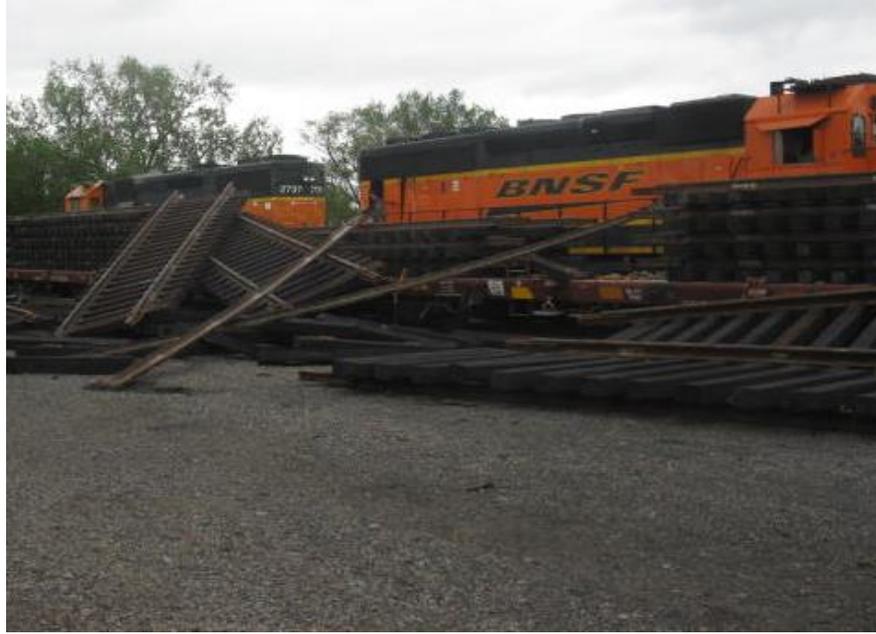
As the track panels slid from the east flat car, the other panels were quickly dislodged. Meanwhile, the foreman either jumped or fell to the ground near the west end of the west flat car. A witness said the foreman appeared to be hurt, but before the foreman could move away, a track panel struck him. Before the crew could react, another track panel fell on top of the first one with the foreman still underneath. (See figure 3.)

Figure 3. Dislodged track panels. (Photo: BNSF Railway)
