**RAILWAY INVESTIGATION REPORT  
R06T0281**

**EMPLOYEE FATALITY**

**TOTAL TRACK RAILWAY CONSTRUCTION AND  
MAINTENANCE SERVICES INC.  
(UNDER CONTRACT TO CANADIAN NATIONAL RAILWAY)  
NORDCO GRABBER MODEL A SPIKE PULLER  
MILE 223.0, KINGSTON SUBDIVISION  
MOIRA, ONTARIO  
11 NOVEMBER 2006**

Report Number R06T0281

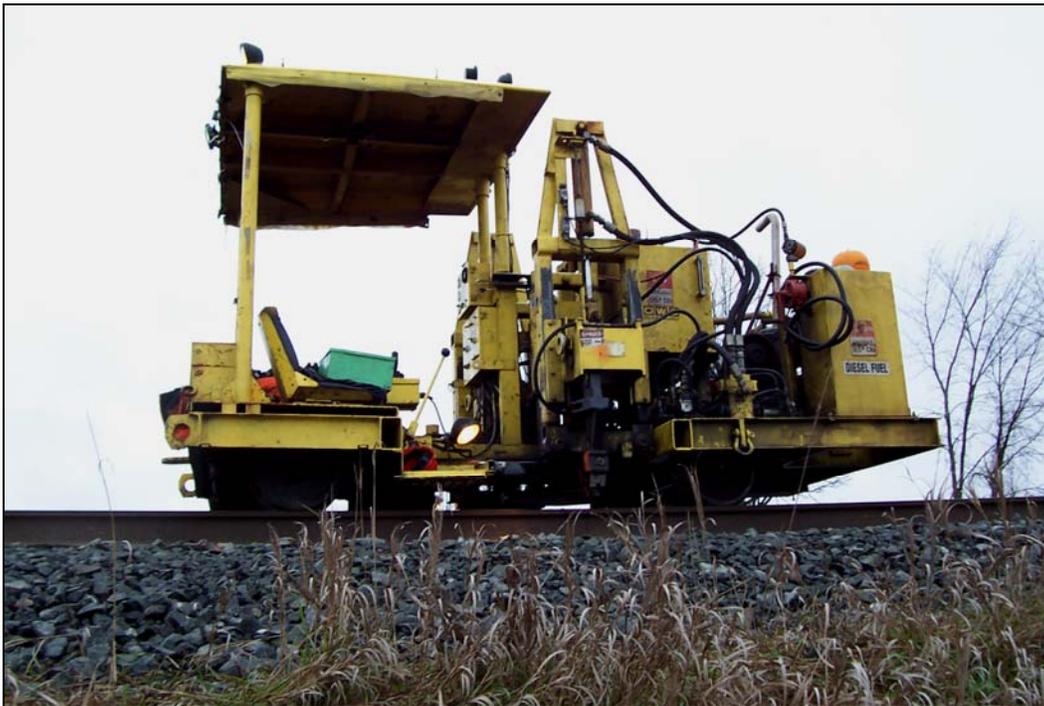
At 0200, the spike puller (see Photo 1) had advanced approximately 250 feet ahead of the following machine in the tie gang. The crew had just finished their work at this location and were preparing the spike puller to travel when its drive mechanism failed.

**Photo 1.** Side view of spike puller at accident location (*Source: OMOL*).

- The spike puller was not equipped with cab or control panel lighting, did not have a large shutdown button, and the drive chain guard was removed.
- At the time of the accident, the spike puller was not locked out to ensure the safety of the workers.

The right-hand roller frame assembly travel pin was not inserted at the time of the accident. The travel pins are designed to prevent the roller frame assembly from lowering onto the track structure during travel between work locations. However, when inserted, the travel pin does not completely restrict the downward movement of the roller frame assembly, nor does it affect

the speed at which the assembly deploys. Testing of the machine determined that with the travel pin in place, the bottom of the alignment guide on the roller frame assembly lowers to within five inches of the rail head. Therefore, had the travel pin that limits the downward movement of the right-hand roller frame assembly been inserted prior to commencing the repairs, downward movement of the assembly would still have been sufficient to cause serious or fatal injury.
