Perspective Property Inspections
 A Steel Rhino Property Inspections Affiliate
 P.O. Box 3441, Littleton CO 80161
 720-221-3669
Providing the Peace of Mind You Deserve!

Client: Sample Client SClient@gmail.net (720) 555-1212	Property Address: 1005 E Sample St City, Colorado 80000	Date: <Today>
---------------------------------------------------------------------------------------------------------------	----------------------------------------------------------------------	-------------------------

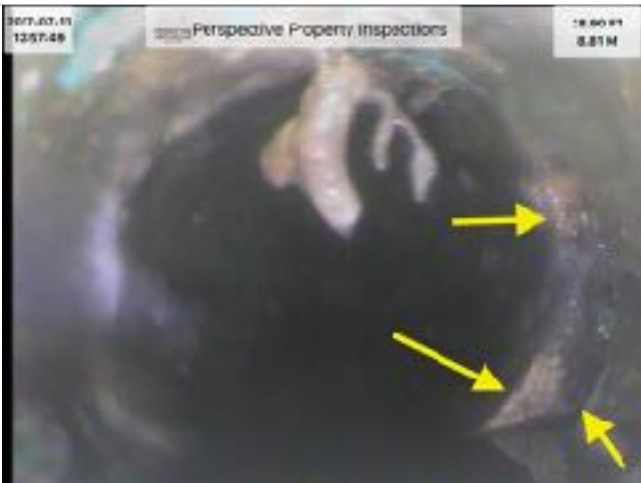
The installation of SDR ends at the offset. Root intrusion is between the off set and the sewer tap.

Off Set noted at transition from SDR to Concrete.

Recommend contacting a sewer line plumbing contractor to evaluate and repair the segment between the SDR/Concrete transition and the sewer tap. *Recommend re-scoping post repair and 1-2 years to monitor.

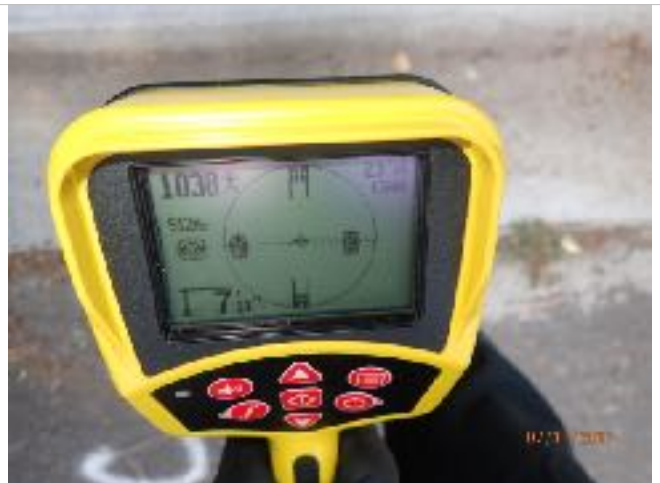
Offset ~7' - 8' deep at the at the storm curb

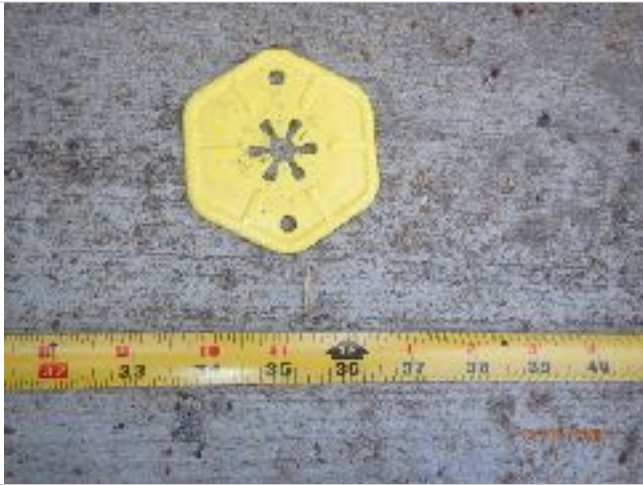
Surface measurements and view of off set and root intrusion

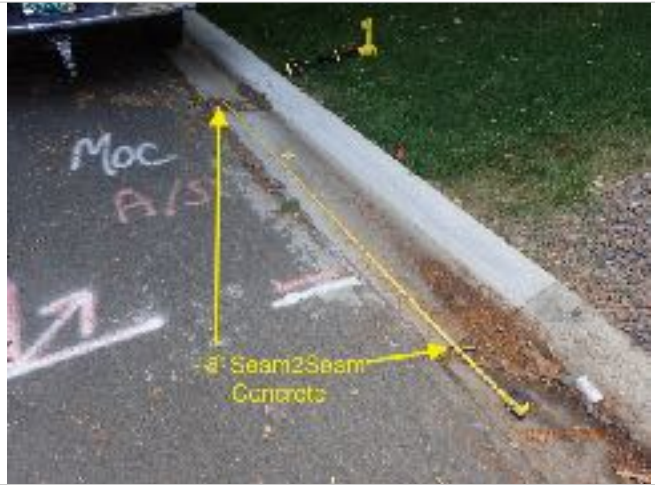
Surface view of off set.

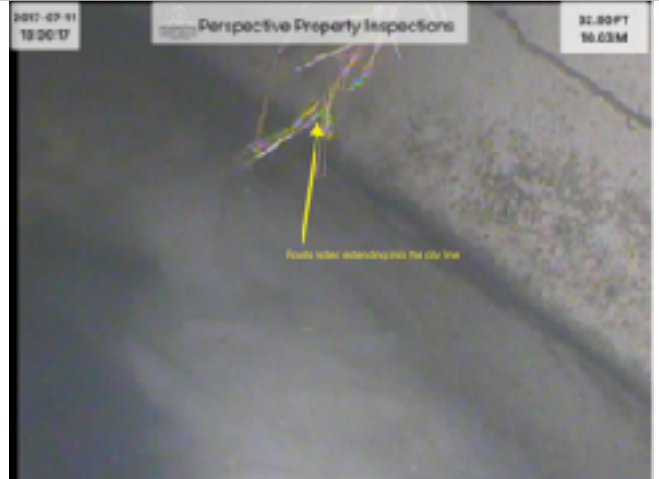
Root intrusion/growth extends into the sewer tap.

Roots extend into the city sewer line

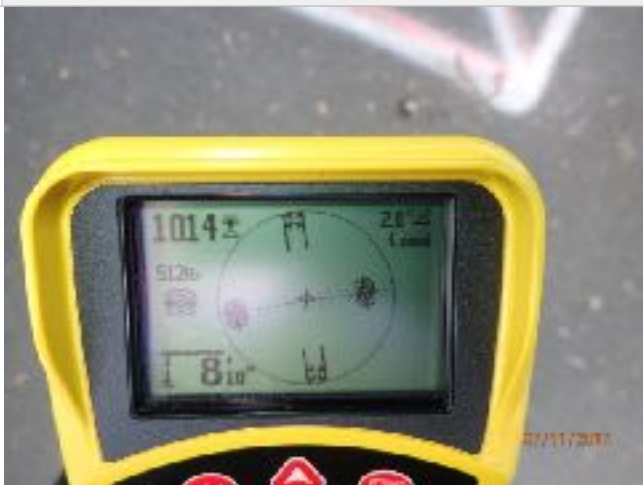
Approximate depth and location of sewer tap. Surface view
