Rock slopes and reservoirs - lessons learned

Dennis P. Moore

BC Hydro, Power Supply Engineering, Burnaby, B.C.

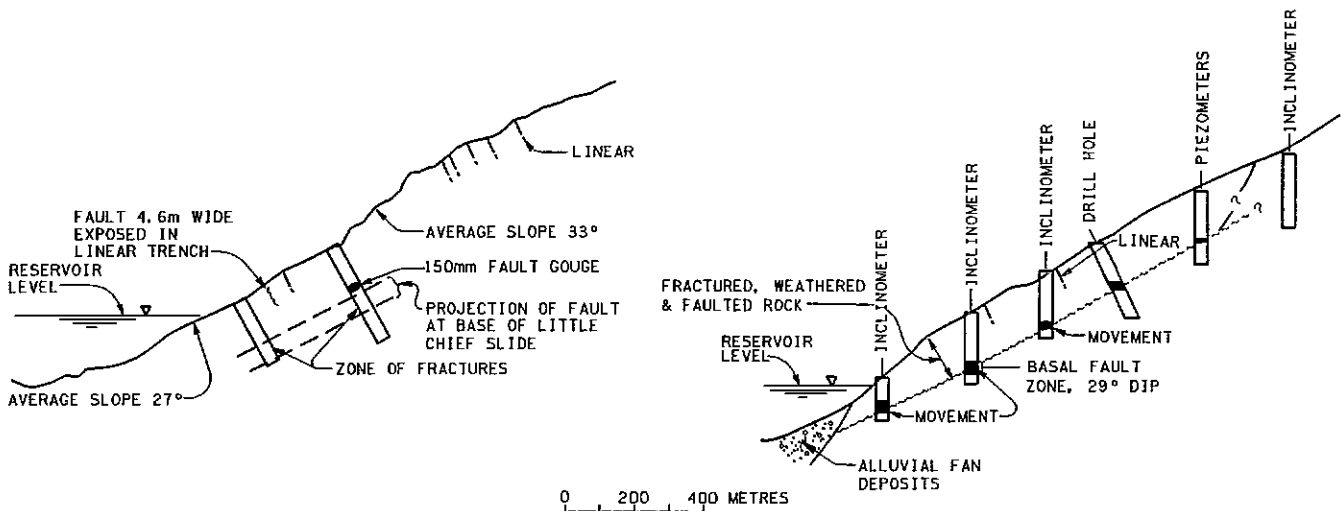
Fig. 3. Cross sections through Little Chief Ridge on the left and Dutchman's Ridge on the right. In spite of very similar topography and surface geology, the probabilities of rock slides from these ridges are judged to be very different due to the absence of an underlying fault zone at Little Chief Ridge and its presence at Dutchman's Ridge.

Three holes were drilled and several exploratory trenches were dug on Little Chief Ridge (Fig. 3). The rock is generally unaltered and not closely fractured, although there are some zones of intense fracturing. Some fractures were rusty at depths to several hundred metres. Faults that were determined to exist beneath the adjacent Little Chief Slide did not exist at their projected locations beneath Little Chief Ridge. Trenches excavated along some of the linears indicated that there had been some post-glacial movement but that this movement was

localized along pre-existing fracture zones which dipped steeply into the slope. Based on this surface and subsurface information the designers concluded that the investigation had not shown very convincing evidence of the presence of an adverse, continuous weak plane which would be required for rapid sliding of the rock mass. Therefore, the possibility of the entire mass moving as a high velocity rockslide was considered remote.

At Dutchman's Ridge, holes drilled in 1969 intersected highly fractured, rusty and decomposed rock averaging 110 m thick overlying a major fault zone. Core recovery was much less than that for Little Chief Ridge, averaging about 70% compared to 95%. After the fourth hole was drilled at Dutchman's Ridge it was recognized that the fault intersections were coplanar, that the plane dipped about 29° downslope, and that the toe of the overlying mass of about $115 \times 10^6 \text{ m}^3$ of rock would be inundated by the reservoir. This fault was not seen at the surface until it was exposed in 1986 in an extensive bulldozer trench. Thus, two adjacent ridges with very similar surface appearance presented widely disparate risks. Not until the subsurface was investigated did this become apparent.

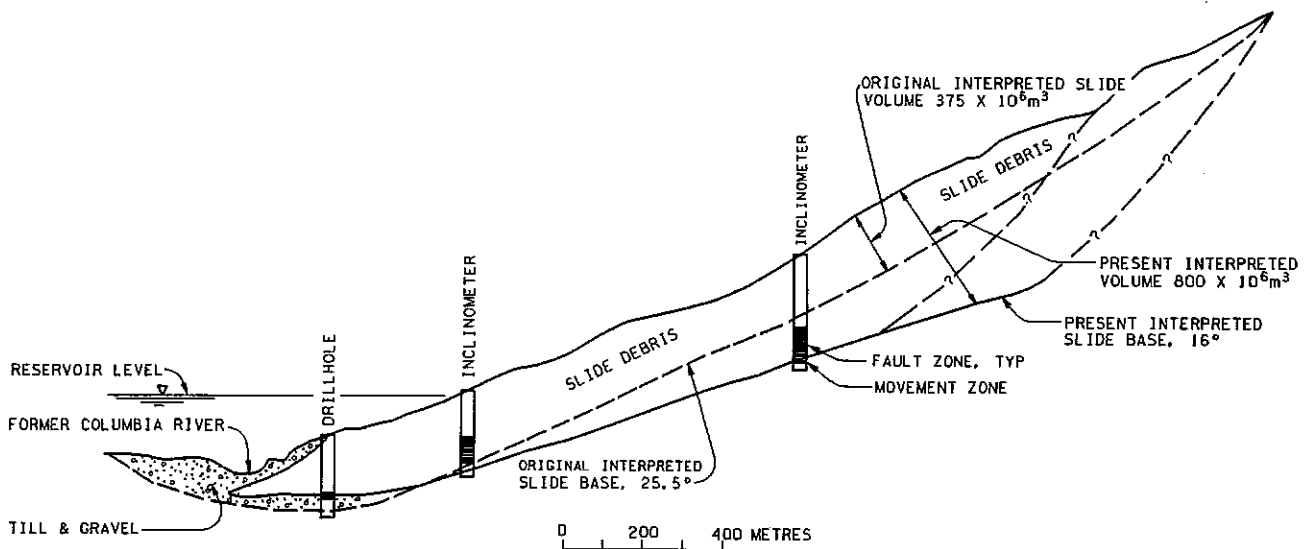
Fig. 4. Cross section through Little Chief Slide, an existing slide about 3 km upstream from Mica Dam. The initial subsurface interpretation based on drill core and seismic refraction surveys indicated a slide of $375 \times 10^6 \text{ m}^3$ on a 25.5° surface compared to the current interpretation based also on monitoring results which indicate a slide of $800 \times 10^6 \text{ m}^3$ on a 16° surface.

Monitoring of the inclinometers at Little Chief Slide was carried out and the results were reviewed periodically. Eventually downslope creep movements were detected which showed that the actual slide base was the lower of the two possibilities. This realization resulted in a new cross-section with a dip of the base of about 16° and a volume about $800 \times 10^6 \text{ m}^3$. This is equivalent to a 40% decrease in the ratio of shear to normal forces at the slide base and a 113% increase in the estimated volume. Both the original and the current interpretation are reasonably consistent with measured residual frictional strengths which, as is often the case for large rockslides, varied widely. Similarly, water levels varied from hole to hole and were subject to considerable interpretation. Fortunately this new information did not change the original conclusion that the possibility of a rapid acceleration of Little Chief Slide was unlikely. Nevertheless monitoring is to be continued.

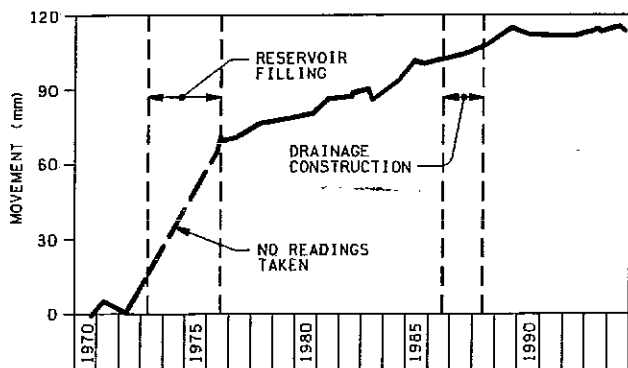
No movements were detected during the few years prior to reservoir filling, although the loosened, weathered nature of the rock above the fault indicated that there had been a long history of downslope creep. Movement was triggered during reservoir filling at a rate of about 20 mm/year while filling was in progress. These slowed to a steady movement of about 10 mm/year during normal operation of the reservoir (Fig. 5).

Fig. 5. A record of the movement along the fault zone underlying Dutchman's Ridge during reservoir filling and stabilization by drainage. Movement currently continues at the post-drainage rate of one or two millimetres per year.

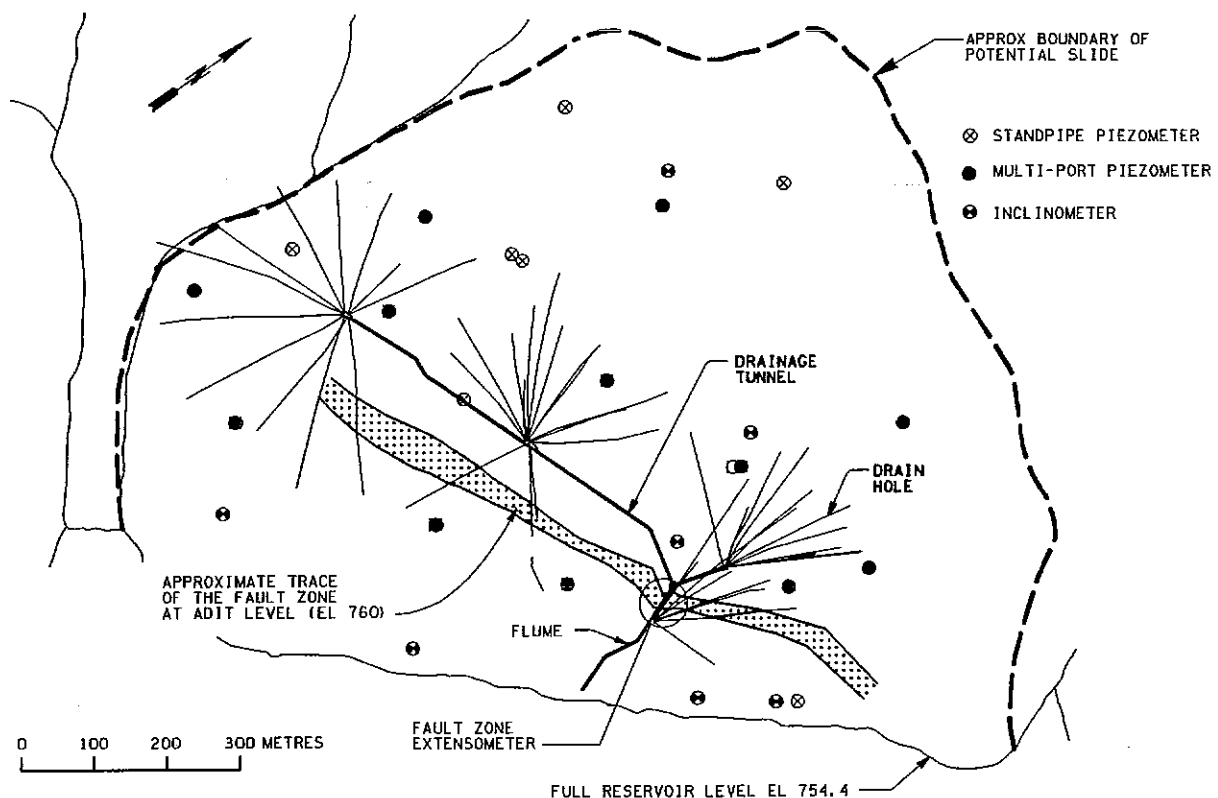
Fig. 6. Plan view of Dutchman's Ridge showing the extensive investigations and the drainage system installed to increase the stability of the ridge to at least its pre-reservoir condition.

At Dutchman's, an 800 m adit, mainly just below the basal fault zone, and 17,000 m of drainholes were constructed to reduce the average head at the base from 36 m to 10 m. There was a rapid response to drainage (Fig. 6) and having proper instrumentation in place allowed us to adjust the numbers and locations of drill holes and the layout and length of the adit to achieve our objective in the most economic manner. No reasonable amount of pre-construction information could have allowed an efficient fixed design to be determined. The observational method had to be used to minimize the number of drain holes and length of adit.

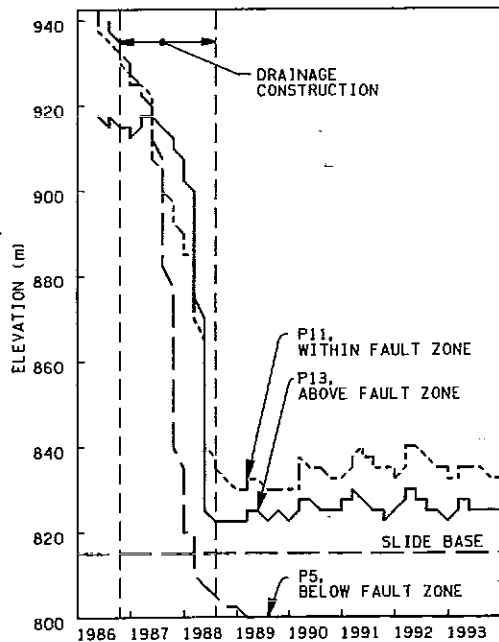
Widespread reduction in water pressure was achieved both above and below the basal fault zone although significant pressure differentials remain across the basal fault (Fig. 7 and 8). The movement along the fault zone has almost stopped (Fig. 5) even though the increase in factor of safety was only in the order of 5%.

Fig. 7. Typical drop in piezometric levels at Dutchman's Ridge when drainage paths were intersected. Even after drainage, significant pressure differences can exist across less permeable barriers such as fault zones which divide the rock mass into isolated compartments which have to be individually drained.

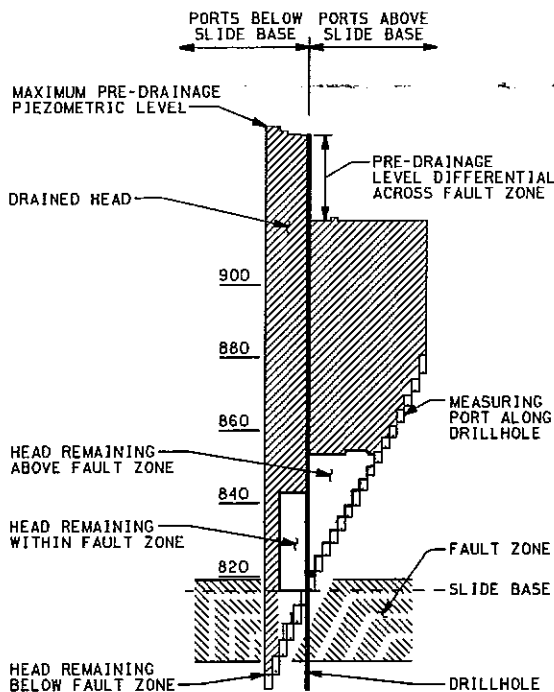
Fig. 8 A graphic log of multiple piezometers installed in a drill hole crossing the basal fault zone at Dutchman's Ridge illustrates the pressure differential which can still exist across faults in spite of extensive drainage. At one location a 75 m differential existed across 150 mm of gouge.

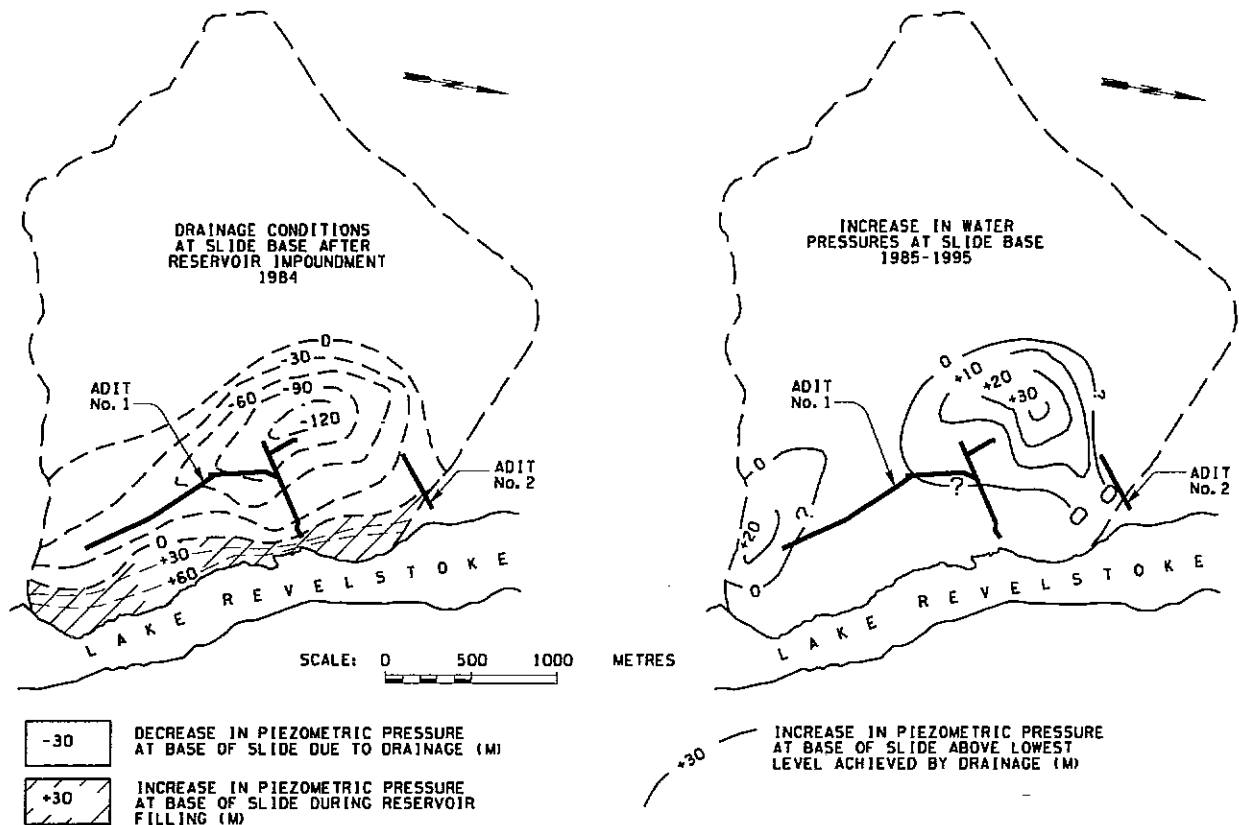
Fig. 9 Plan view of the 1.5×10^9 m³ Downie Slide showing the original depressurization done using drainage adits and drain holes and the deterioration in the efficiency of this drainage system during the next ten years. Similar deterioration has been noted at Dutchman's Ridge and at the Revelstoke Damsite.

One aspect of drainage systems, such as this one, which first became apparent at Downie is the gradual decrease in efficiency that occurs over time (Fig. 9). Piezometric pressures at Downie and elsewhere have gradually increased from the drained minimums. The cause of these increasing pressures is not known. Possibilities include blockage of drainholes by hole collapse, calcite, eroded debris, algae or movement, as well as, blockage of fractures by calcite, redistribution of fine materials, closing of fractures due to increased effective stress or gas bubbles forming due to the decreased water pressures. Cleaning of the existing drainholes with air and water jets has had little effect. The decrease in the factor of safety over about the last 15 years has been about 1% which still leaves a sufficient margin, but future drainage could be required.

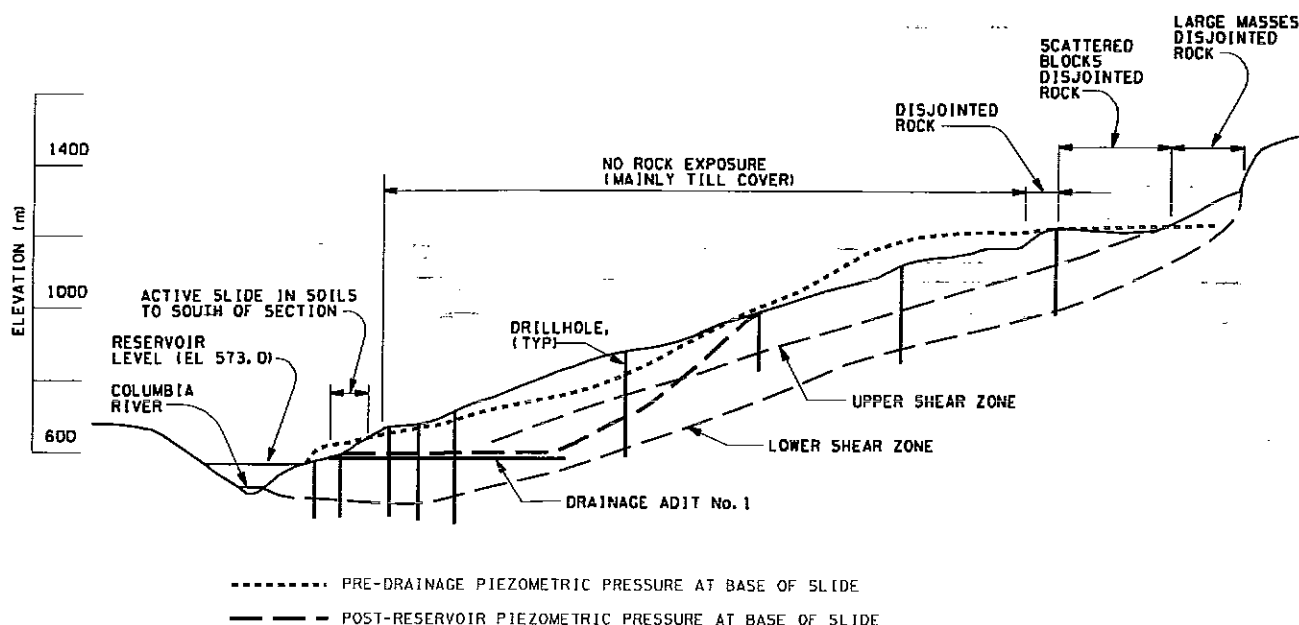
Fig. 10 A cross section of Downie Slide showing the lower shear zone developed parallel to the foliation in the schists and gneisses which form the slope. The overall slope of the surface and the lower shear zone is about 18° and the movement has been about 300 m.

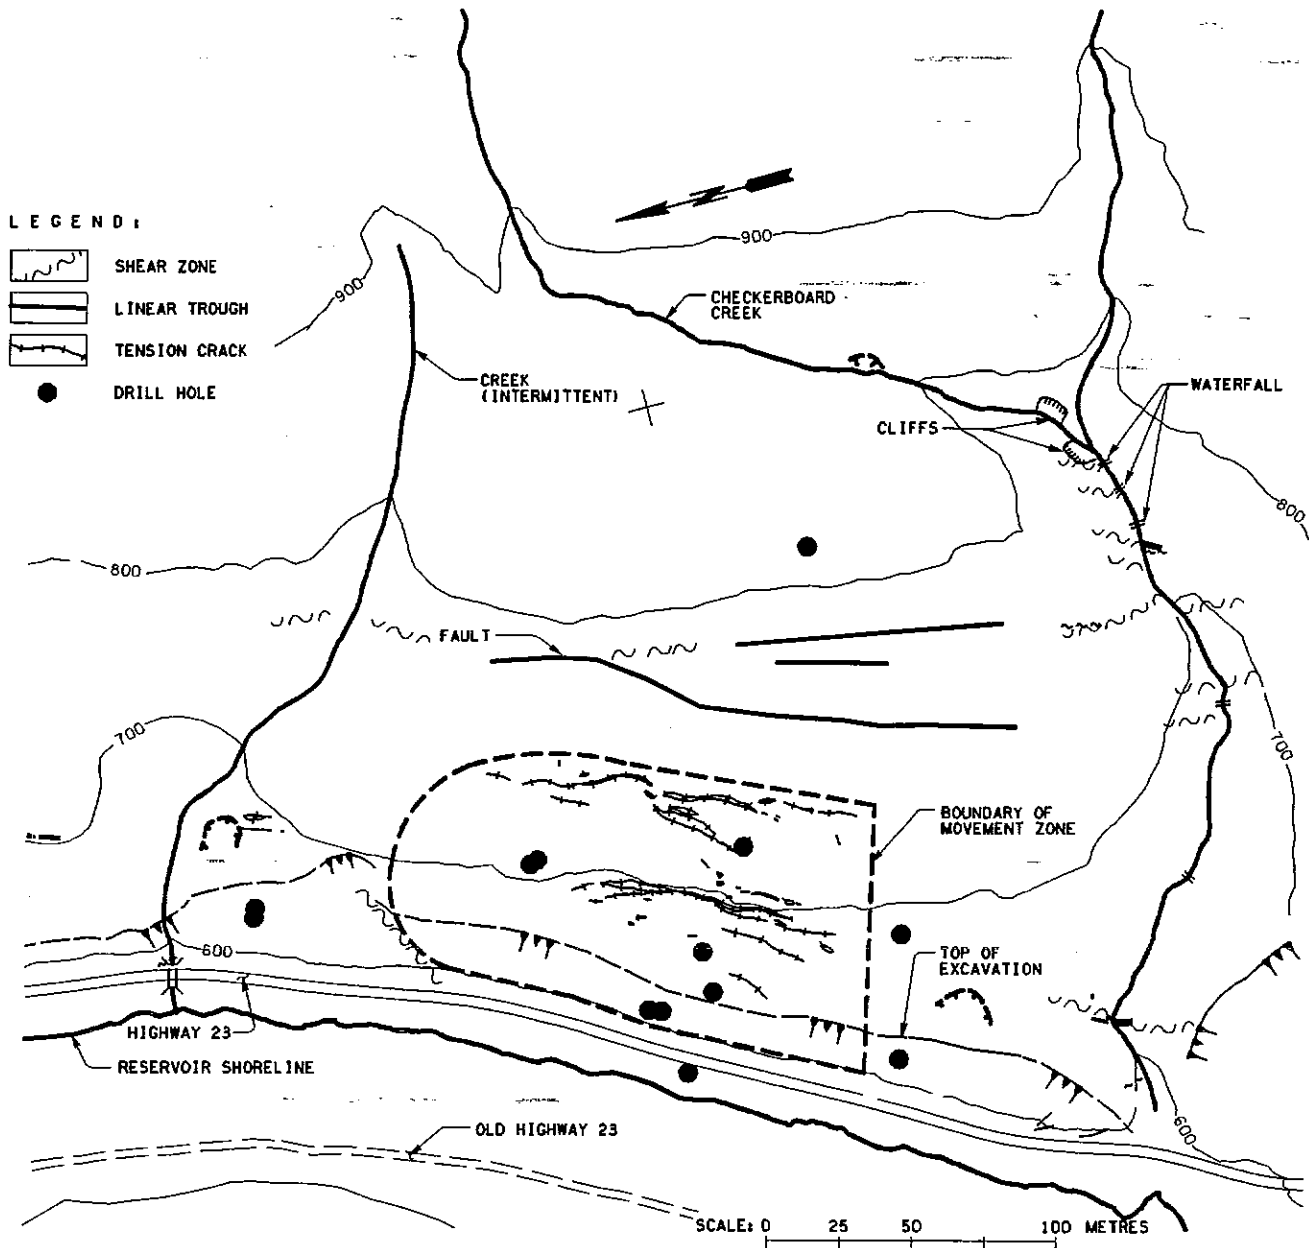
Fig. 11. Plan view of the Checkerboard Creek rock slope which is about 1.5 km upstream of Revelstoke Dam. Movement on ancient tension cracks was renewed when the excavations to relocate Highway 23 were carried out.

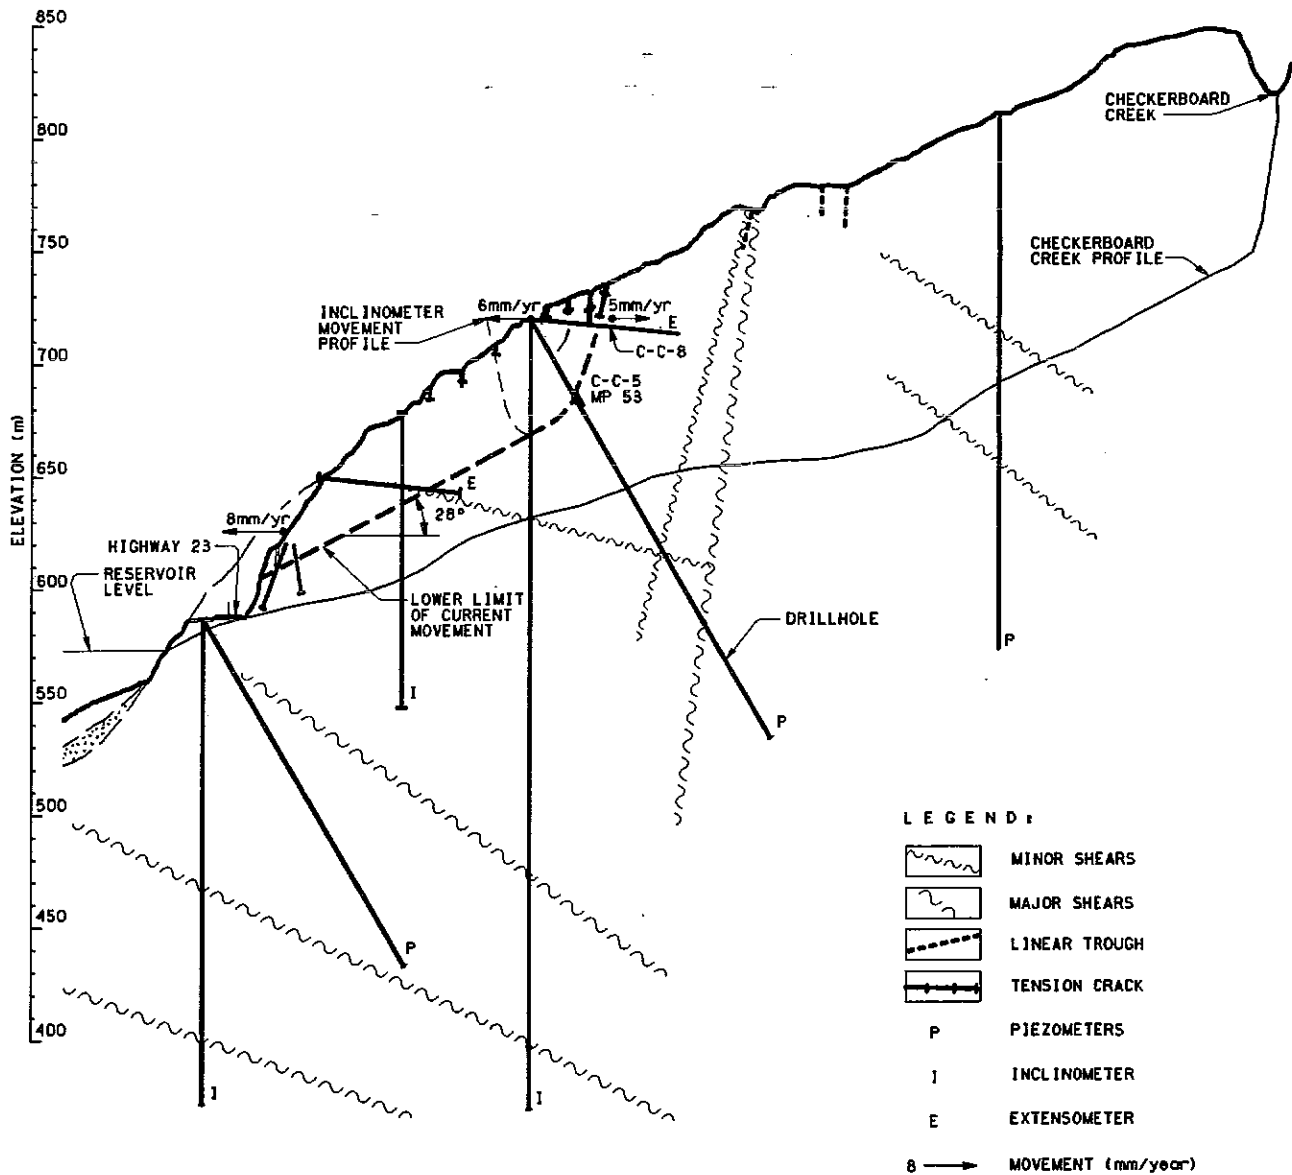
Fig. 12. Cross section of Checkerboard Creek showing the limits of the current creep movements. The cause of the linear troughs further up the slope is not known. The phreatic surface is irregular but generally parallel to the slope and always below the limit of current movement.

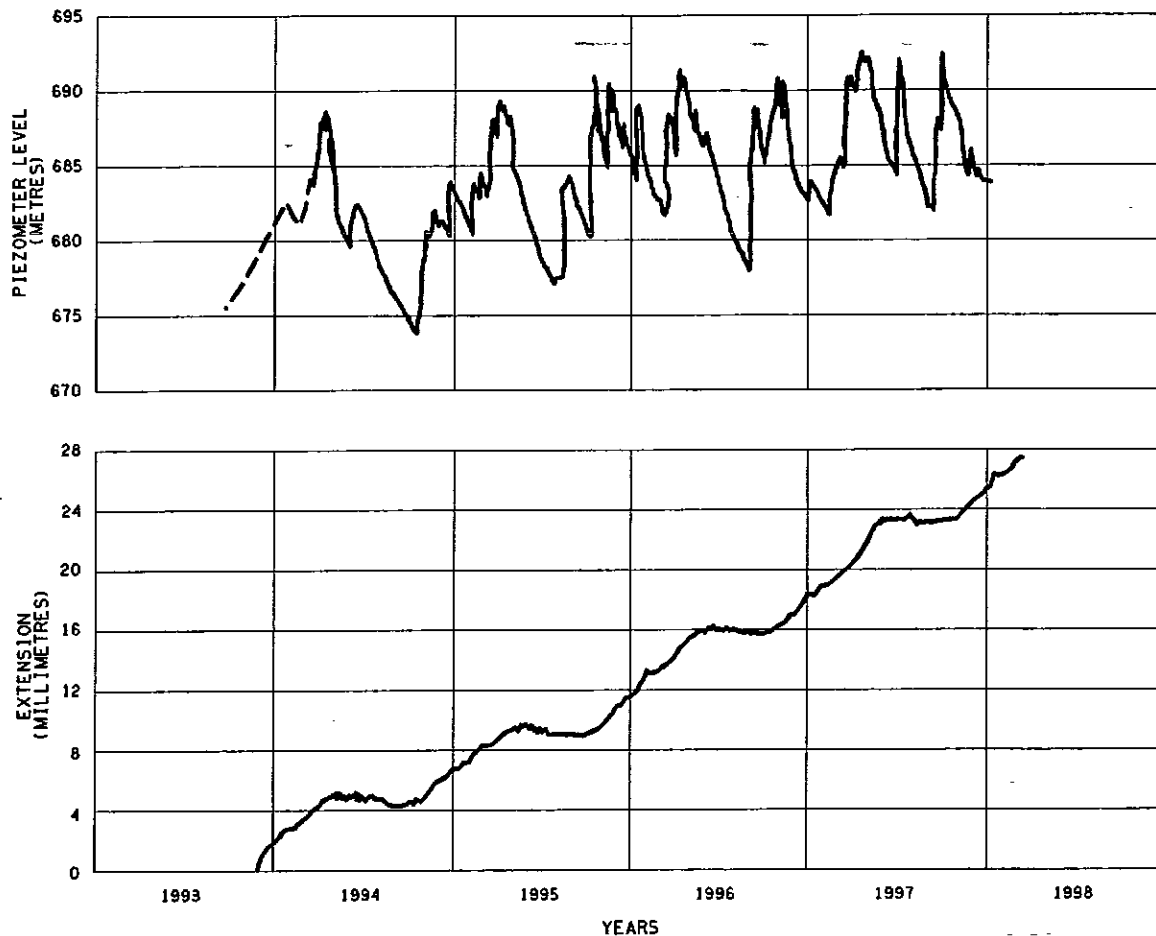
Fig. 13. Correlation of movements measured at Checkerboard Creek above the phreatic surface and pressures nearby but below this surface. Movement occurs in the Fall-Winter period and is associated more with increasing pressures than with any particular pressure level.

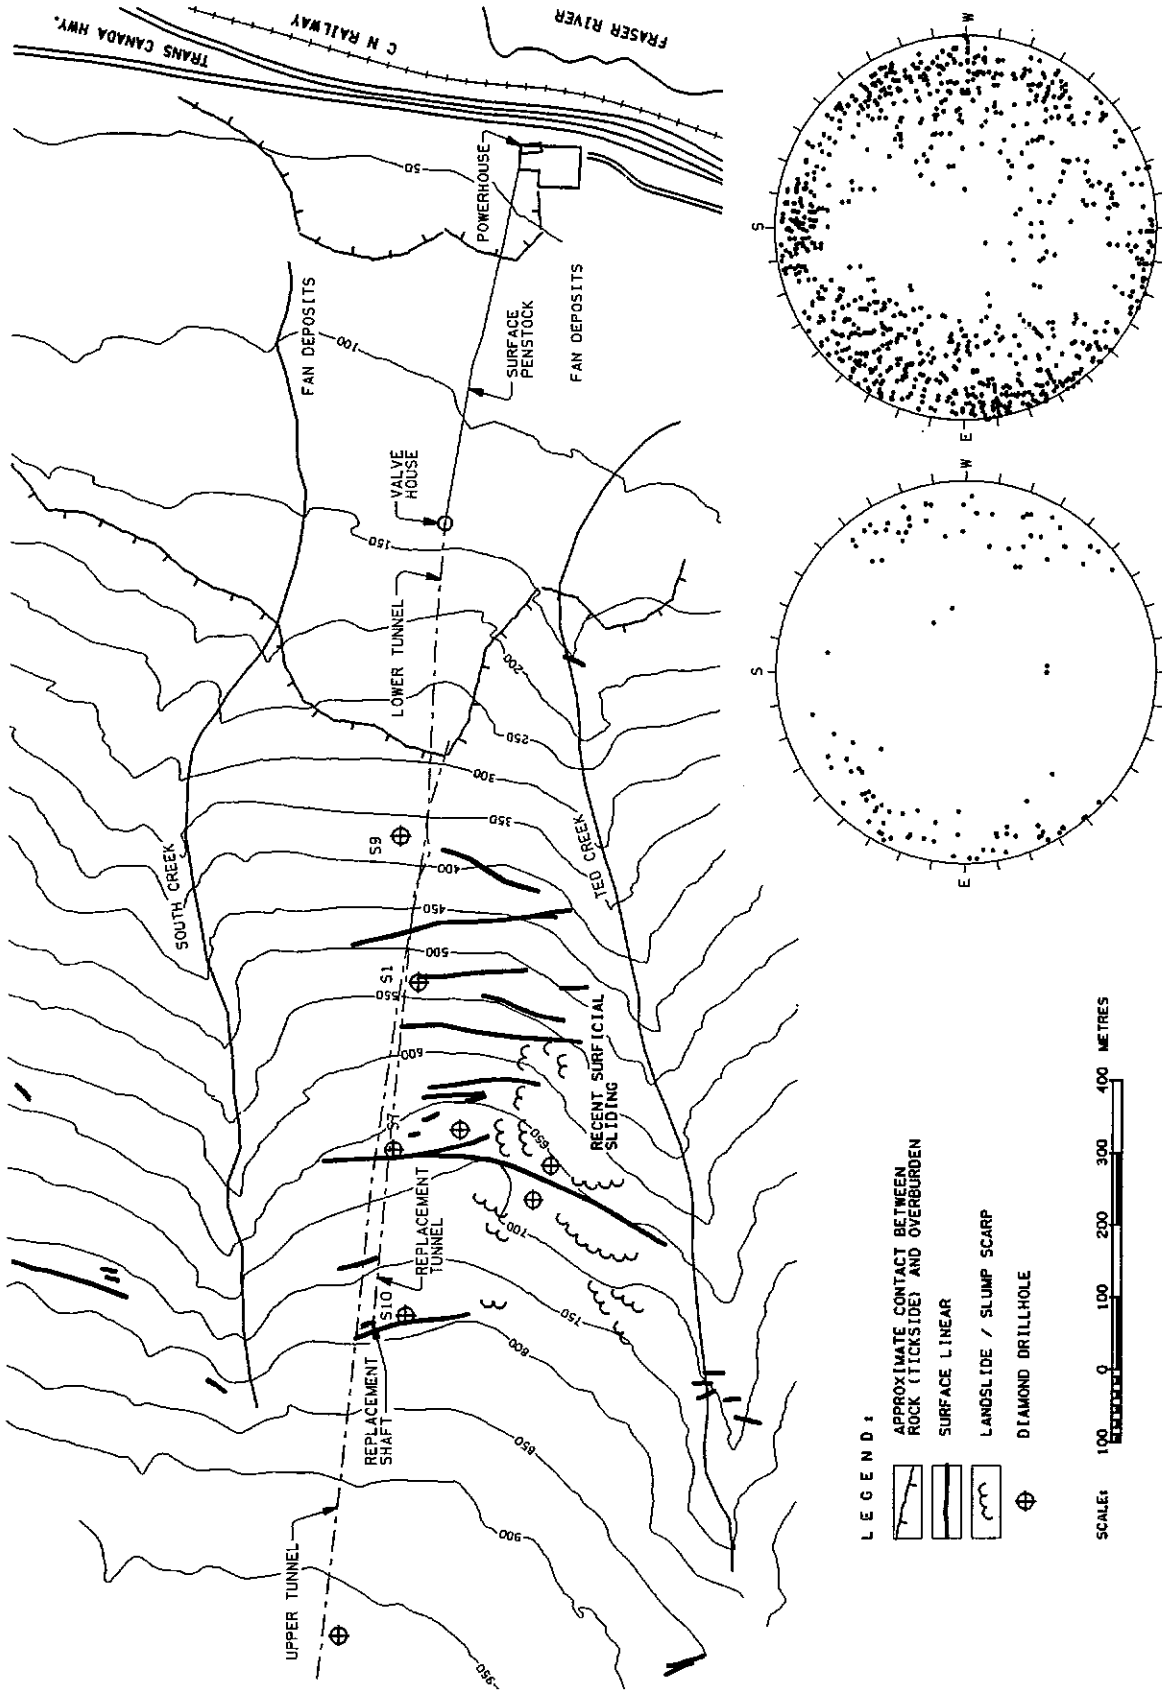
1. Generally within the moving rock mass the movements are diffuse but at a few locations they are concentrated.
2. Towards the uphill part of the slope the movements tend to be more concentrated within zones and the greater rates of deformation tend to be at the base of the moving rock mass.
3. The movements generally are not associated with any notable or unusual geological features in the drill core.

Fig. 15. Cross section of the Wahleach slope showing movement measured in inclinometers and a survey of the position of the steel lining in 1990 compared to its 1951-52 position.

4. The movements are seldom, if ever, associated with downslope dipping discontinuities.
5. The movements at depth have resulted in the larger cumulative displacements being at the ground surface and near the uphill boundary of the moving rock mass.
