**Olander Home Inspection Services LLC**

Report: 0000024

## **Confidential Inspection Report**

**123 Main St.**

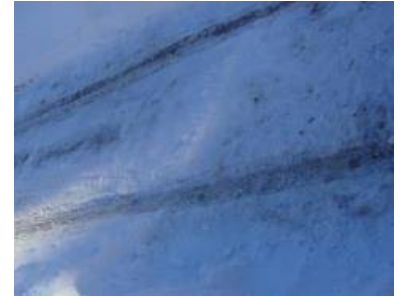
**Driveway Condition:**

- The driveway was snow covered at the time of inspection. From the few areas I checked, it appeared to be functional.

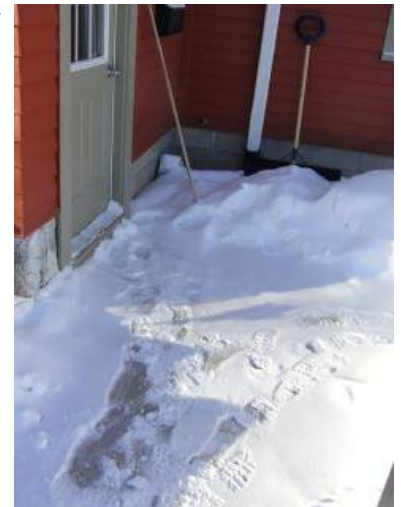
**Walkway Condition:**

- The walkway surface material is in functional condition with only normal deterioration noted.

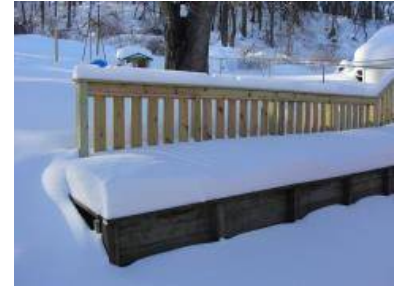
Rear of house.

The retaining wall is made of wood. It appears to be treated wood.

**Condition of Wall and Materials Used:**    The retaining wall is in functional condition.**Water Drainage:**    The water above the retaining wall is correctly directed away from the wall.**Retaining Wall Anchoring:**

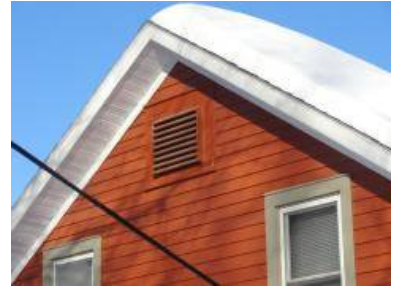
The fascia and rake boards appear to be in adequate condition and show only signs of normal wear.

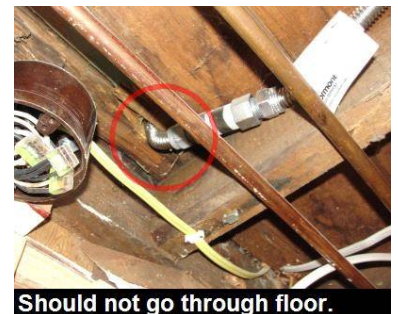
**Secondary Supply Piping:**

**Action Necessary** - Flexible copper lines are not allowed to pass through walls or floors because of the danger of rupture of the lines. Replacement with approved piping material is required. Copper - Type K & L copper piping is only allowed for interior piping and should never be used on the exterior or underground.

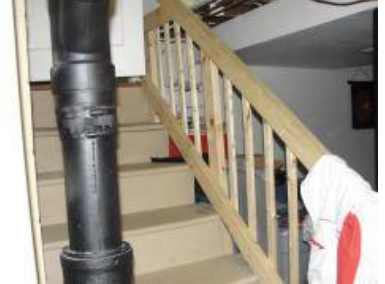
- The staircase to the basement level appears functional. There are handrails solidly attached and in useable condition. The staircase is lighted.

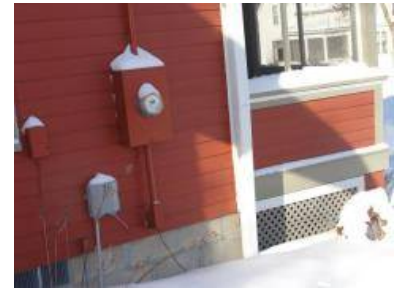
- Overhead, 120/240 Volt, Circuit breakers, Appears serviceable.

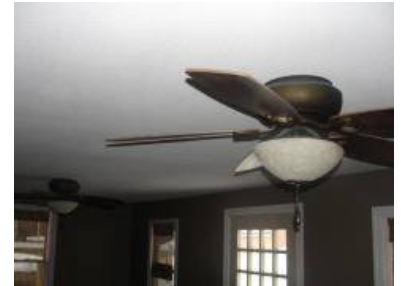
**Living Room:**

Satisfactory - There is a ceiling fan installed in this room. It appears to be functional.

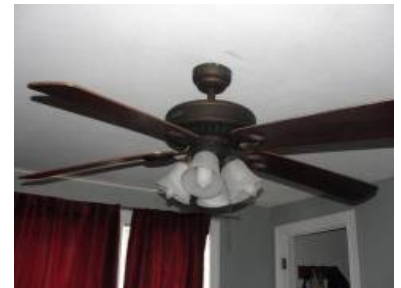
**Bedroom #1:**

Satisfactory - There is a ceiling fan installed in this room. It appears to be functional.

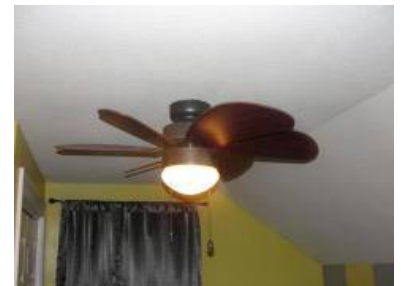
**Bedroom #3:**

Satisfactory - There is a ceiling fan installed in this room. It appears to be functional.

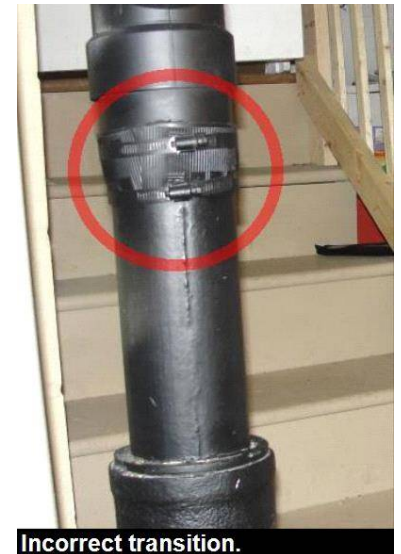
**Waste Piping Condition:**

There is an unapproved coupling used to join to pieces of pipe.

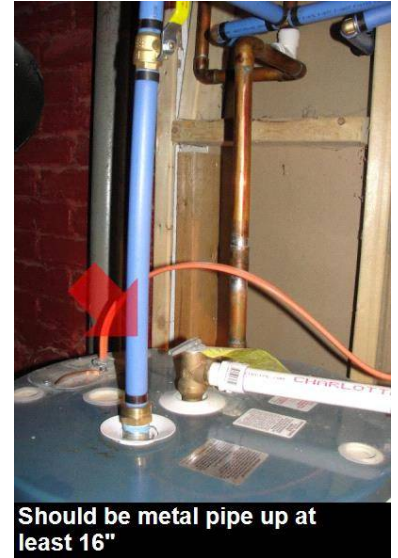
**Water Piping Condition:**

**Action Necessary** - Plastic water lines in contact with the top of a hot water tank are not allowed. Pipe failure may occur. Plastic piping should be maintained at least 16" away from the tank.

- 
- 
- Action Necessary** - Plastic water lines in contact with the top of a hot water tank are not allowed. Pipe failure may occur. Plastic piping should be maintained at least 16" away from the tank.
-

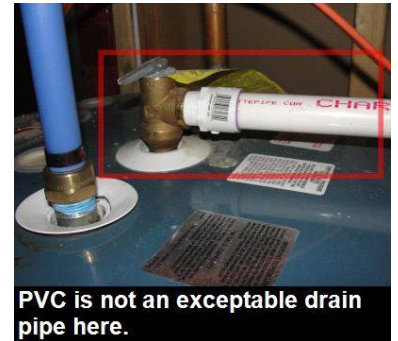
**Safety Overflow Pipe:**

**Action Necessary** - PVC pipe is not allowed to be installed as an overflow or discharge pipe for the water heater. The temperature rating for the pipe material is only 73 degrees, and the water at the discharge could be 210 degrees at over 150 PSI. It is recommended that this pipe be replaced with a copper pipe or CPVC pipe. The pipe should extend to within 4 inches of the floor. If plastic, it should be supported with non-abrasive straps at 3' intervals.

- 
- 
- 
- Action Necessary** - PVC pipe is not allowed to be installed as an overflow or discharge pipe for the water heater. The temperature rating for the pipe material is only 73 degrees, and the water at the discharge could be 210 degrees at over 150 PSI. It is recommended that this pipe be replaced with a copper pipe or CPVC pipe. The pipe should extend to within 4 inches of the floor. If plastic, it should be supported with non-abrasive straps at 3' intervals.

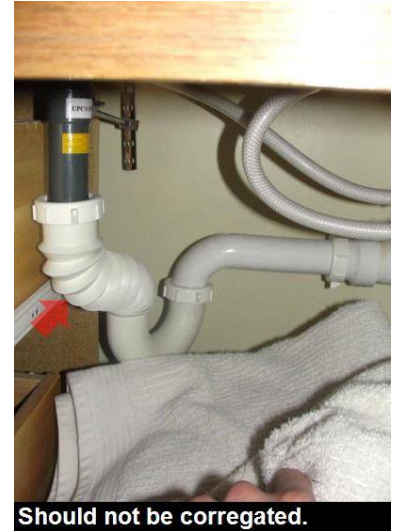
**Basin and Drain Fixture:**

- Action Necessary** -The installed trap is not an approved P-Trap, or it is installed in an unacceptable manner. Services of a qualified licensed plumber are recommended.

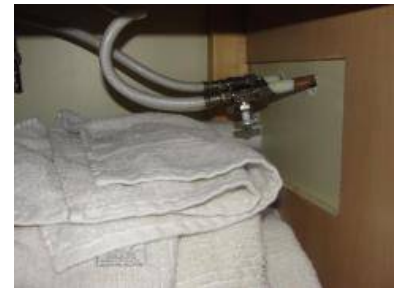
- Faucets and supply lines appear functional. There are shutoffs installed for both hot and cold water pipes under the basin.

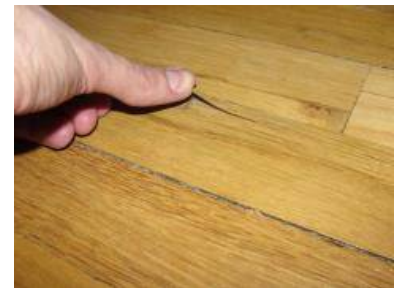
**Bedroom #3:**

The floor covering material is hardwood. Limited Visibility - Repairs Needed - The floor in this room needs some repair; but due to the floor covering, furniture, or stored items, it is not possible to determine the extent of the repairs needed.
