Evaluation of Predicted and Actual Water Quality Conditions at the Marlin Mine, Guatemala

**Prepared by
E-Tech International**

August 2010

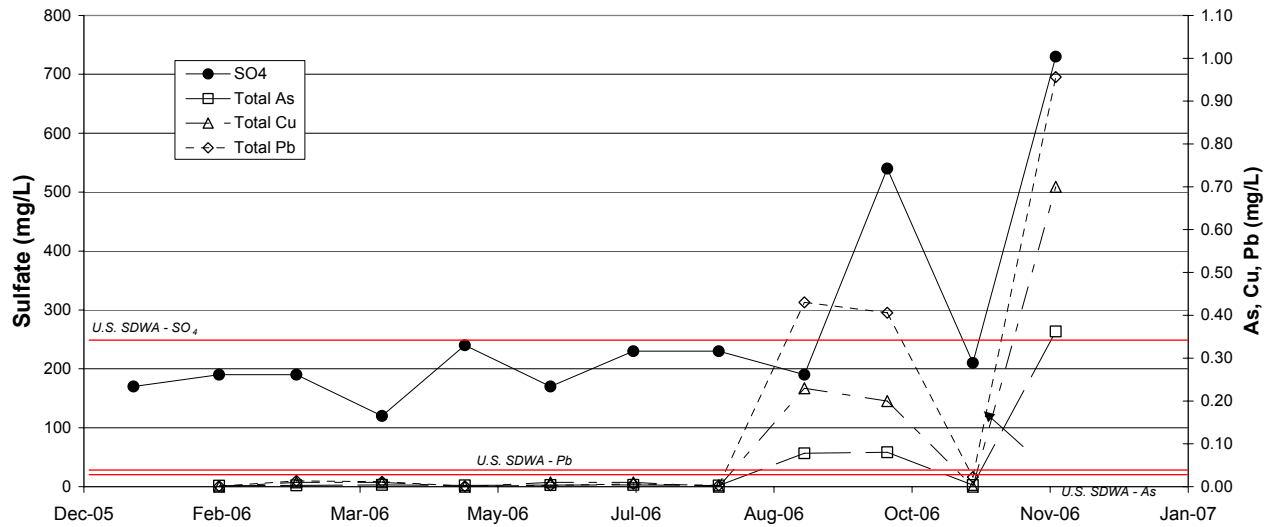
mg/l), chromium (up to 0.6 mg/l), iron (up to 737 mg/l total iron), manganese (up to 36.7 mg/l total manganese), nickel (up to 0.4 mg/l), silver (up to 0.263 mg/l), lead (up to 0.956 mg/l), vanadium (up to 1.32 mg/l), and zinc (up to 3.6 mg/l). Most of these concentrations exceed relevant drinking water or potable water standards by many times (see Table 2 for water quality standards). These standards are relevant because the groundwater in the underground mine could move to surface water or springs and be used for drinking water. A number of the contaminants of concern had markedly increasing concentrations at the middle and end of 2006, as shown in Figure 3 for sulfate, total arsenic, total copper, and total lead. Concentrations of sulfide were also elevated at the end of 2006 (increasing from below detection (<0.020 mg/l) in June to 31.8 mg/l in December). The presence of particulate metals and sulfide in the mine water suggests that solid metal sulfides from the ore may account for the observed increases. The pH of the mine water was above neutral in 2006, but changes in pH (higher or especially lower) could solubilize metals from the particulates and add to the more mobile dissolved metal load in groundwater or the tailings impoundment.

Figure 3. Concentrations of selected contaminants of concern in underground mine water (D1) in 2006.

Based on the water quality data for the underground mine water, the contaminants of concern include:

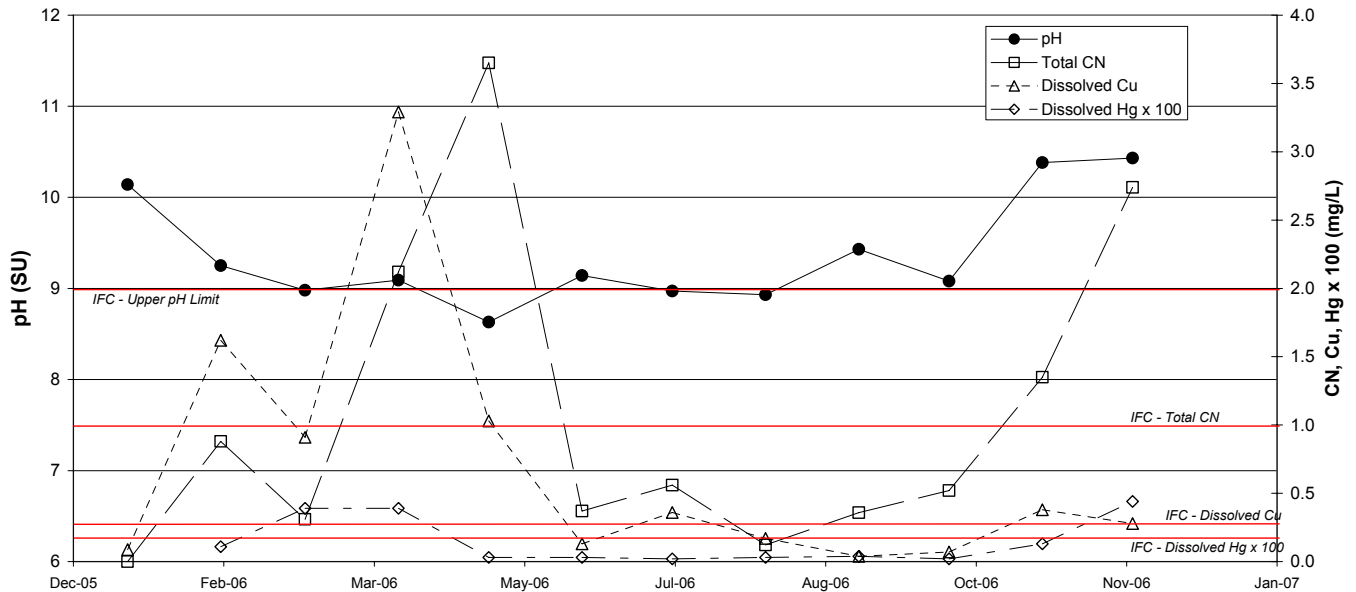
In 2006, sample D4 also had elevated concentrations of the same constituents and total dissolved solids (up to 2,960 mg/l), total cyanide (up to 3.65 mg/l), total aluminum (up to 2.87 mg/l), total iron (up to 1.6 mg/l), and mercury (up to 0.011 mg/l). Antimony concentrations were not elevated after Goldcorp switched to ACZ Laboratories from the onsite SGS laboratory. Sulfate concentrations were as high as 1,830 mg/l. Figure 4 shows the concentrations of selected COCs in tailings supernatant during 2006. Concentrations of total cyanide, dissolved copper, dissolved mercury, and pH values exceeded IFC discharge standards at different points in 2006. Maximum concentrations of cyanide, copper, and mercury were over three, ten, and 20 times higher than IFC standards.

Figure 4. Concentrations of cyanide (CN), dissolved copper (Cu), dissolved mercury (Hg), and pH in tailings supernatant water (D4), 2006.

Based on the water quality results for the tailings water, the contaminants of concern include:

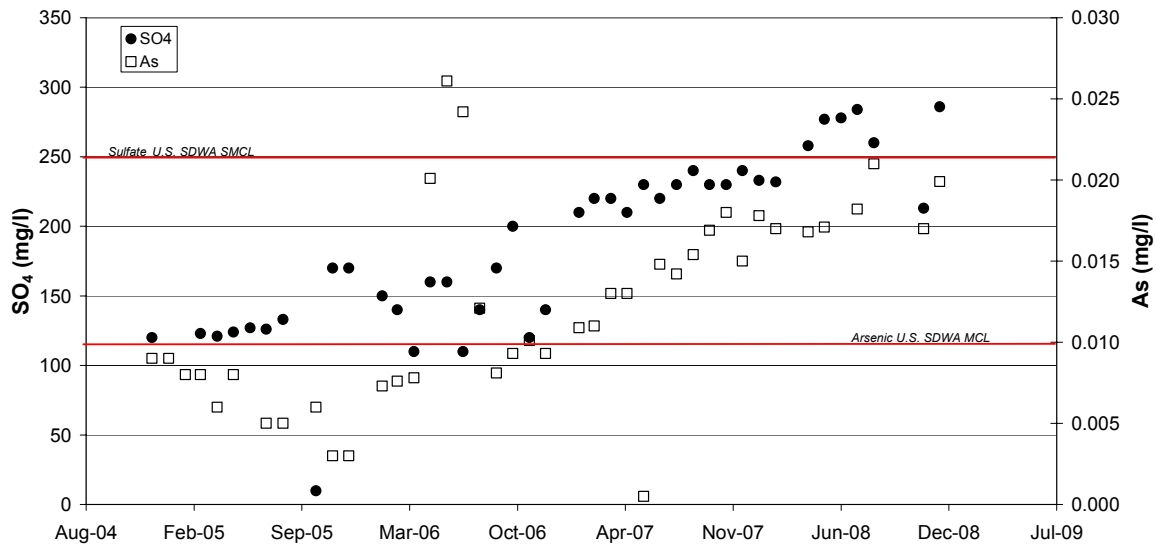
Figure 5. Sulfate and dissolved arsenic concentrations in monitoring well MW5 over time.

MW10 (up to 450 mg/l) and are lower in MW11 (high of 70 mg/l). Sulfate concentrations are high in tailings impoundment water (up to 1,830 mg/l; 2006 AMR).

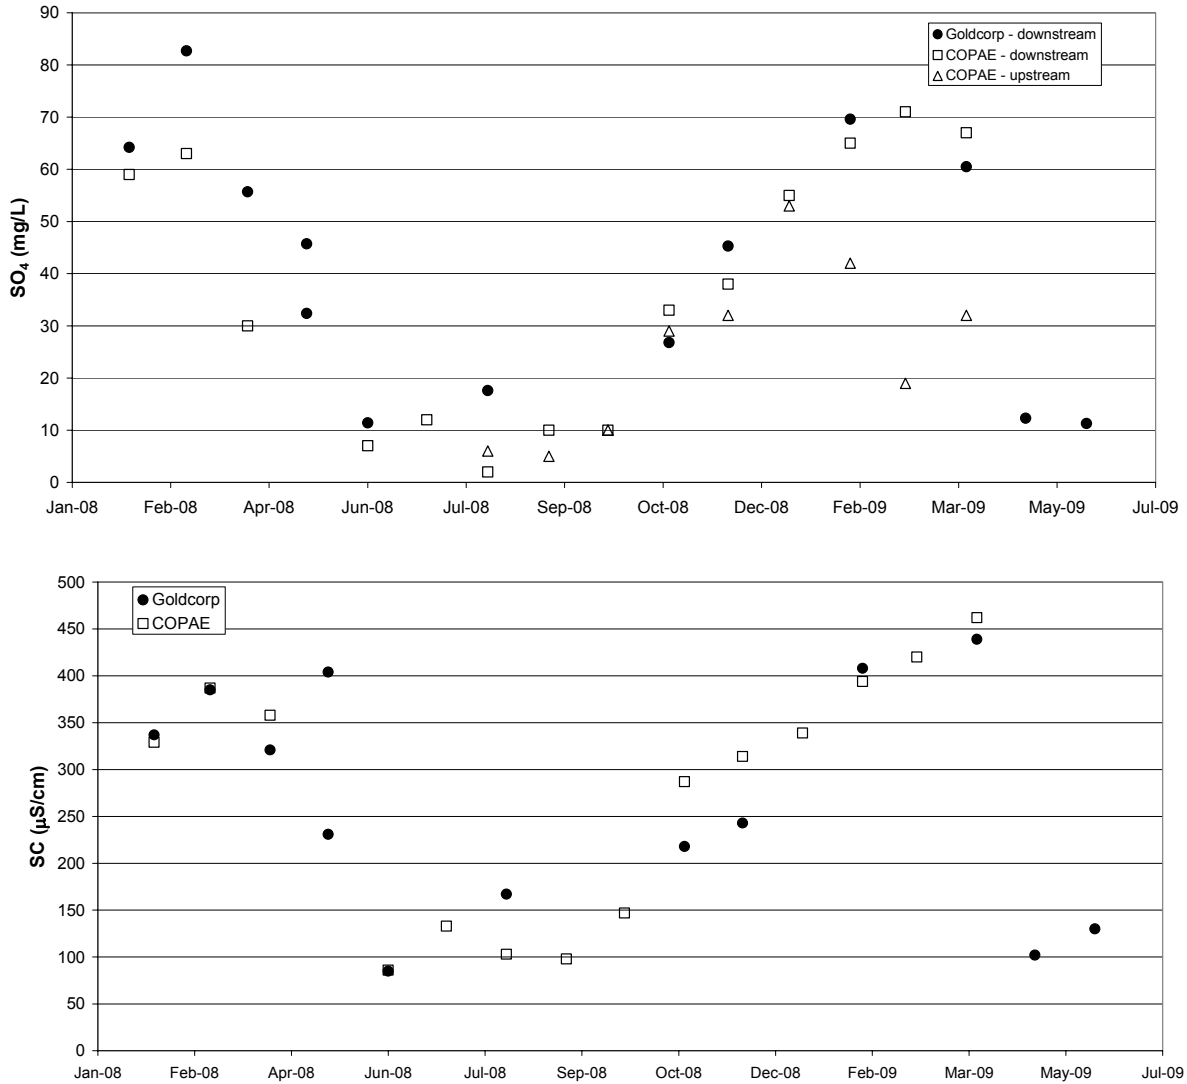
AMAC's total cyanide values for D6 in 2007 and 2008 are shown in Figure 8. The highest measured concentrations exceeded U.S. Clean Water Act aquatic life criterion values by over 12 times, and infiltration to groundwater from this source could adversely affect downgradient surface water. AMAC's results for D6 indicate that tailings seepage has elevated concentrations of sulfate, TDS, and cyanide. More information on the engineering of the tailings seepage pond and possible transport to the tailings tributary and Quebrada Seca should be investigated.

Figure 6. Comparison of Goldcorp and COPAE results for (a) sulfate concentrations in Riachuelo Quivichil upstream (SW6_C) and downstream (SW3 and SW2_C) of Quebrada Seca, and (b) specific conductance downstream of Quebrada Seca (SW3 and SW2_C).

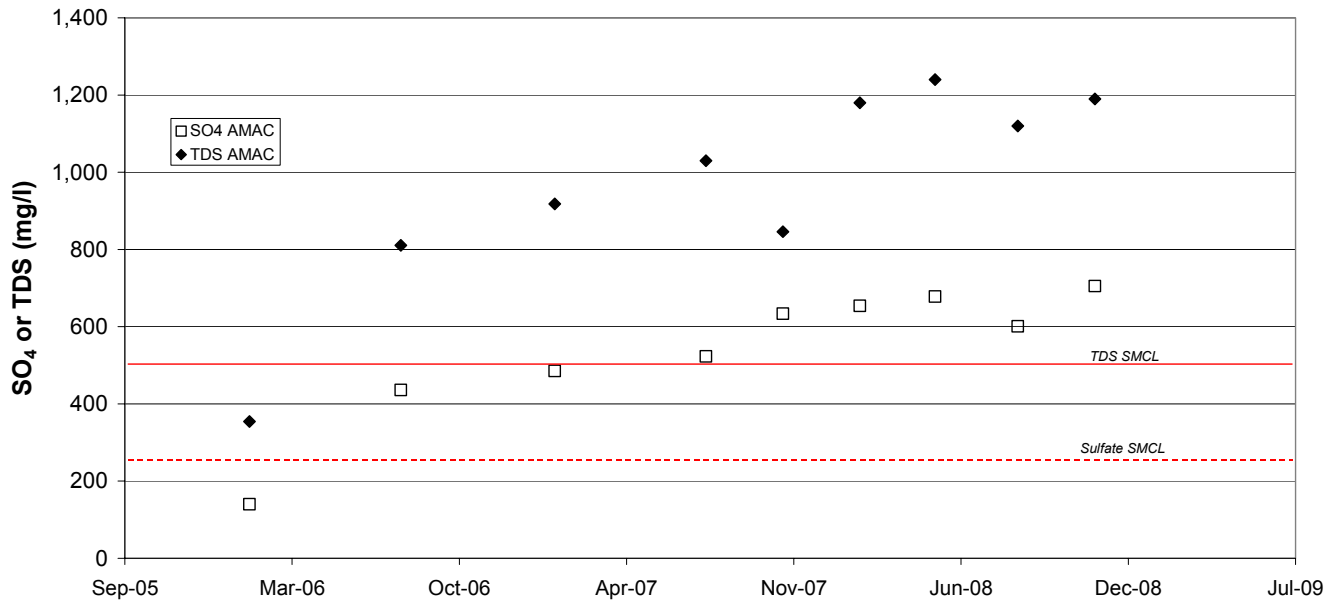
Figure 7. Sulfate and TDS values in tailings seepage pond below the dam (D6), AMAC data.

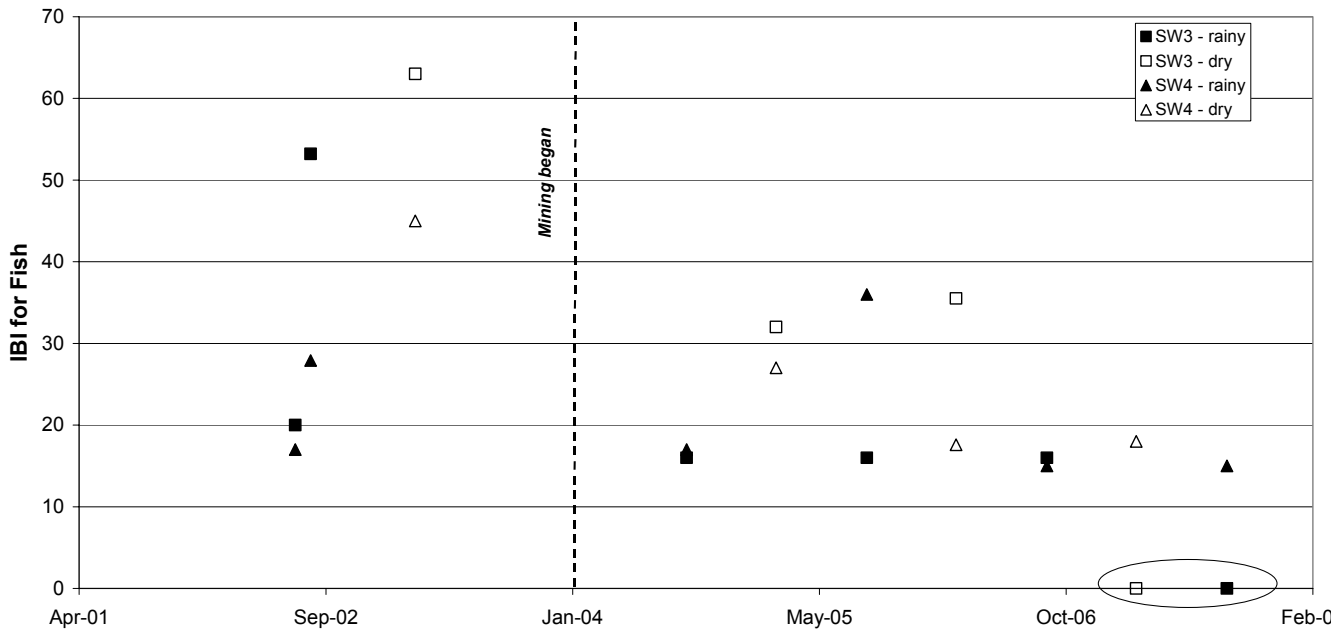
Figure 10. Index of Biotic Integrity (IBI) for fish at SW3 and SW4.

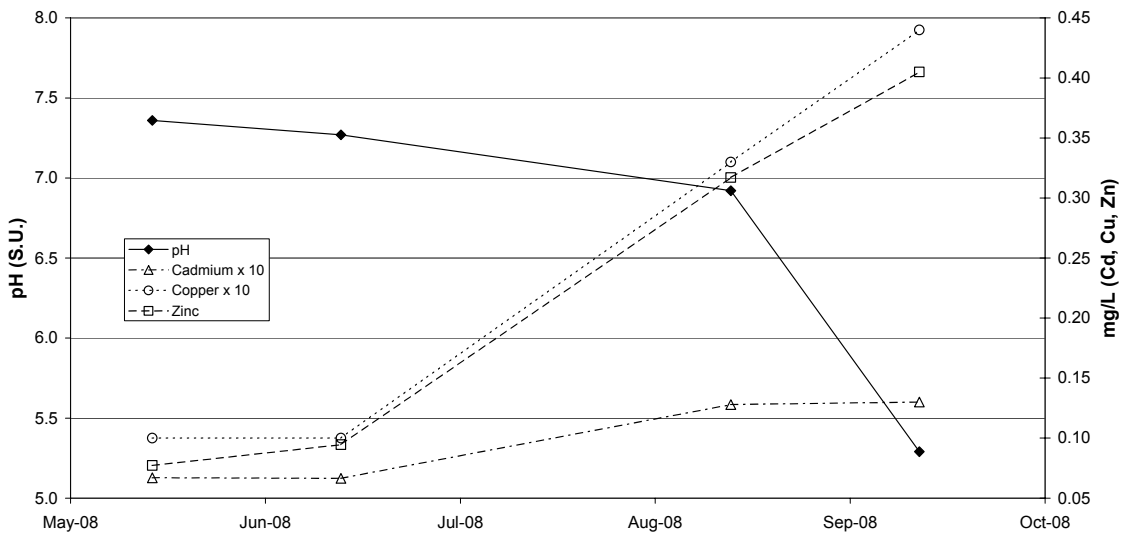
Figure 11. Decreasing pH and increasing metal concentrations in waste rock field sample 2188-29-126.
