The Potential for Imminent Endangerment to Human Life and the Environment from the Mirador Open Pit Copper Mine in Southeastern Ecuador

Submitted to the InterAmerican Commission on Human Rights

E-Tech International

28 August 2022

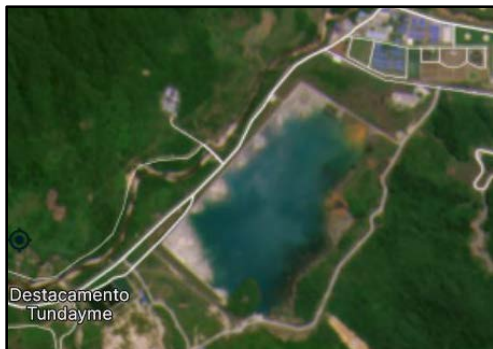
Figure 6. Quimi TDF almost full of water in June 2020

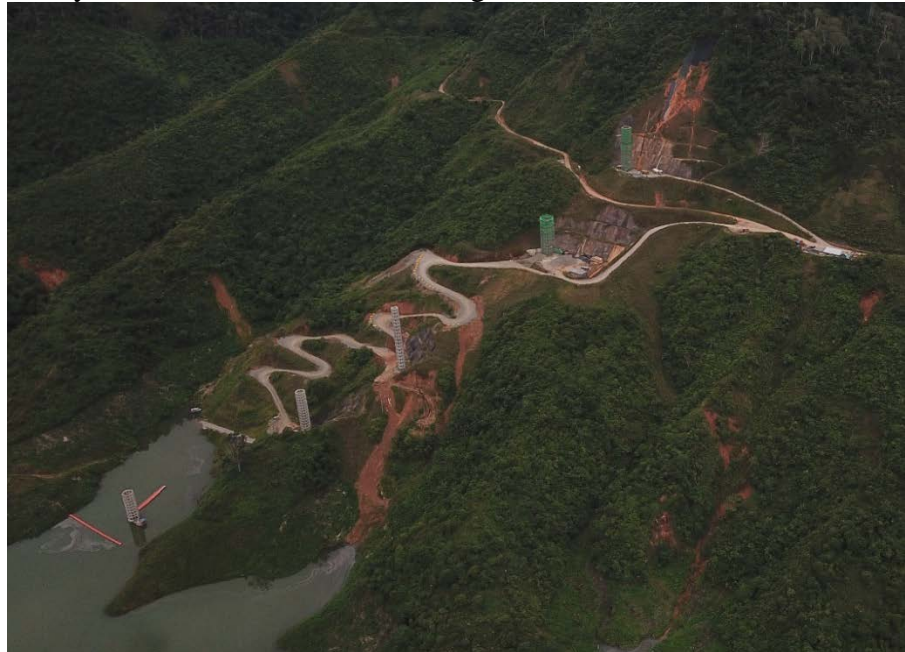
Figure 7. Decant Towers under construction. The tower in the lower left appears to be operational. Towers higher on the hillside are for future use. Late May 2022. *Source: locally provided photograph.*

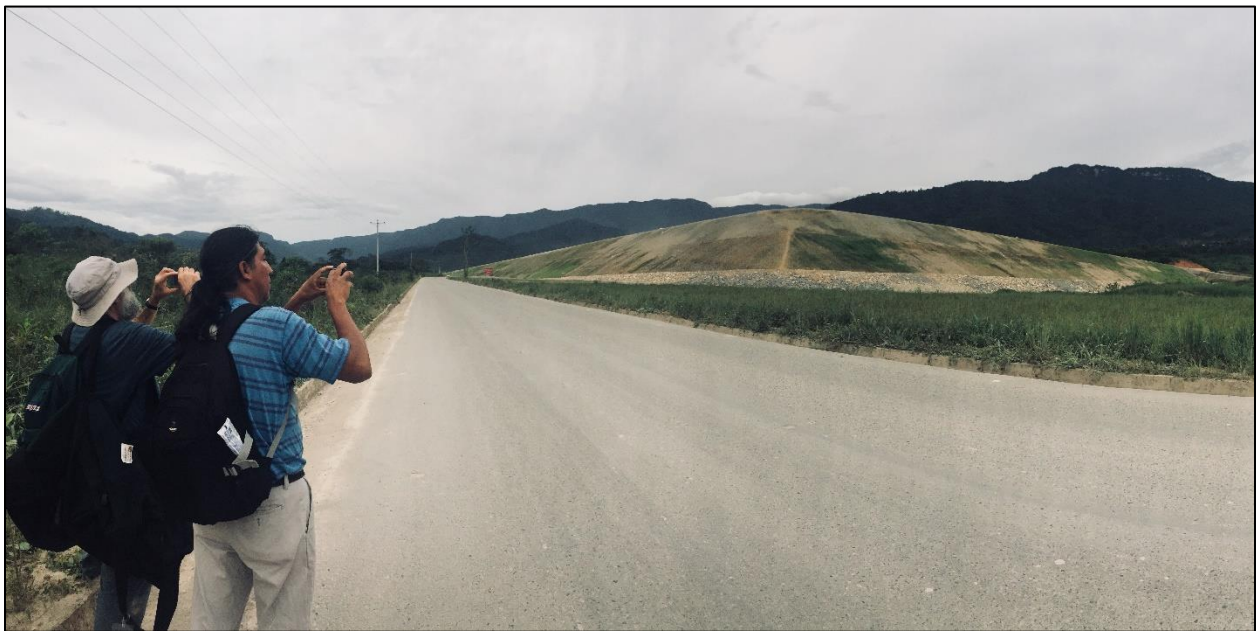
Figure 1. The author (on the left) and Luis Sanchez Zhiminaycela (activist with Comunidad Amazónica de Acción Social Cordillera del Cóndor Mirador) study the starter dike of the Quimi tailings dam at the Mirador mine. Photo taken by Evelyne Blondeel on November 6, 2018.

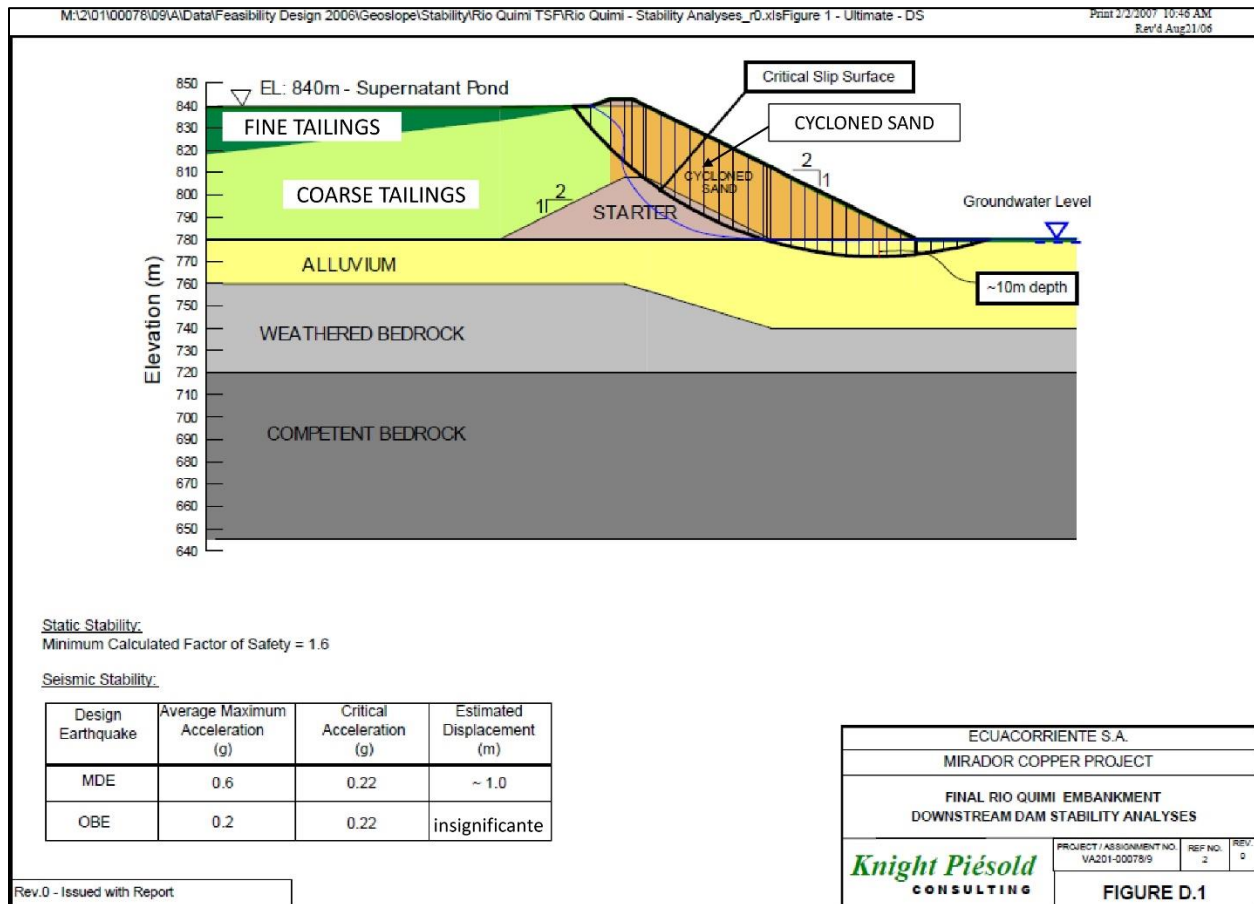
Figure 10. Knight-Pièsold (2007), consultants hired by Ecuacorriente S.A., determined that “the entire depth of the tailings deposit is potentially liquefiable for the MDE and OBE [Operating Basis Earthquake]. Liquefaction is also predicted for the loose alluvial soils near surface (in the upper 10 meters) for the MDE and OBE.” Knight-Pièsold (2007) identified the MDE (Maximum Design Earthquake) with the MCE (Maximum Credible Earthquake). The Operating Basis Earthquake is the earthquake that is expected to occur during the life of the project. Note that it was predicted that the maximum accelerations during the MCE and OBE would be 0.6g and 0.2g, respectively, while the critical acceleration for liquefaction was calculated to be 0.22g, where g is the acceleration due to gravity. Knight-Pièsold (2007) recommended that “ground improvement to increase the liquefaction resistance of these loose soils will be required within the embankment footprint and for a distance downstream of the embankment. Stability analyses indicate that a 100 meter wide zone of ground will require treatment along the embankment alignment.” However, there were no details nor guarantees that the “ground improvement” would eliminate the possibility of liquefaction of the foundation. The Knight-Pièsold diagram (2007) clarifies that the earlier design of the Quimi tailings dam included centerline construction and an outer embankment slope of 1V:2H. Figure modified from Knight-Pièsold (2007).

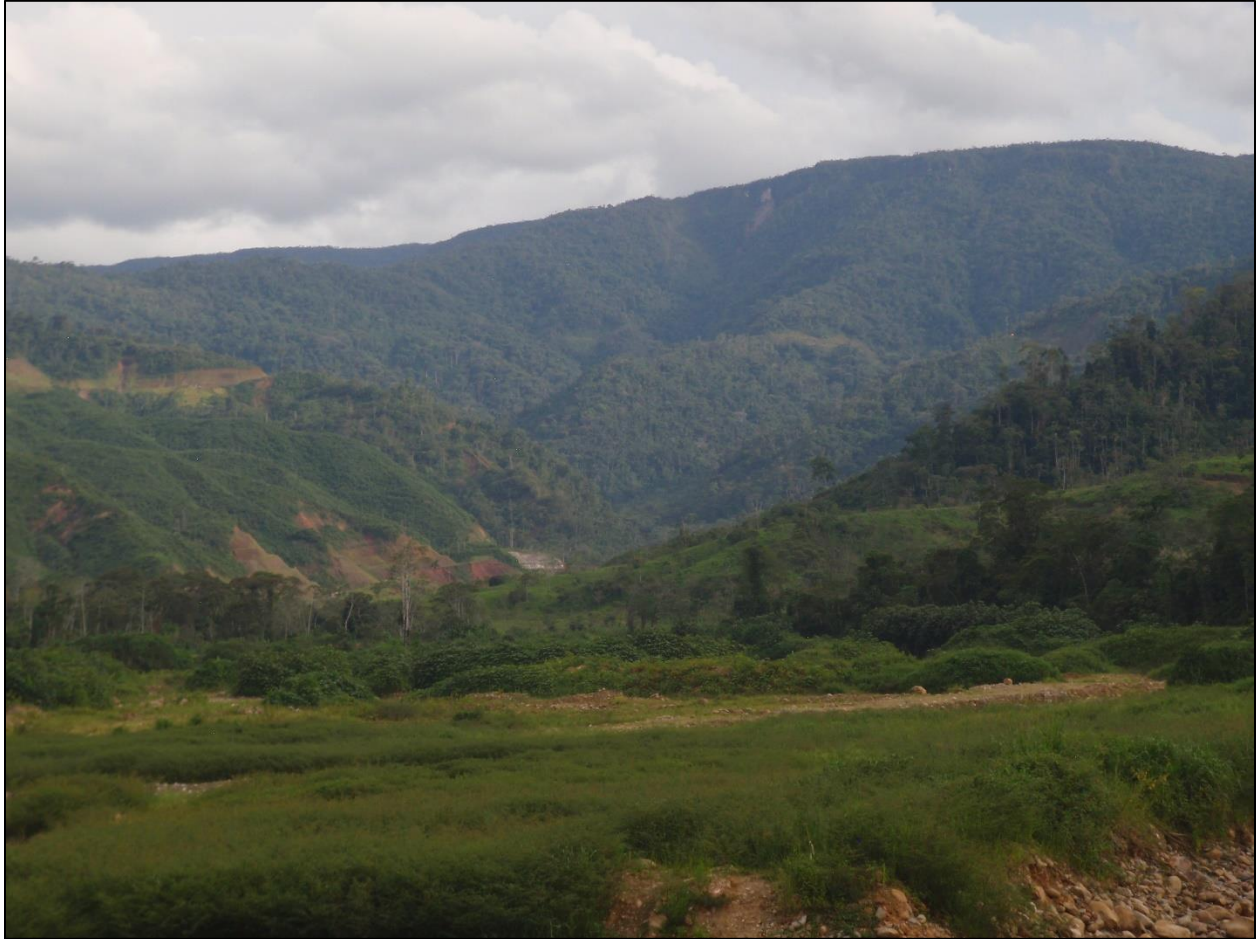
Figure 12. The cost of construction would be cheaper for the Tundayme tailings management facility because it is possible to take advantage of the steep slopes of the Tundayme valley (shown above) for confinement of the tailings (Cardno, 2014a). However, the steep slope of the valley (around 13%) in the direction towards the Rio Quimi (see Fig. 11) increases the risk of failure due to the increase in gravitational force that would act on the dam. In addition, steep side slopes pose a risk of landslides into the tailings pond, which could cause dam failure by overtopping. Photo taken by the author on November 6, 2018.

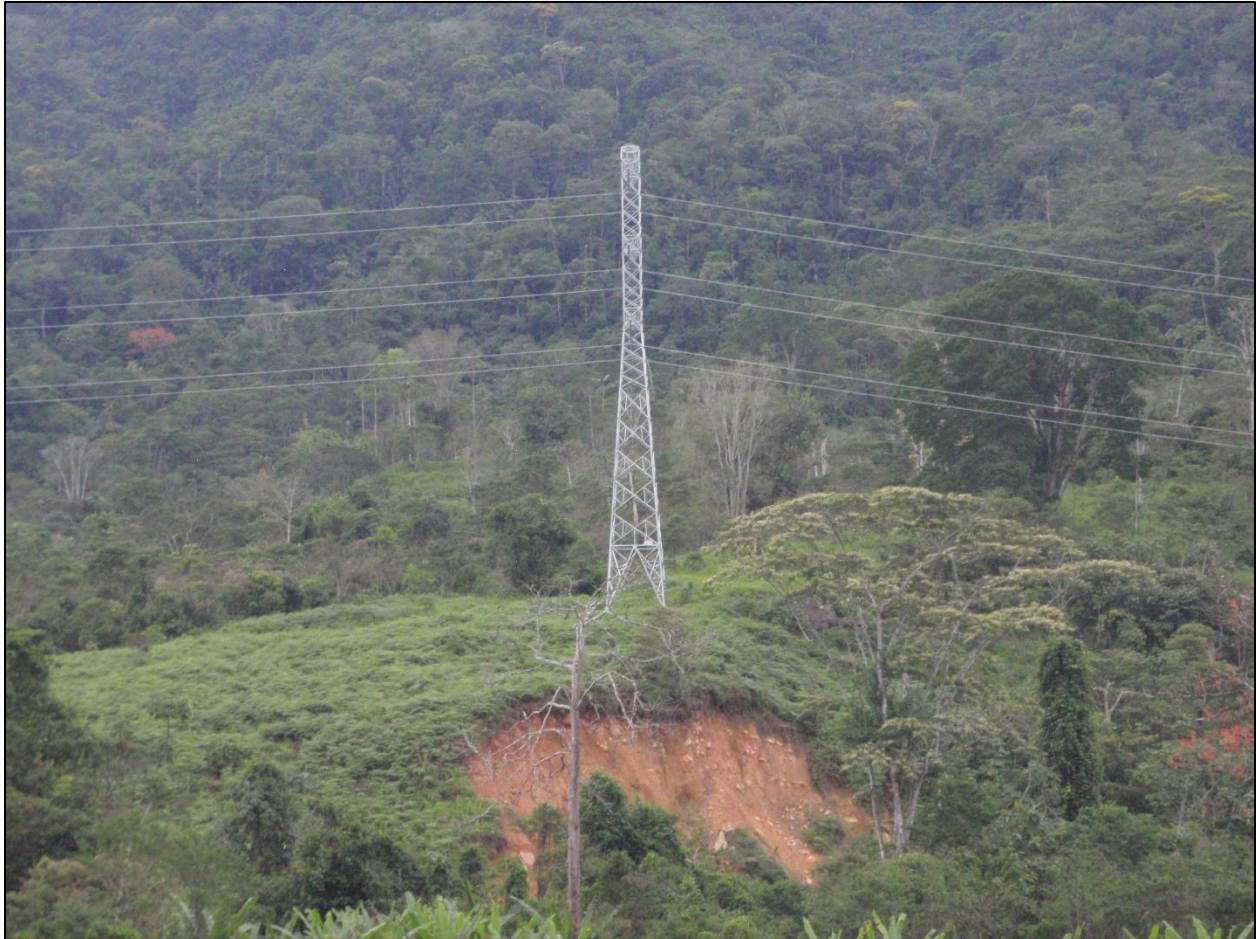
Figure 15. The high erosion rate in the project area is indicated by the landslide scar below a transmission tower on the north bank of the Rio Quimi (see Fig. 11), opposite the Quimi tailings dam. Photo taken by the author on November 6, 2018.

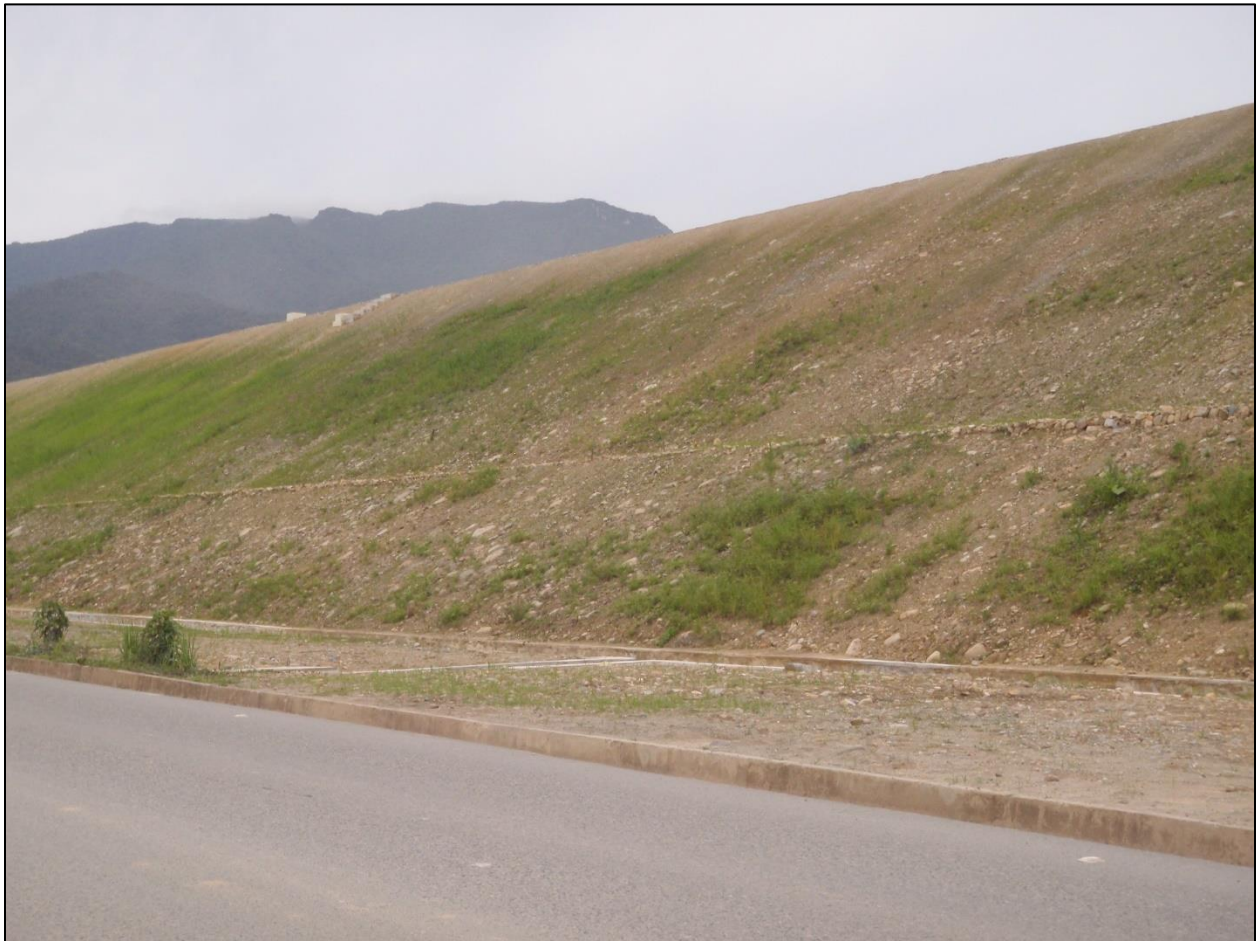
Figure 16. The starter dike for the Quimi tailings dam was built at the edge of the highway, the other side of which is the Rio Quimi (see Fig. 11). Since it is not possible to advance the dam farther in the downslope direction, the intention must be to build the entire dam using the upstream method (compare Figs. 5a-c). This is inconsistent with the design evaluated by Knight-Pièsold (2007) and both Environmental Impact Studies (Walsh Scientists and Engineers, 2010b; Cardno, 2014a), which included the centerline construction method for the Quimi tailings dam. Tailings dams built by the upstream method are more susceptible to failure from both earthquakes and floods. Due to the impossibility of installing impermeable layers (see Figs. 5a-c, 8), their higher water content also makes them more susceptible to failure due to internal erosion, static liquefaction and foundation failure. Photo taken by the author on November 6, 2018.

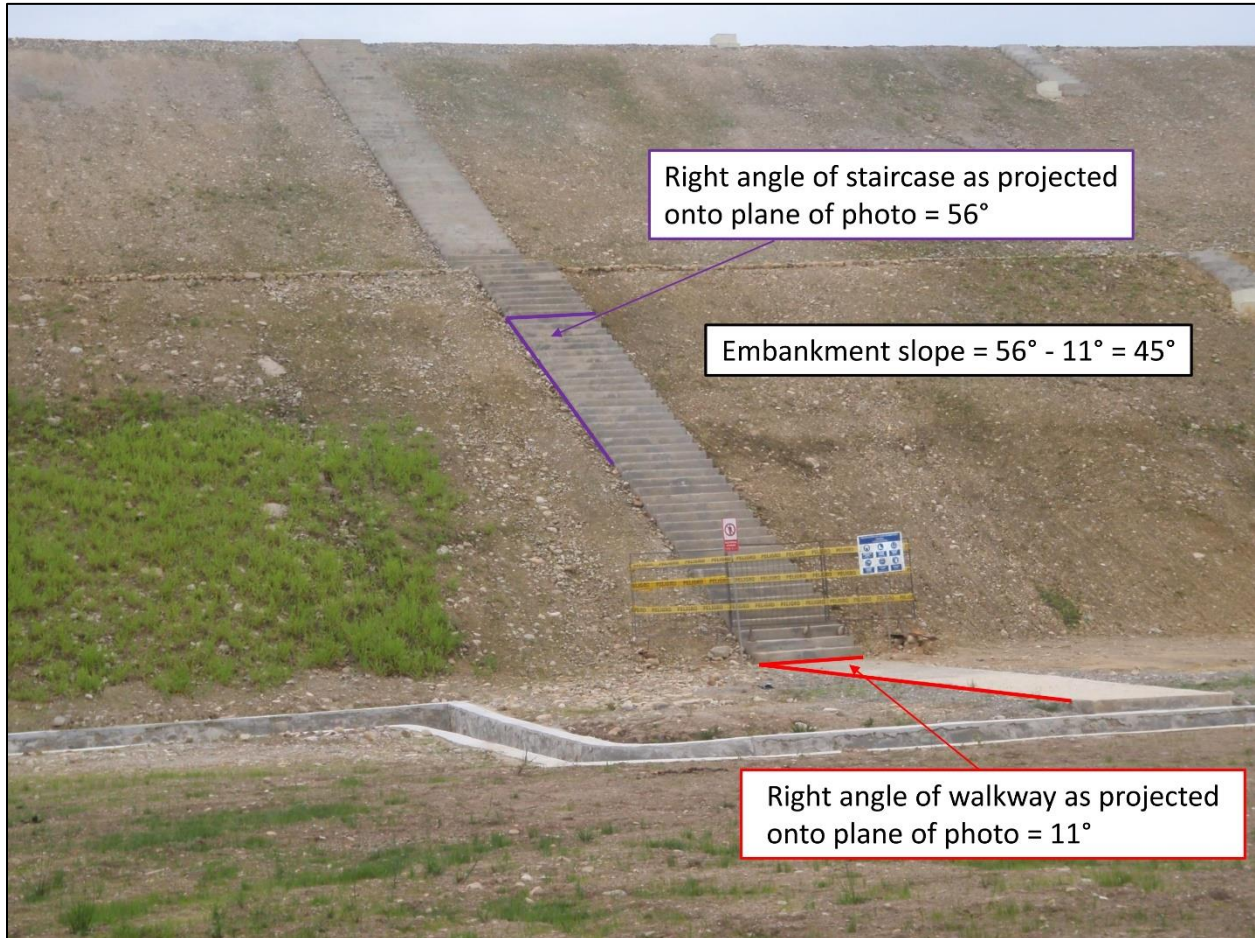
Figure 17. The starter dike for the Quimi tailings dam has a slope of 1V:1H (45°). This is inconsistent with the design evaluated by Knight-Pièsold (2007; see Fig. 10) and both Environmental Impact Studies, which stated that the slope would be 1V:2H (26.6°). A slope of 1V:1H is considered the maximum critical angle to prevent internal erosion of the dam without any margin of error (safety factor = 1.0). In contrast, according to the U.S. Army Corps of Engineers (USACE, 2000), “for sand levees, a 1V on 5H landside slope [11.3°] is considered flat enough to prevent damage from seepage exiting on the landside slope.” Photo taken by the author on November 6, 2018.

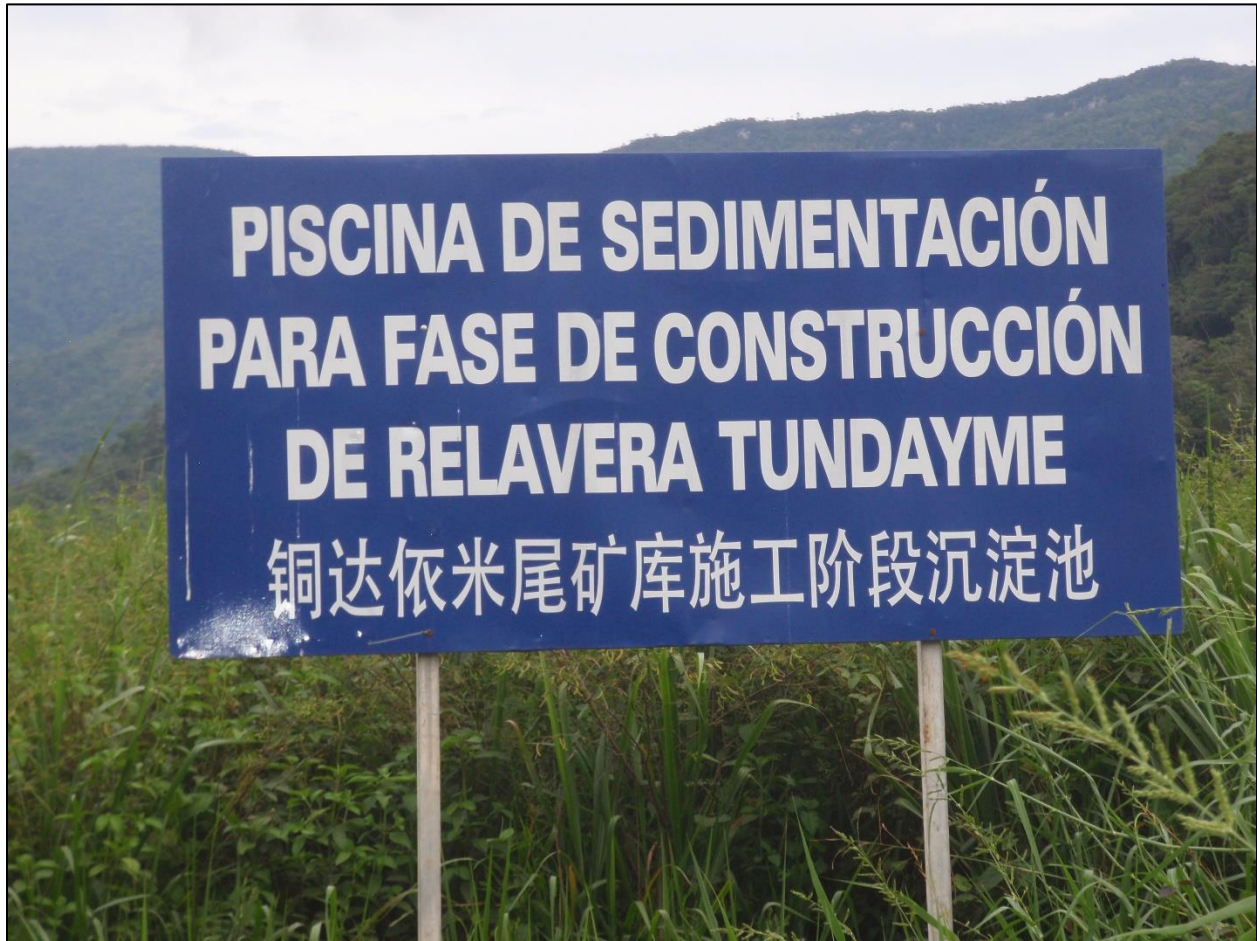
Figure 18. The sign (“Sedimentation Pond for Construction Phase of Tundayme Tailings Management Facility”) clarifies that both the Quimi tailings management facility (see Figs. 1, 16 and 17) and the Tundayme tailings management facility are currently under construction. This is inconsistent with the Environmental Impact Study (Cardno, 2014a), which listed the two tailings management facilities as alternatives. Photo taken by the author on November 6, 2018.

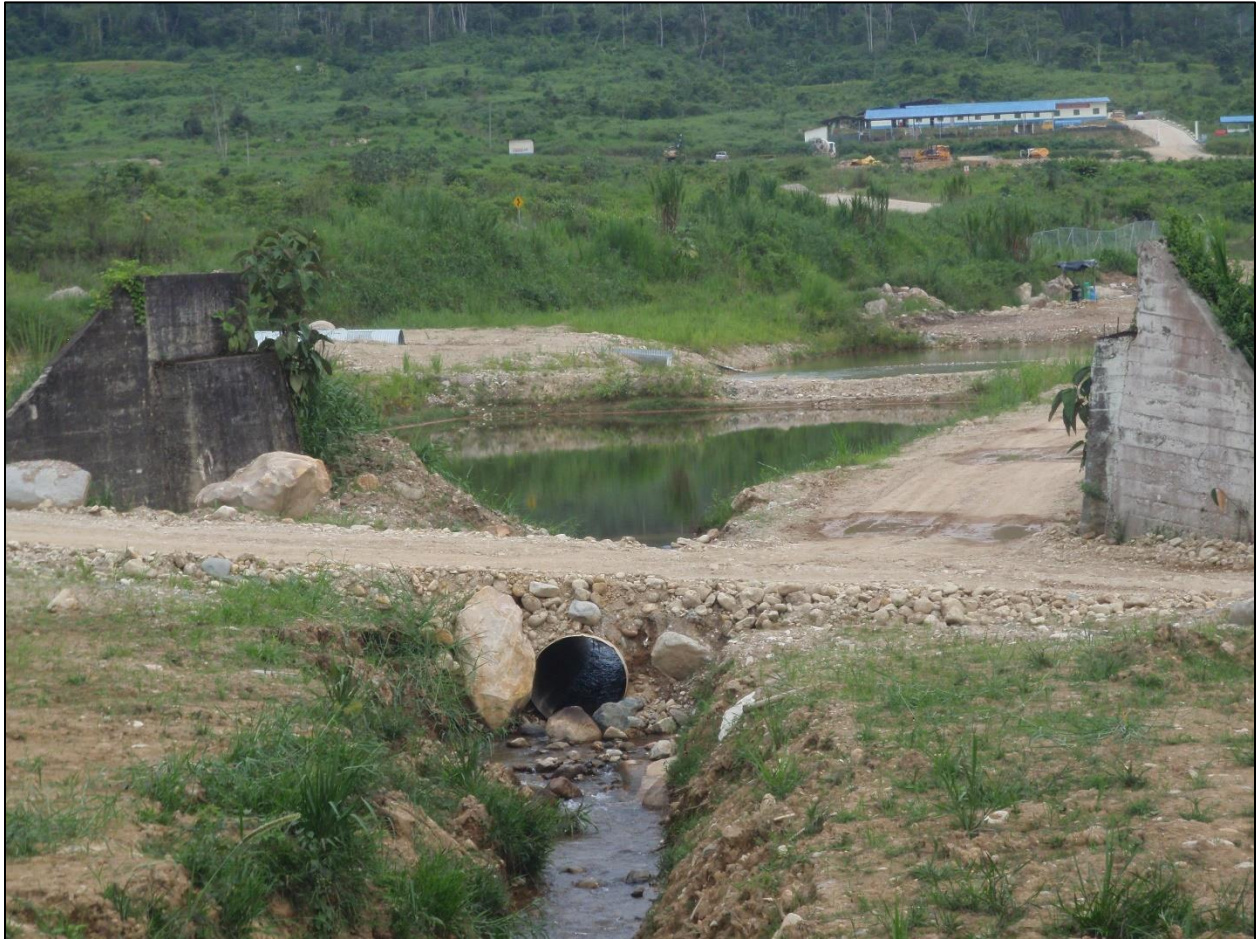
Figure 19a. The overflow from the sedimentation ponds for the Tundayme tailings management facility is discharged into a pipe and flows to the Rio Quimi (see Fig. 11). Photo taken by the author on November 6, 2018.

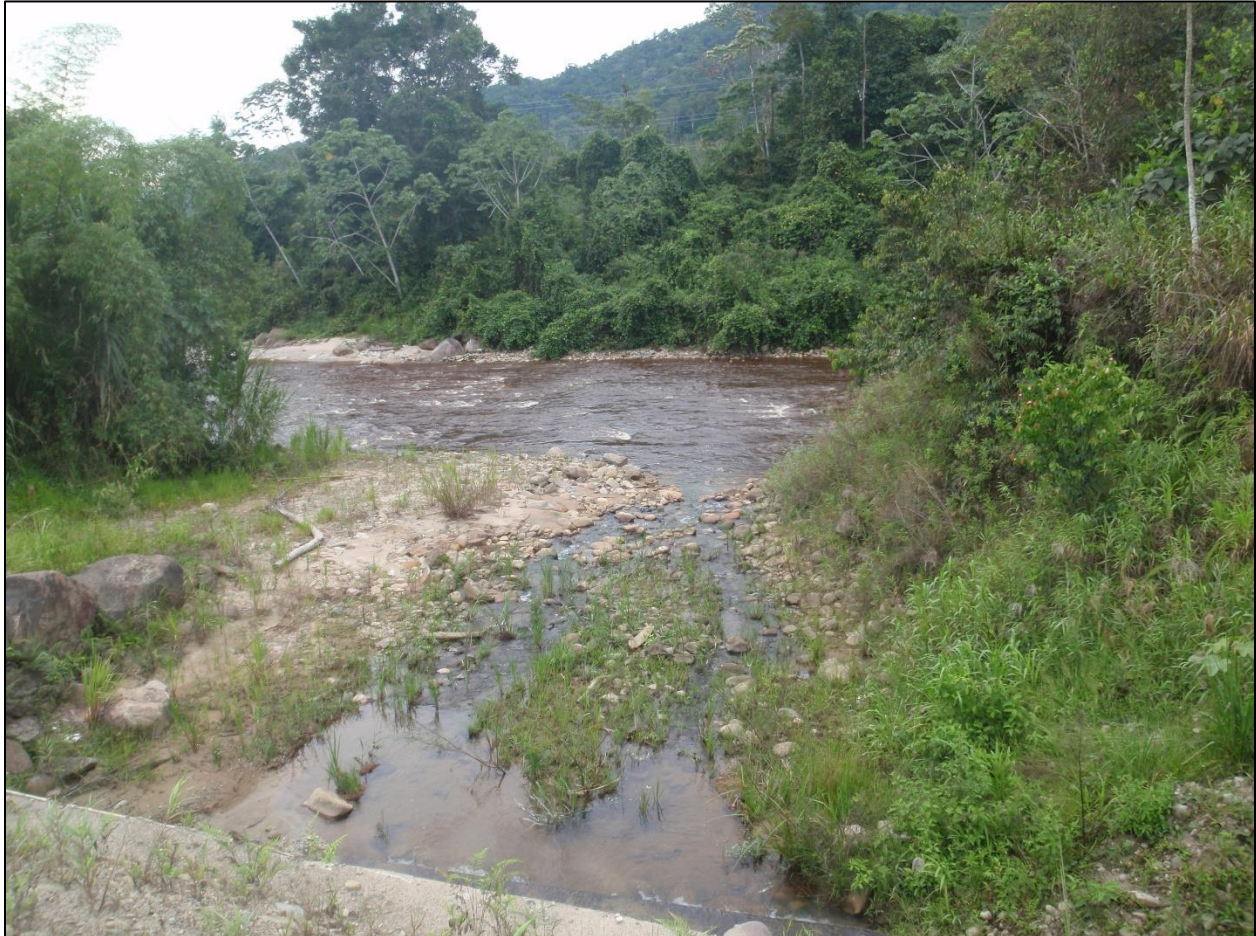
Figure 19b. The pipe from the sedimentation ponds discharges directly into the Rio Quimi. Photo taken by the author on November 6, 2018.

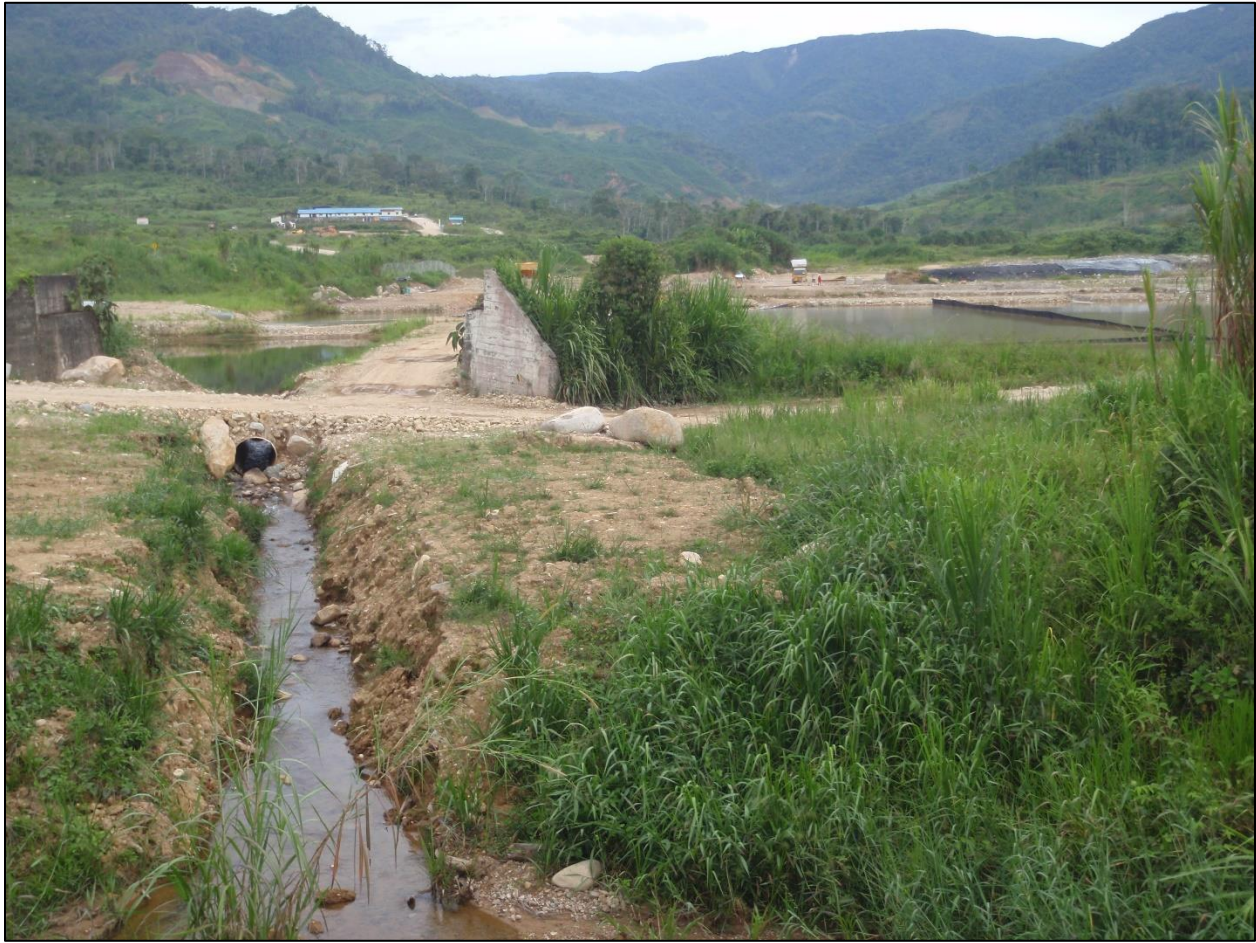
Figure 19c. The gray color of the discharge from the sedimentation pond demonstrates that the sedimentation ponds are not working (Quishpe Lozano et al., 2018). Photo taken by the author on November 6, 2018.

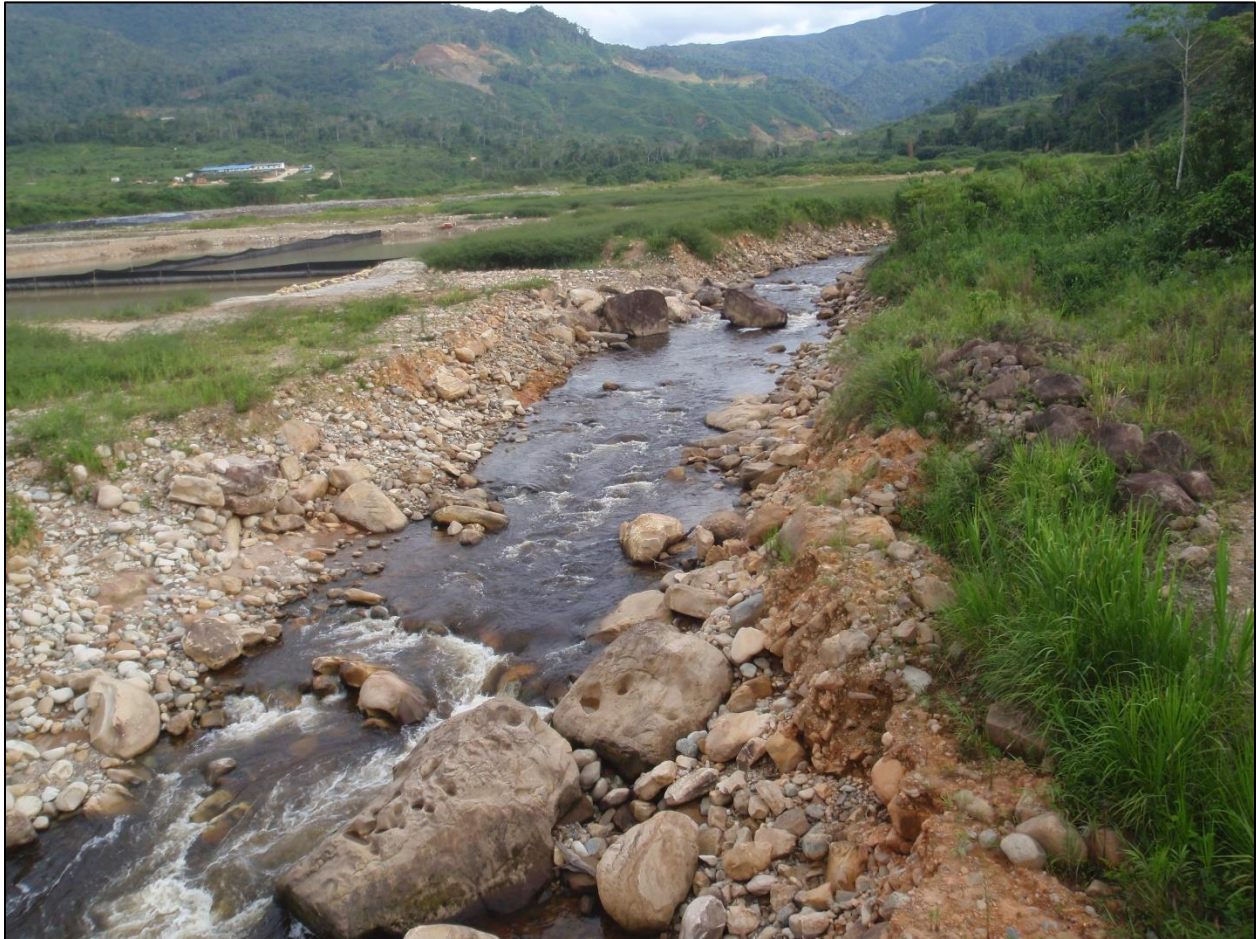
Figure 20. According to a complaint by the provincial government of Zamora Chinchipe (Quishpe Lozano et al., 2018), “Here the extraction of rock material was carried out in a portion of the Rio Tundayme [shown above]. As in the Rio Quimi and the Rio Waywayme [see Figs. 2 and 11], the extraction of rock material in this area is not carried out within any mining concession for the exploitation of aggregates and rock...It should be noted that in the review conducted for the National Mining Registry, mining titles are not registered for the exploitation of rock material within the Mirador project in the aforementioned area.” A possible explanation for the illegal extraction of construction material from rivers is the lack of other sources of construction material. A shortage of construction material could also explain the change from centerline construction to upstream construction (see Fig. 16) and the excessively steep embankment of the starter dike (see Fig. 17). Photo taken by the author on November 6, 2018.
