Tree Inventory Report

Central Erin Property Management

2228 Marine Drive
Oakville, ON
L6L 1C1

August 11, 2022

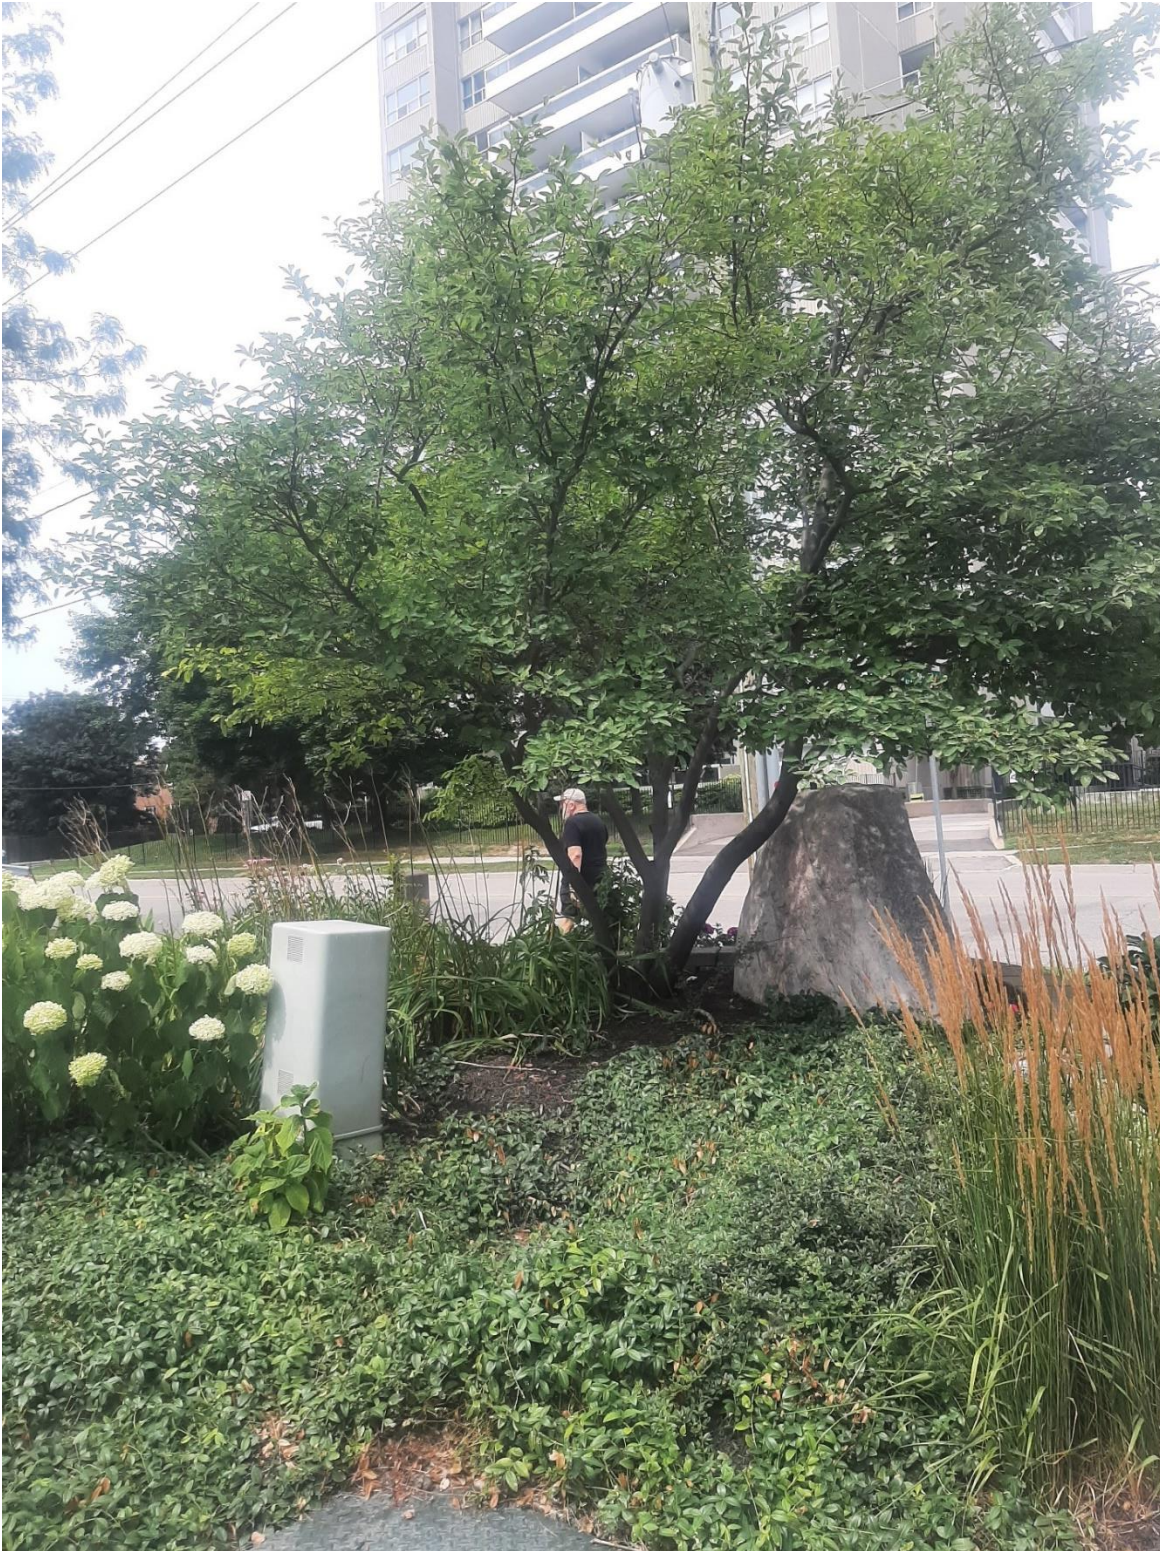
Tree #401

- Powdery mildew was found on the leaves of Tree #401, a Serviceberry. This is mostly cosmetic and caused by overly moist conditions, likely due to frequent watering of garden beds.

- Tree #401: Recommended the client selectively prune overcrowded areas to increase air circulation around tree this helps to reduce relative humidity. Watering away from the basal area of tree can help.
- Trees #404, 405 and 406: Recommended to apply fertilizer and monitor for increased dieback, pruning dead branches..
- Trees# 419,449,457, 458 and 459: Check cable tension and equipment condition, monitor for any new structural defects
- Tree #432: Recommend to prune and remove smaller leader which exhibits dieback
- Tree#433: Crown clean to remove deadwood, monitor condition for decline in health, raise mower height when mowing around root system to prevent further damage.
- Tree#448: Monitor tree for any increase in lean.
- Tree#464: Add fertilizer and mulch, increase waterings in summer.
- Tree#413: Recommend pruning for clearance over the sidewalk.

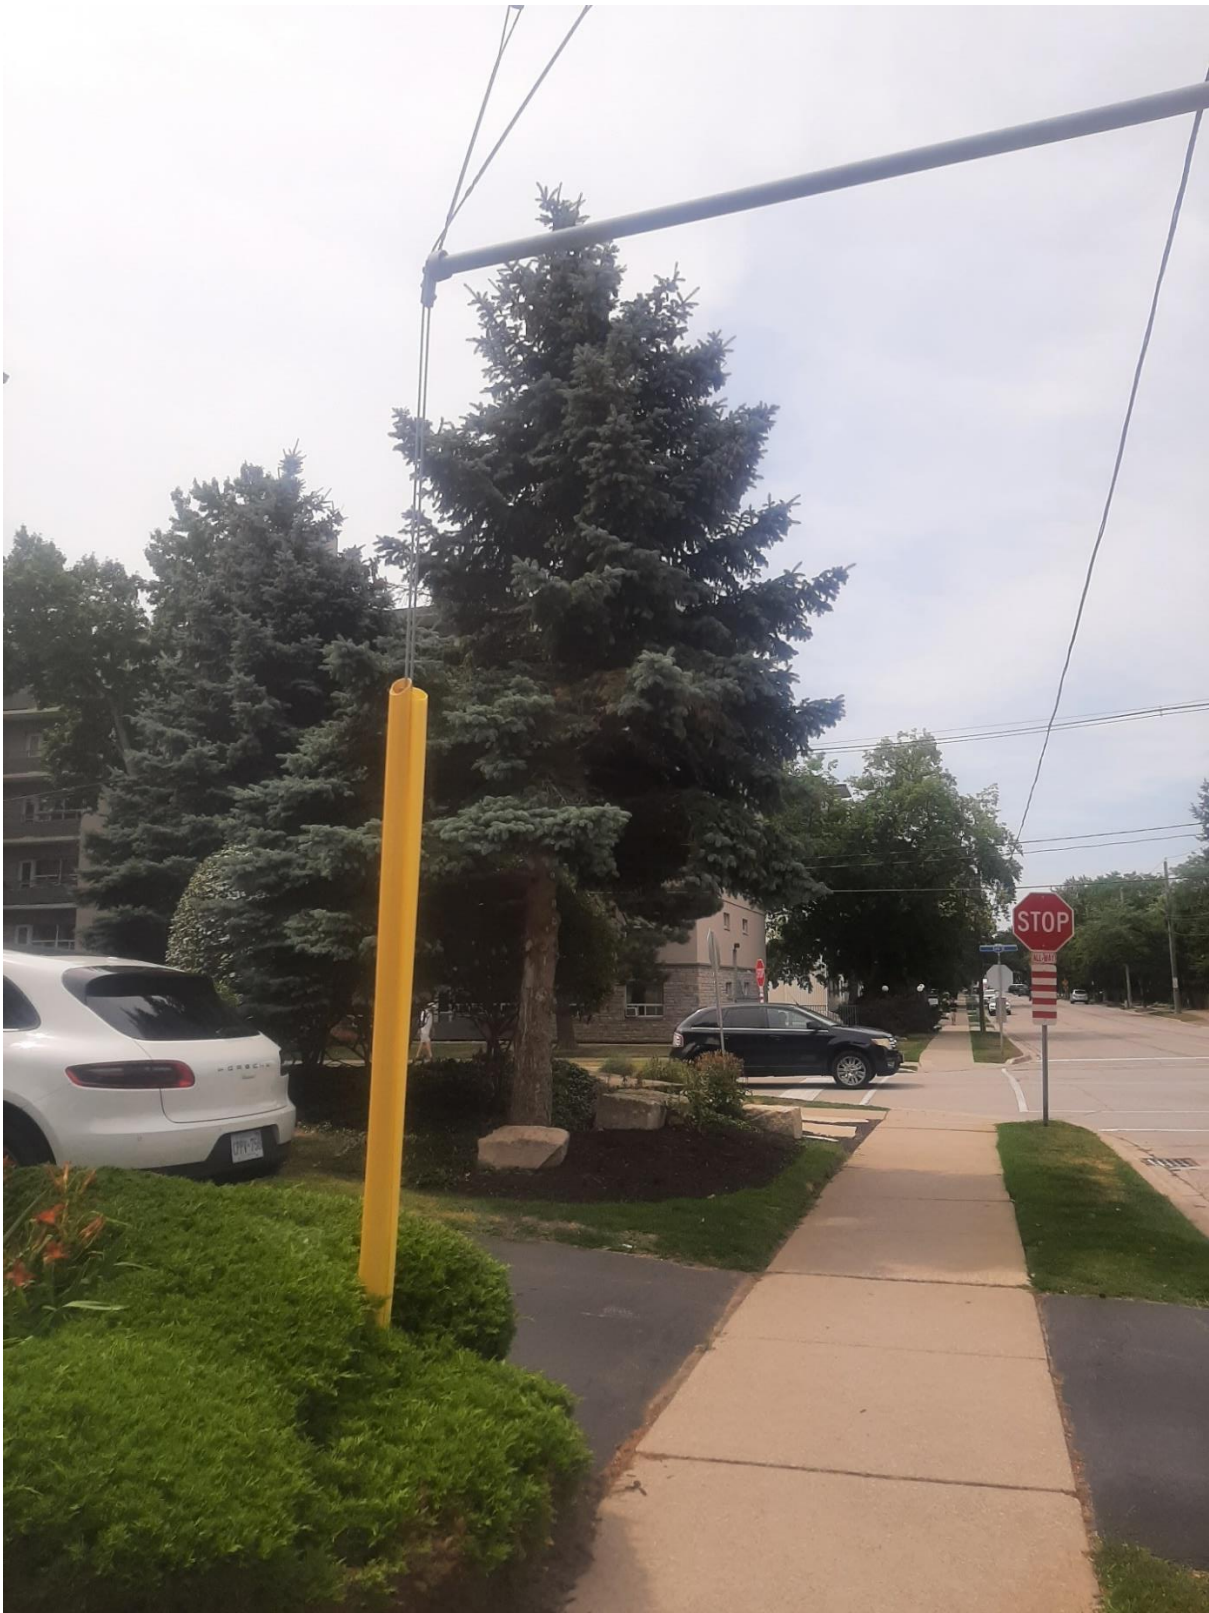
Trees #404, 405

- Trees #404, 405, and 406, Blue spruces, are affected by Cytospora canker. This disease has no direct treatment, but the health of the tree can be prolonged through application of fertilizer.

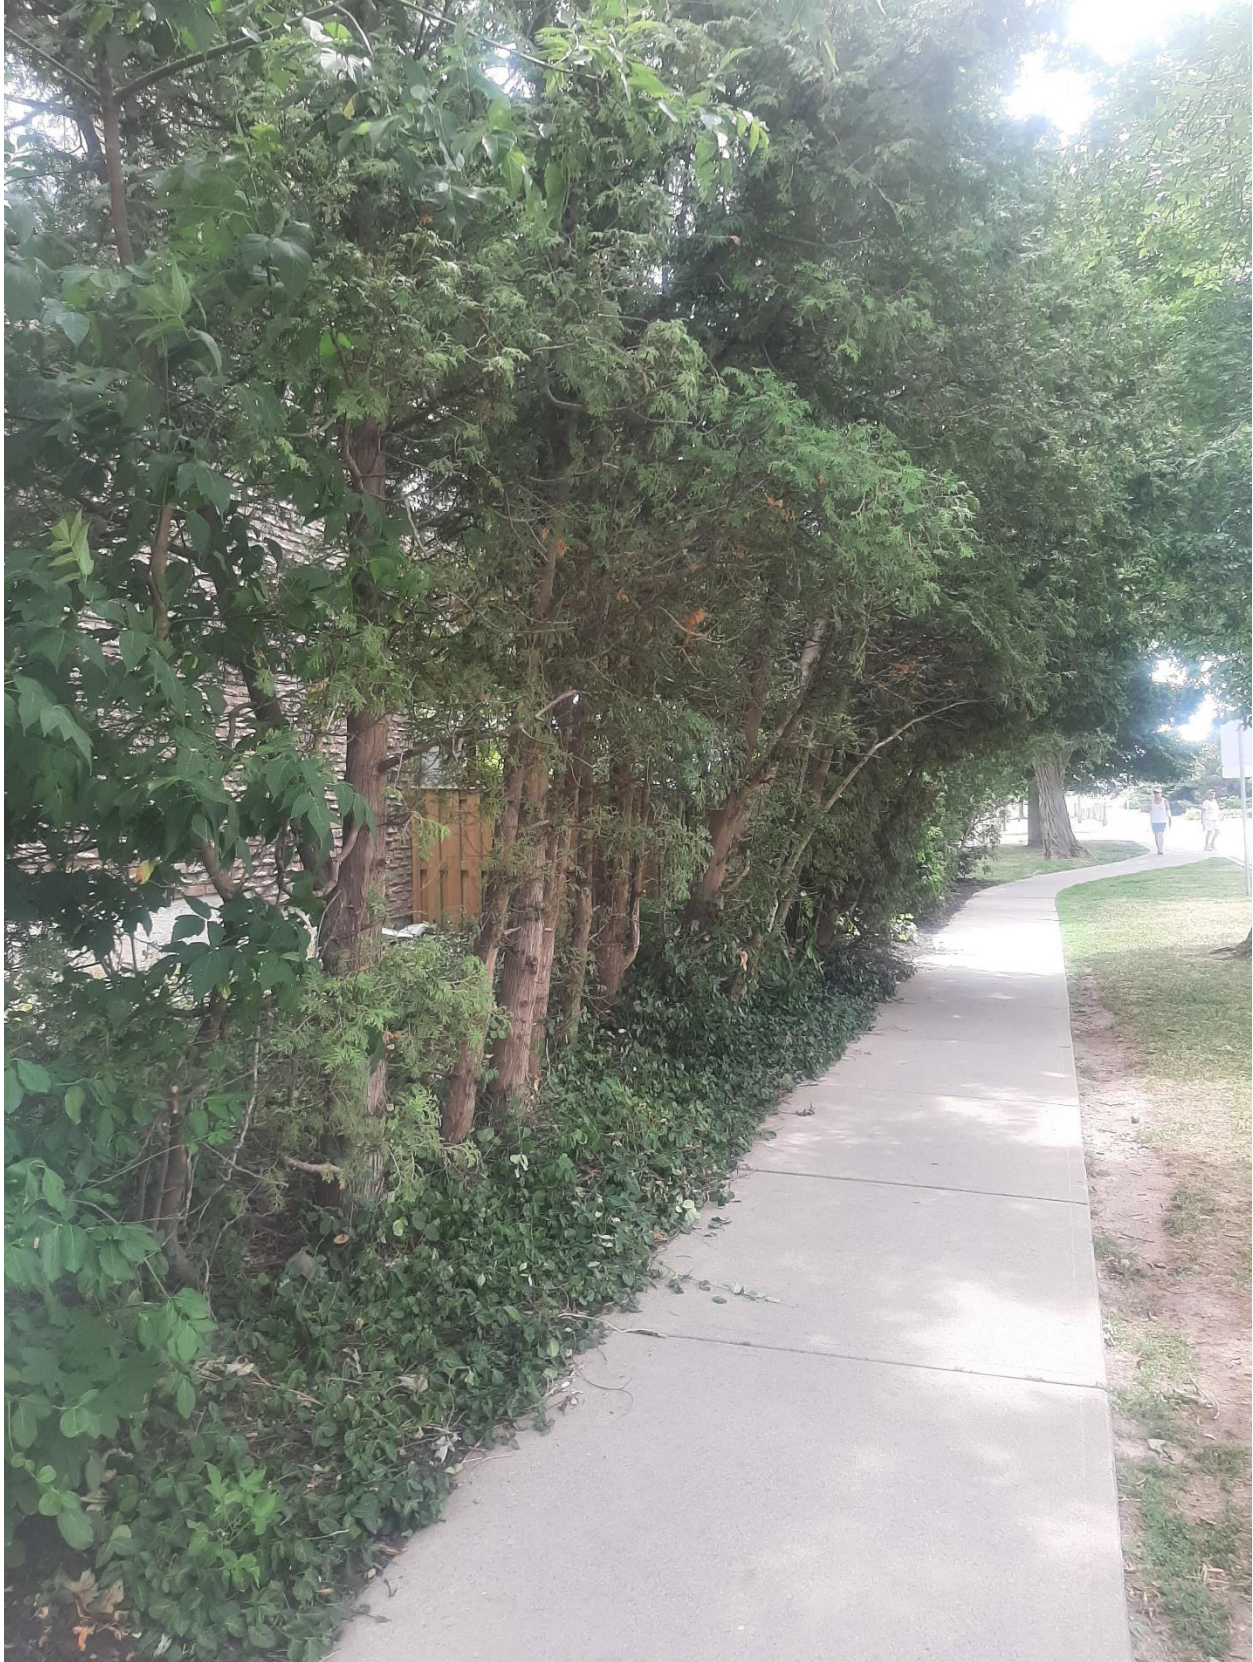
Tree #413

- Tree#413 is a hedge row made up of white cedar which have started out growing their rooting space, this will require pruning for clearance away from the sidewalk.

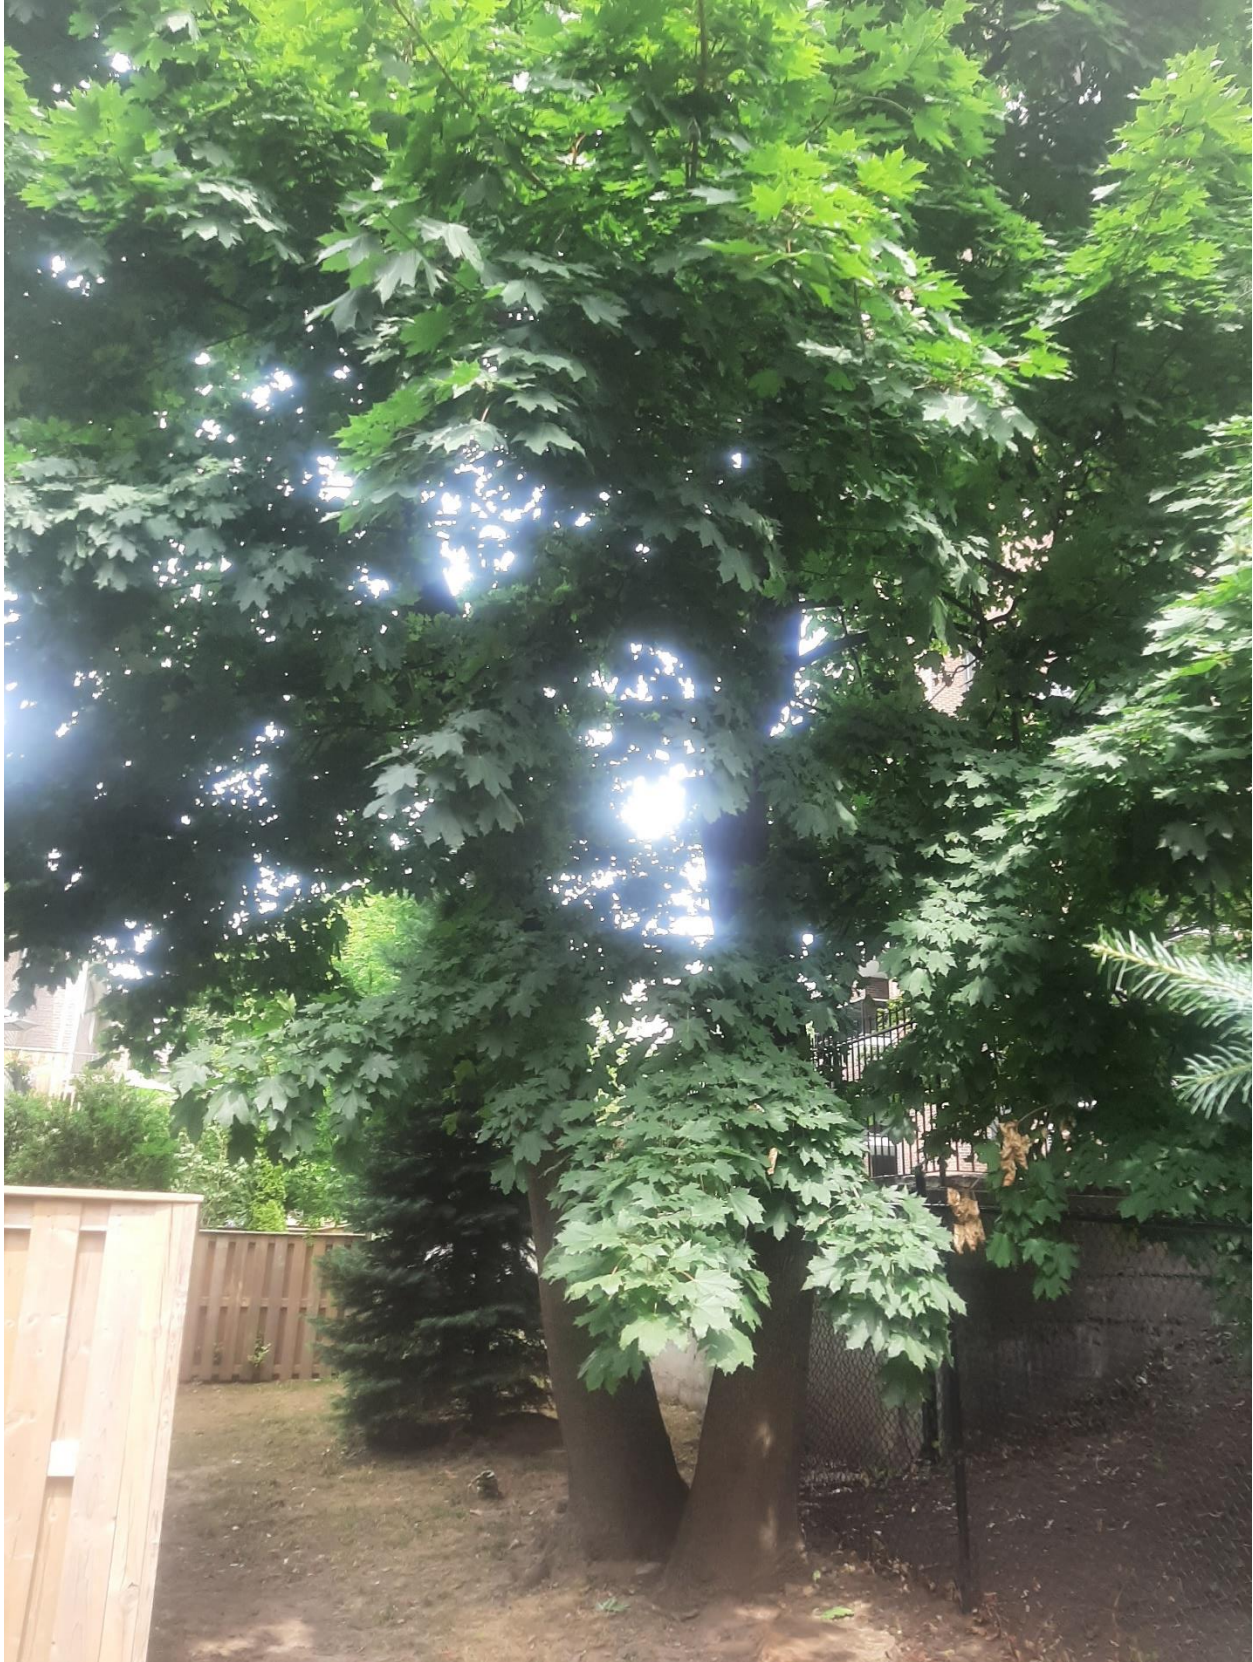
Trees #419, 420

- Trees #419, 449, 457, 458 and 459 have upper limbs supported by cables and it is recommended to check the cables for tension and condition of the equipment.

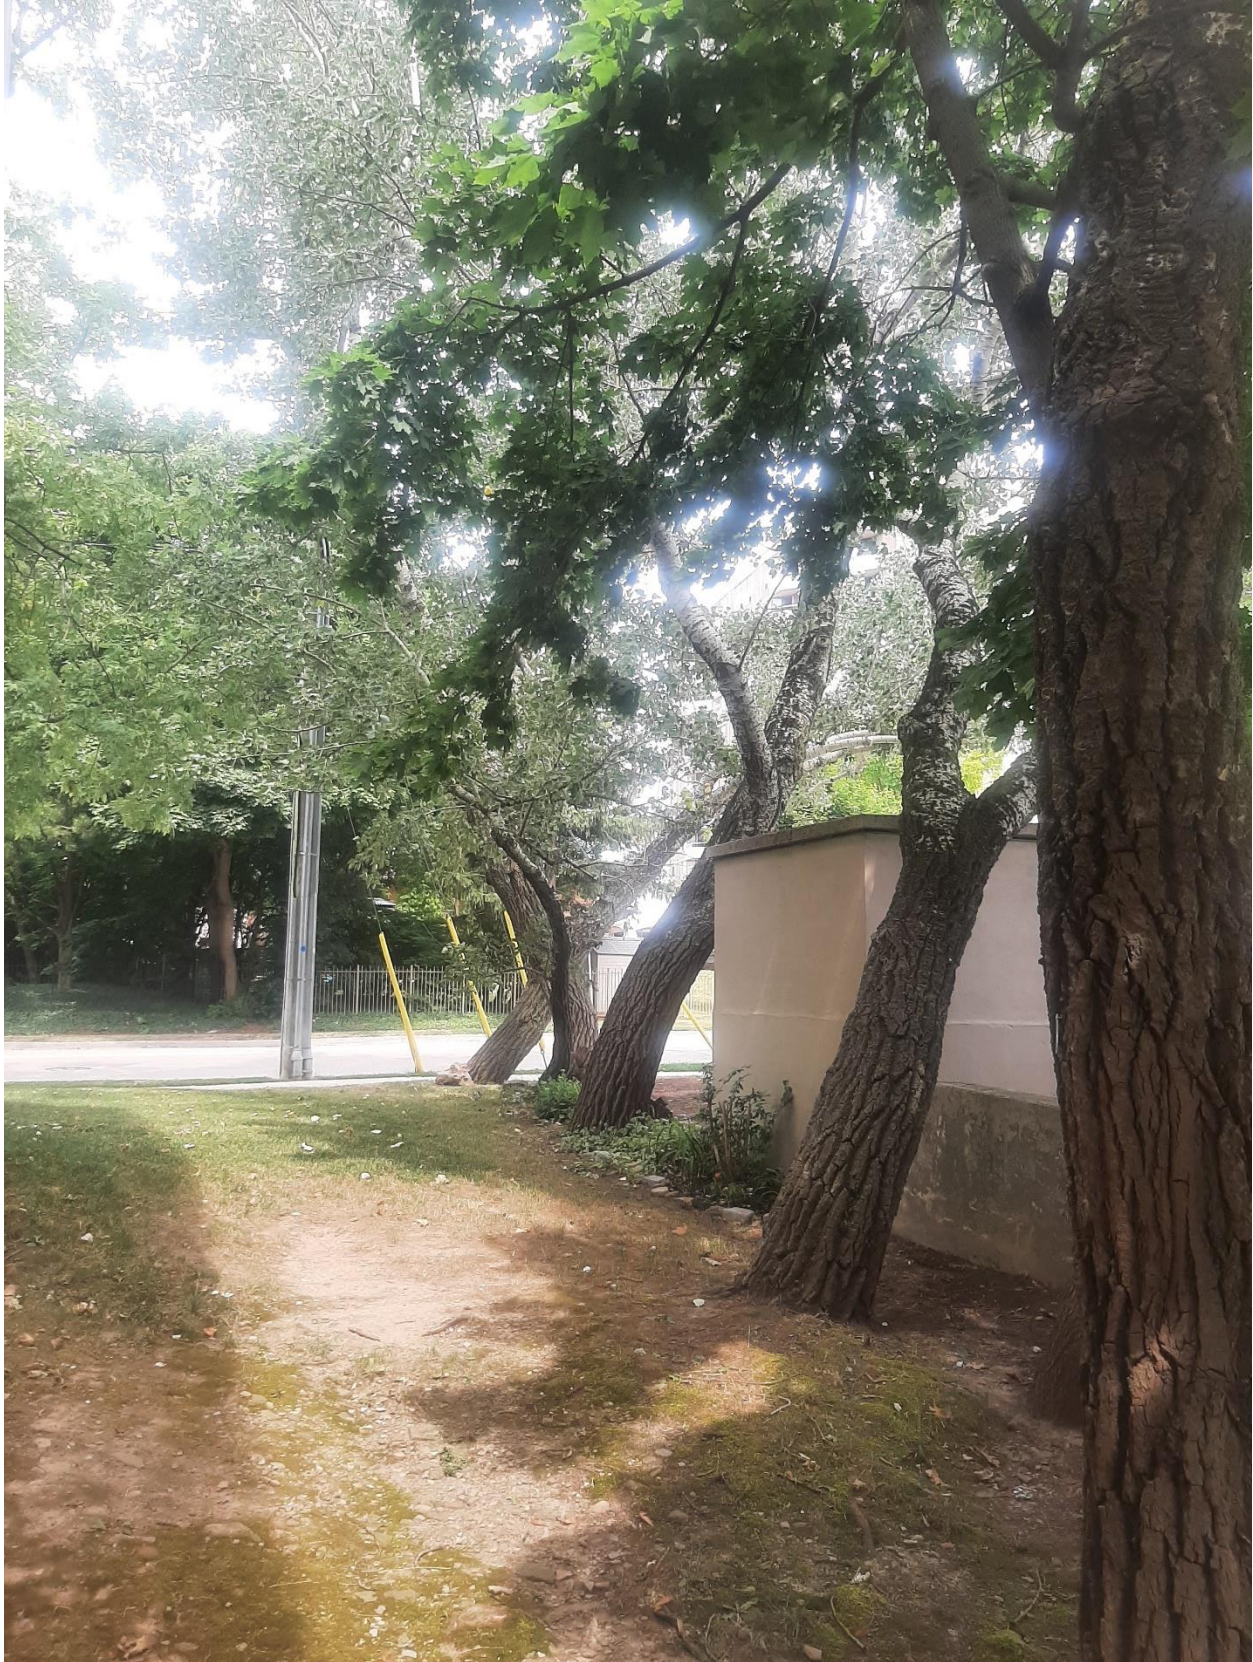
Trees #430-432

- Tree #432, white poplar, has two main stems (44 and 17 cm). The smaller leader exhibits significant dieback and is recommended to be removed.
- Tree #433, silver maple, has roots showing significant damage due to continued lawn mower impact which has resulted in some crown dieback. It is recommended that the crown be cleaned of deadwood and monitored, and extra care is taken when mowing over its roots.

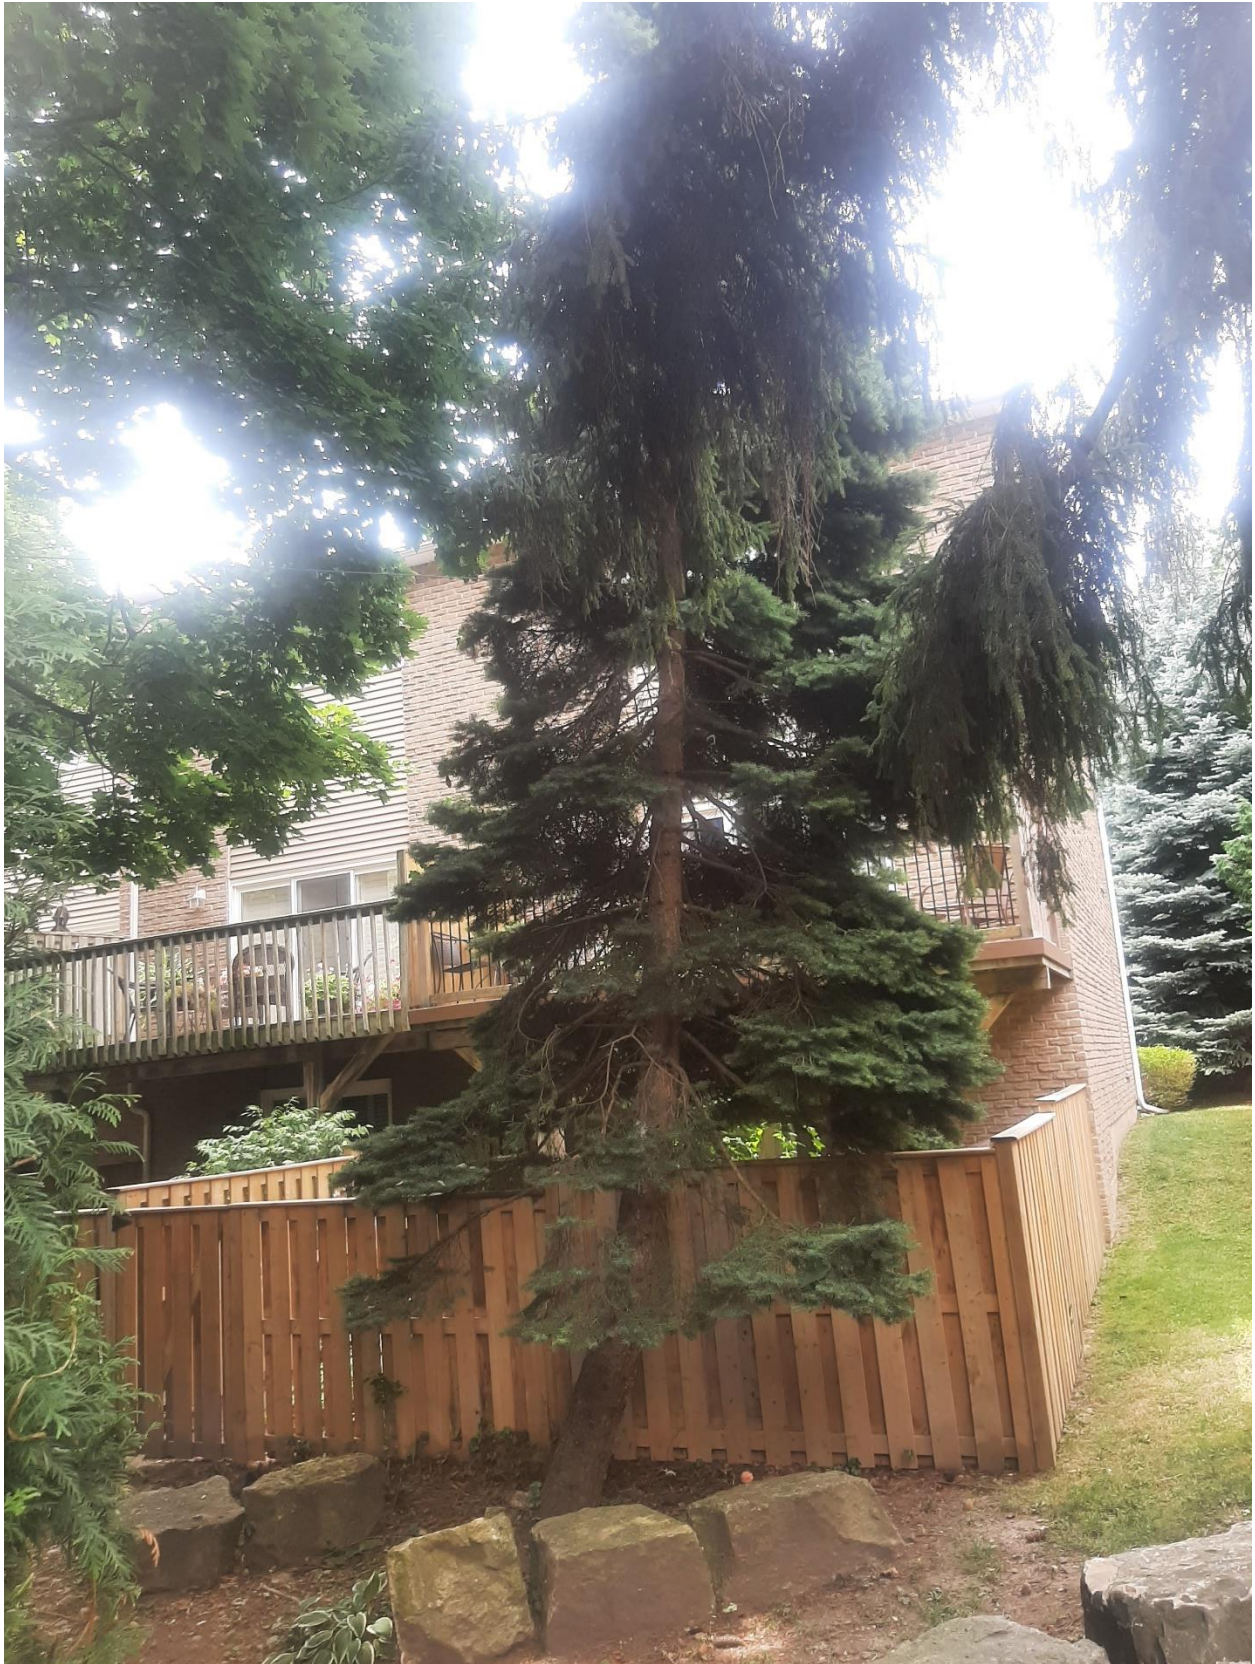
Tree #448

- Tree #448, Austrian pine, is leaning and has an unbalanced crown. The tree is in good condition, so it is recommended to be monitored for any increase in lean.

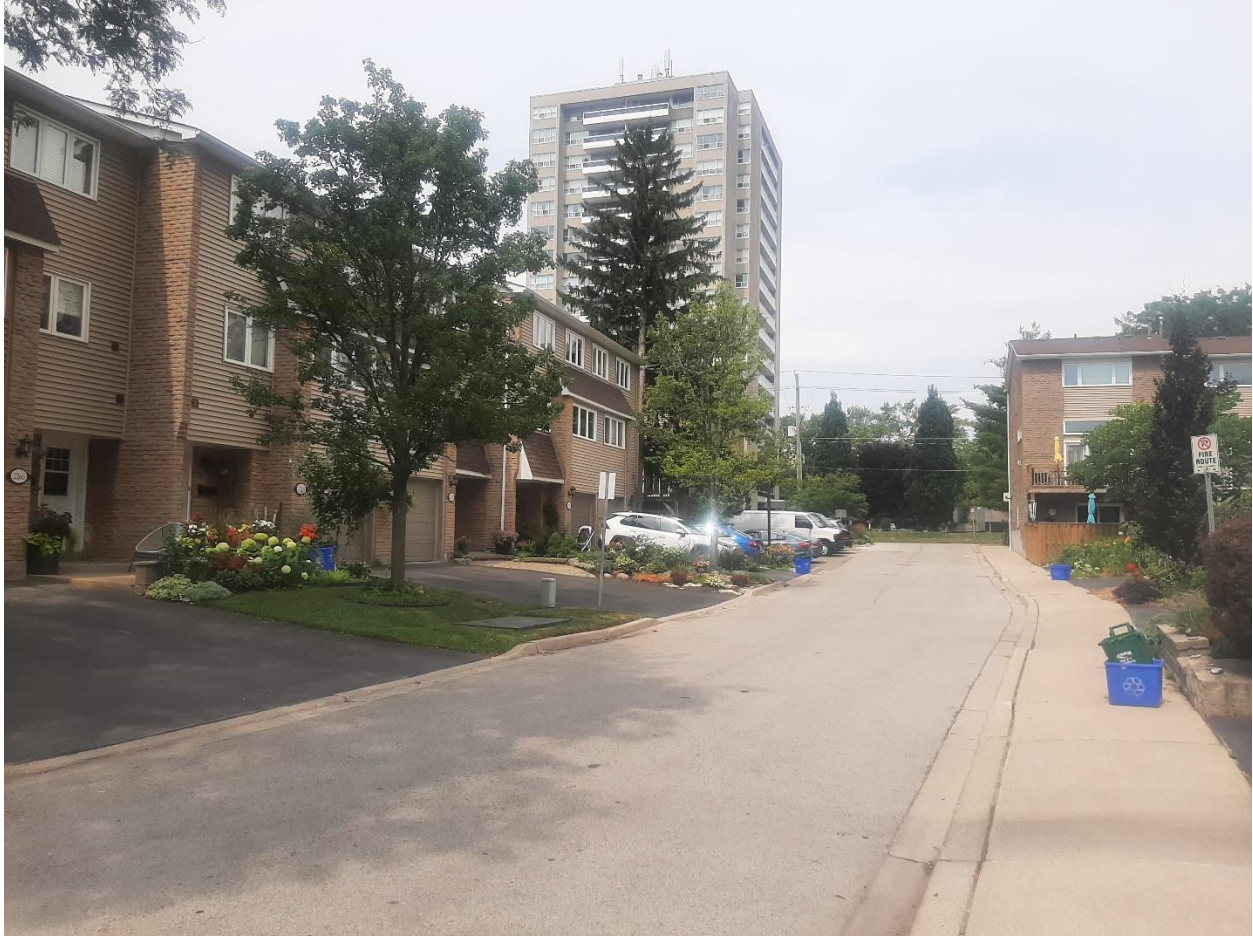
Trees #463-467

- Tree #464, Flowering pear, has nutrient deficiency and it is recommended to add fertilizer and mulch.
