Architectural
Resources Group

Architecture
Planning
Conservation

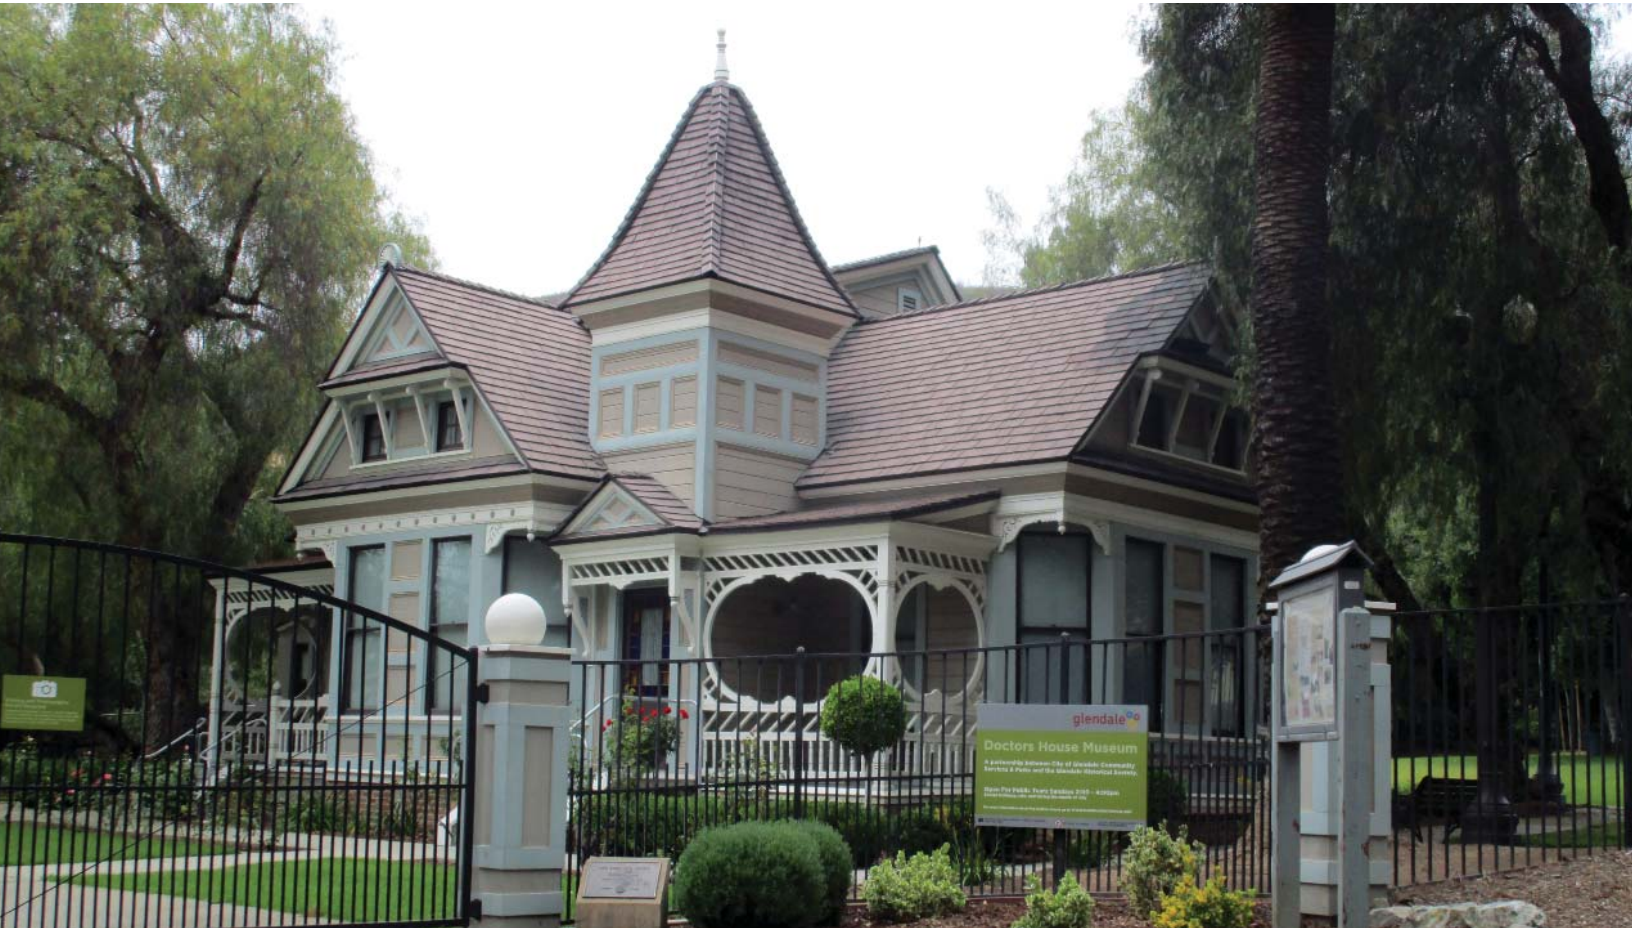
Doctors House Museum & Gazebo Conditions Assessment Report

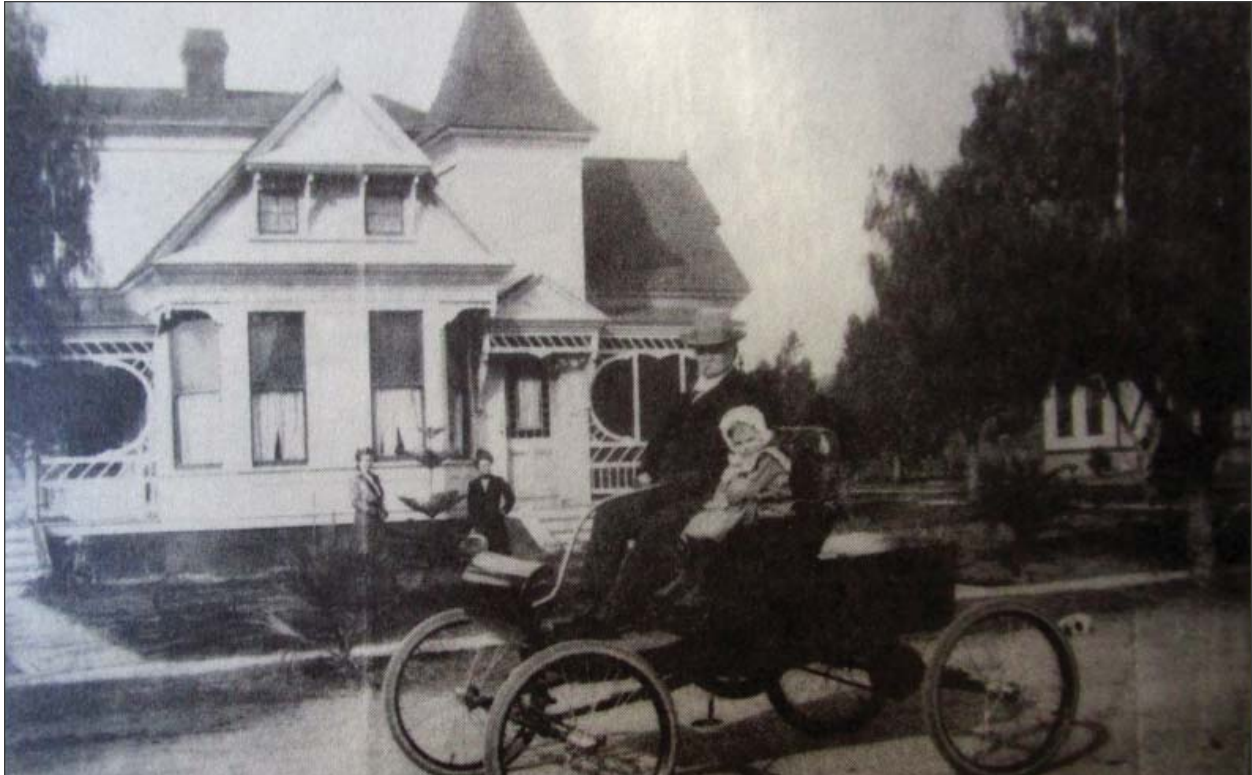
Doctors House, circa 1901 (courtesy The Glendale Historical Society)

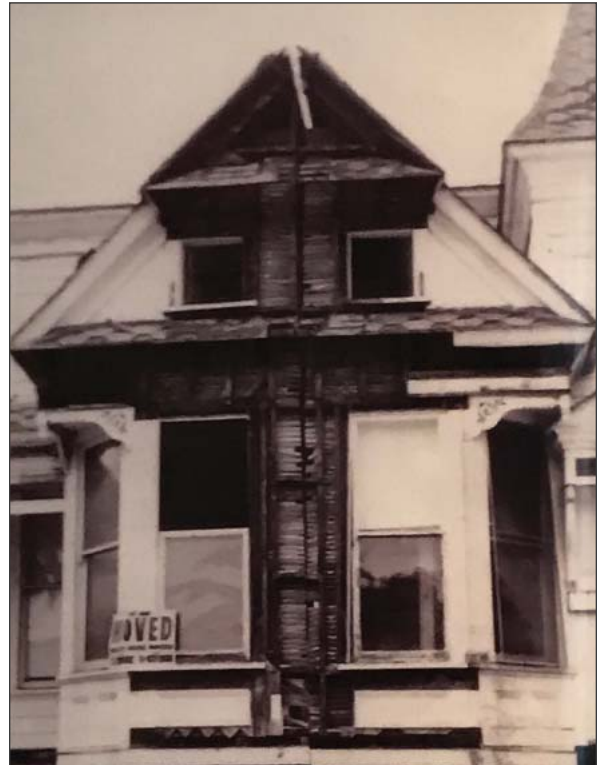
Doctors House, circa 1980, showing the house split into two section for relocation (courtesy The Glendale Historical Society)

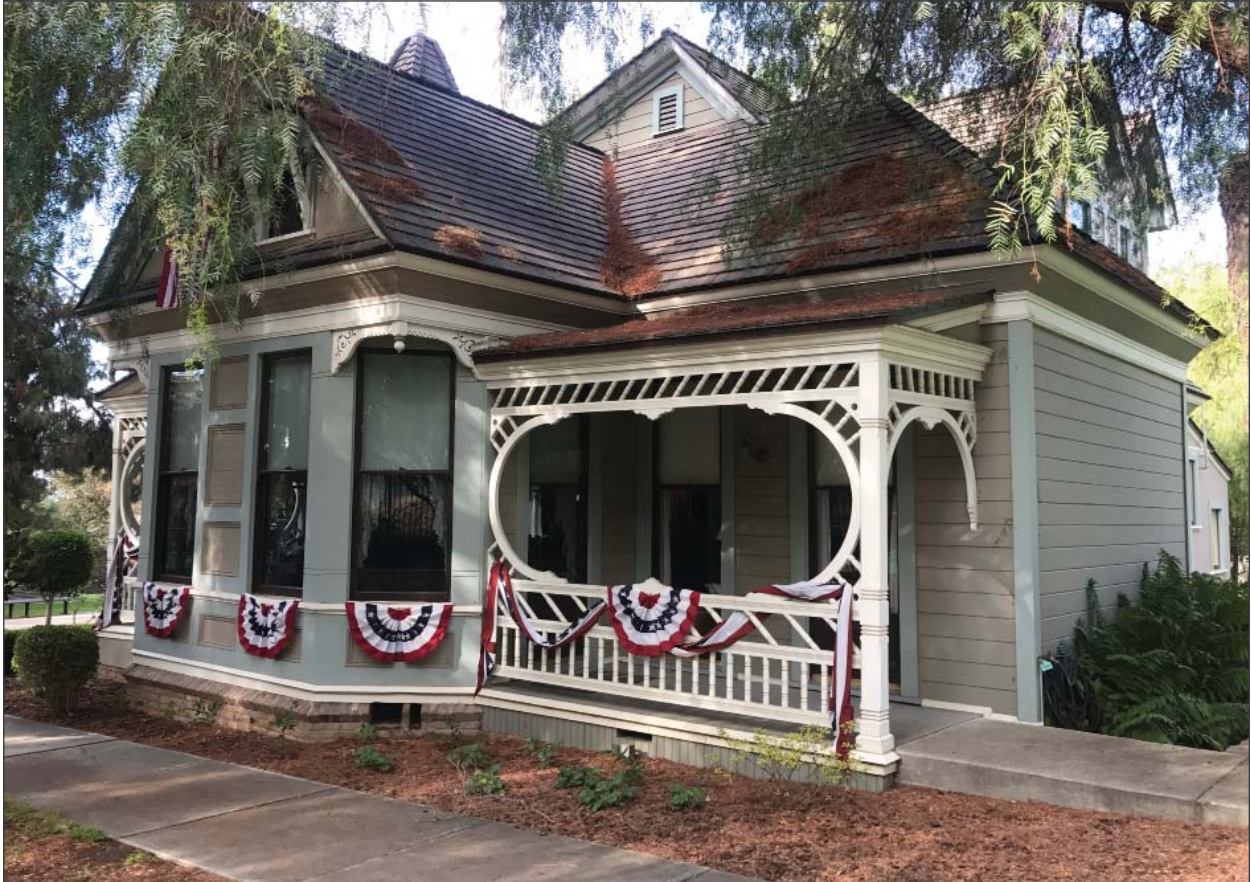
Doctors House Museum (ARG, 2016)

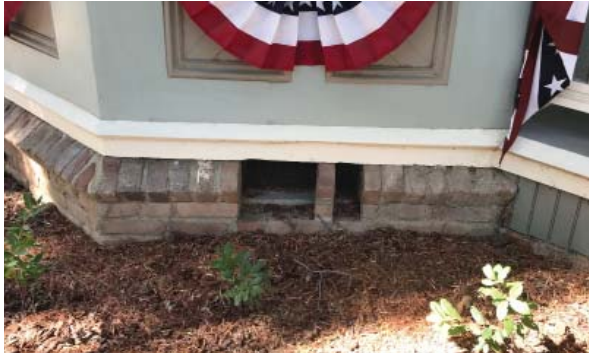
Typical brick foundation and crawl space vents. (ARG, 2016)

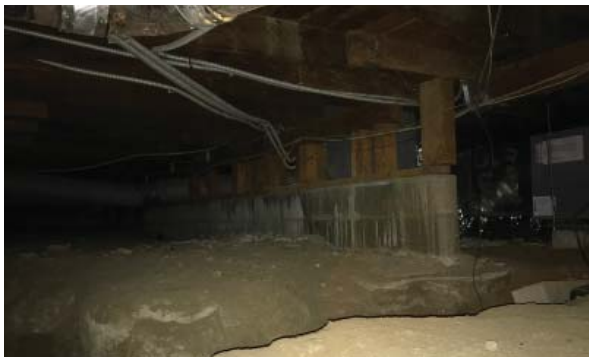
Crawl space and concrete stem wall foundations. Note water staining at stem wall. (ARG, 2016)

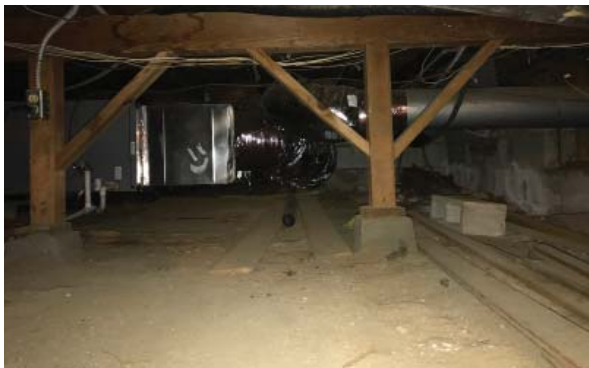
Crawl space and concrete pier footings. Note misc. lumber at grade. (ARG, 2016)

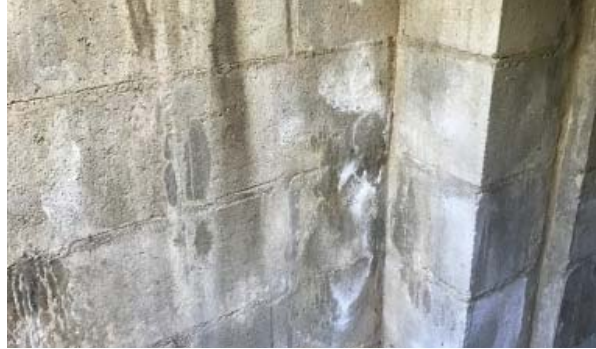
Efflorescence and staining at CMU walls of basement stair. (ARG, 2016)

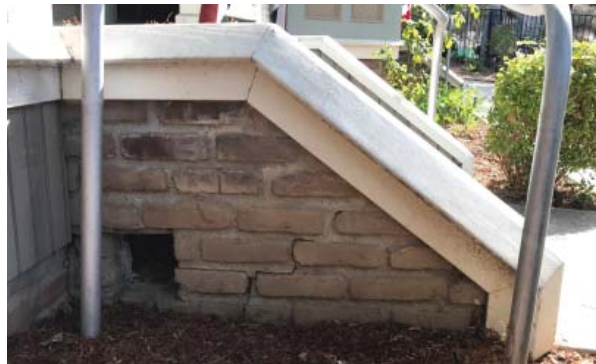
Cracking through mortar joints at brick stair wall, south elevation. (ARG, 2016)

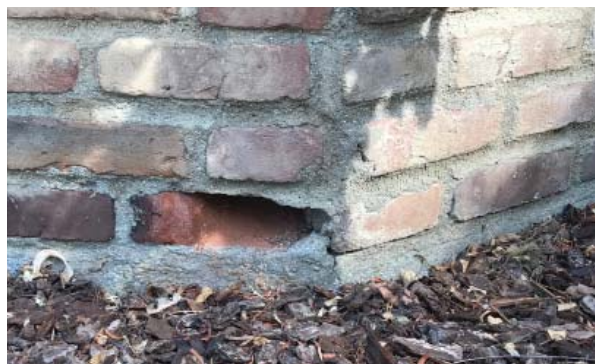
Eroded brick unit at foundation wall, south elevation. (ARG, 2016)

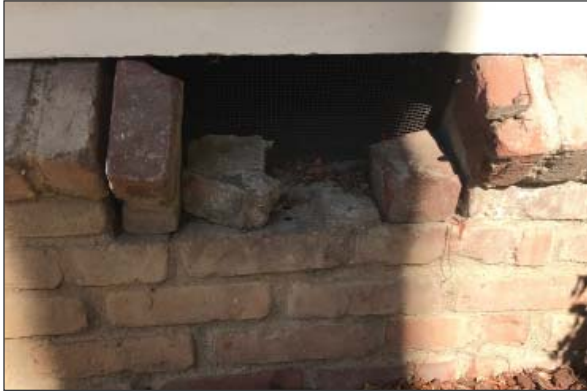
Loose brick units at crawl space vent, south elevation. (ARG, 2016)

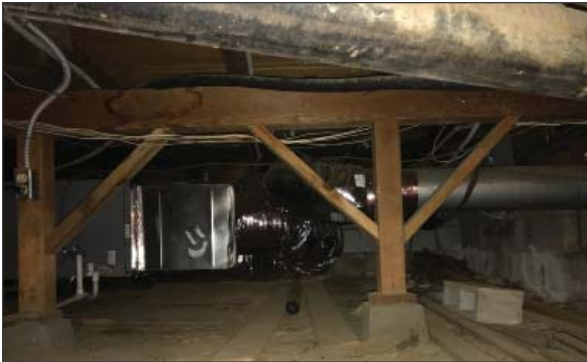
Structural floor framing at crawl space. (ARG, 2016)

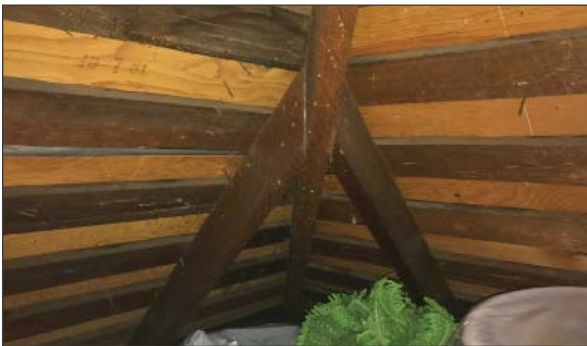
Structural roof framing at attic storage area. Also note spaced roof sheathing boards and plywood sheathing overlay. (ARG, 2016)

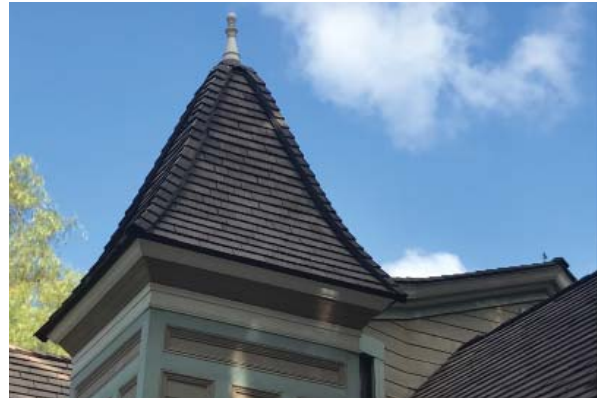
Concrete roof tiles at tower. (ARG, 2016)

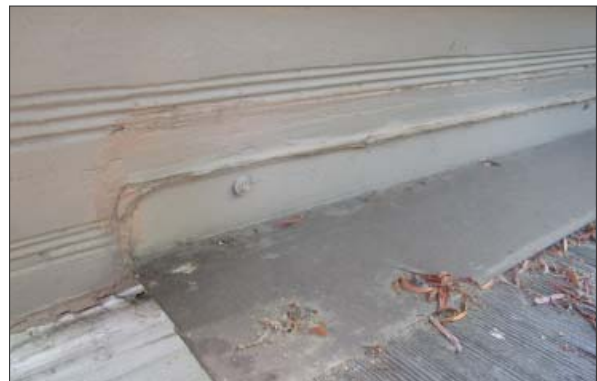
Typical painted sheet metal wall flashing. Note screw fasteners and sealant joint. (ARG, 2016)

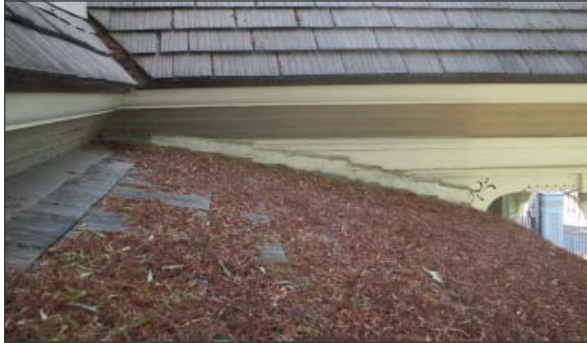
Heavy debris accumulation at southwest porch. (ARG, 2016)

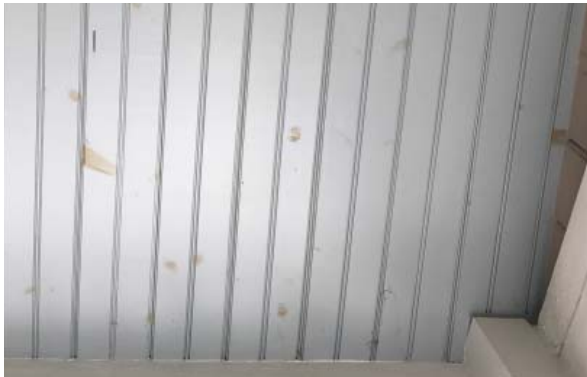
Stains at southwest porch ceiling. (ARG, 2016)

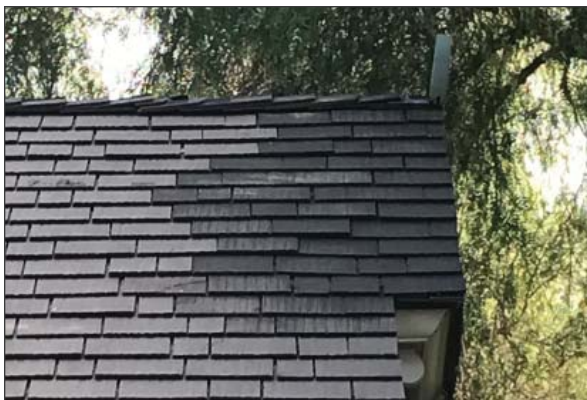
Darker colored tile at east gable end. (ARG, 2016)

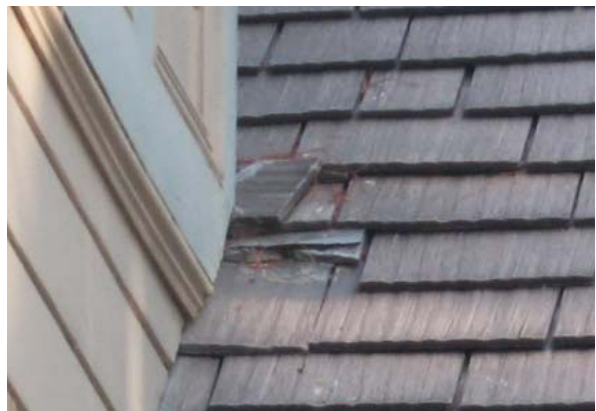
Cracked and loose tiles at south elevation adjacent to tower. (ARG, 2016)

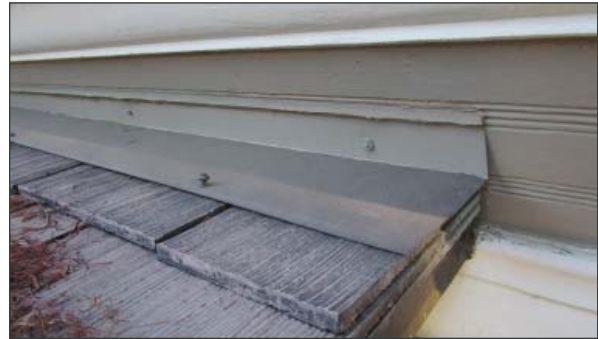
Loose screw fasteners at metal flashing. (ARG, 2016)

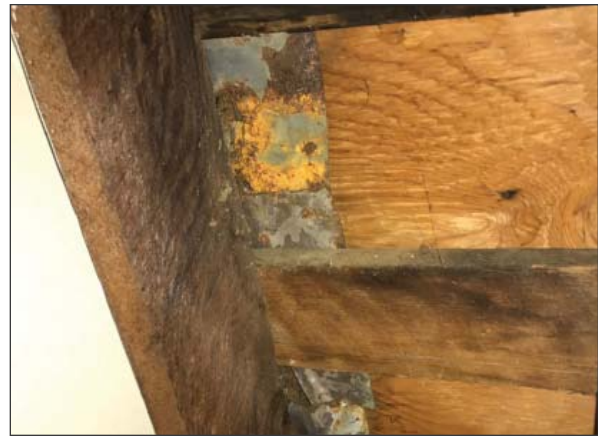
Corroded sheet metal flashing, visible from attic storage area. (ARG, 2016)

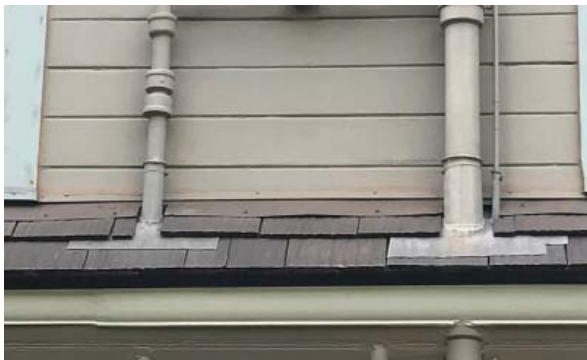
Sheet metal flashing at dormers. Note sealant at wood siding, evidence of prior flashing installation. (ARG, 2016)

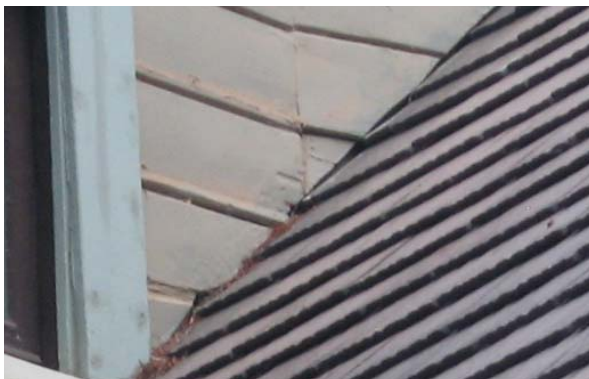
Wood decay and splits at base of shingles near roof surface. (ARG, 2016)

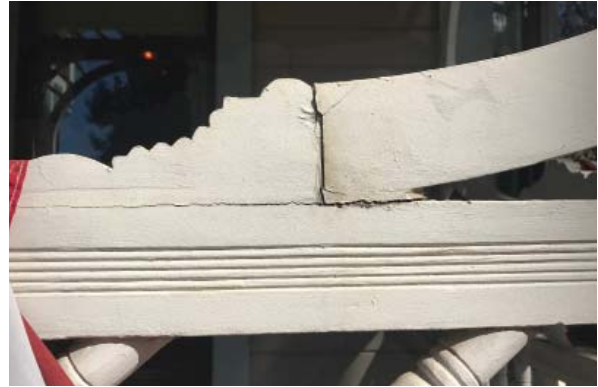
Wood decay and separations at porch trim. (ARG, 2016)

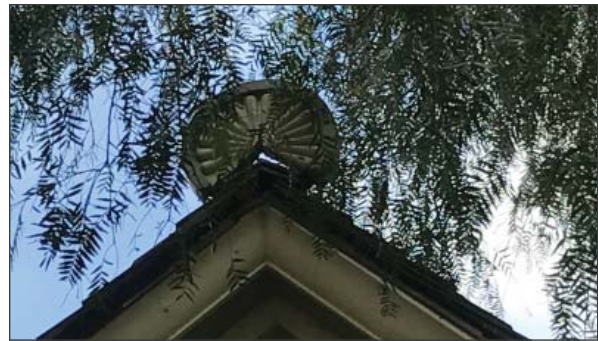
Wood decay and ill-fitting, possibly loose, spoked wheel trim at east gable. (ARG, 2016)

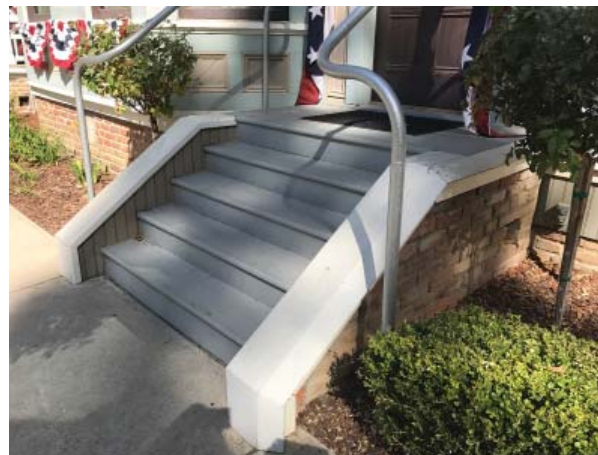
Steps and pipe handrails at main entrance porch. (ARG, 2016)

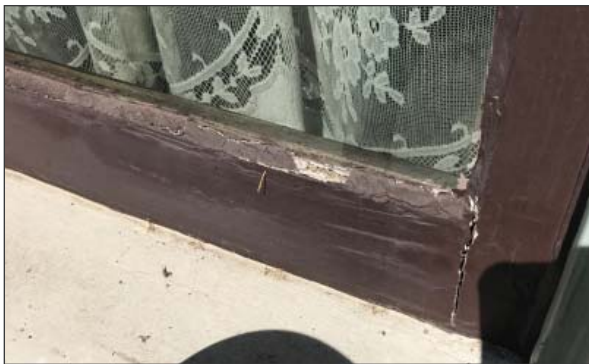
Deteriorated putty and separation in sash at south elevation bay windows. (ARG, 2016)

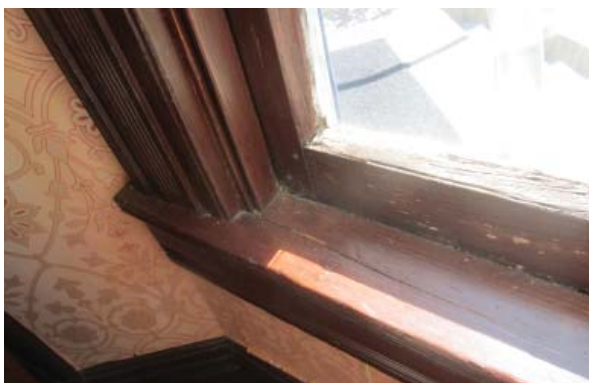
Large split at interior window sill, south elevation bay window. Also note dry/desiccated wood sash and stain loss. (ARG, 2016)

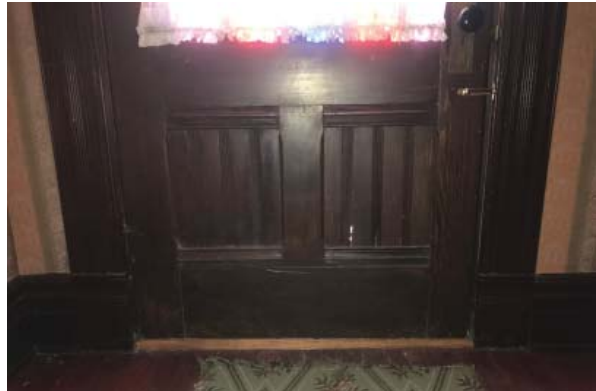
Daylight seen through separations in recessed bead board panels at front door. (ARG, 2016)

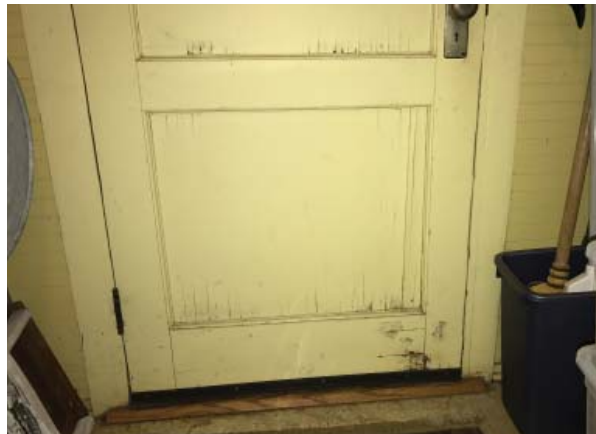
Multiple splits and wood decay at door to west enclosed porch. (ARG, 2016)

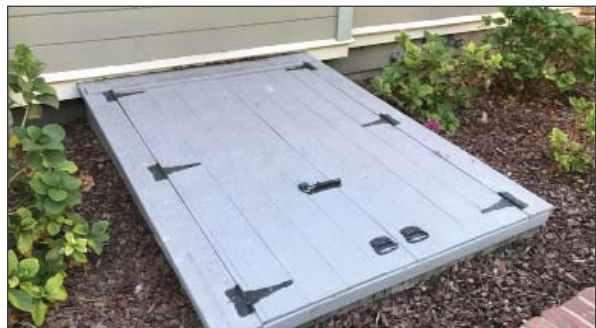
Basement access door. (ARG, 2016)

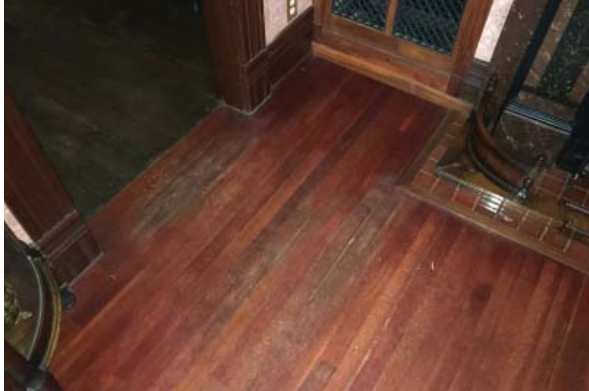
Burgundy-stained fir floor at dining room, and green-stained pine floor at kitchen beyond (top left). Also note abrasion/wear from foot traffic. (ARG, 2016)

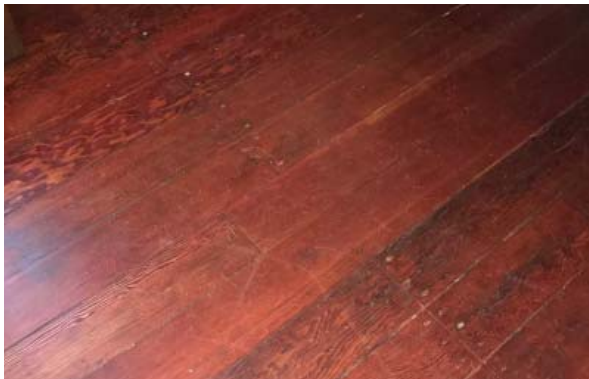
Line of copper nails at floor in guest bedroom indicating where the house was divided for relocation. (ARG, 2016)

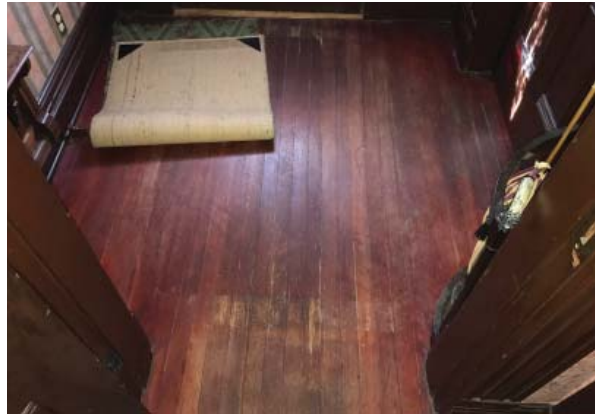
Abrasion/ wear of stained finish at entry vestibule floor. (ARG, 2016)

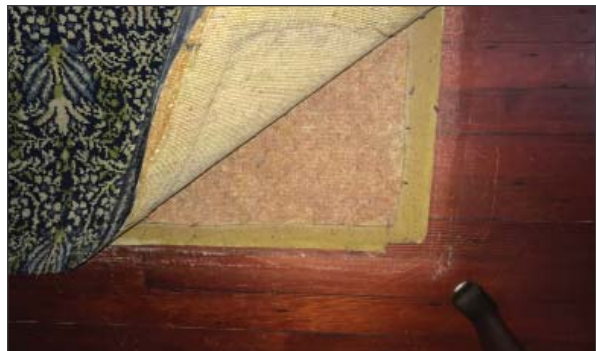
Carpet pad affixed to parlor floor with unknown adhesive. (ARG, 2016)

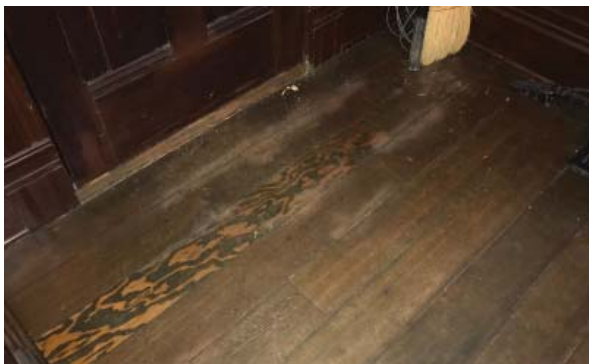
Abrasion/ wear of stained finish at kitchen entrance. Also note prior repair with mismatched wood. (ARG, 2016)

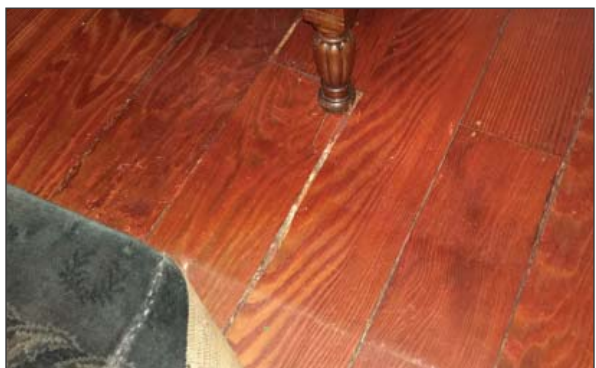
Split at floor board below chest of drawers in master bedroom. Also note stain color difference below carpet. (ARG, 2016)

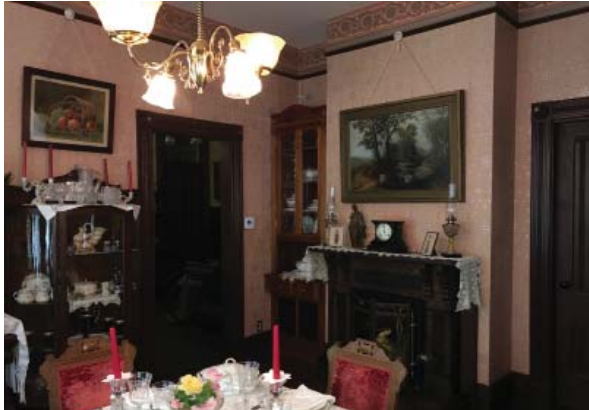
Reproduction wallpaper and border at dining room. (ARG, 2016)

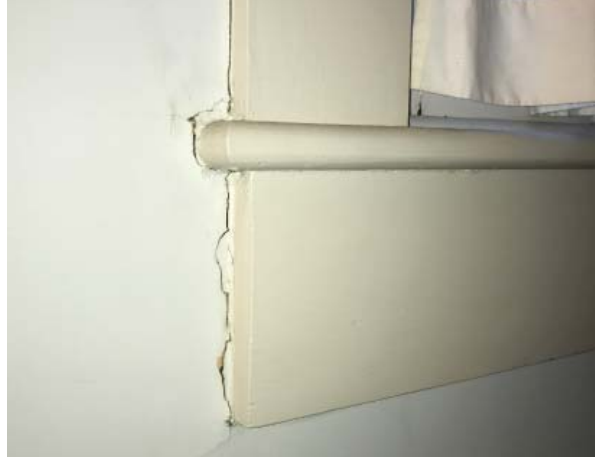
Separations between wall and trim at window casing in child's bedroom, second floor. (ARG, 2016)

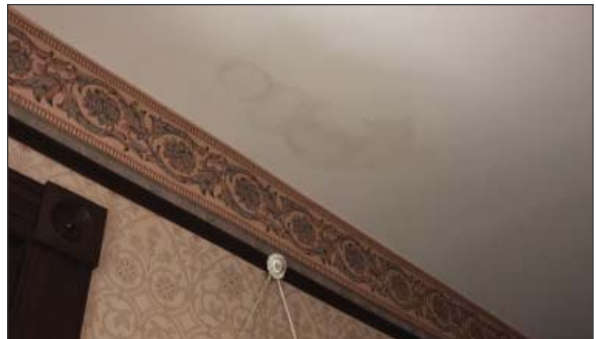
Stains at dining room ceiling from previous leak. (ARG, 2016)

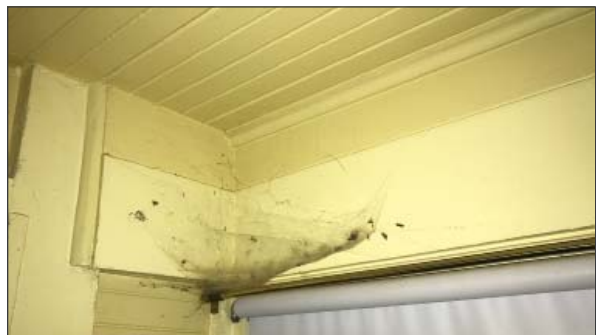
Soiling and cobwebs at utility room entrance. (ARG, 2016)

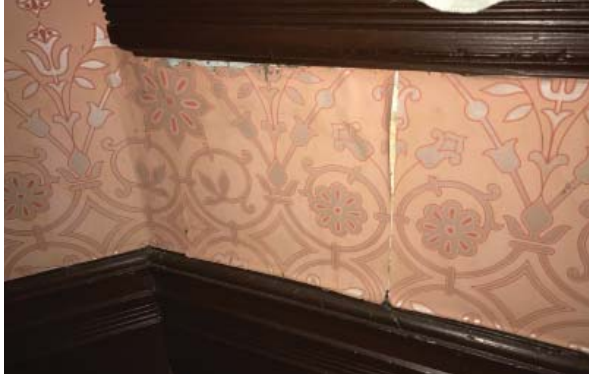
Tears and lifting of seams at dining room wallpaper. (ARG, 2016)

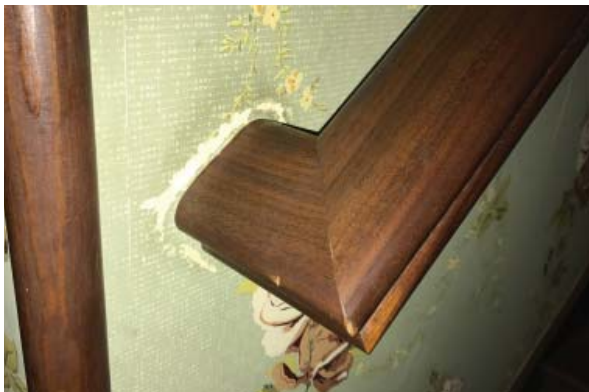
Wallpaper stains and wear/loss at stair handrail. (ARG, 2016)

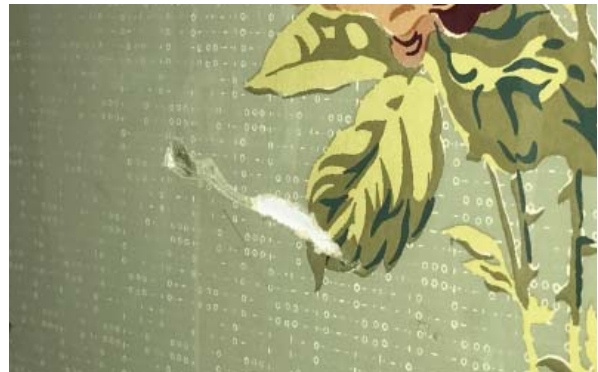
Gouge at stair hall wallpaper. (ARG, 2016)

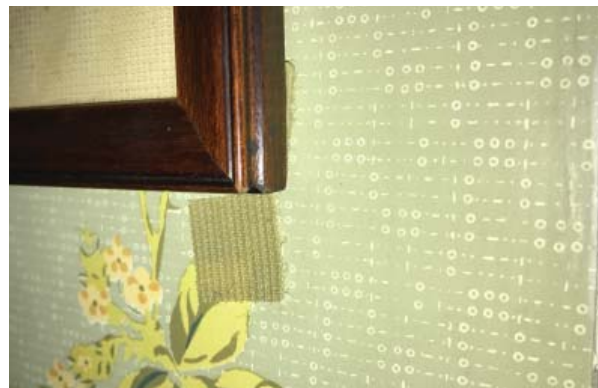
Velcro adhesive at stair hall wallpaper. (ARG, 2016)

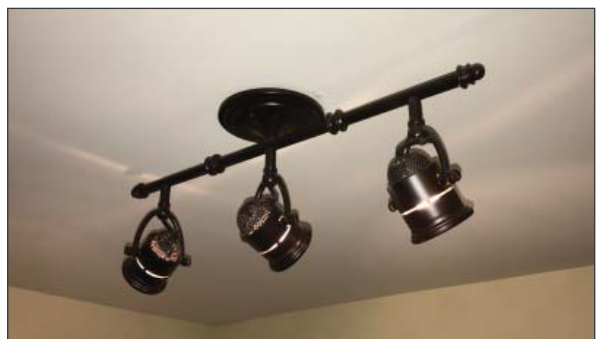
Contemporary lighting for master bedroom exhibit case. (ARG, 2016)

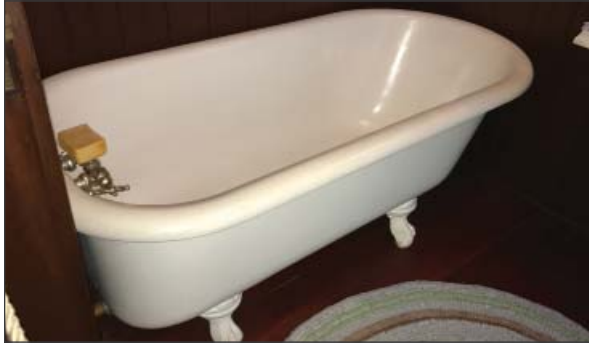
Bathtub at first floor bathroom. (ARG, 2016)

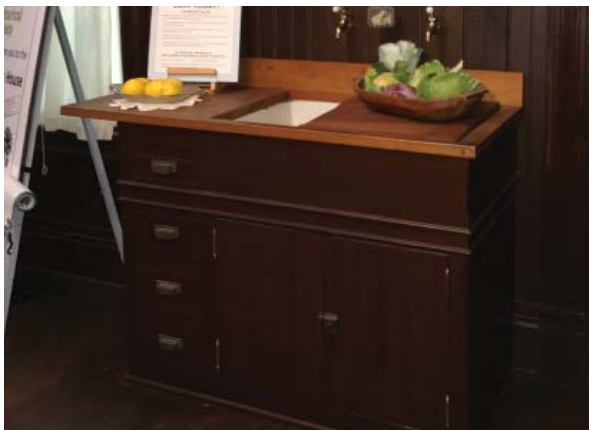
Enameled cast iron kitchen sink, set in reproduction cabinet. (ARG, 2016)

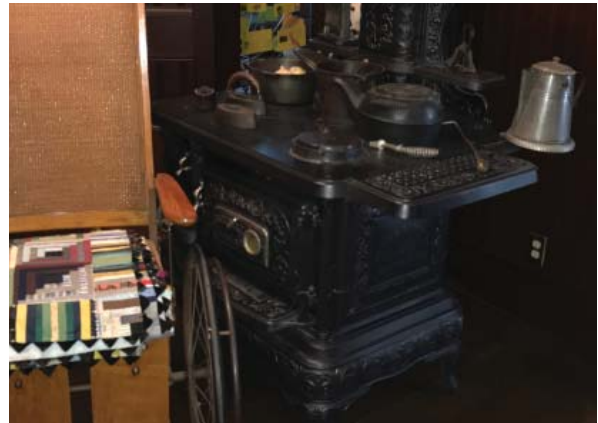
Imperial Clarion cast iron stove. (ARG, 2016)

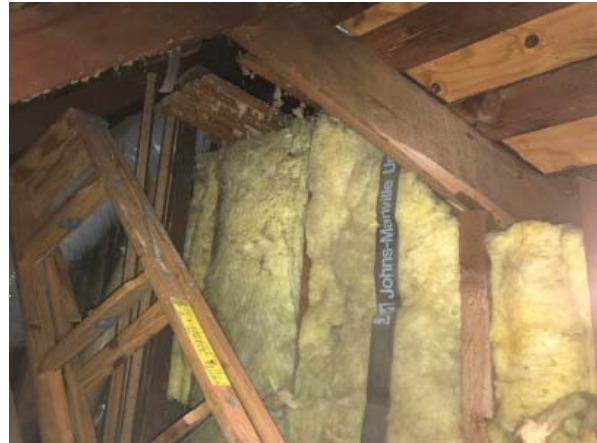
Insulation at attic wall. (ARG, 2016)

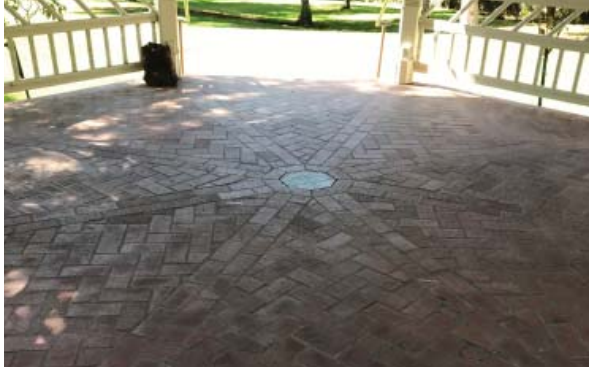
Quarry tile paving and central plaque. (ARG, 2016)

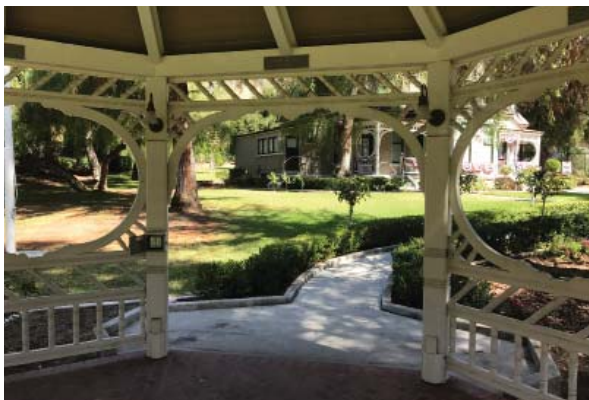
Accessible entrance. Also note wall sconces at columns. (ARG, 2016)

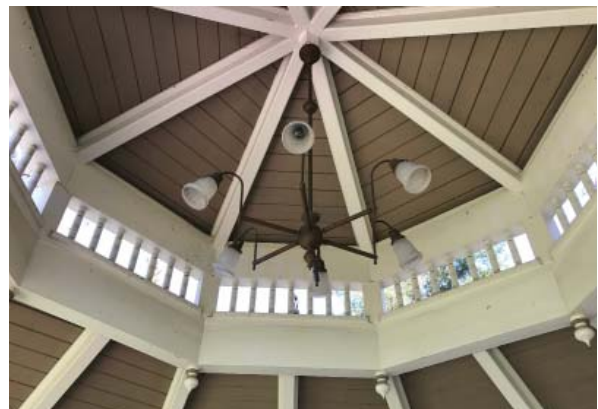
Central chandelier. (ARG, 2016)

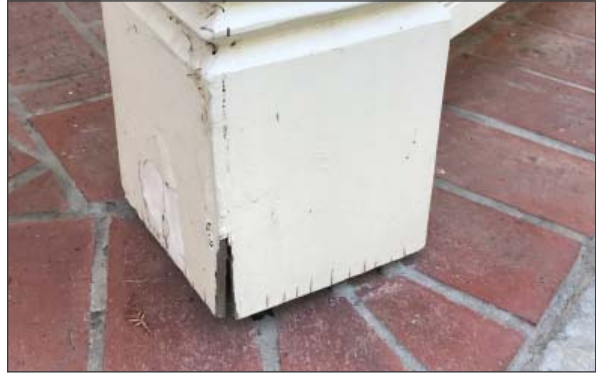
Decay, splitting, and peeling paint at base of column. (ARG, 2016)

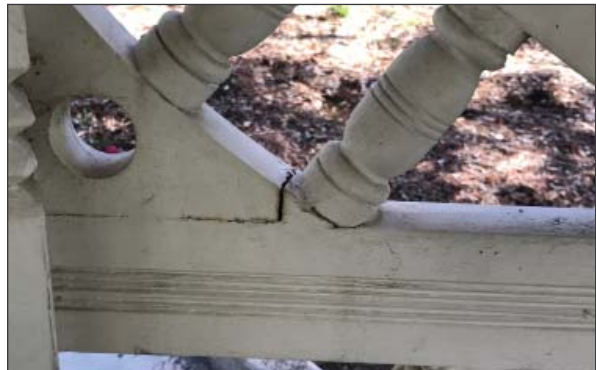
Separations and loose components, soiling and decay at railing. (ARG, 2016)

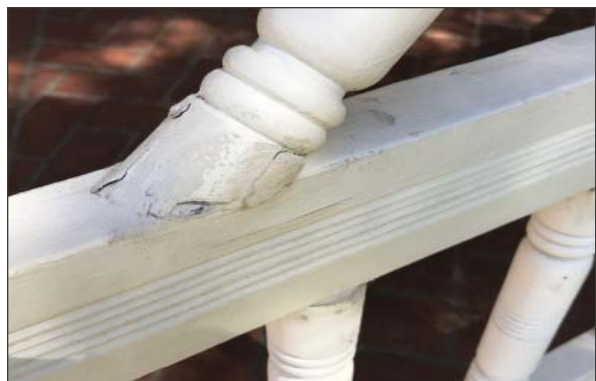
Deteriorated/ spalling prior wood fill repairs. (ARG, 2016)

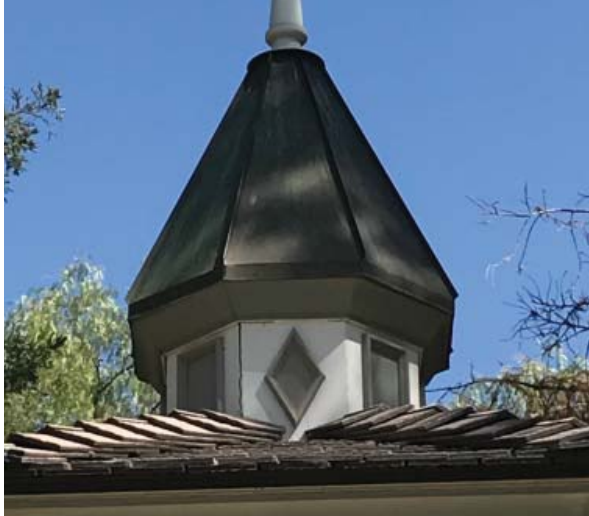
Copper sheet metal-clad finial. (ARG, 2016)

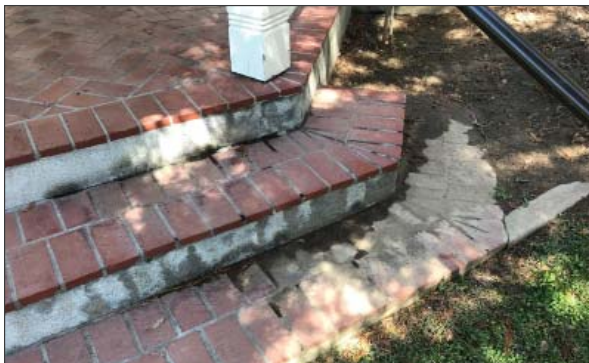
Soil sedimentation at southeast steps. (ARG, 2016)

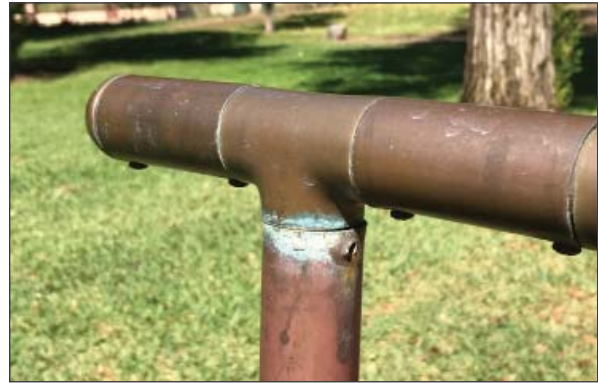
Oxidation at copper tubing. (ARG, 2016)

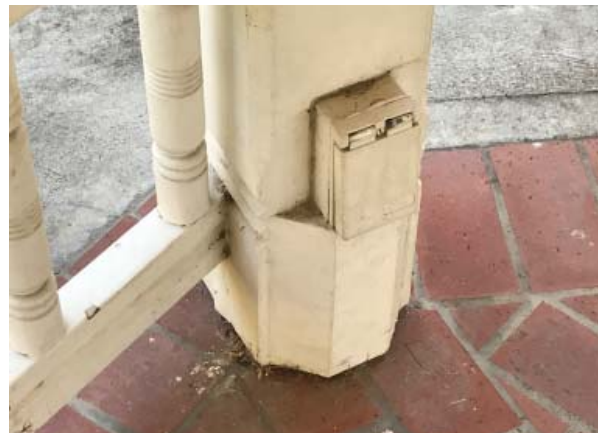
Outdoor electrical outlets. (ARG, 2016)

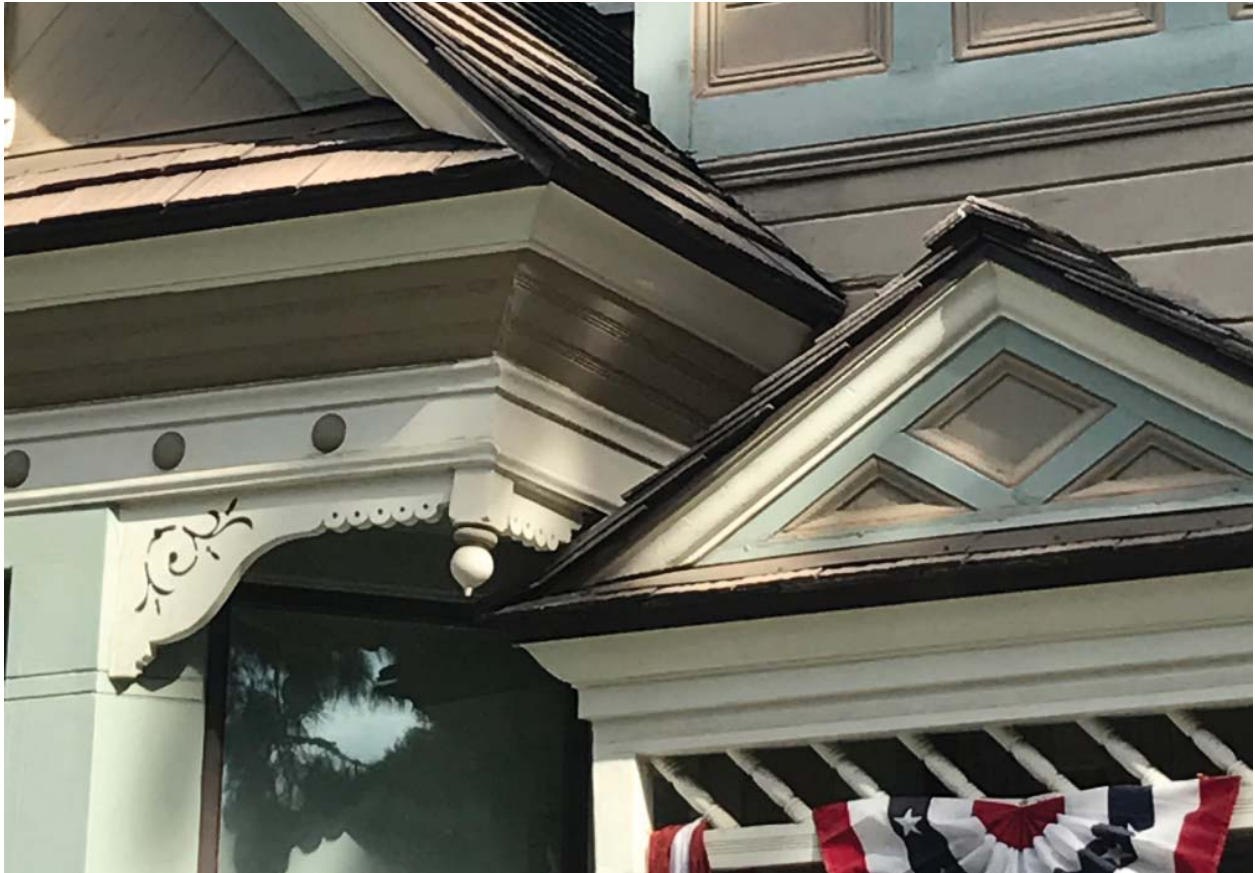
Doctors House details. (ARG, 2016)

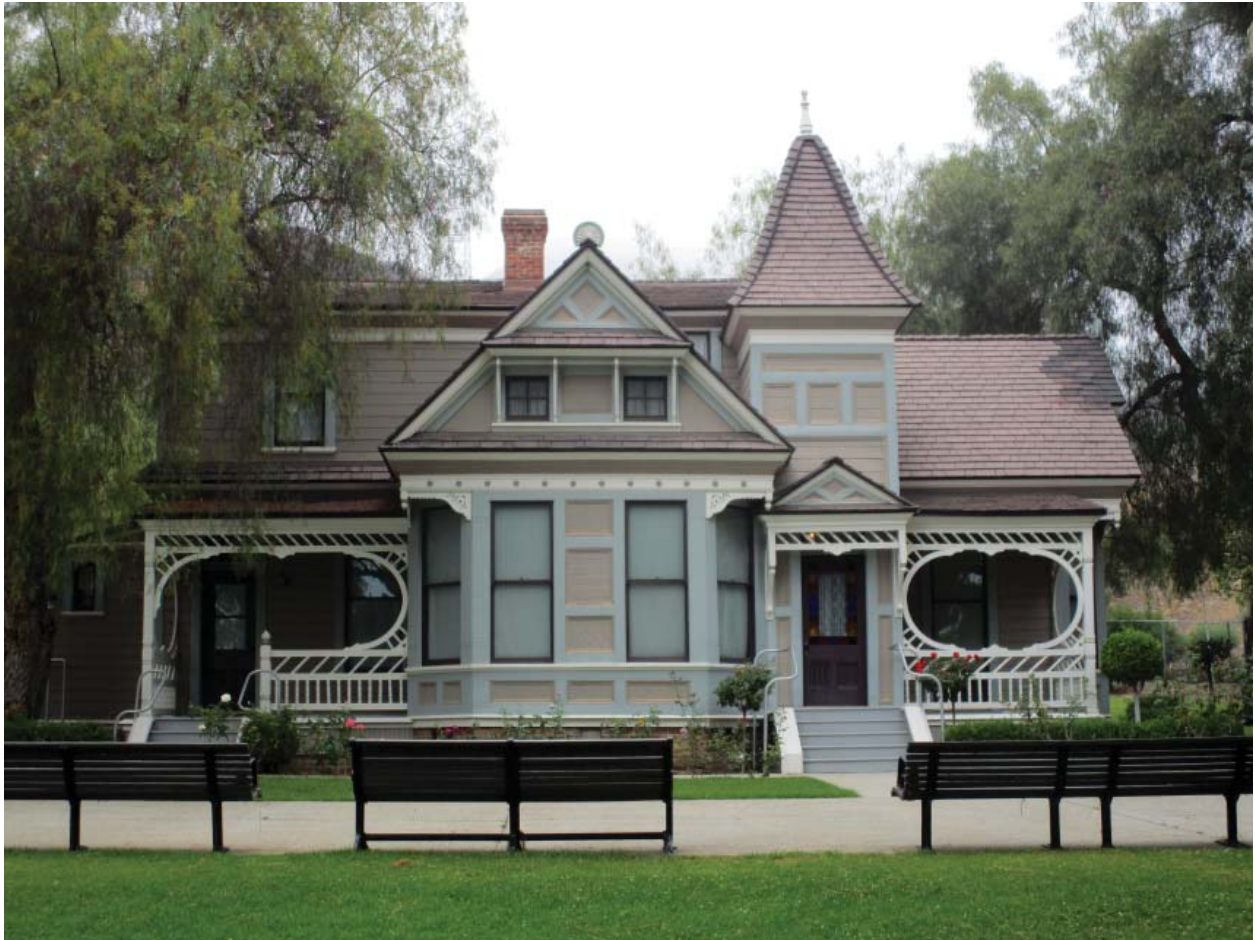
Doctors House Museum (ARG, 2016)

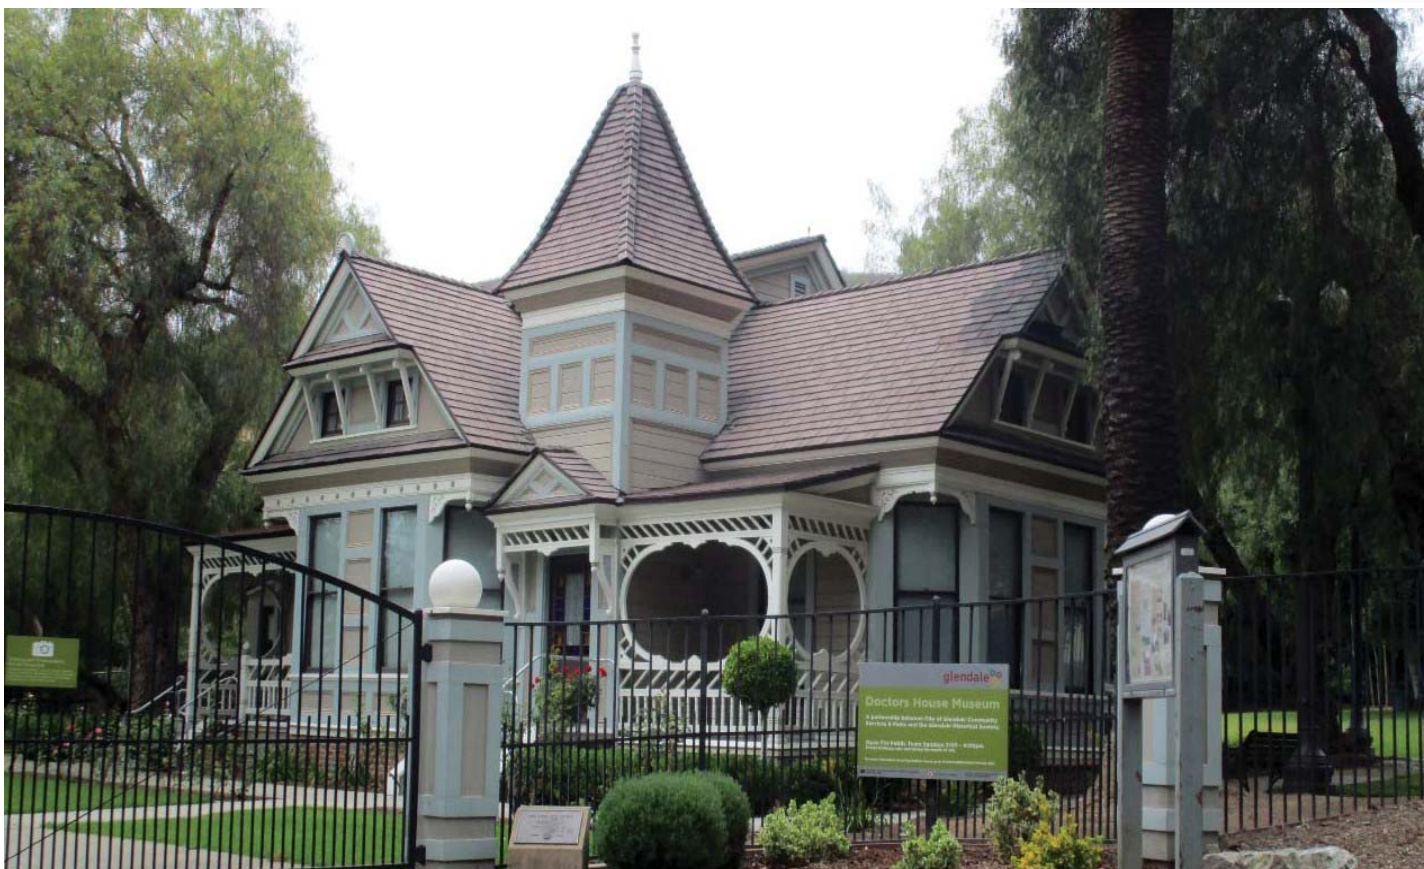
Conditions Assessment Report
