Safety Culture and Safe Sealing- Anacortes Refinery Explosion

**Engineering Symposium in Rochester
Hyatt Regency Downtown, Rochester, NY
April 18, 2017**

**Jim Drago, P.E.
Principal Applications Engineer
Garlock Sealing Technologies,
Palmyra, NY**

Naphtha Hydro-treater (NHT) Heat Exchanger - E-6600E

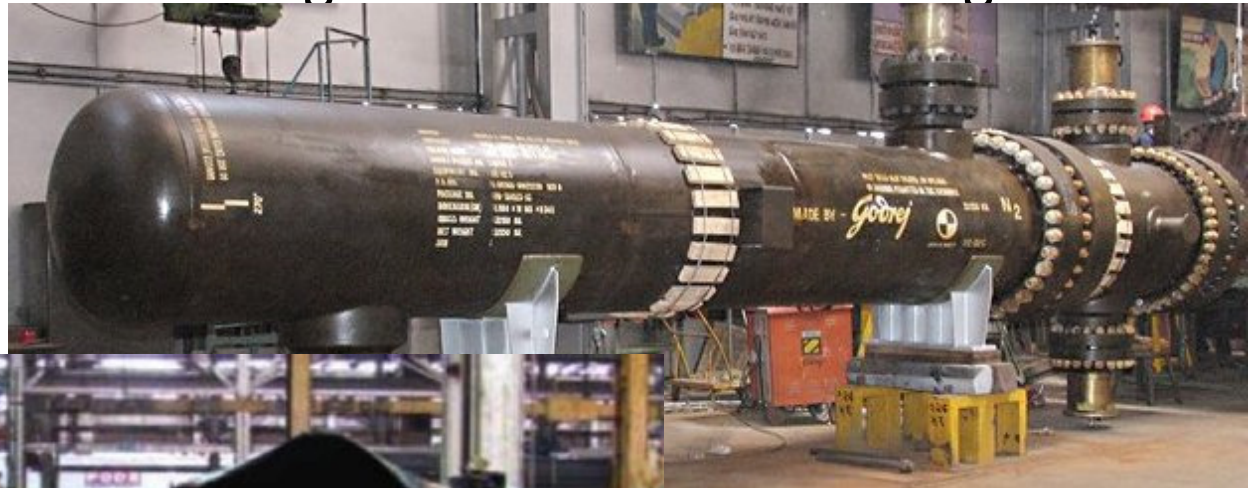
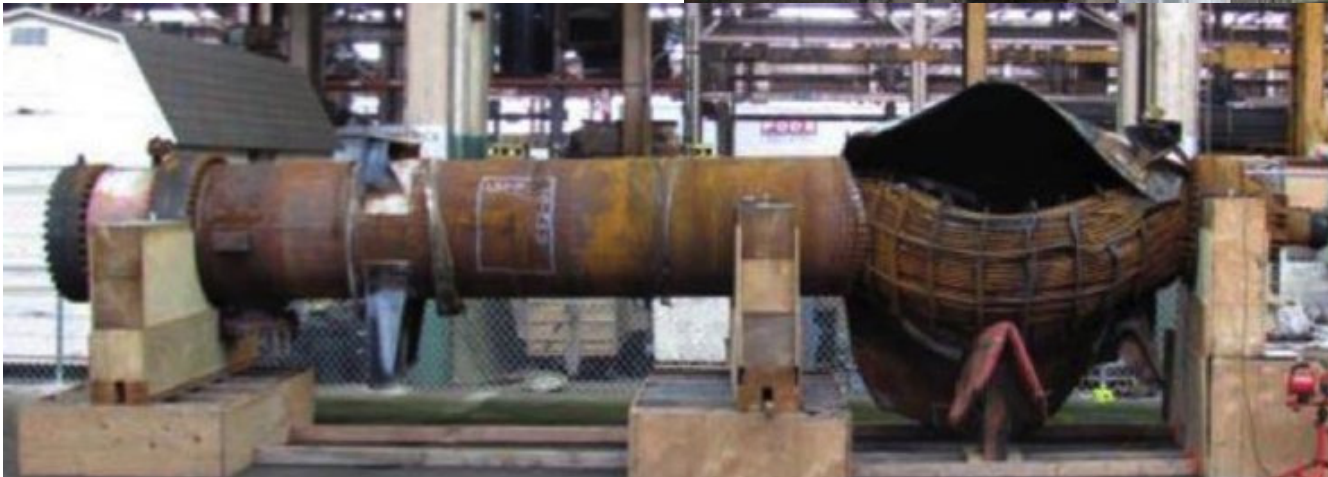
- Catastrophically ruptured at the Tesoro refinery at Anacortes, WA on April 2, 2010
- Hydrogen and naphtha at more than 500°F were released, ignited and exploded resulting in an intense fire lasting over three hours

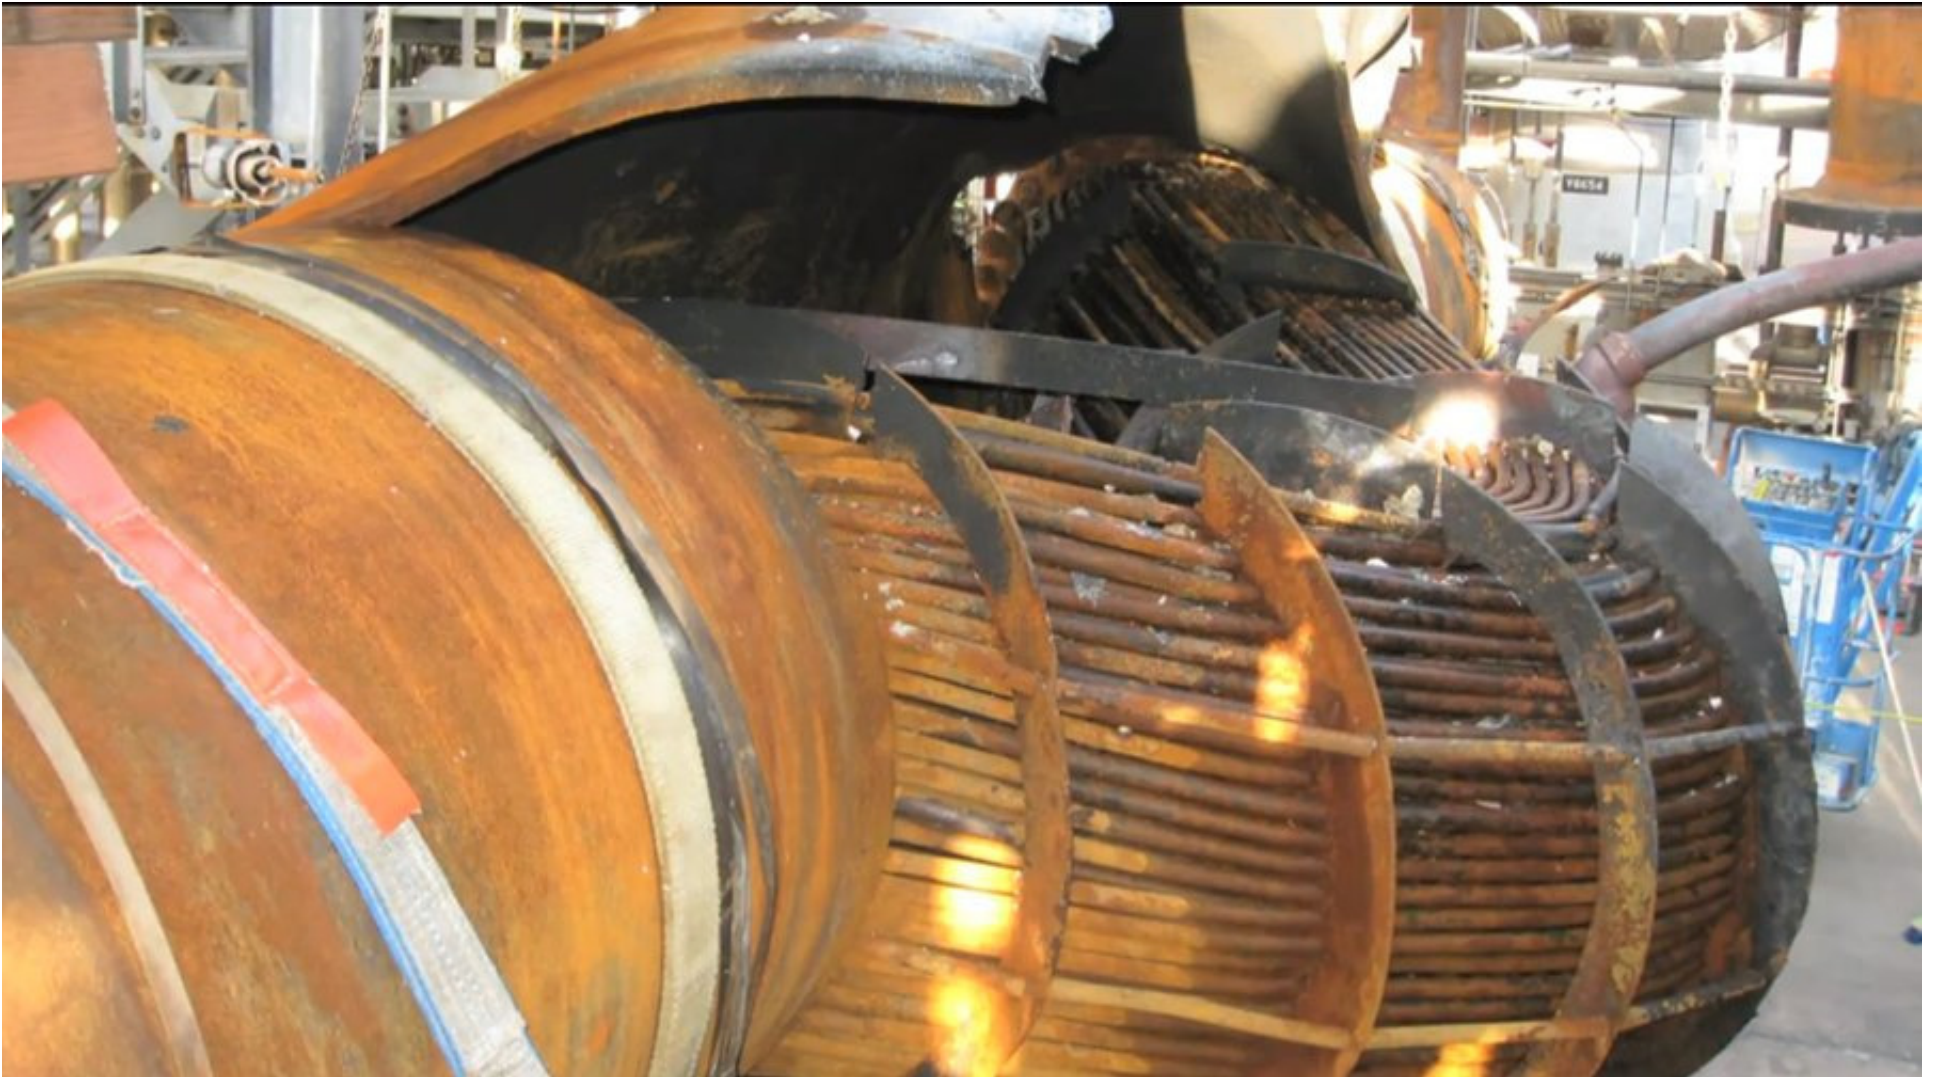
CSB Investigation Photo
Tesoro Heat Exchanger

Ruptured heat exchanger

- Carbon steel vessel weakened by HTHA
- API recommended practice for design
 - Nelson curves predict HTHA for various materials and temperature
 - Based on self-reported past failures
 - Failure occurred within the safe range given on the curves
- Inspection is difficult
- Designing for safety is best
 - API recommends high chrome steel
 - Failed exchanger was carbon steel

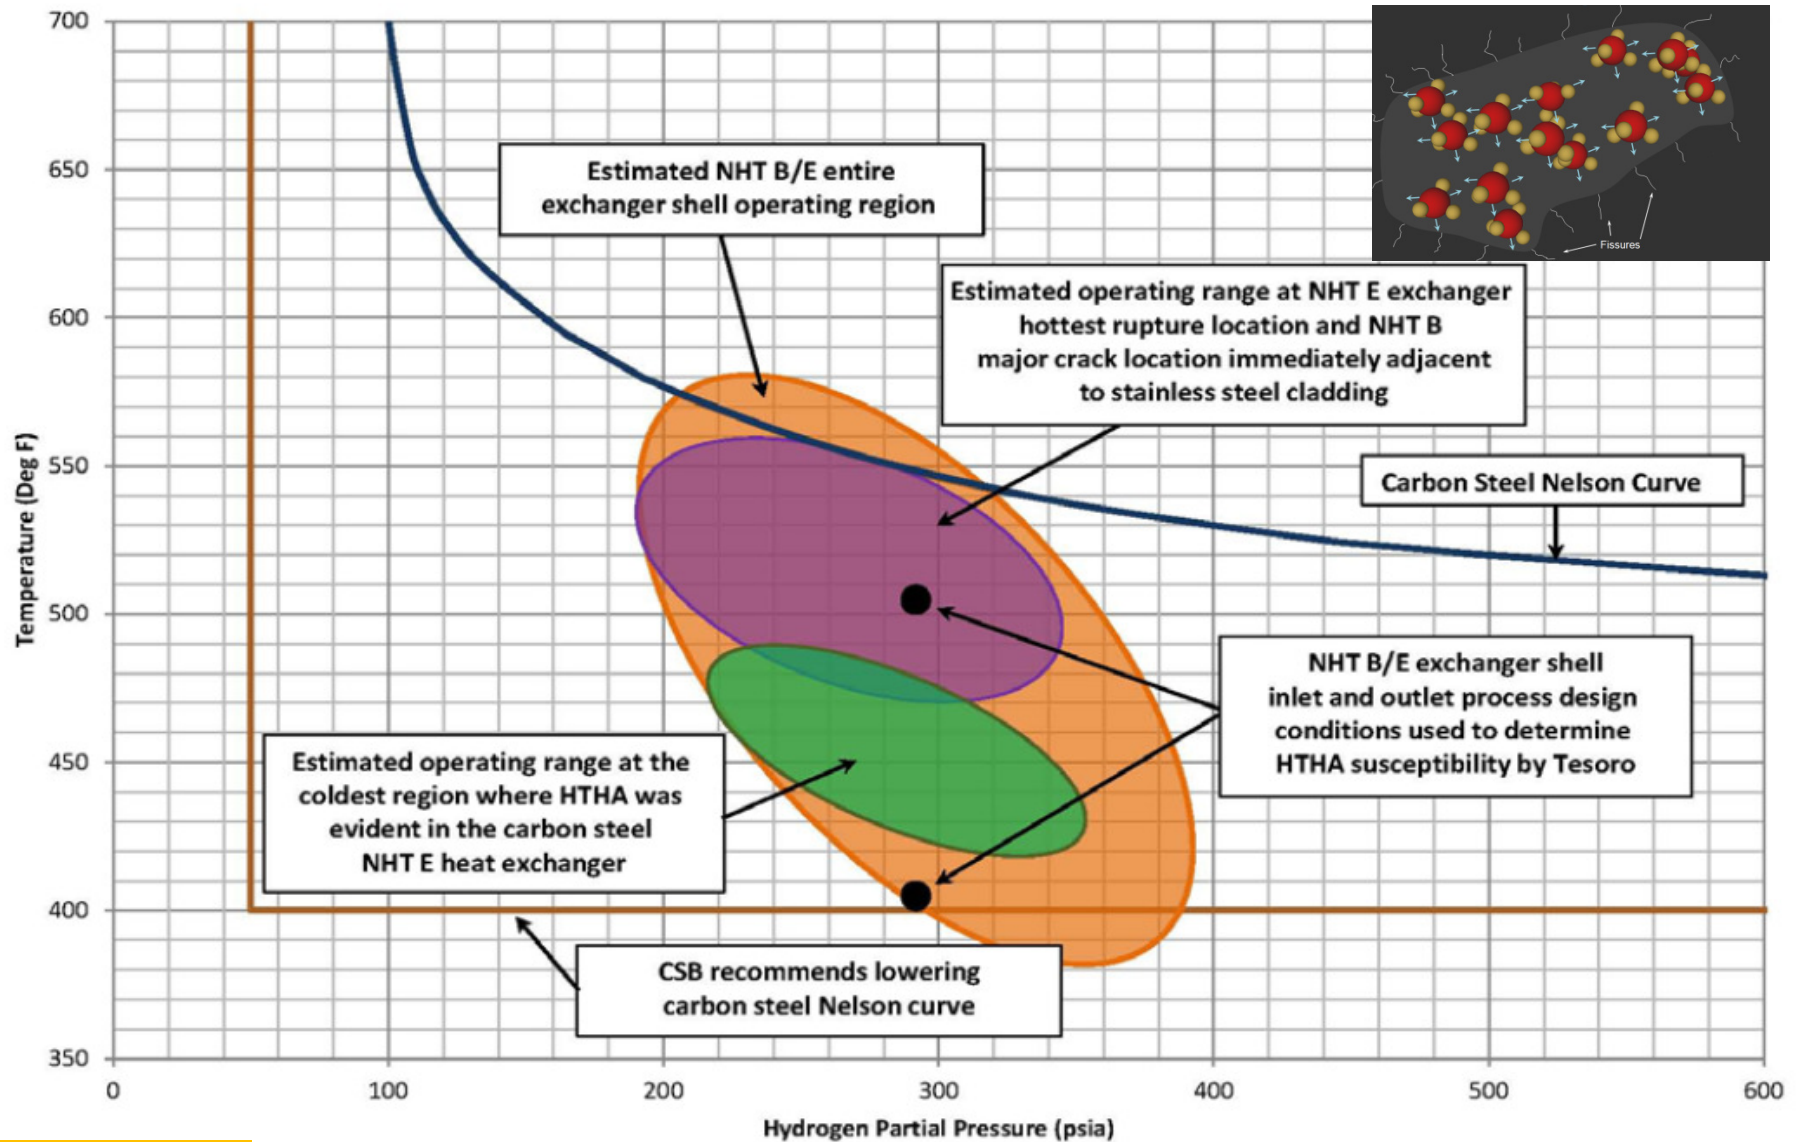
Figure 46. Estimated Operating Conditions of the B and E Heat Exchangers

CSB Modeled Operating Regions of Tesoro NHT B/E Exchangers

- Increased heat to shorten the heat-up time of the NHT
 - Contributing factor to the rupture
- Heat Exchanger Materials of Construction
 - Lack of preventive/conservative specification of the heat exchangers' MOC
 - Design norms of using Nelson curves to predict safe region of carbon steel judged flawed by CSB
 - Equipment operated at temperatures above the material safe range as dictated by the Nelson curves.
- Difficult to operate control components (valves) require human intervention
- Inspections favored over designing for mechanical integrity and safety
- Gaskets were routinely re-used
- Start up was categorized as a hazardous activity

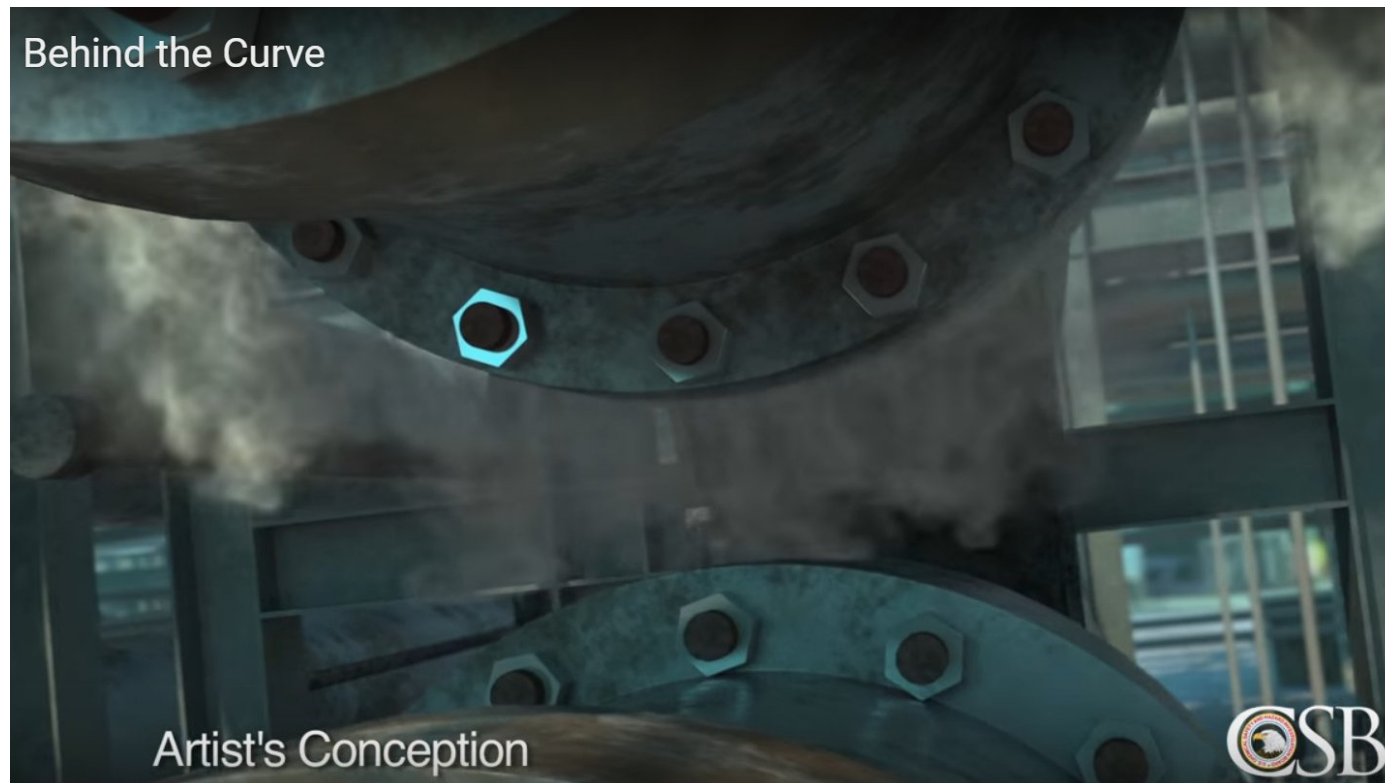
- CSB report, “The NHT heat exchangers frequently leaked flammable hydrocarbons during startup, sometimes resulting in fires.... management had been complacent about these hazardous leaks and did not always investigate the cause of the leaks.”
 - E-6600E’s flanges had been leaking for many years
- Corrective action process failed so reactive actions were taken

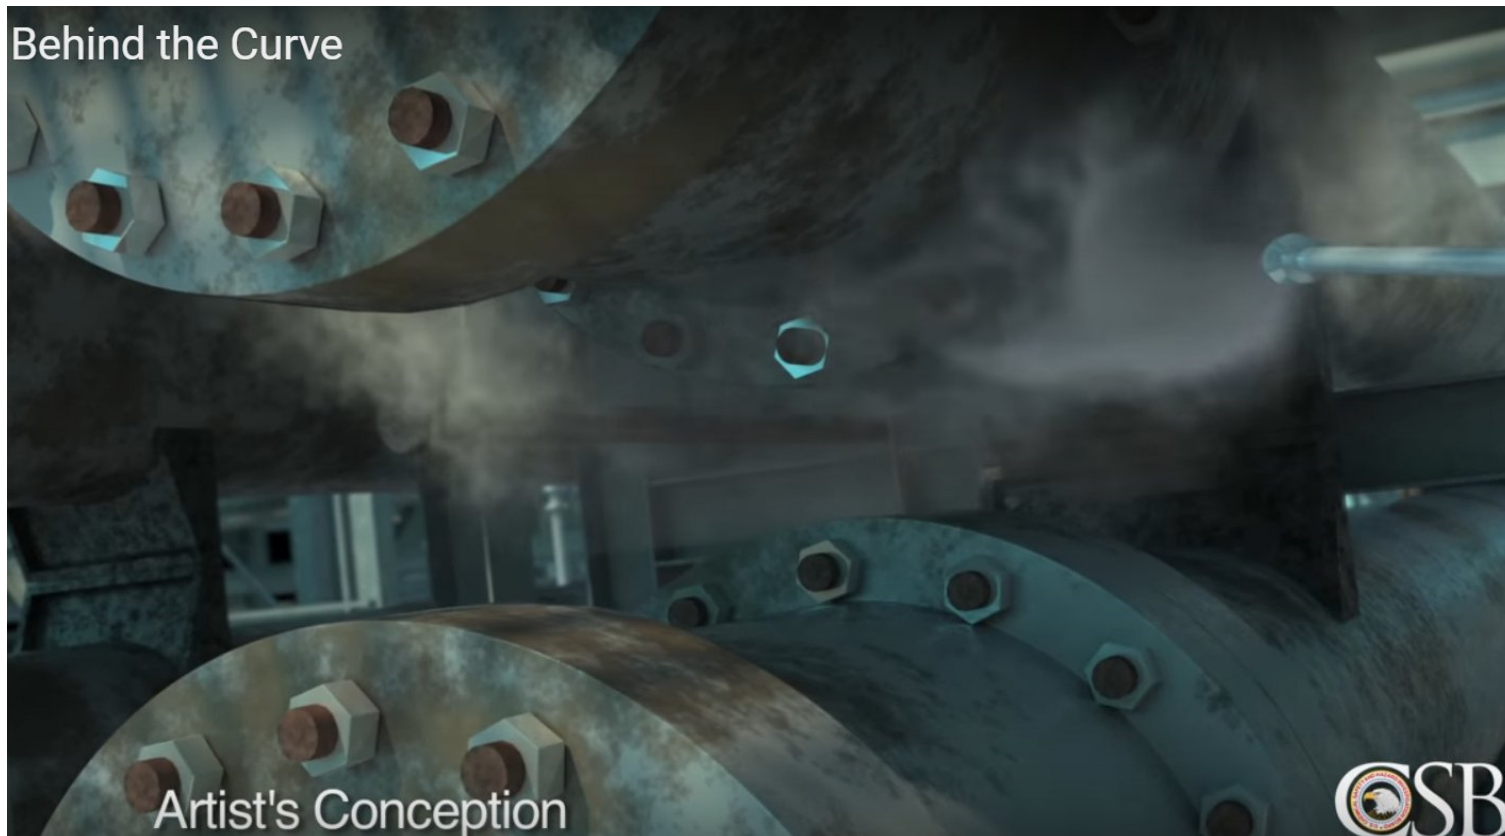
- Use of steam lances to spray on the leaking flanges during start-up to mitigate fires
 - Cause of the fires not corrected
 - This action required additional personnel to be in close proximity to the NHT heat exchanger
- Use of clamps and active leak repair masked the sealing problem

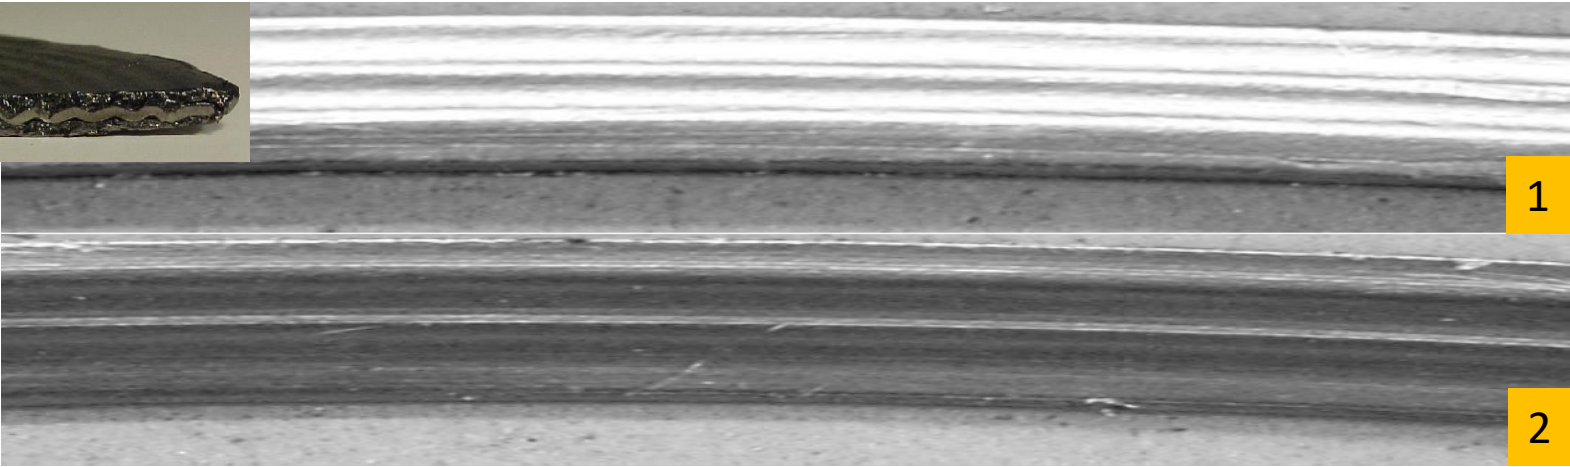
Before

Results of Radial Shear

Example - Corrugated Metal with Flexible Graphite
