Stephen J. Wedlock
MARINE SURVEYOR
Surveying the Bay area since 1998

Survey Report #Sample
© 2014 - All rights reserved

Vessel name:

Purpose of survey: Condition and valuation for purchase and insurance underwriting.

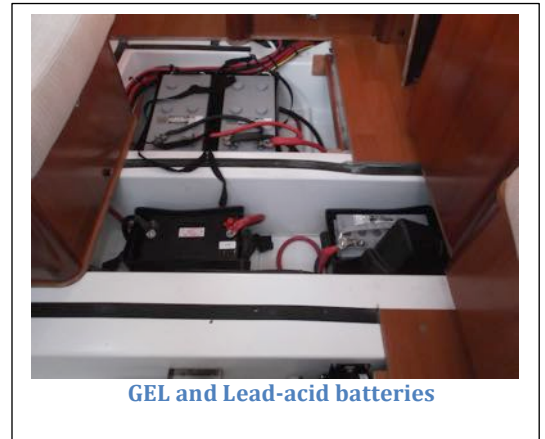
GEL and Lead-acid batteries

****The plastic terminal cover on the bow-thruster battery is melted. Suggest inspection to determine reason for melting and possible a different cover.**

-Lead-acid and GEL batteries require different charging voltages. Assure the battery charger is set correctly.

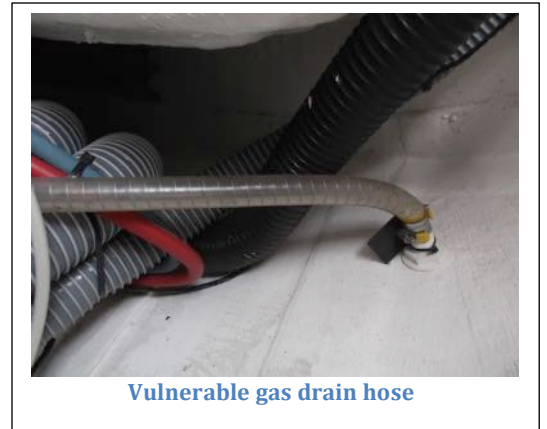
Vulnerable gas drain hose

-The propane tank drain hose is not well secured or protected. Suggest protection to prevent damage from gear in lazarette.

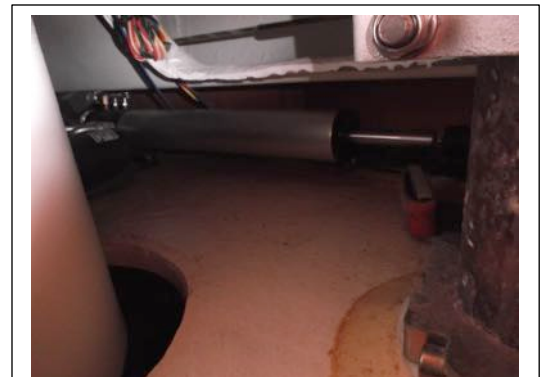
Leaking auto pilot ram

-The auto-pilot ram is leaking. Suggest inspection and repair/replacement as needed.
