NUCLEAR CONTAINMENT FAILURES:

Ramifications for the AP1000 Containment Design

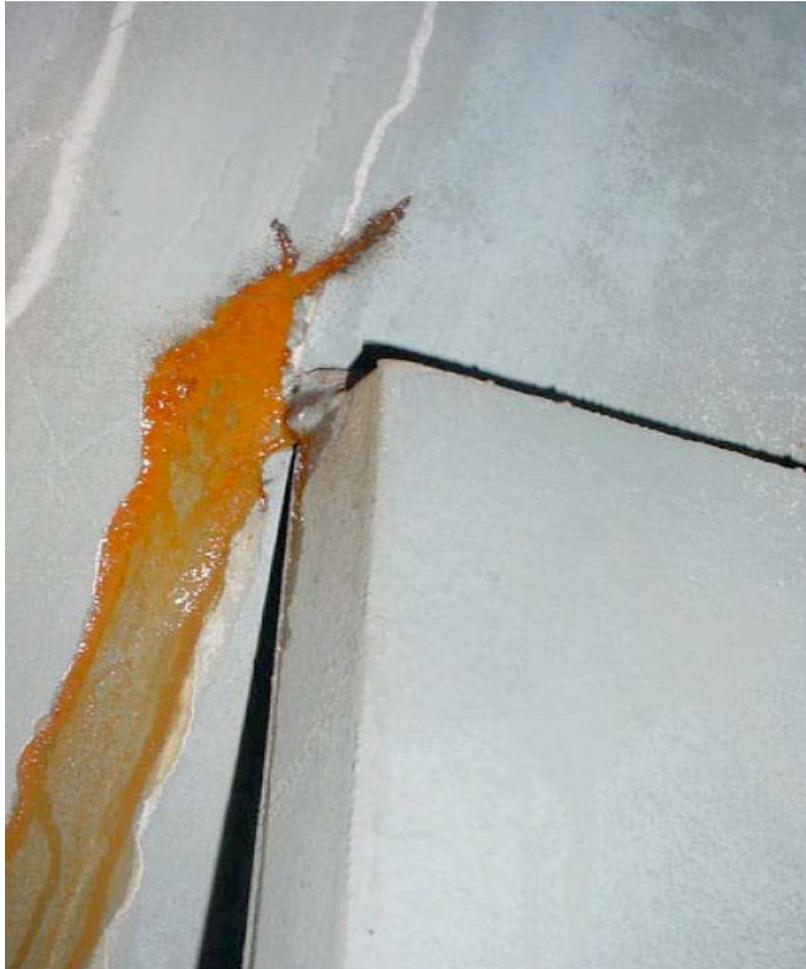
On June 28, 2010, three days after the ACRS meeting, Fairewinds Associates, Inc informed the ACRS of *yet another containment failure*, this time at the Fitzpatrick nuclear power plant in 2005. The photo below of the 4 ½” crack was taken in 2005 from the outside of the containment torus at the Fitzpatrick nuclear power plant in Oswego, NY.

As a result of questions during the ACRS discussion period relating to BWR thick containment designs like the through wall cracks at Hatch 1 and 2, Fairewinds researched additional failures and found that the Fitzpatrick nuclear power plant developed a large through-wall leak that was not due to corrosion. Once again, here is a unique violation of the BWR containment system that is directly applicable to the Westinghouse design of the AP1000.

The Fitzpatrick crack is due to differential expansion in a thick containment that is of similar thickness to the proposed AP1000 design and like the cracks previously uncovered at Hatch 1 and Hatch 2. Thus to date, three thick containments have experienced complete through-wall

failures that remained undetectable by ASME visual techniques until each through-wall crack actually appeared.
