**AGENDA FOR THE SPECIAL MEETING  
DUNSMUIR CITY COUNCIL  
COUNCIL CHAMBERS  
5902 DUNSMUIR AVE, DUNSMUIR, CA  
SEPTEMBER 22, 2016  
CLOSED SESSION: NONE  
REGULAR SESSION: 3:00 PM**

Phase 1 Bridge Feasibility Study  
Butterfly Bridge

**PHASE 1 BRIDGE EVALUATION  
FEASIBILITY STUDY**

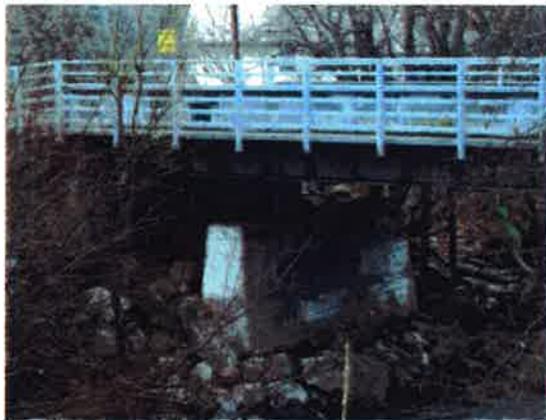
East Abutment (Abutment 2)

*Bridge is scour critical; field review indicates that extensive scour has occurred at bridge foundations, which are determined to be unstable by:*

Should the bridge scour get worse, failure of the abutments would be imminent, and the bridge would be closed to traffic.

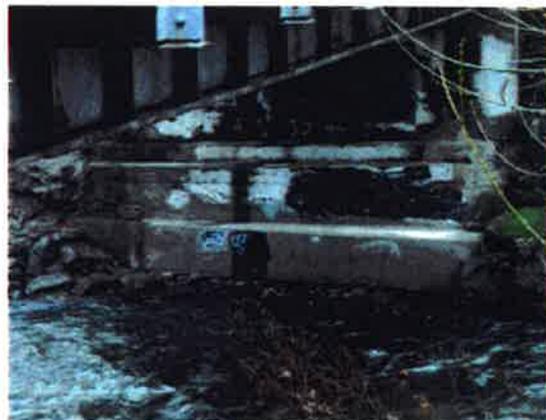
West Abutment (Abutment 1)

Concerns regarding scour at Abutment 1 have been noted since 1981. Abutment 1 is the west abutment adjacent to the railroad tracks; on the right side when looking downstream. The 2013 Bridge Inspection indicates that the scour is on the left side of Abutment 1 and is about 20 feet long x 1.5 feet high and extends back under the footing approximately 3 feet. These conditions appear to have remained unchanged since the last assessment. It was the intent of this study to address how to resolve these concerns with the recommended improvements.

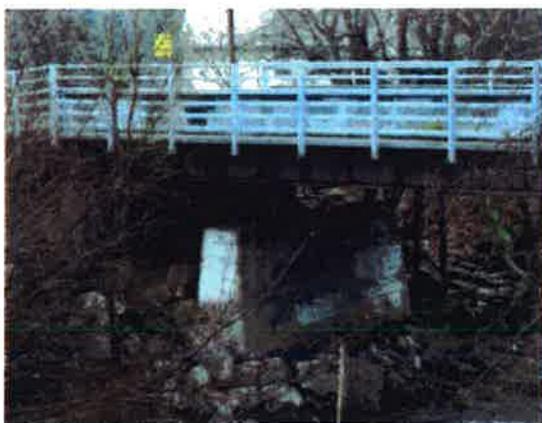
East Abutment (Abutment 2)

Despite this floodplain geometry, the west abutment (Abutment 1) has been the subject of concern for the existing bridge much more so than the east abutment. According to City sources, more severe scour has been recently observed on the west abutment, and concerns about the scour on Abutment 1 have been noted since 1981.

Scour countermeasures are recommended at both abutments. The degree of these measures is dependent on which structural retrofit solution is selected. During the next design phase, with additional geotechnical information provided as the basis for the design, a more detailed scour analysis will be performed. In addition, scour countermeasures will be designed in accordance with HEC-23, Bridge Scour and Stream Instability Countermeasures. Such countermeasures are needed for local scour only (at the bridge abutments), and are not anticipated for contraction scour across the width of the channel.

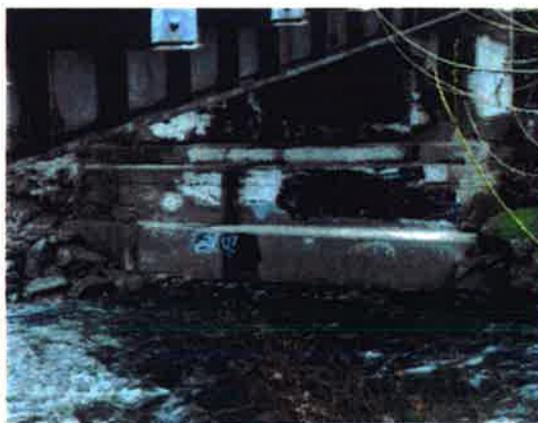
West Abutment (Abutment 1)

Some reasons why the west abutment may be more subject to scour under normal flow conditions, despite calculations that would suggest the opposite, could include:

- the west abutment is on the outside of a bend
- geological and soils conditions on this side of the channel in the vicinity of the bridge;
- the steepness of the slope on this side; or
- the effectiveness of the countermeasures that have been installed.

For example, the east bank is protected with loose riprap, while the west bank near the toe is also protected

with grouted riprap in some areas. The downstream grouted riprap toe location is inconsistent and in places protrudes into the channel approximately 5 to 8 feet. These protrusions occur immediately downstream from the Abutment 1 spread footing and cause back eddies, upstream flow, and vortices at the abutment face. The configuration of the countermeasures, or perhaps the lack of proper maintenance and/or repair of the riprap following a major flow event, may be exacerbating the scour issues at this location. (See the utility discussion later in this report for how utility foundations may be the reason for this protrusion).

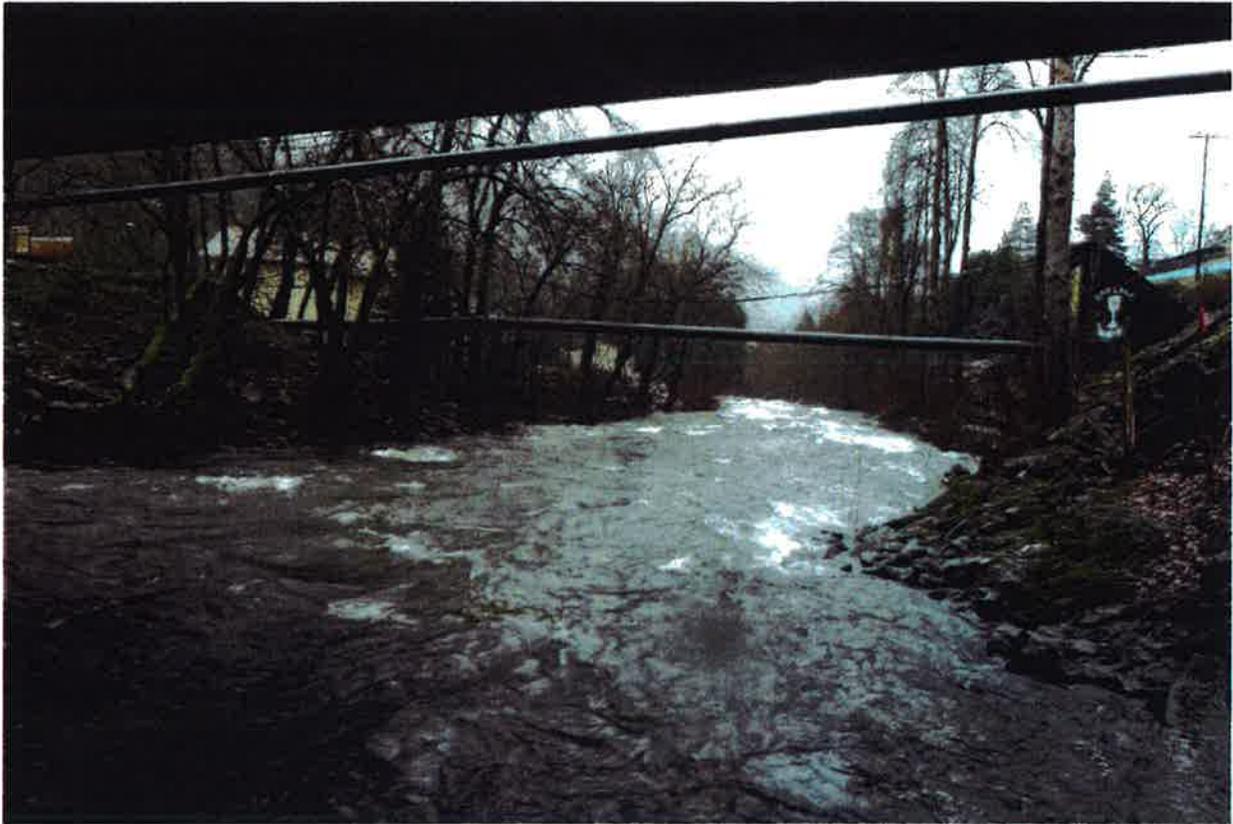
The downstream grouted riprap toe location is inconsistent and in places protrudes into the channel approximately 5- to 8-ft. These protrusions occur immediately downstream from the west abutment spread footing and causes back eddies, upstream flow and vortices at the western abutment face. Riprap slopes are generally at 1.5H:1V and locally steeper on the right bank. *Note: removal of this downstream protruding slope may have upstream benefits at the abutment, but it may also have been placed to protect the downstream utility crossing foundation, the triangular structure immediately downstream of the bridge shown in the picture below. With no as-builts and no plans for the placement of this riprap, the intended purpose is not known. More site analysis is required before this material can be modified. If the utility crossing is not dependent on this protruding protection, it will be removed.*

The Sacramento River flows approximately perpendicular to the bridge alignment with the channel thread located closer to the western third of the bridge. The flow impinges upon the Abutment-1 spread footing and is deflected easterly immediately downstream from the footing by the grouted riprap.

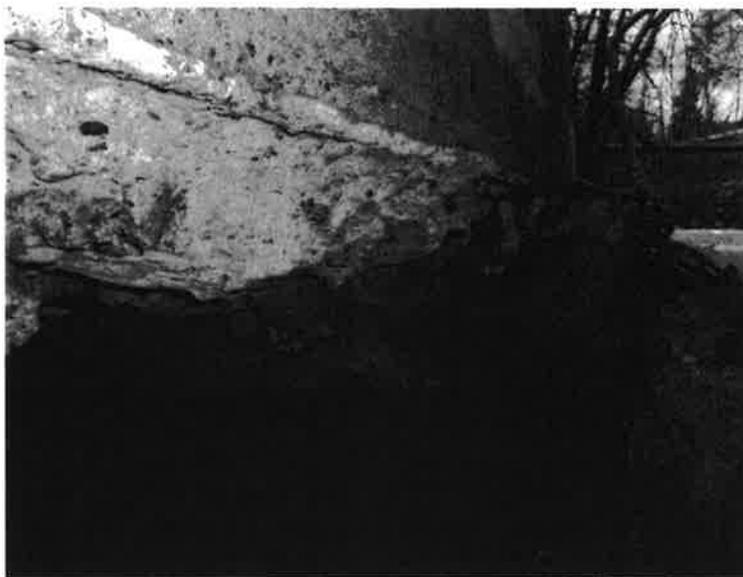
Scour has primarily been a concern for the western abutment, based on previous Caltrans bridge inspection reports. The magnitude of scour along and under the abutment was not determined during the geotechnical site review due to elevated and fast river flows (the picture to the right of the western abutment was taken during a lower flow event, February 2015.)

While the scour has been a concern historically with the west abutment, any site improvements will include scour mitigation at both abutments. Additional investigation is needed to determine if the abutments are founded on stable, competent rock. If they are, additional structural measures may not be necessary since no observable problems have been identified. Scour countermeasures such as placement of additional riprap will be evaluated and developed for both abutments as part of the final design solution.

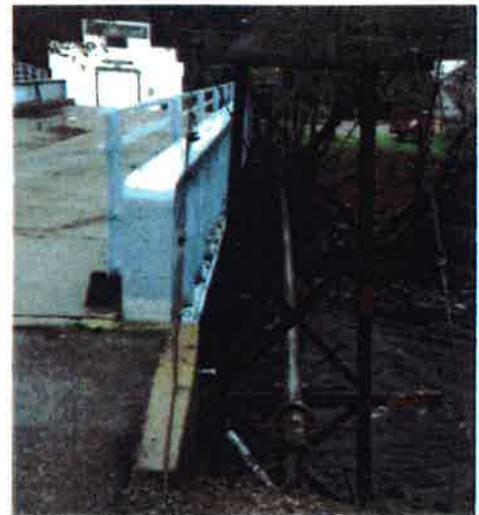
In the picture to the right, the shows the tower support structure for this waterline to the right (downstream) of the old bridge pier.

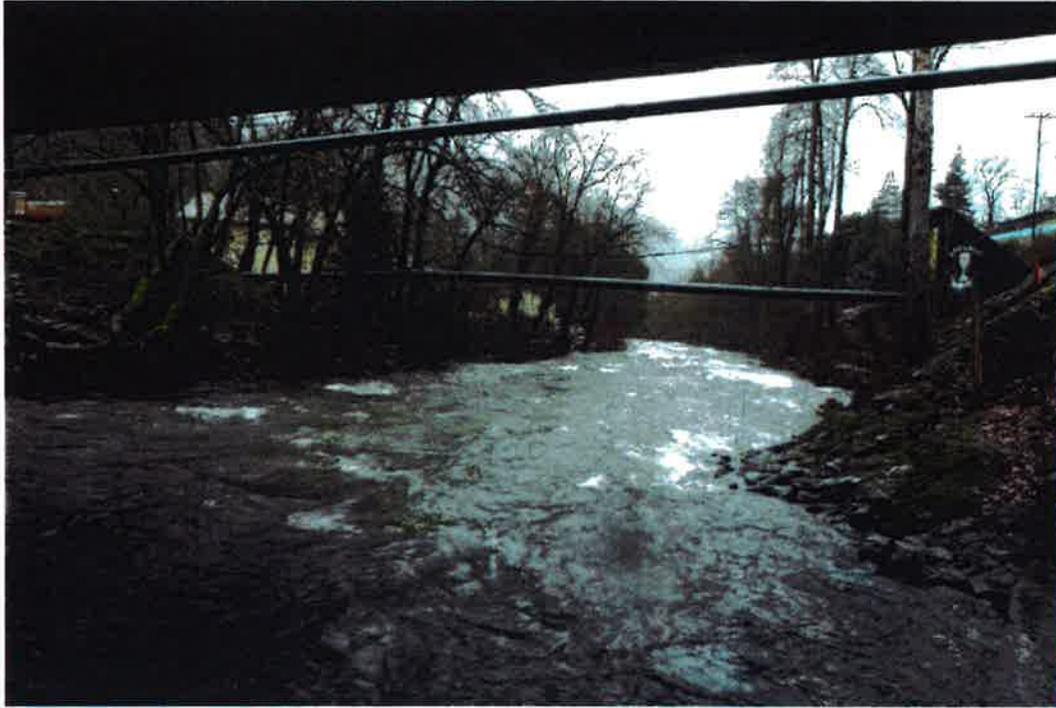
In the picture above, the right side embankment protrudes into the channel approximately 5- to 8-ft. These protrusions causes back eddies upstream and vortices at the western abutment face. Removal of this downstream protruding slope may have upstream benefits at the abutment, but it may also have been placed to protect the downstream utility crossing foundation, the triangular structure immediately downstream of the bridge shown in the picture below. With no as-builts and no plans for the placement of this riprap (or this structure), the intended purpose is not known. More site analysis is required before this material can be modified. If the utility crossing is not dependent on this protruding protection, it will be removed.
