Gear Pump Failure Analysis

David Earls

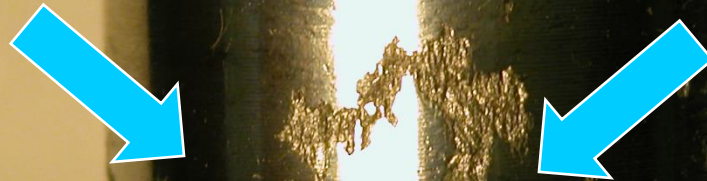
(1)

Beginning Bearing Failure

Start spalling

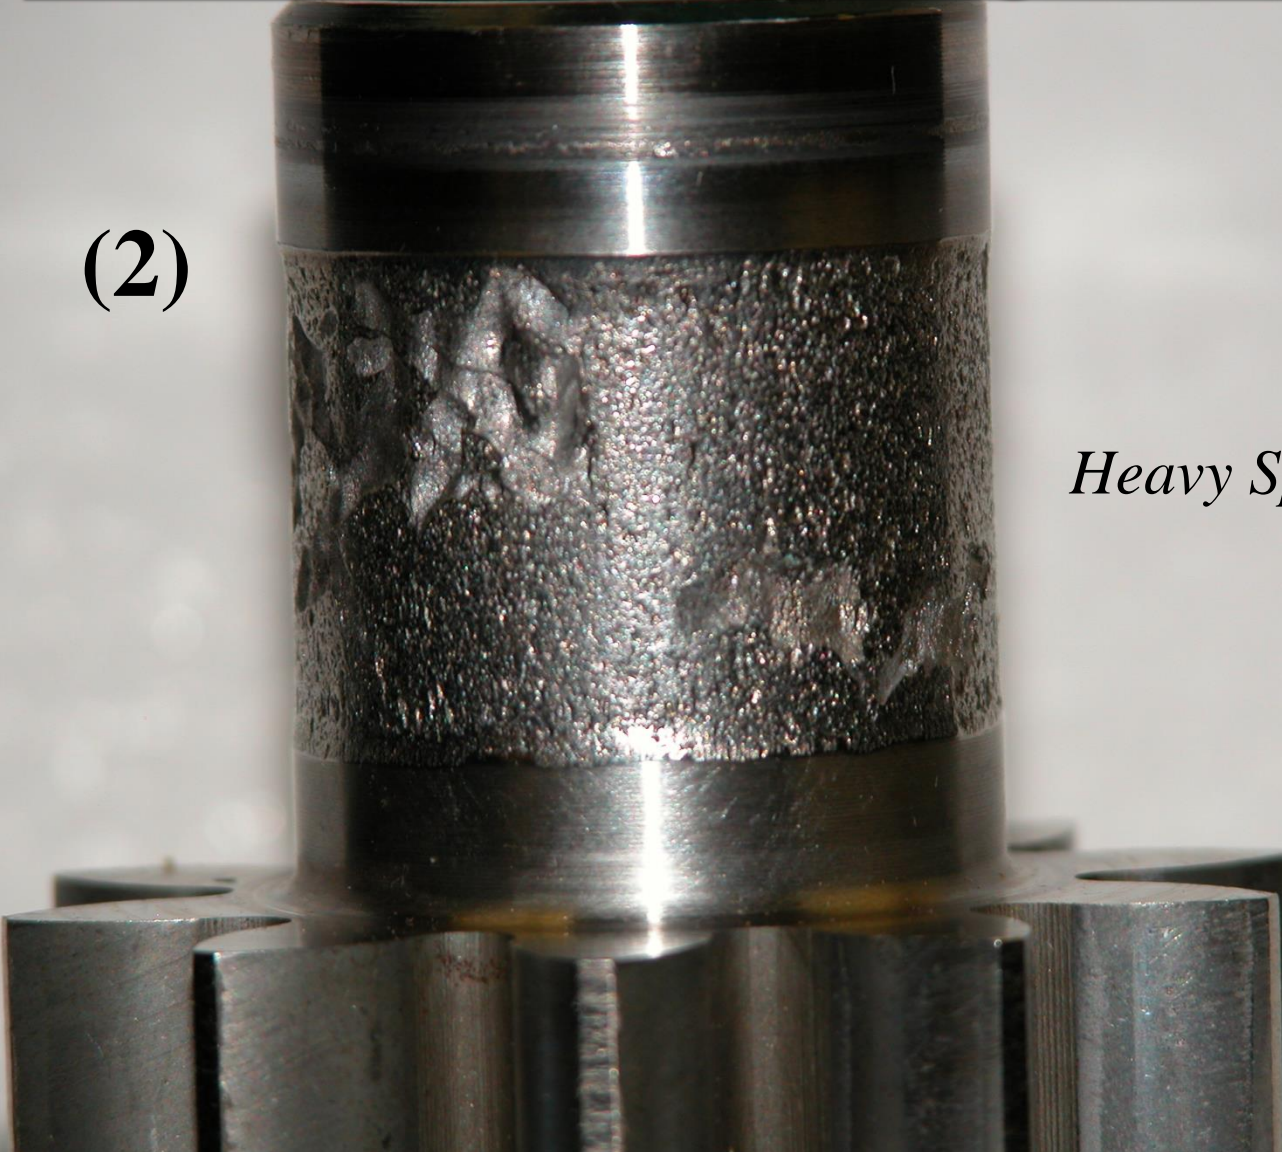
(2)

Advanced Bearing Failure

Heavy Spalling

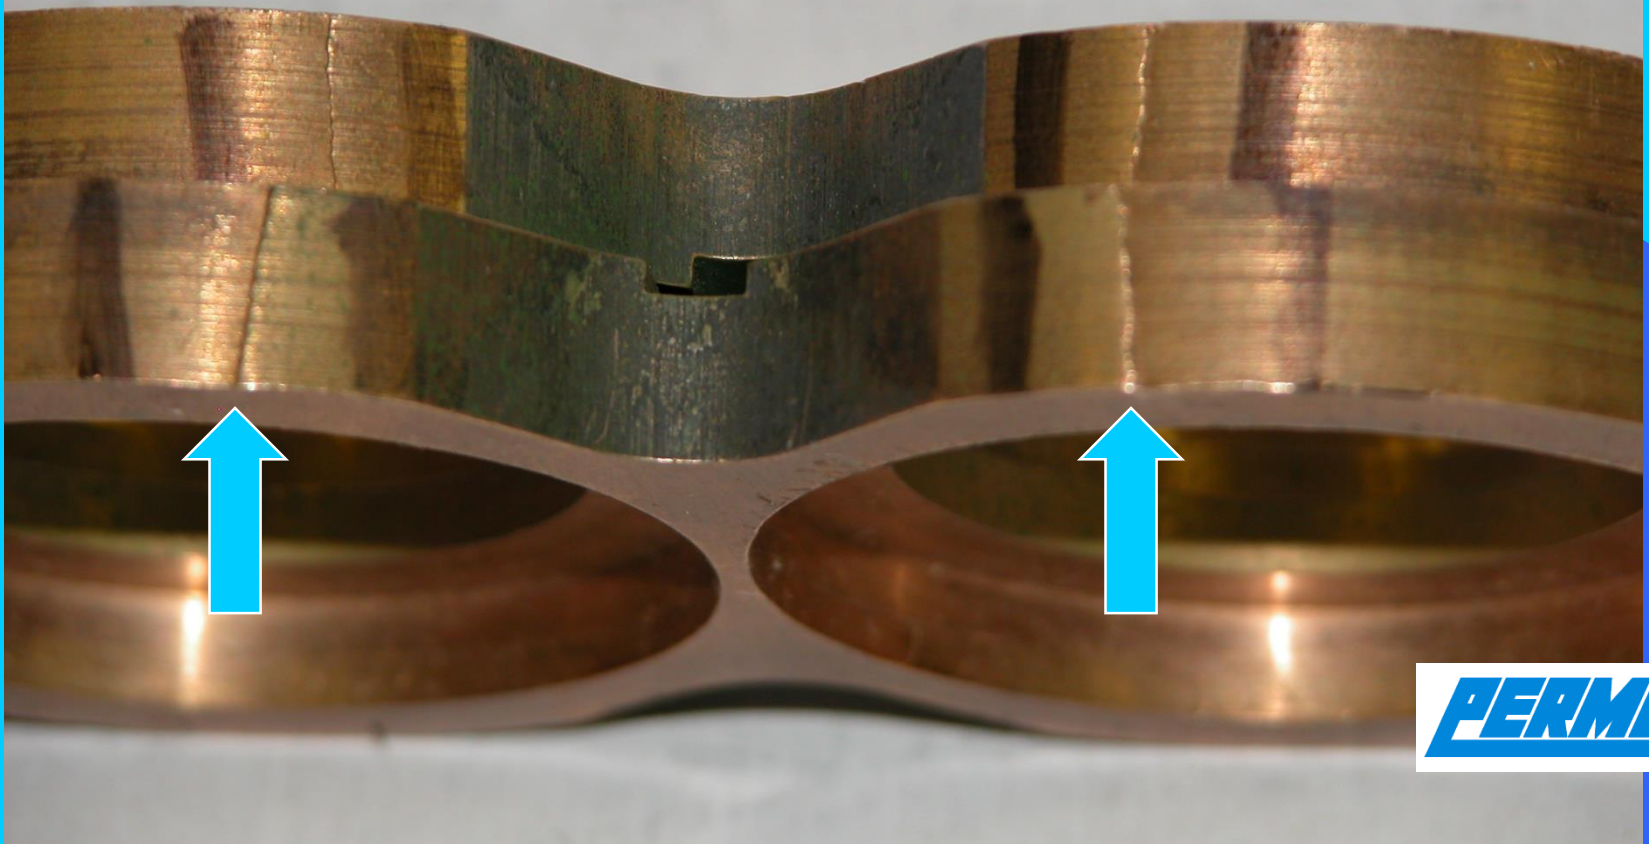
(3)

Housing Shift From Pressure

Lines in gear bores

- *Most likely cause: Pump dead head*
- *Relief valve bottomed out*
- *Valve shut off at outlet*
- *Quick disconnect not on properly*

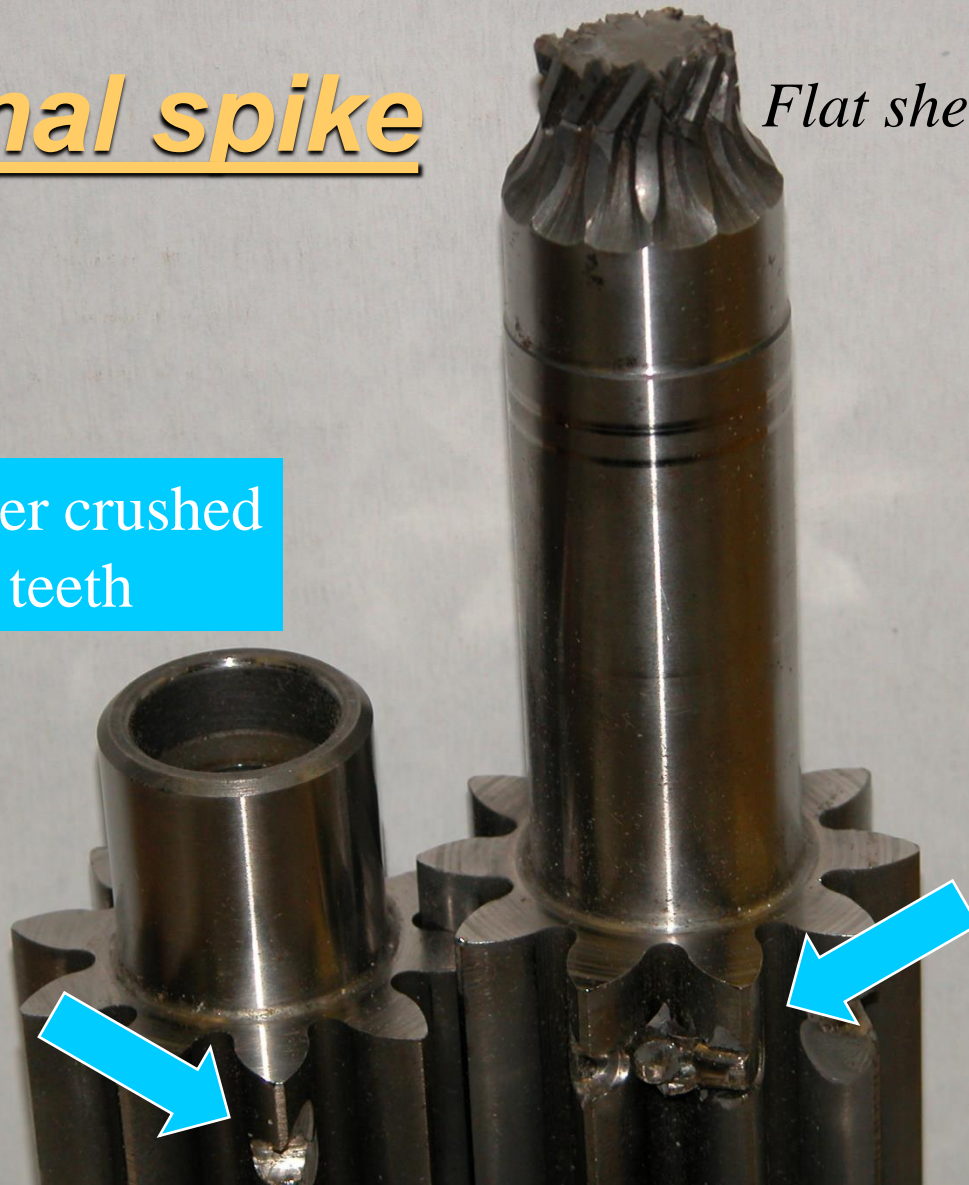
(5)

Torsional spike

Flat shear (overload)

Note roller crushed
Between teeth

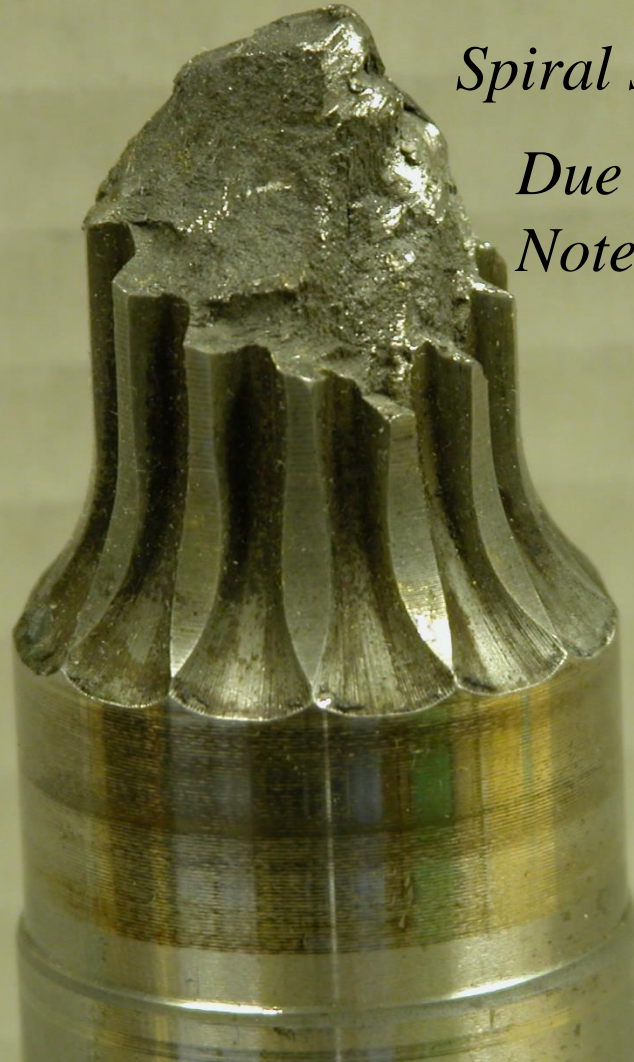
(6)

Fatigue Failure

Spiral shear

Due to stresses

Note: On a 45° angle

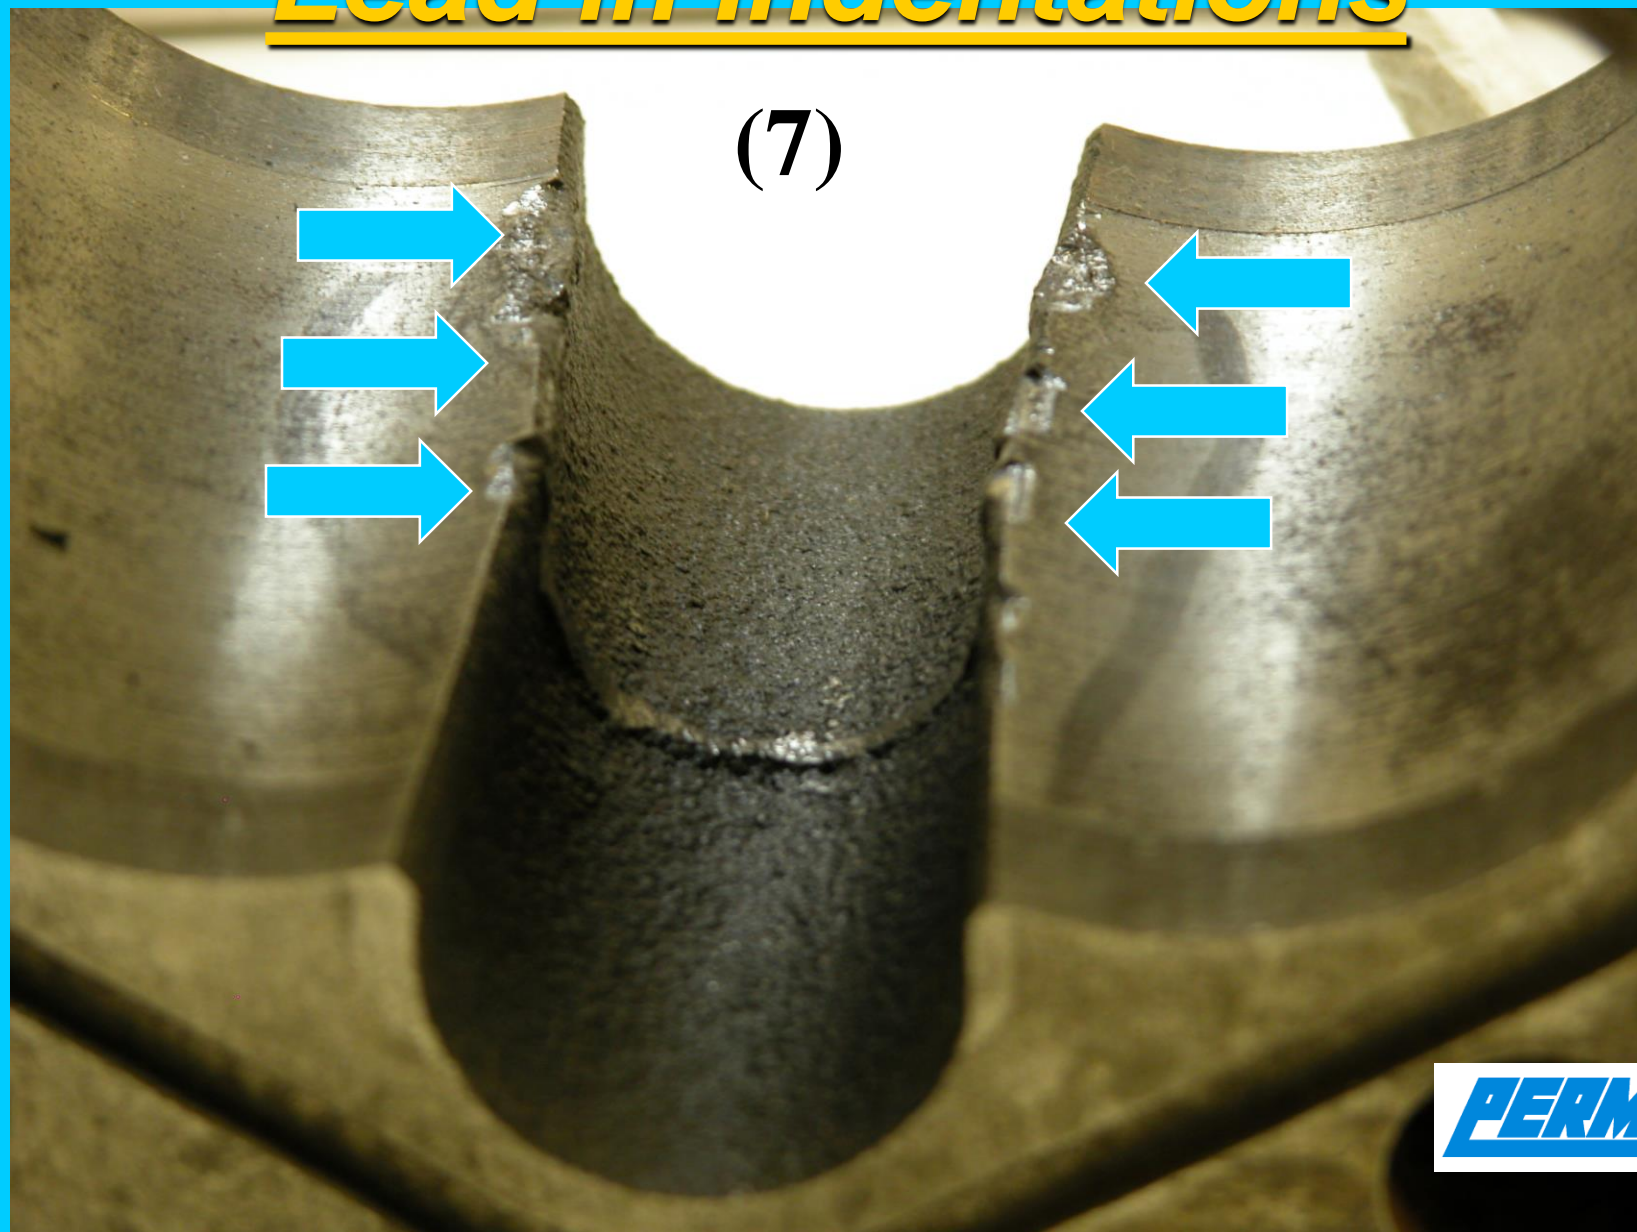
- *Large/hard contamination will be crushed between teeth and “lead in” on housing bore (see next slide)*
- *Will cause grooves in wear plates looking like a record*
- *Could cause gears to lock up and twist off drive shaft*

Lead in Indentations

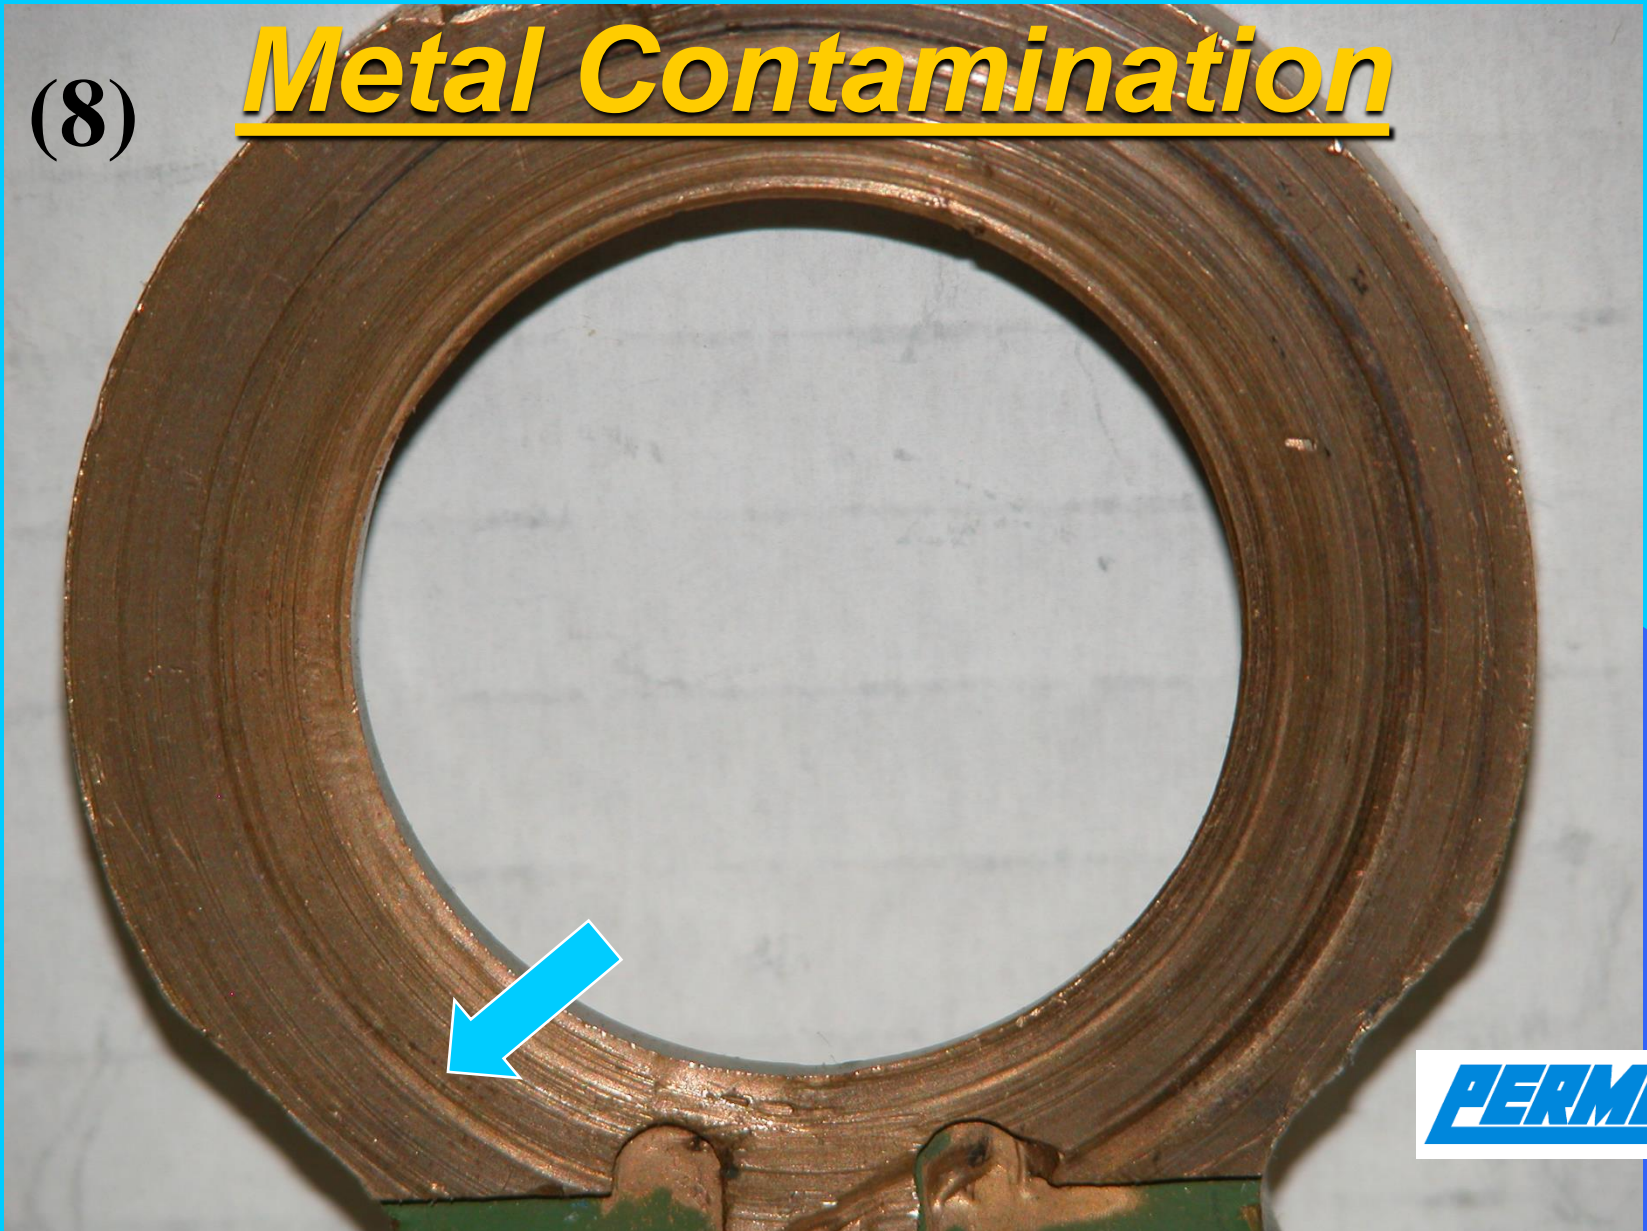
(8)

Metal Contamination

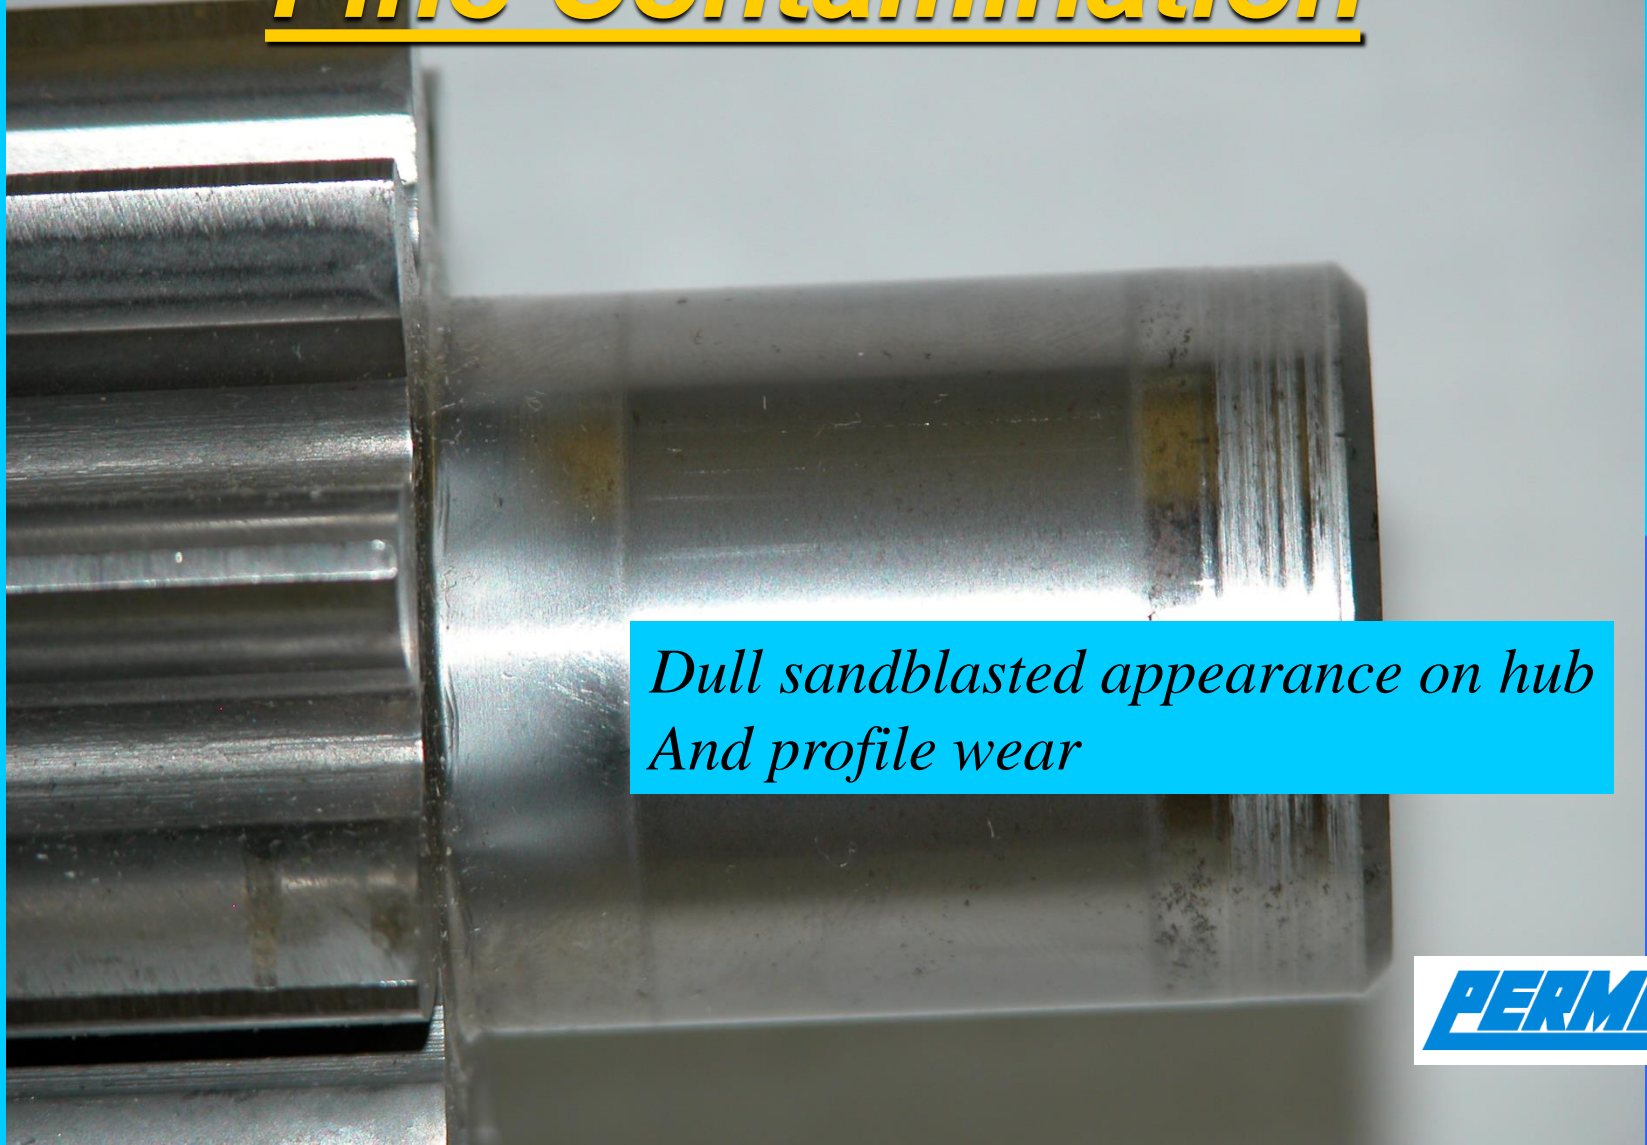
(10)

Fine Contamination

*Dull sandblasted appearance on hub
And profile wear*

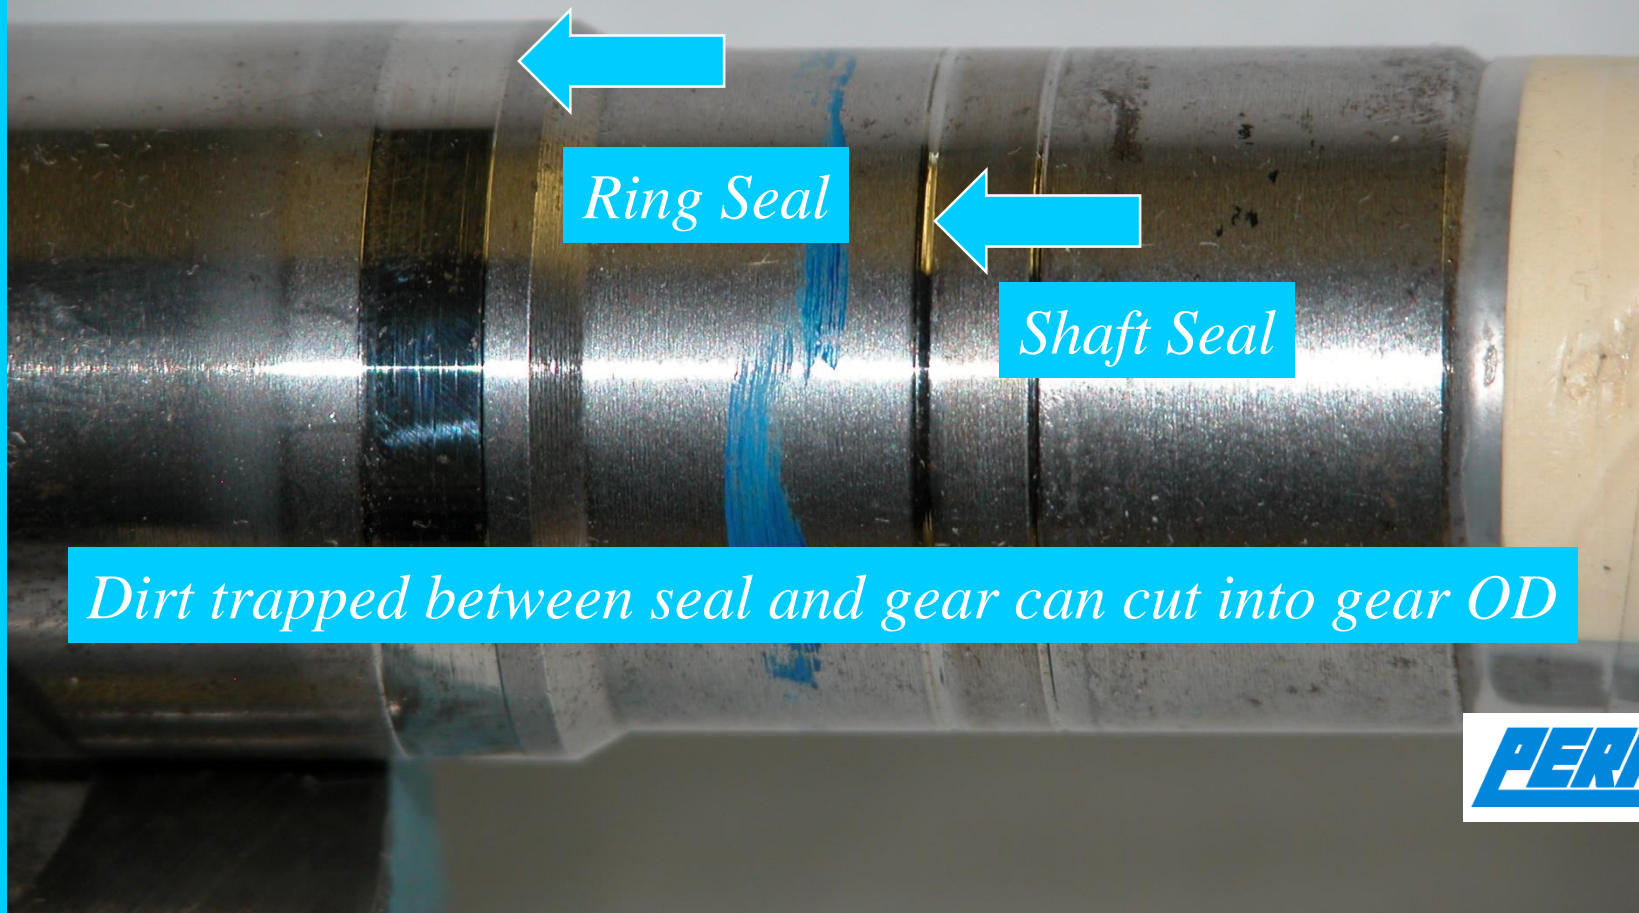
(11)

Dirt in Seal Area

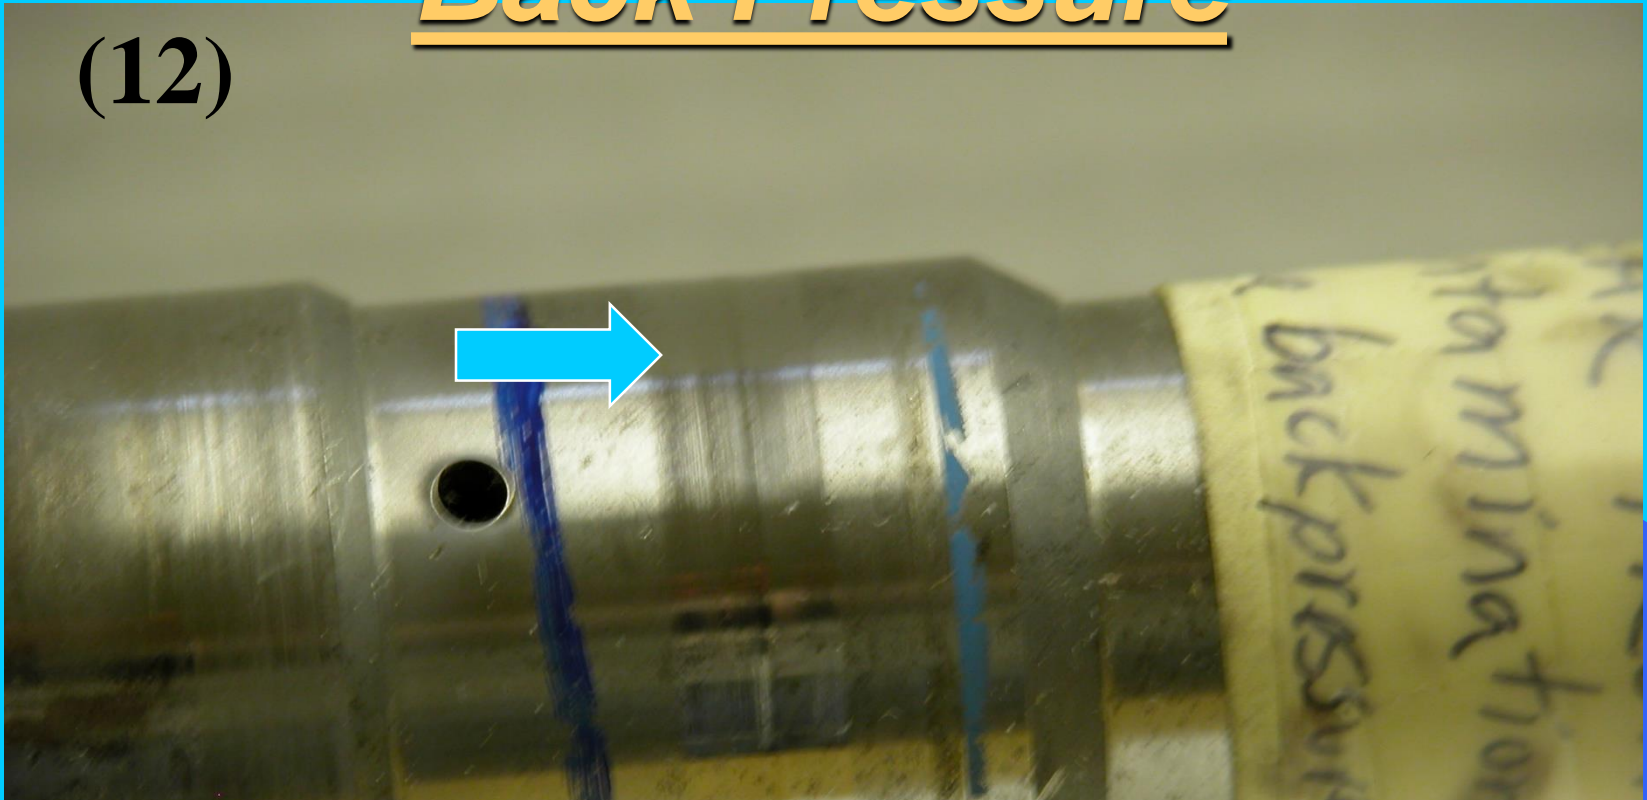
(12)

Back Pressure

Dirt and back pressure will cause grooves in seal area on motors

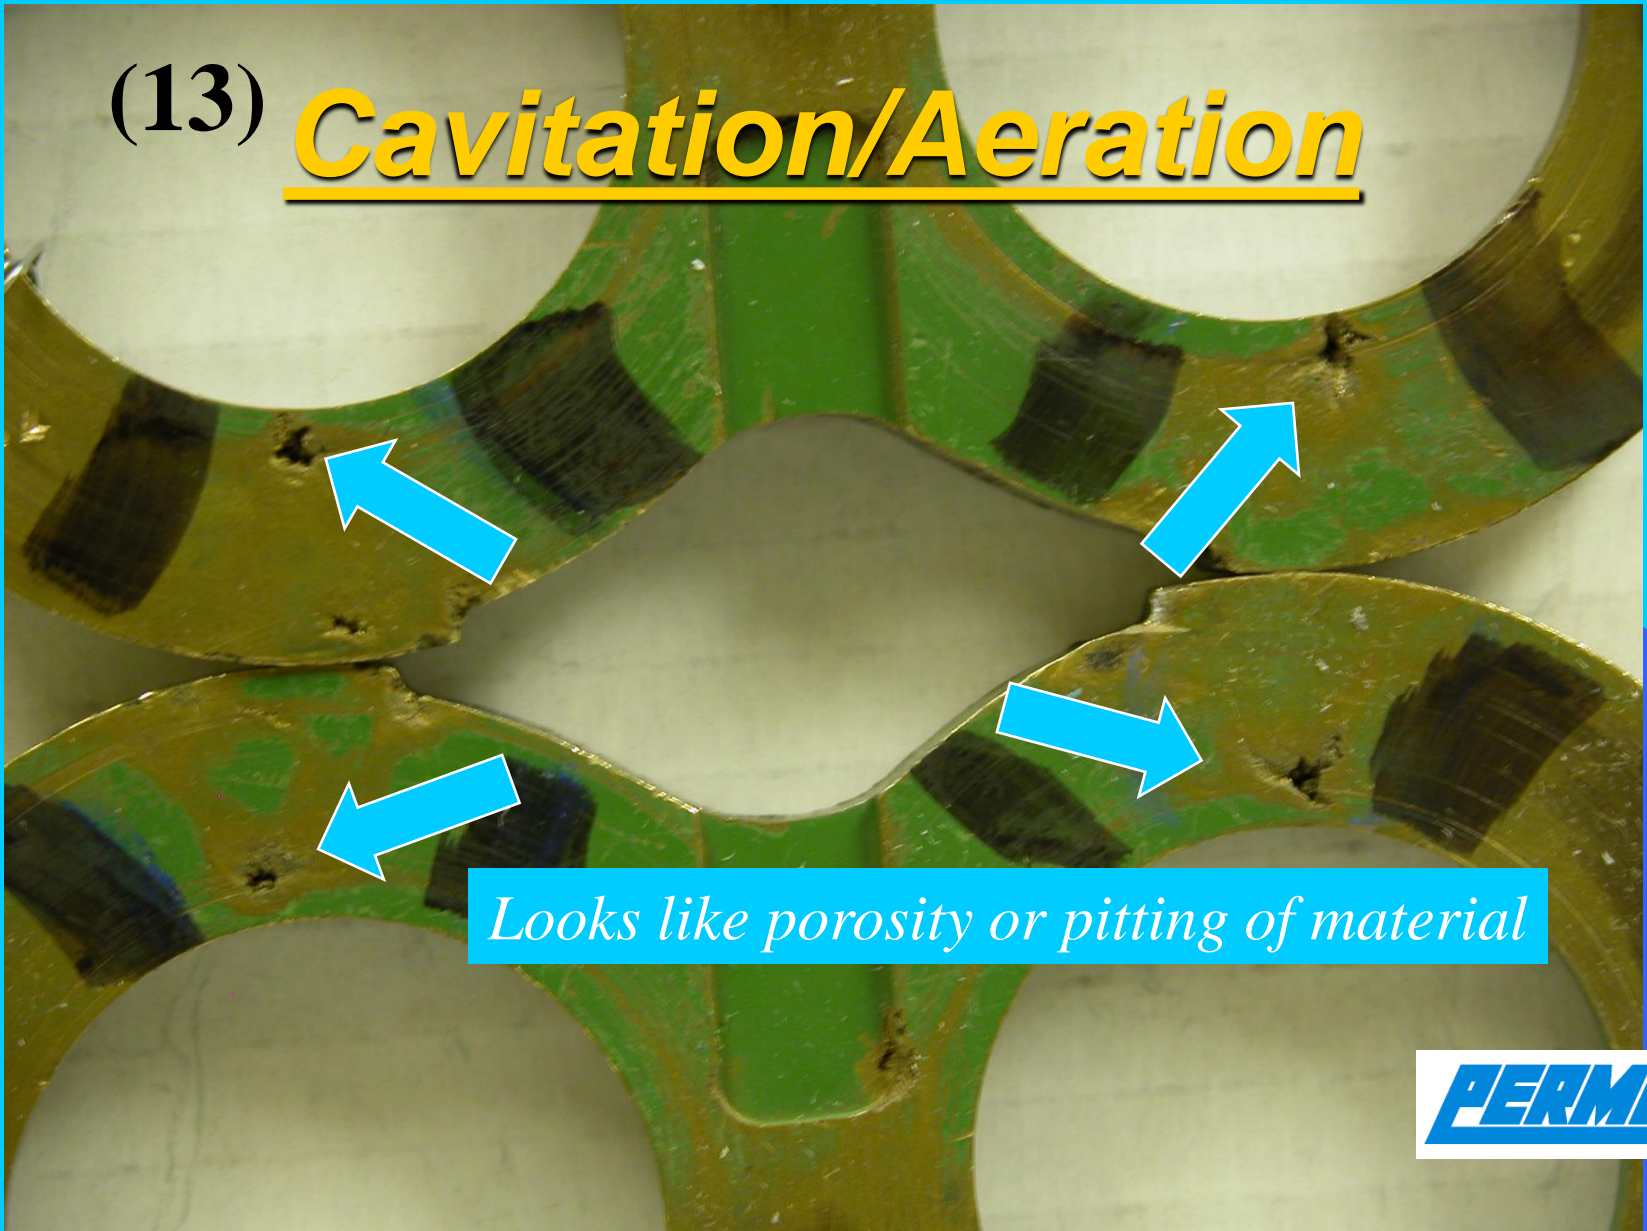
(13) Cavitation/Aeration

- *Cavitation or Aeration will cause localized heat and pitting at area of pressurization of gas, air or vapor.*
- *This pitting is generally most noticeable at the output side, on the wear plates.*
- *This may show up in gear housing as well.*

Looks like porosity or pitting of material

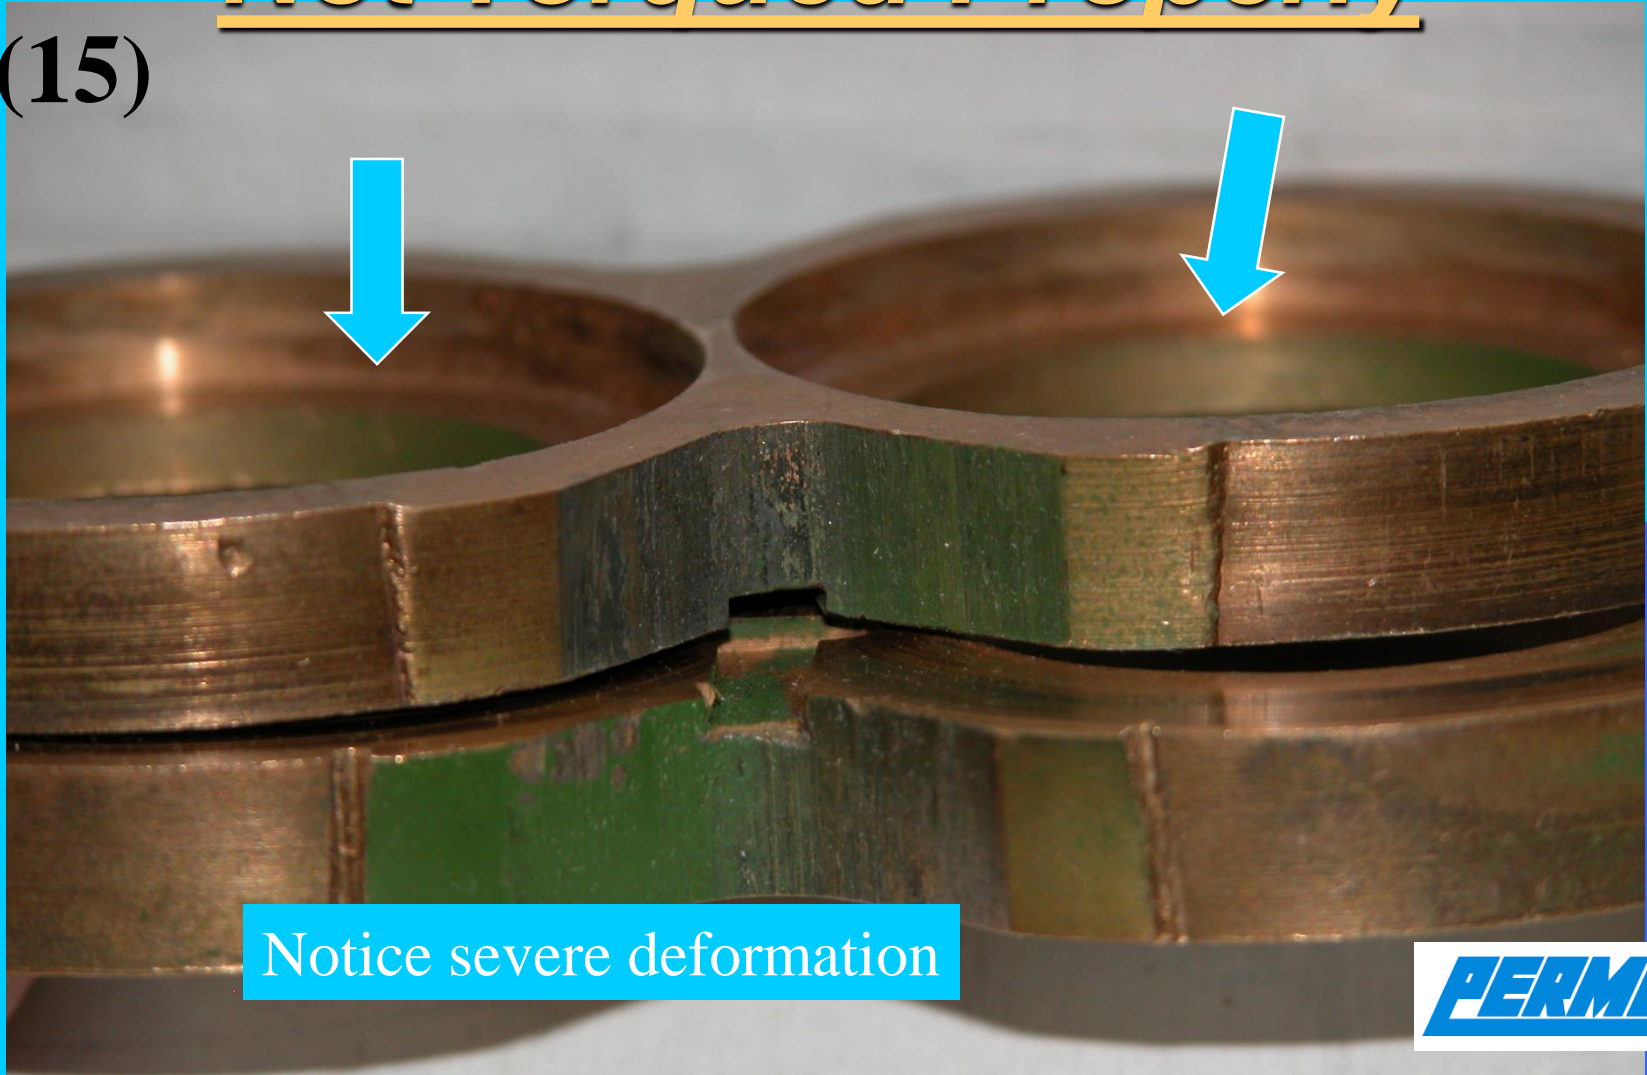
(15)

- *An improperly torqued unit (bolt or stud torque) will also cause housing to shift.*
- *Always check for proper torque before tear down and upon assembly.*

Not Torqued Properly

Notice severe deformation

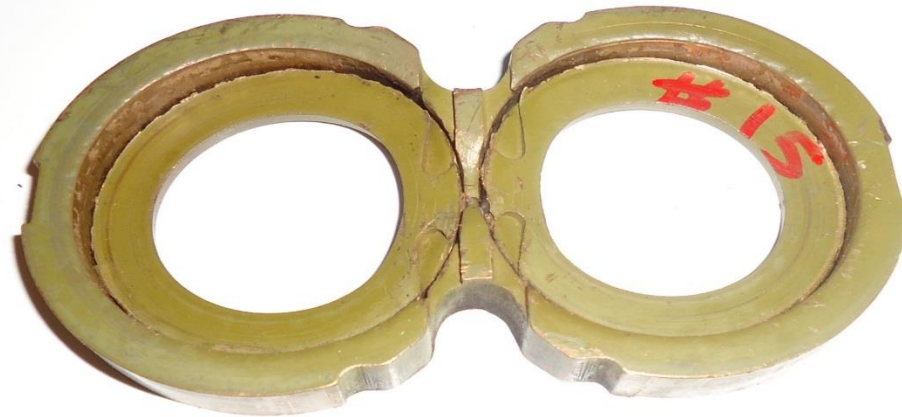
(16)

Plate upside down

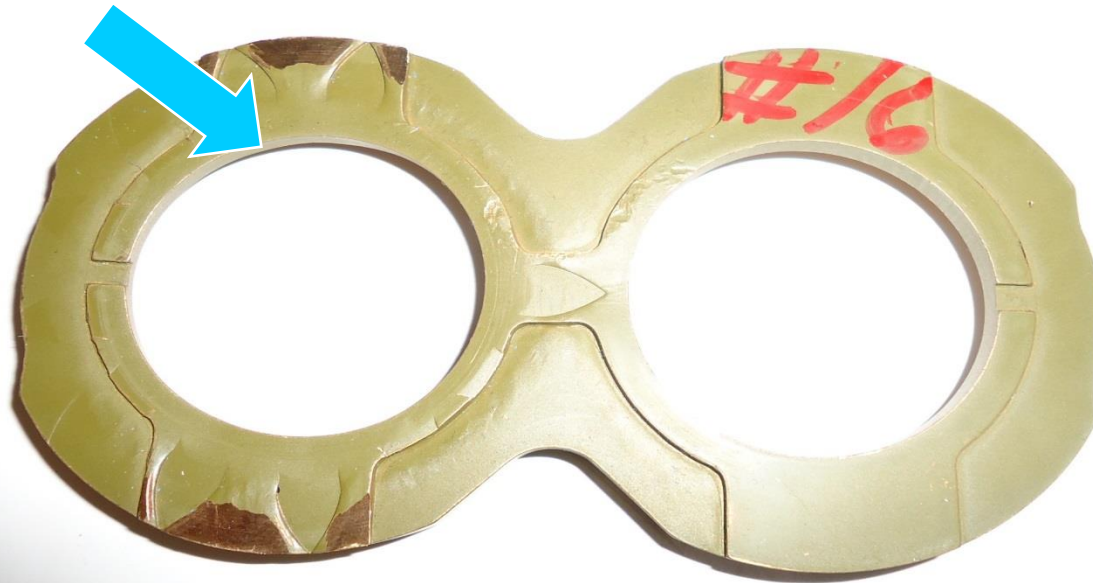
(17)

Drive gear forced into plate

Gear Teeth indentation

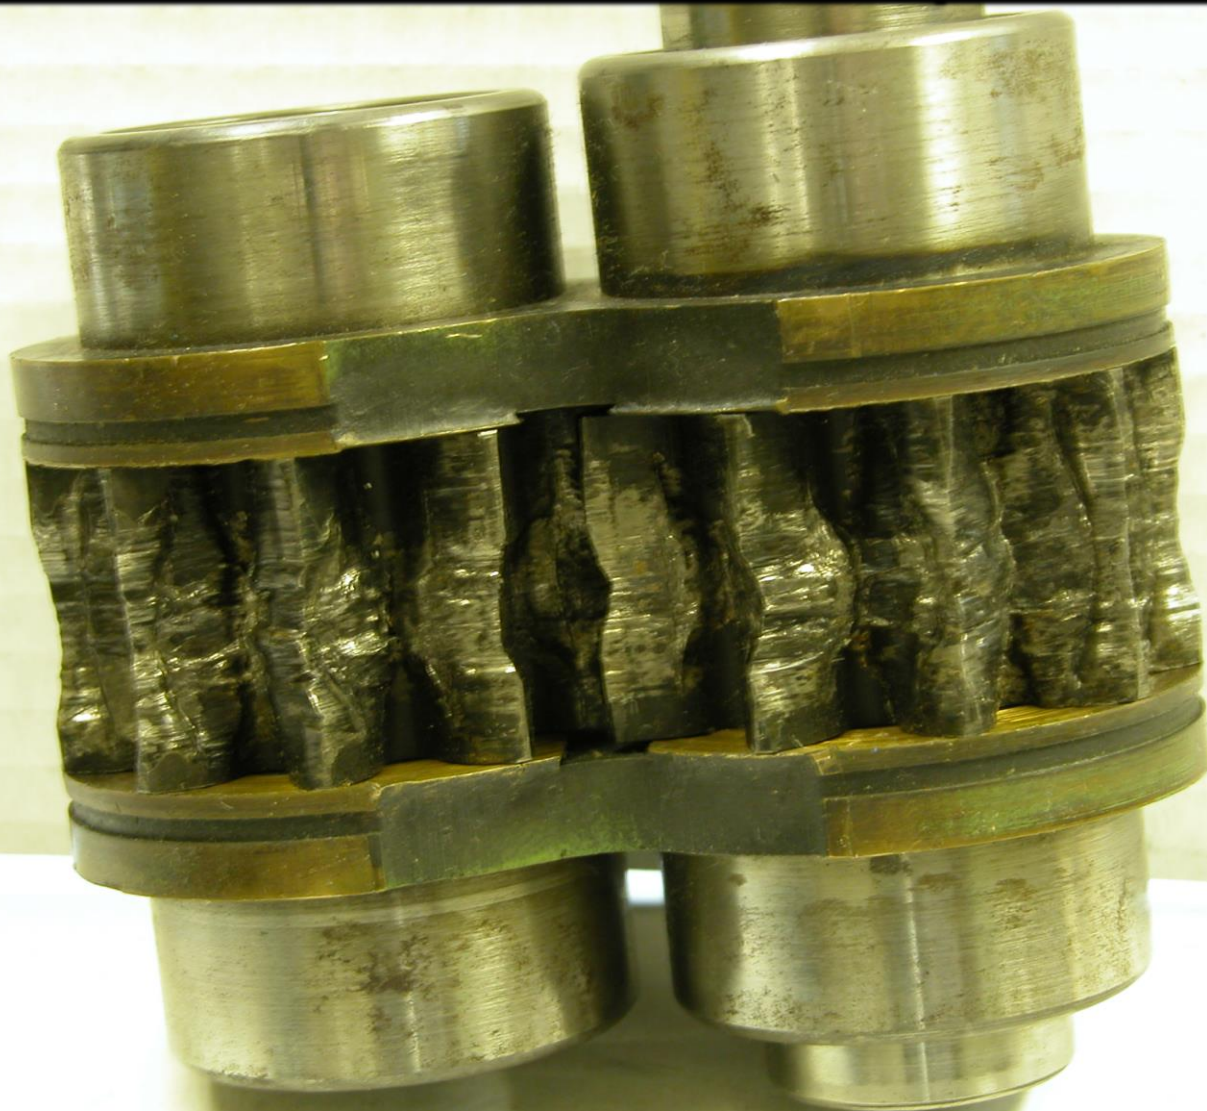
Lack of Lubrication (No Oil?)
