DUTCH CREEK WATERSHED LINEAR FEATURES CLASSIFICATION PROJECT

Submitted to:
Oldman Watershed Council

Submitted by:
**Applied Aquatic
Research Ltd.**
Calgary, AB

October 2014
File: AAR14-105

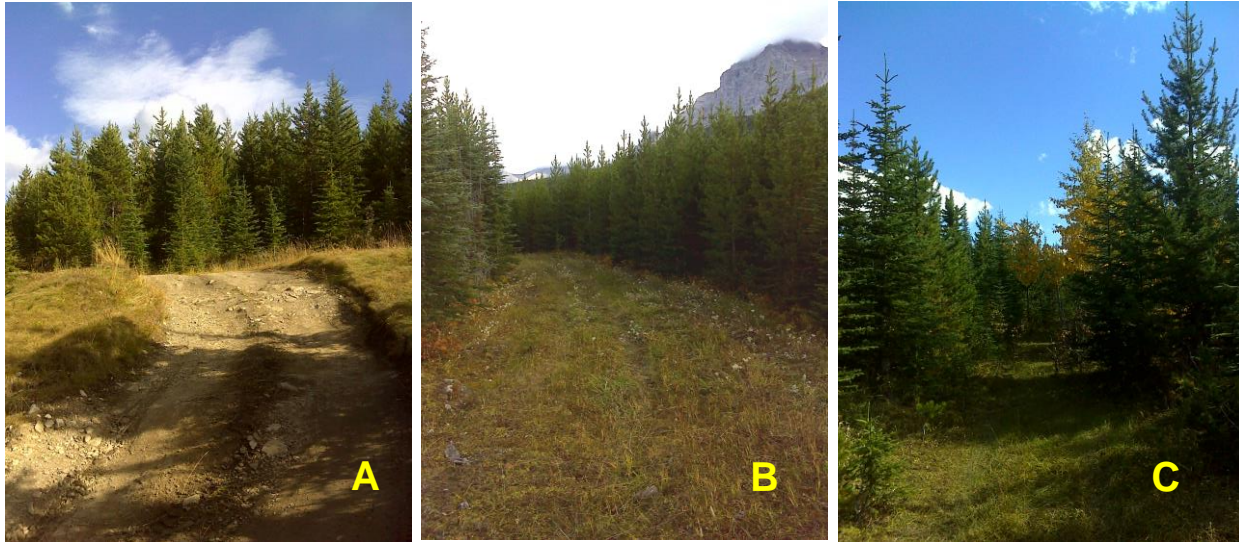
Plate 1 shows examples of active, enduring, and restored linear features, and the status of mapped linear features is shown in Map 2 (Appendix II). The intended and current use of each feature was identified where possible using knowledge of the surrounding environment and its characteristics. However, it was difficult to interpret the intended use of most linear features in the field without detailed background knowledge of the history of linear feature development in the watershed. Of the 205 classified segments, 74% are actively used, 18% are enduring, and 8% are fully restored such that the trail is representative of the adjacent native community. A small number of restored segments were identified due to the difficulty in distinguishing fully restored trails from their surroundings.

Plate 1. Examples of a) an active linear feature, b) an enduring feature, either abandoned or currently undergoing reclamation, and c) a feature undergoing restoration (please note that this was classified as restored in the field).

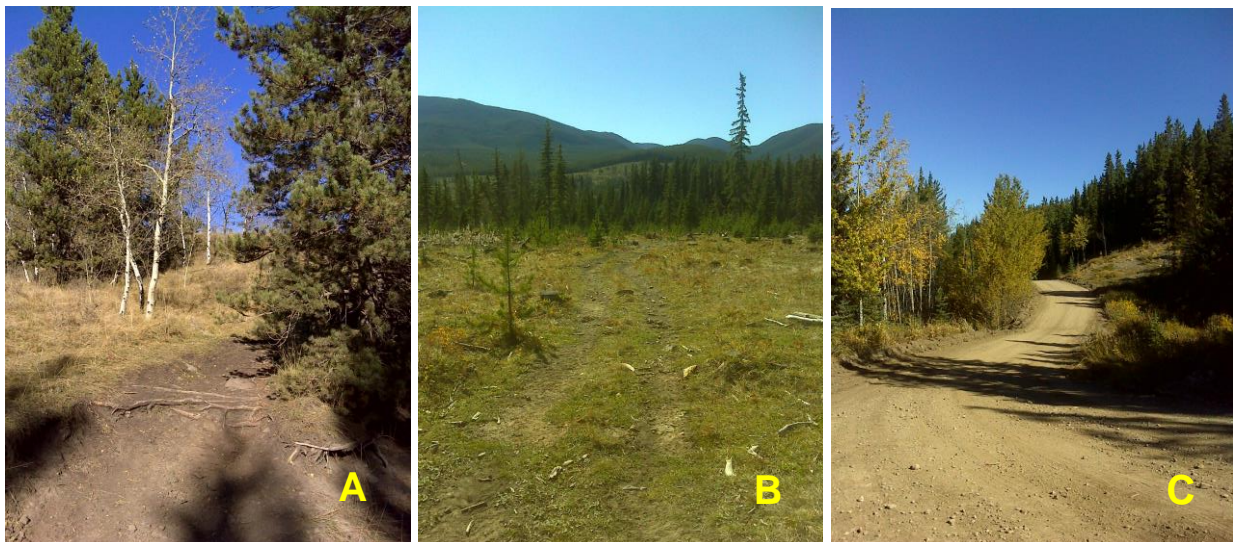
The erosion status of linear features in Dutch Creek is shown in Map 5 (Appendix II), and examples of an eroded, vegetated, and compacted linear feature are shown in Plate 2. The total distance and percent coverage for stable, eroded and restored linear features are summarized in Table 2.

Plate 2. Example of a linear feature that is a) eroded, b) vegetated, and c) compacted.

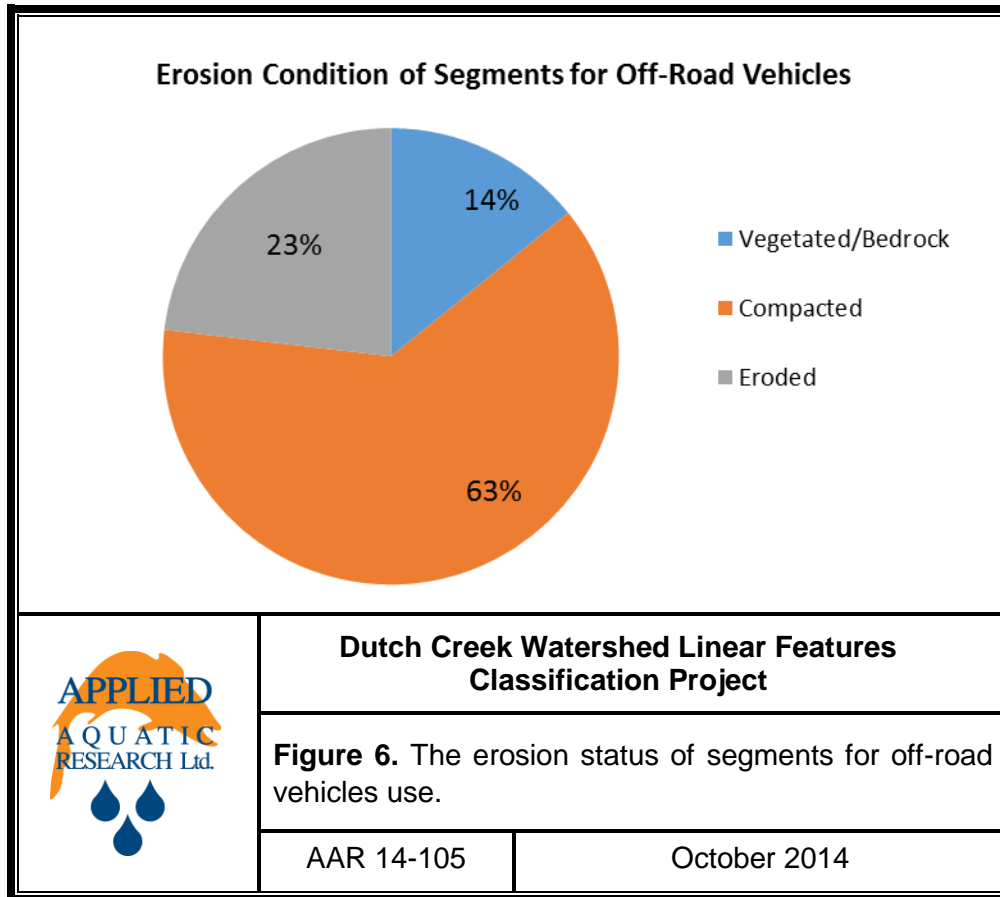
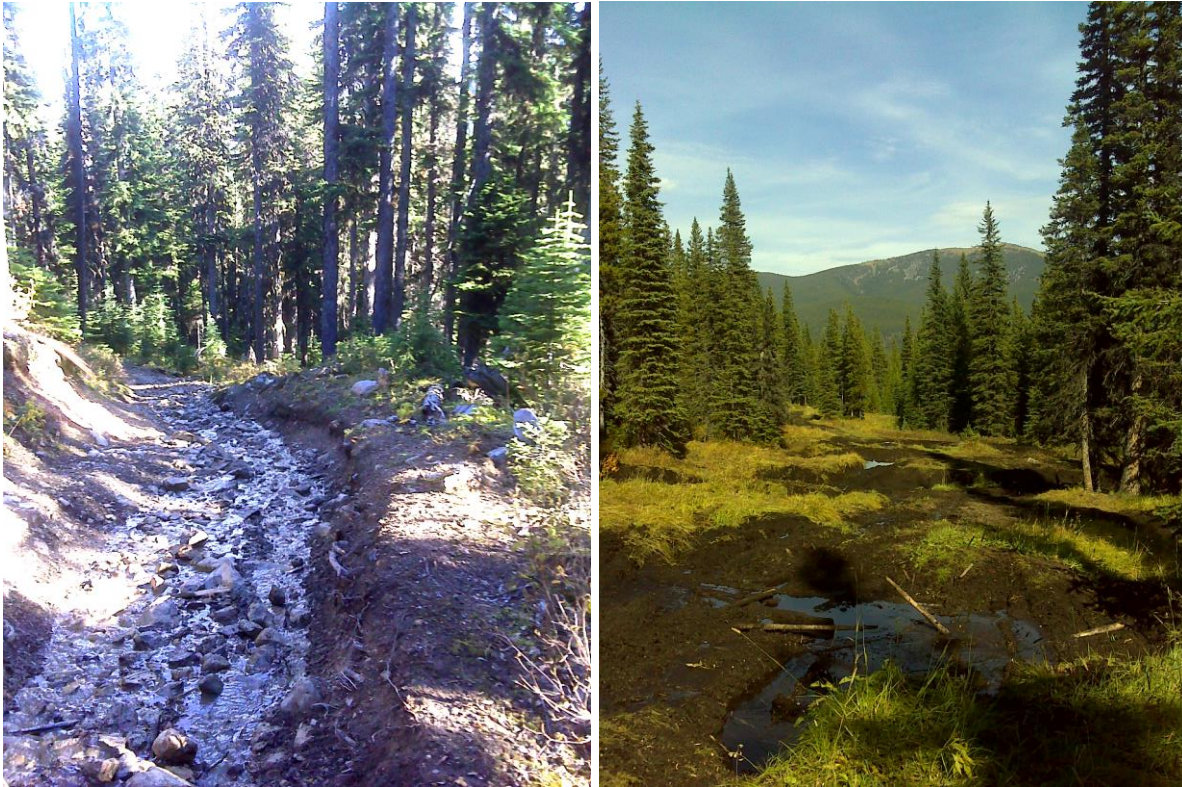
As the majority of segments in Dutch Creek are classified for off-road vehicle use, it is important to pay particular attention to the erosion condition of these features. Figure 6 summarizes the erosion status of all mapped segments used for off-road vehicle use. 23% of all off-road use segments showed signs of erosion. Erosion was most prominent on steeper features, where deep trenches were carved out by water drainage (Plate 3). Heavy erosion was also observed at random camping sites along the main access roads as a result of truck and recreational vehicle use, and most quad trailers were found at lower elevations.

Plate 3. Two photographic examples of ORV trails with deep ruts and erosion from water ponding and drainage.

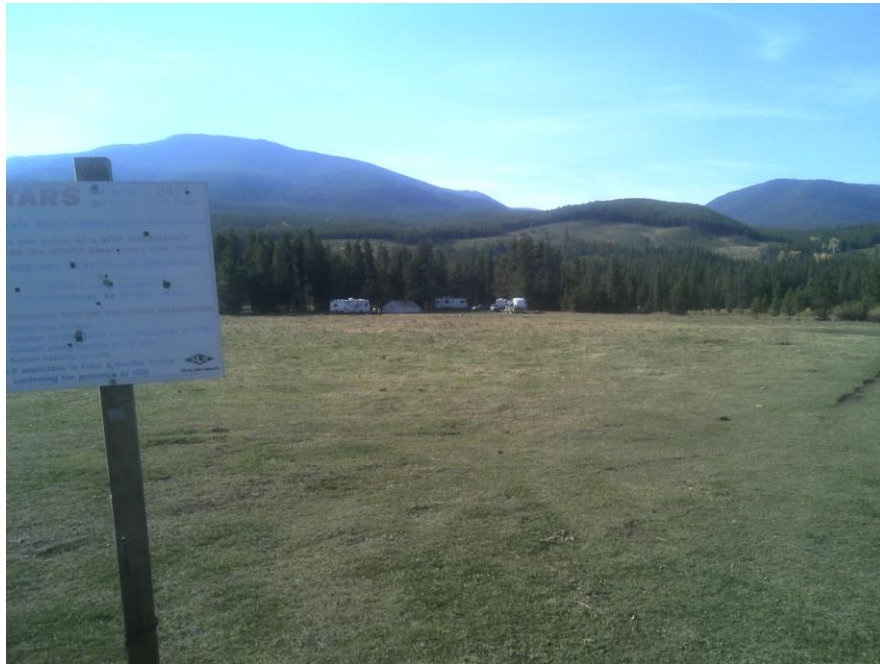
Caesar's Flat is an example of a node in Dutch Creek. It is popular for camping because it is large and flat, thus making it ideal for larger vehicles access (e.g., RVs, and truck trailers with ATVs). During the field program there was a large influx of visitors to Caesar's flat on the weekend, resulting in high use of trails and fords and increased litter near watercourses. As a result of high density camping at Caesar's Flat, many unregulated and short ORV trails originate in this area (Map 5). This is concerning as the quad trails around Caesar's Flat are heavily eroded from high traffic, and cross through watercourses that contain sensitive spawning habitat for Bull Trout (Map 6a).

Plate 4. RVs camping at Caesar's Flat, which is a point of interest and a node.

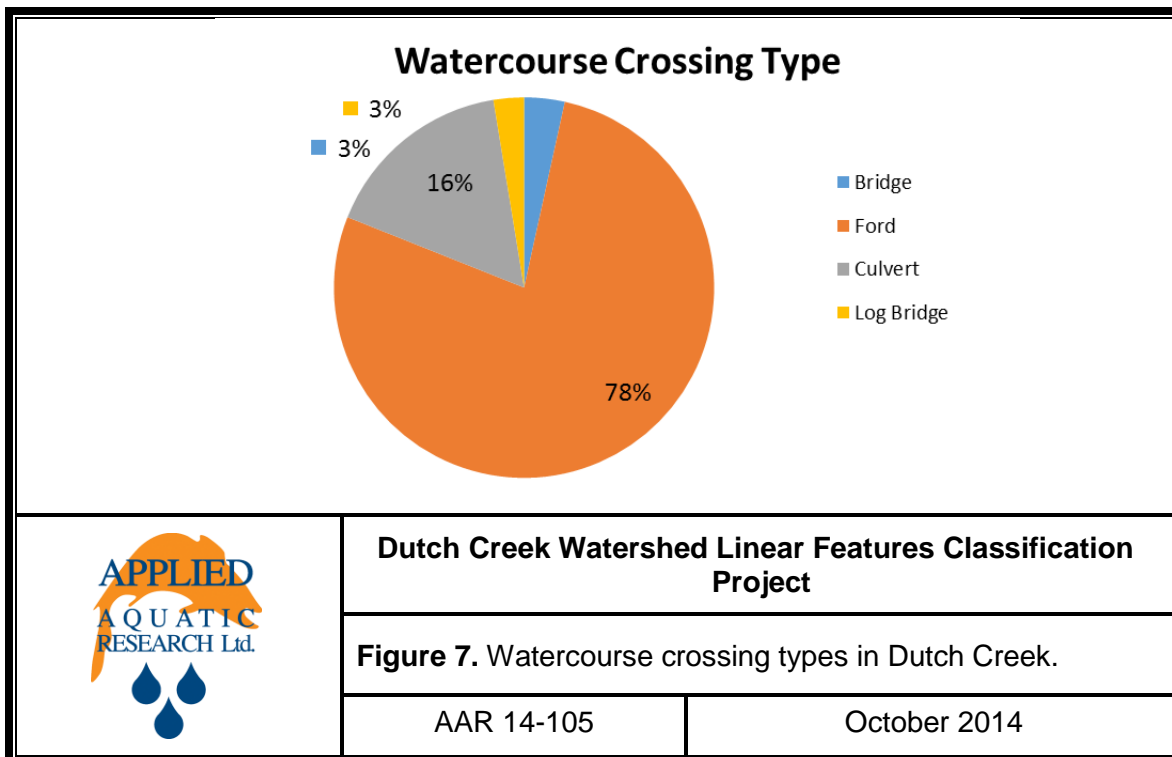
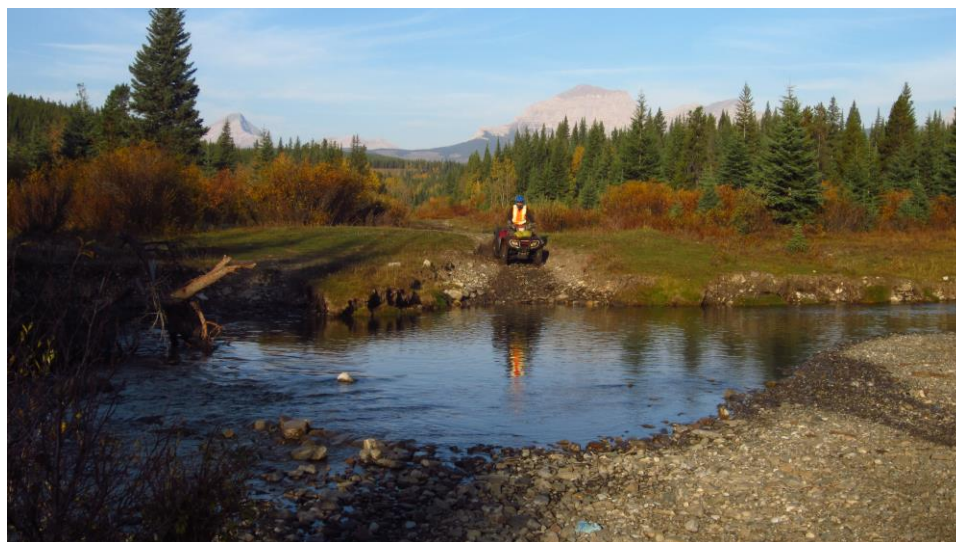
Plate 5. Photograph of an unregulated ford crossing at a large permanent stream showing widened bank widths at the crossing.

unprotected stream banks causes erosion and will subsequently widen the bank width at the crossing (Plate 5). This can lead to shallower flow for fish at the crossing and sediment release downstream. Field observation confirmed lesser fine sediments (“clean cobbles”) at ford crossings.

Based on our observations of watercourse crossings and redd distribution in Dutch Creek, bridges are recommended as alternative crossing method to unregulated fords in the west half of the watershed to minimize sedimentation in water. Crossing restoration is recommended in areas where bridges were wiped out by floods in order to decommission fords that have been formed since that time. A more in-depth stream assessment in high-risk areas would help determine whether crossings at Dutch Creek pose a risk to aquatic habitat. Bull Trout redd information needs be updated when survey data becomes available to determine the effects of floods on their population and distribution.

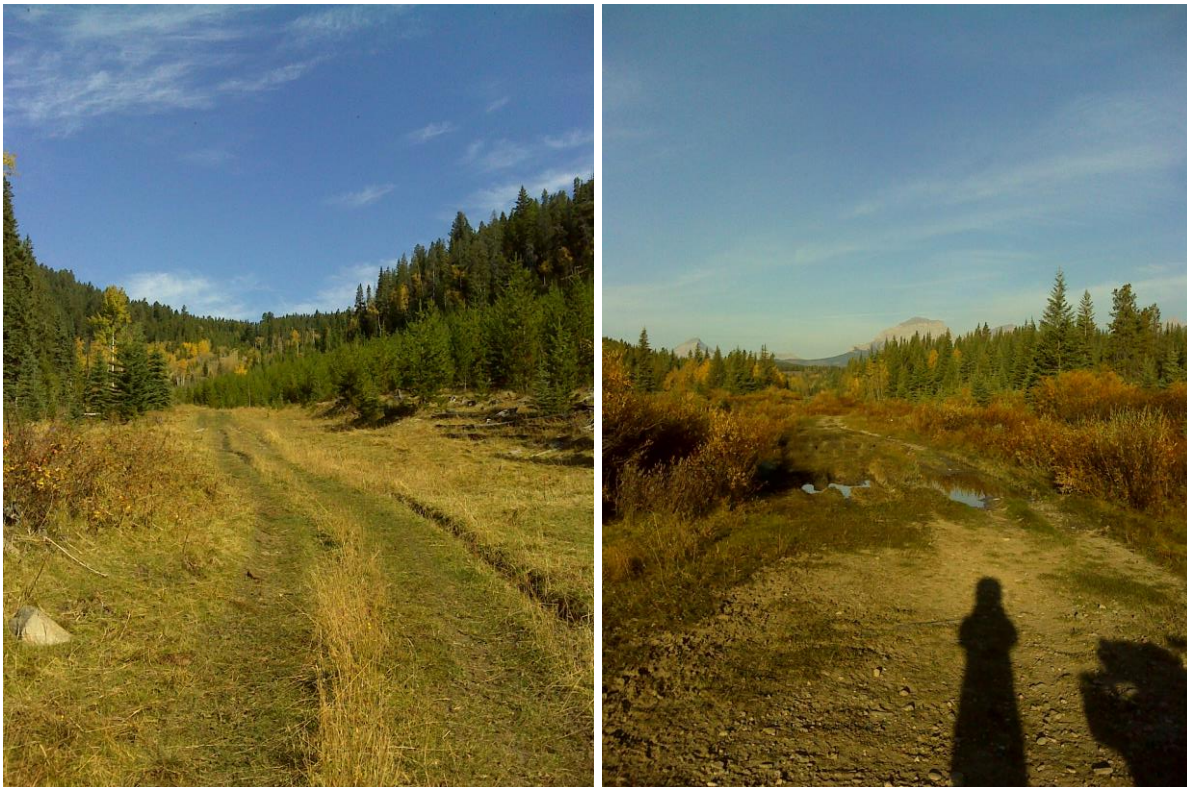
The key area for improvement in future mapping projects is the erosion assessment of linear features. The current classification divides all segments to three categories: vegetated/bedrock, eroded, and stable (compacted). The latter two classifications are largely subjective, and an eroded feature can maintain a stable status, though it is heavily used and compacted. The term “compacted” should replace “stable” to avoid the implication that these features do not effect surface runoff and erosion in the watershed. The vegetated/bedrock category should be a surface type classification parameter because it contains little information about the overall stability of the linear feature. Vegetated linear features in the field can be stable from restored vegetation growth over time, or unstable if the feature is located in a low-lying wet area that is prone to erosion (Plate 6). This ambiguity also applies to bedrock linear features, as their stability largely depends on whether the surface type is scree.

Plate 6. Photographs of two linear features categorized as “vegetated” in the erosion assessment but have a very different erosion status.

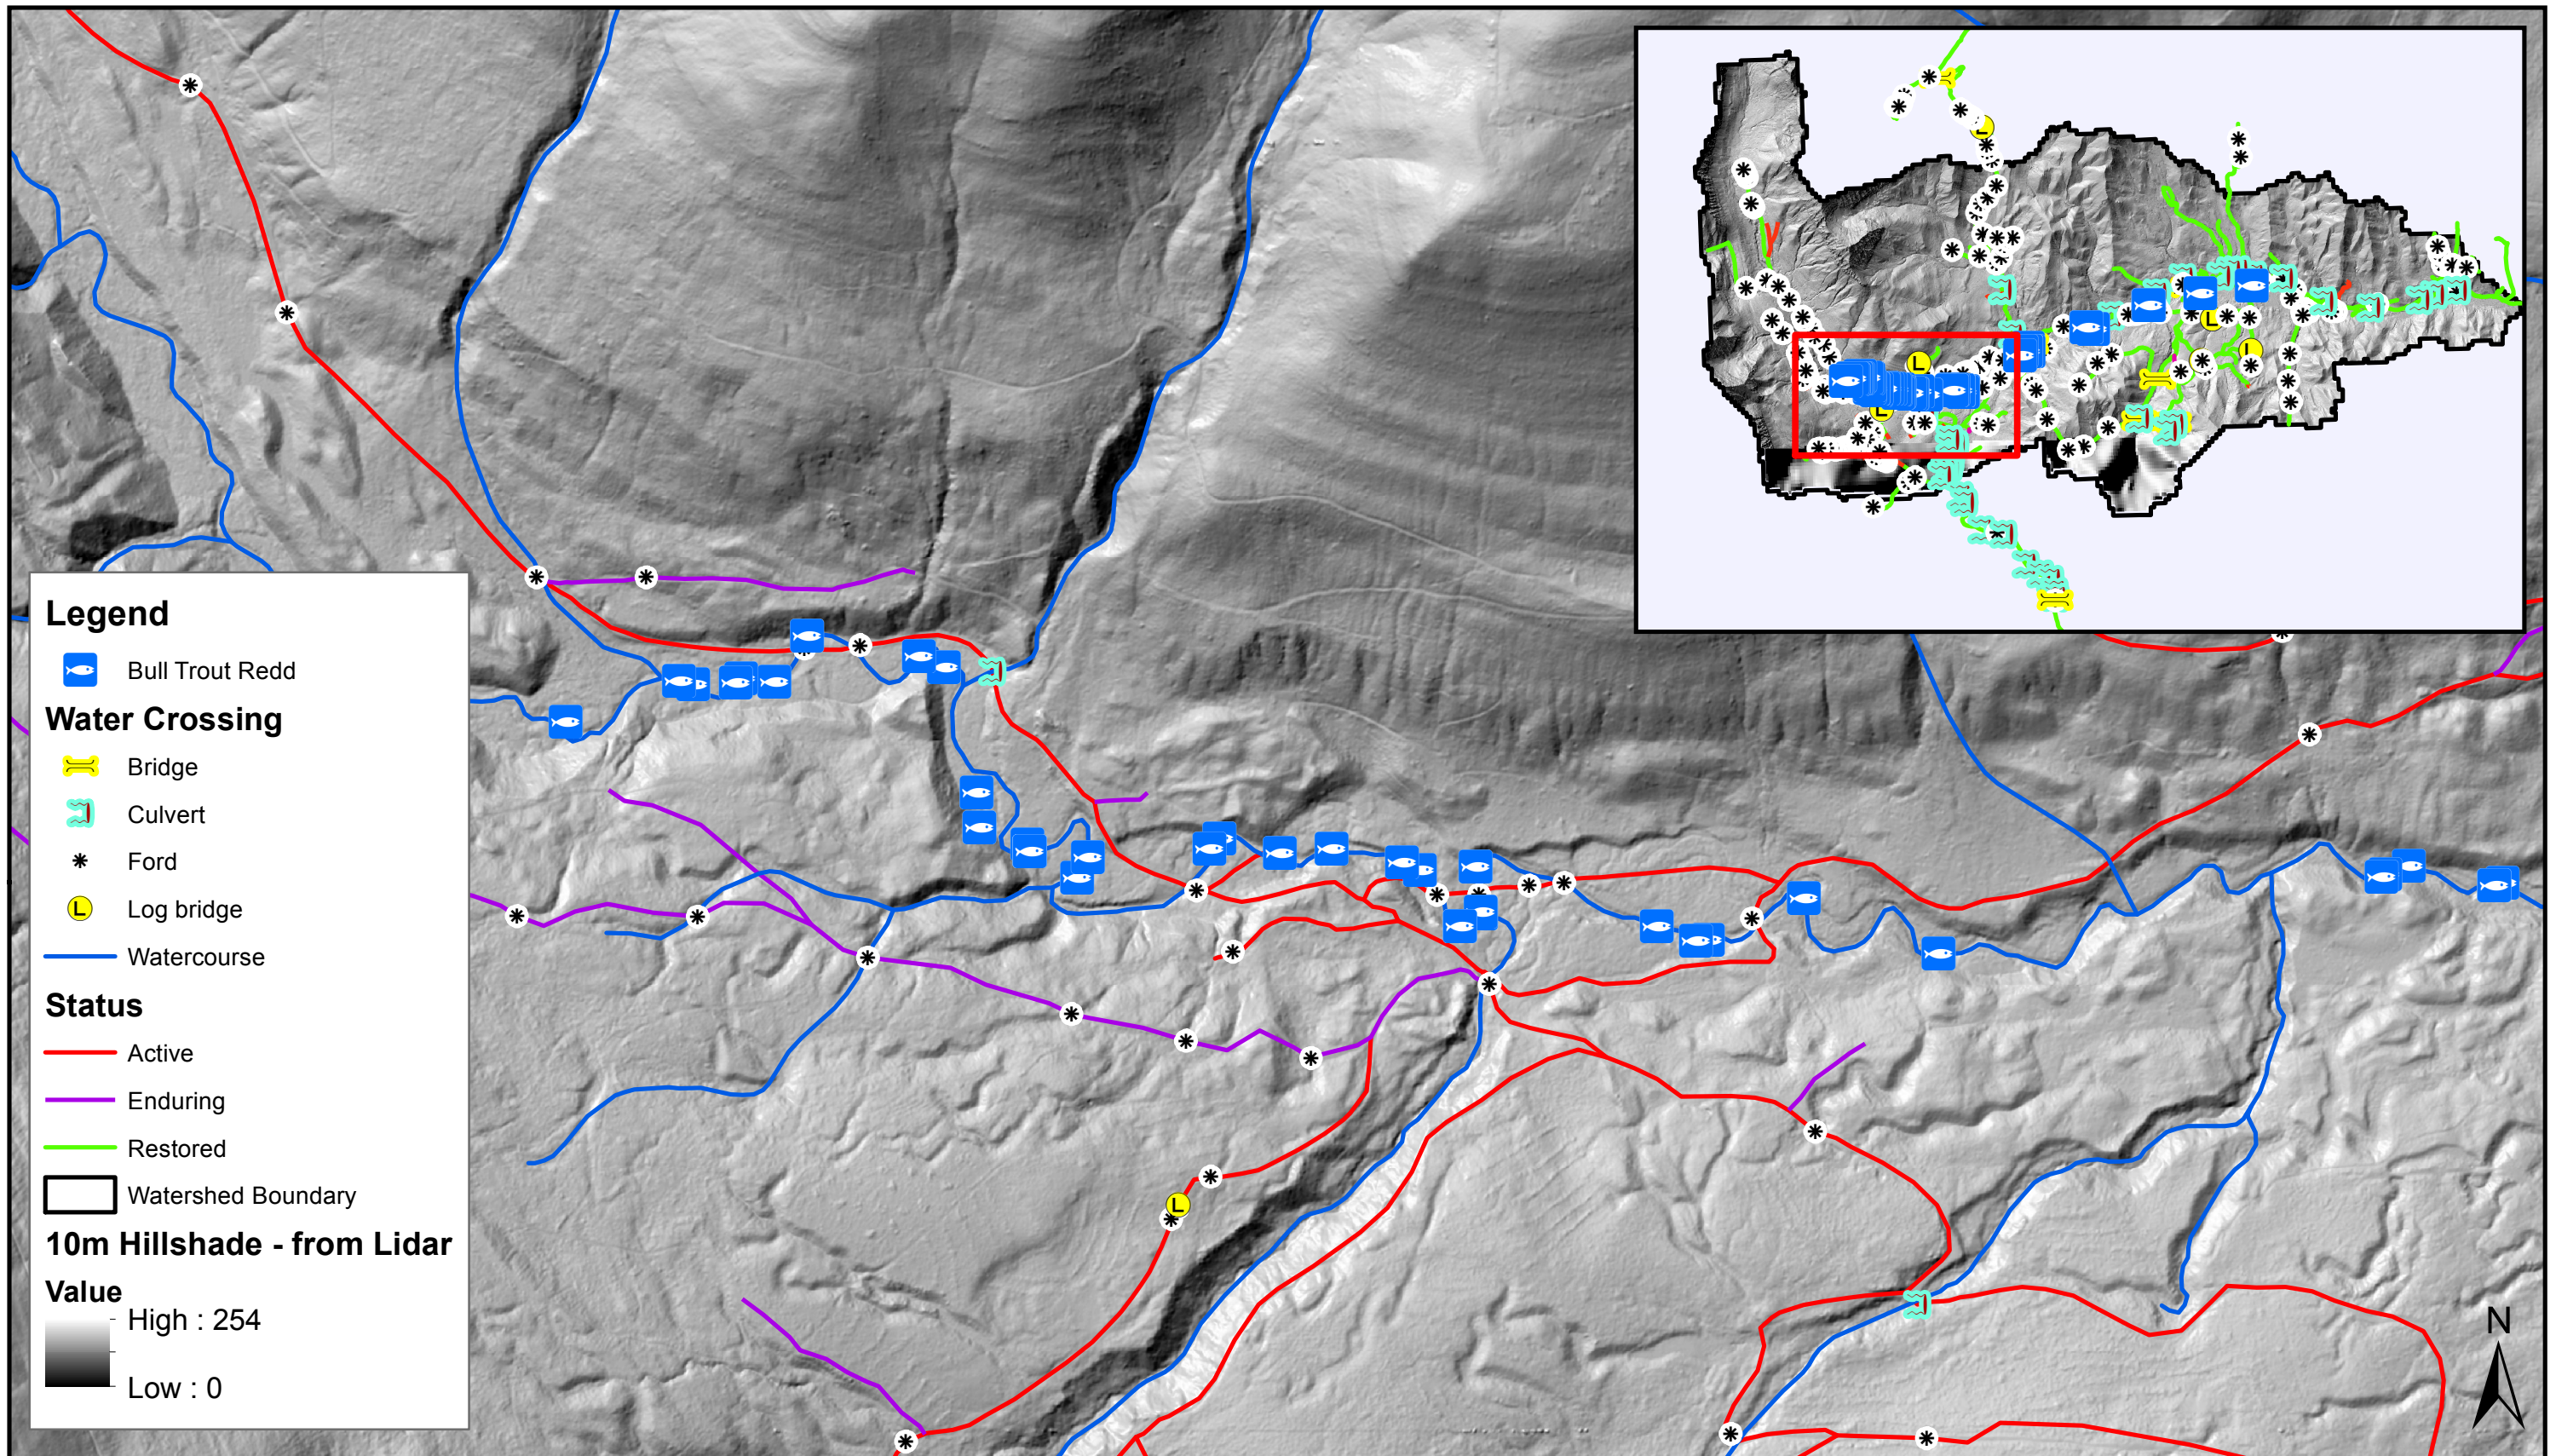
Map 6b - Dutch Creek Watershed - Sub Area of Management Concern

A map of watercourse crossing locations and types in relation to Bull Trout spawning areas surveyed by ESRD in 2012 is shown in Map 6a (Appendix II). There is a high density of unregulated ford crossing in the west half of the watershed, which overlaps with 70% of redds surveyed in 2012 (Maps 6b and 6c). This is problematic because the decline in Bull Trout distribution and population has been accelerated by habitat degradation (Hurkett et al., 2011 and Government of Alberta, 2014).
