Christ Church Cathedral

Materials, Conditions, & Preservation Recommendations

Preservation Technology (PRST6720)
Master of Preservation Studies
Tulane School of Architecture
Spring 2015

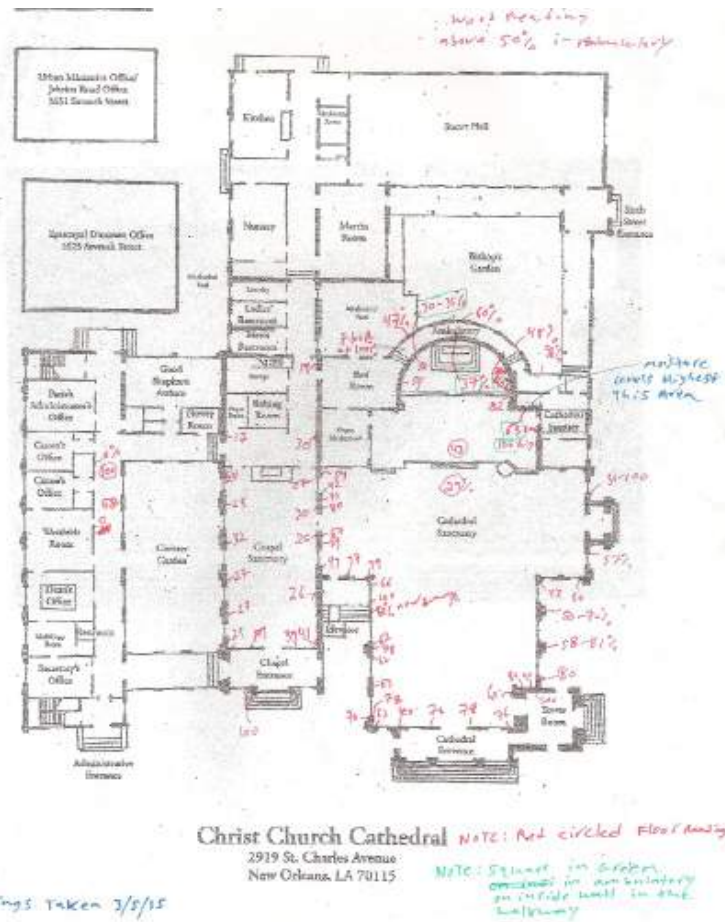
While the cathedral showed evidence of high moisture content within certain wall locations, the chapel did not. This could be attributed to the recent opening of the crawl space vents on the Seventh Street side of the chapel to allow for adequate air flow, negating further rising damp. The Seventh Street wall of the chapel on the interior had moisture readings that showed the walls to be low in moisture with readings from 24% to 32% moisture content/saturation at 4 feet above the floor. One reading in the middle section of this wall read that one foot above the floor was at 72%, four feet above floor at 30%, and eight feet above the floor at 25%, which shows the typical pattern of rising damp. The wall of the chapel closest to Sixth Street showed higher moisture meter readings that ranged from 26% to 47% moisture content/saturation at 4 feet above the floor. One reading closest to St. Charles Avenue on the Sixth Street side wall read that one foot above the floor was at 40%, four feet above floor at

Figure 2.5: Plan of Christ Church Cathedral Showing Moisture Readings at Four Feet. Readings by John Rupley, 2015

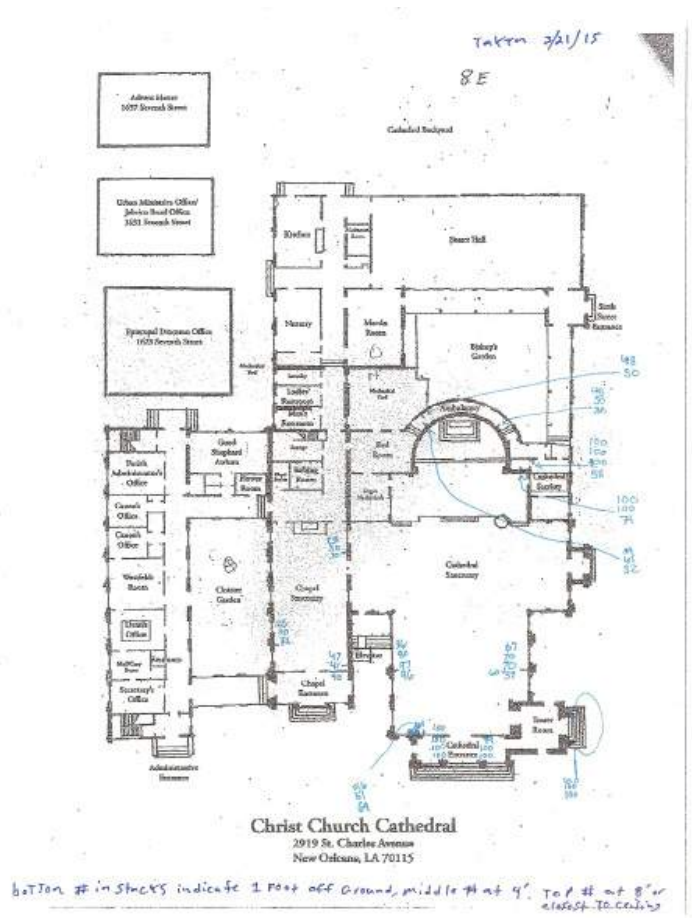
Figure 2.6: Plan of Christ Church Cathedral Showing Moisture Readings at Spot Locations at One, Four, and Eight Feet. Readings by John Rupley. 2015

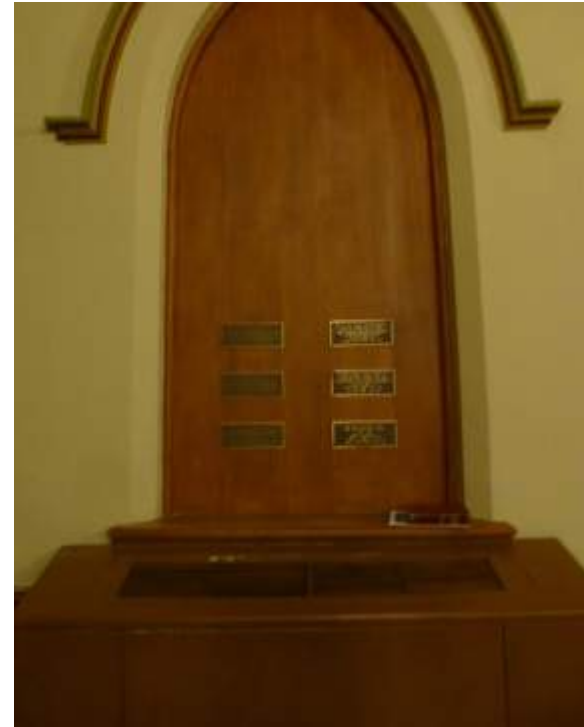
Severe weather has been the leading cause of past interventions. Additionally, a window was removed or destroyed when the ventilation system was being updated¹⁰ and has been replaced with a wooden panel (see Figure 1).

Figure 3.6: Wooden board where stained glass window used to be

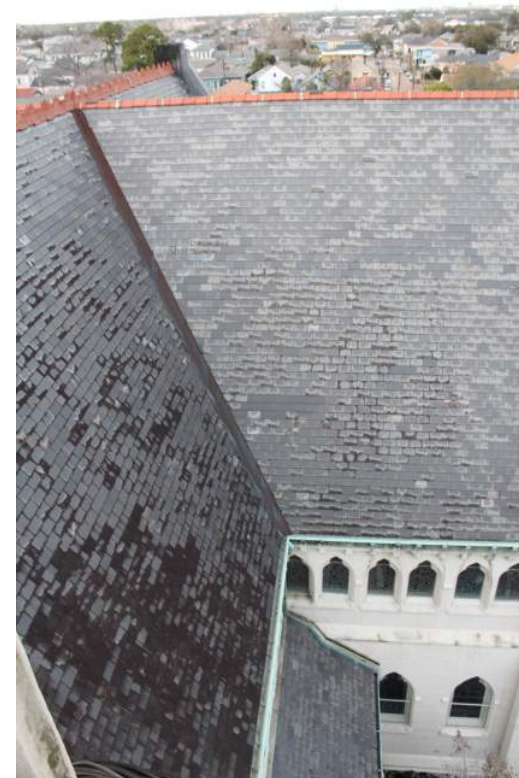
Figure 4.3: Ridge condition of the cathedral roof. Photo by Cody Ellis, 2015.

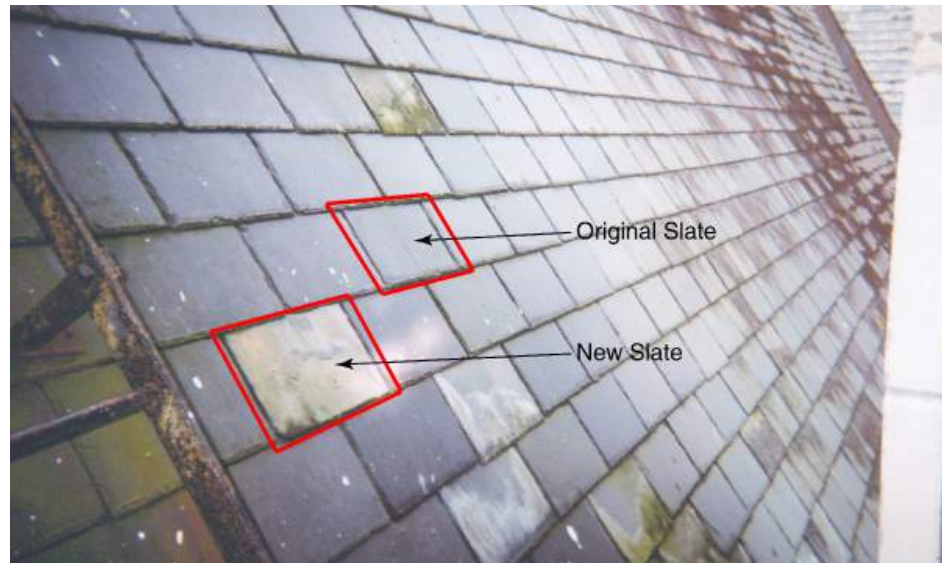
Figure 4.16: New vs old slate shingles. Photo courtesy of Dimitri Roby, 2014.

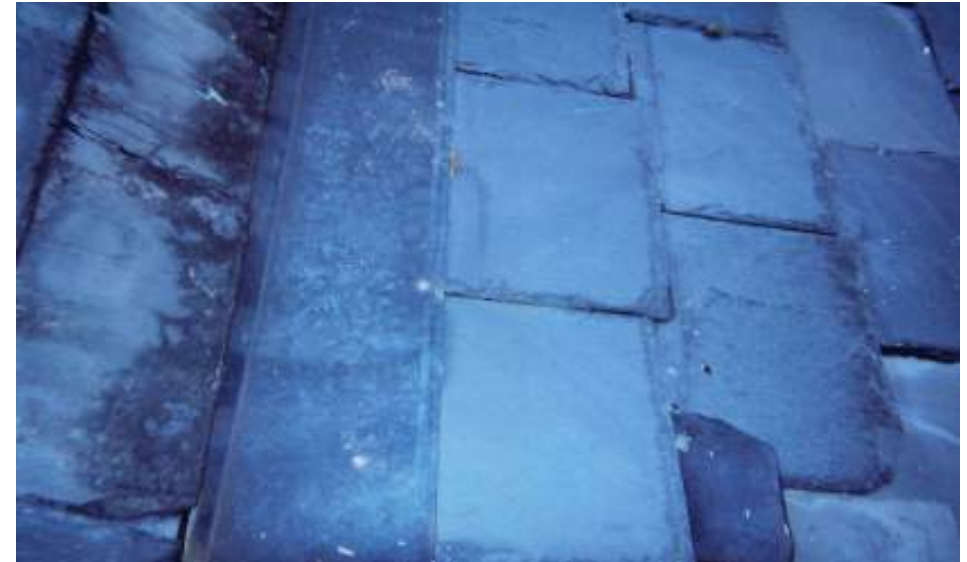
Figure 4.17: Broken shingles. Courtesy of Dimitri Roby, 2014.

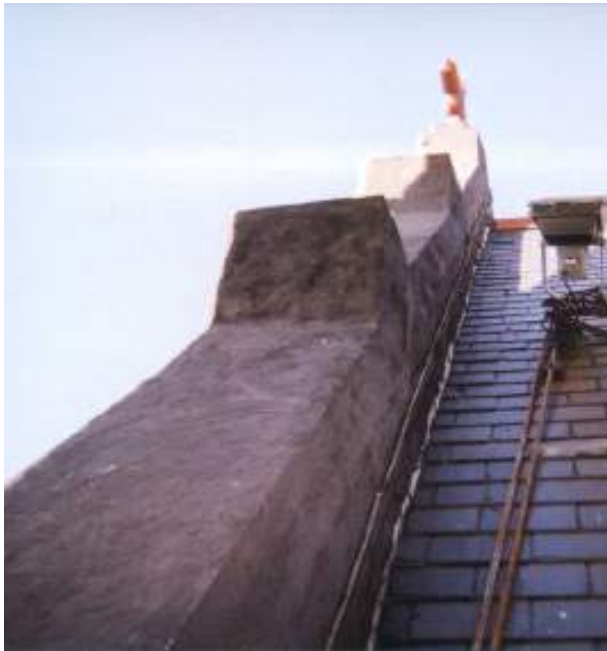
Figure 4.18: Tarred flashing by parapets. Courtesy of Dimitri Roby, 2014.

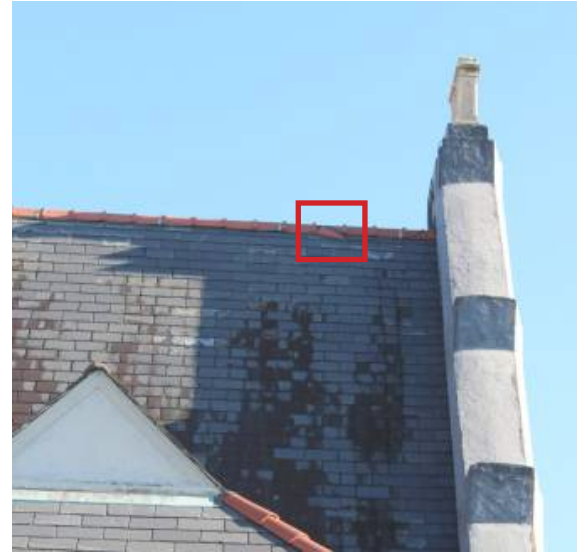
Figure 4.20: Damaged ridge cap. Photo by Cody Ellis, 2015.

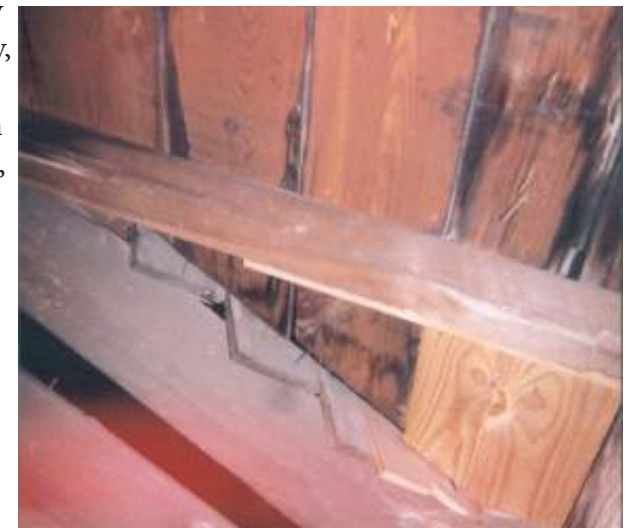
Figure 4.21: Nails protruding through sheathing. Courtesy of Dimitri Roby, 2014.

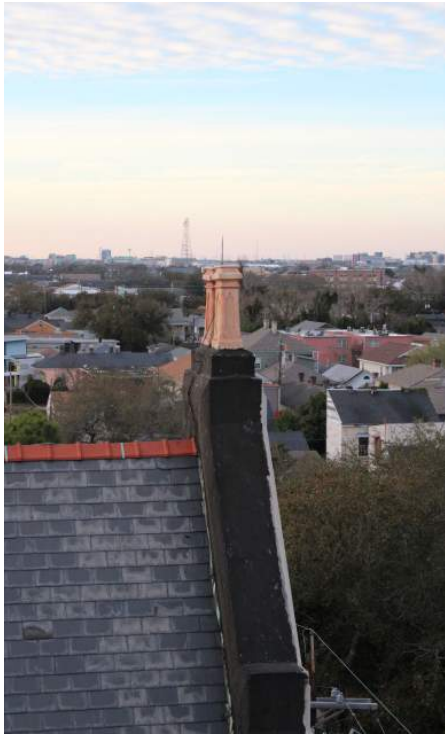
Figure 4.22: Tarred parapets.
Photo by Cody Ellis, 2015.

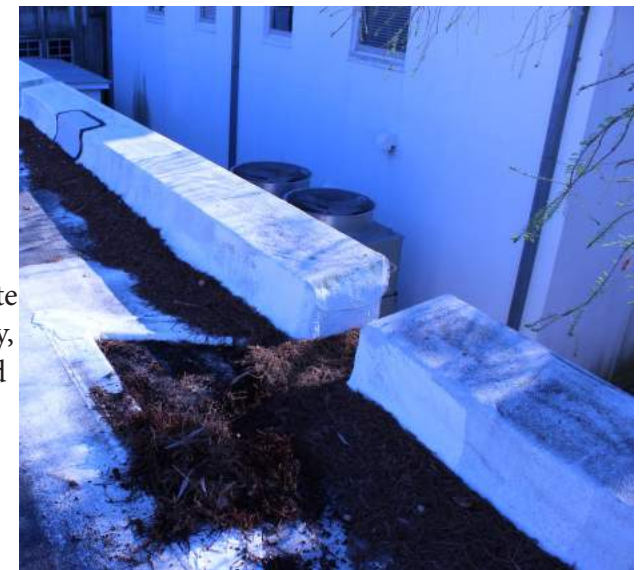
Figure 4.31: Current build up on flat roof overlooking courtyard
Photo Christine Carlo, 2015

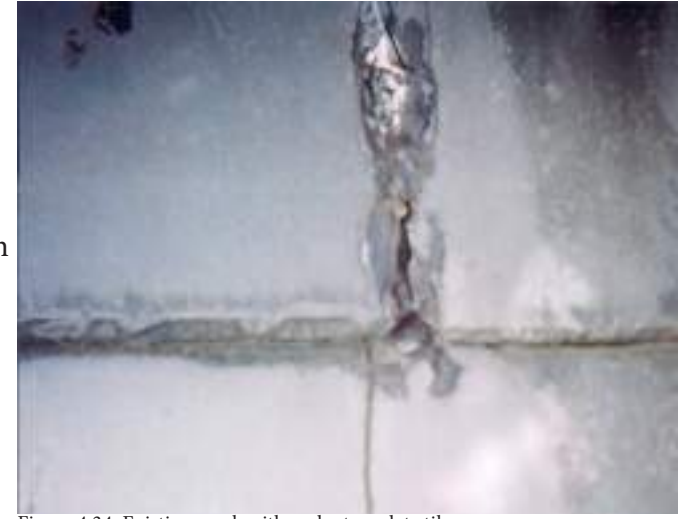
Figure 4.34: Existing crack with sealant on slate tile
Photo courtesy of Dimitri Roby, 2014.

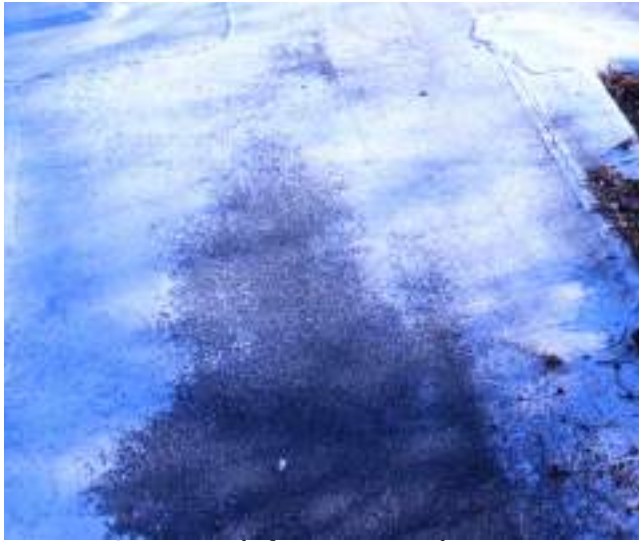
Figure 4.35: Current wear of reflective paint on roof
Photo courtesy of Christine Carlo, 2015

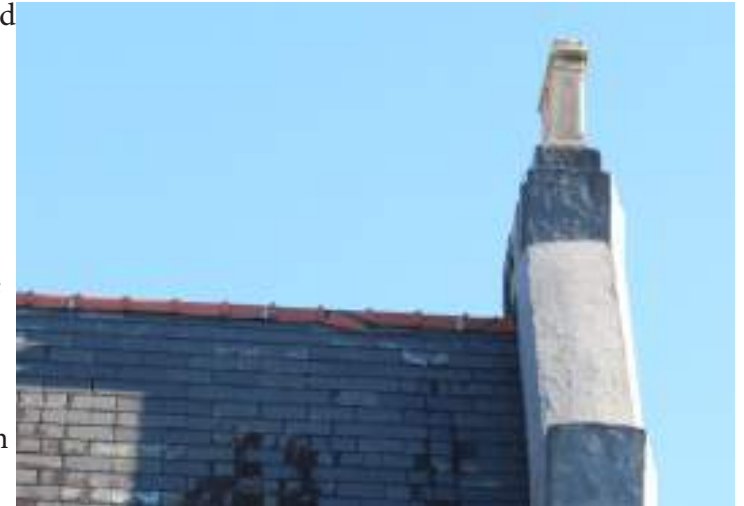
Figure 4.37: Broken finial on north ridge
Photo courtesy of Cody Ellis, 2015

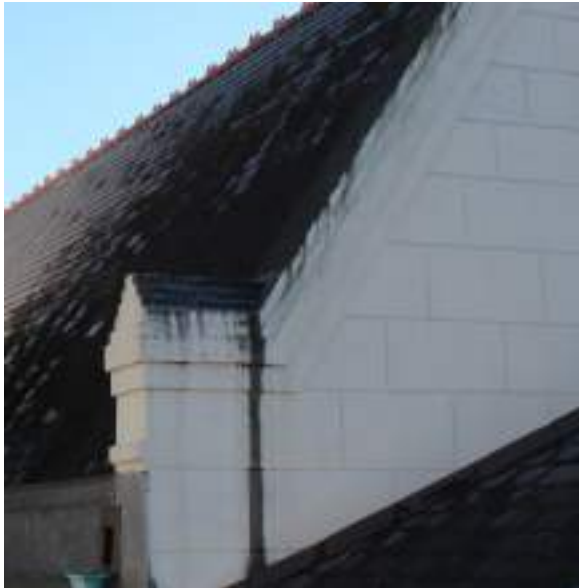
Figure 4.39: Tar covered parapits over chapel
Photo courtesy of Cody Ellis, 2015

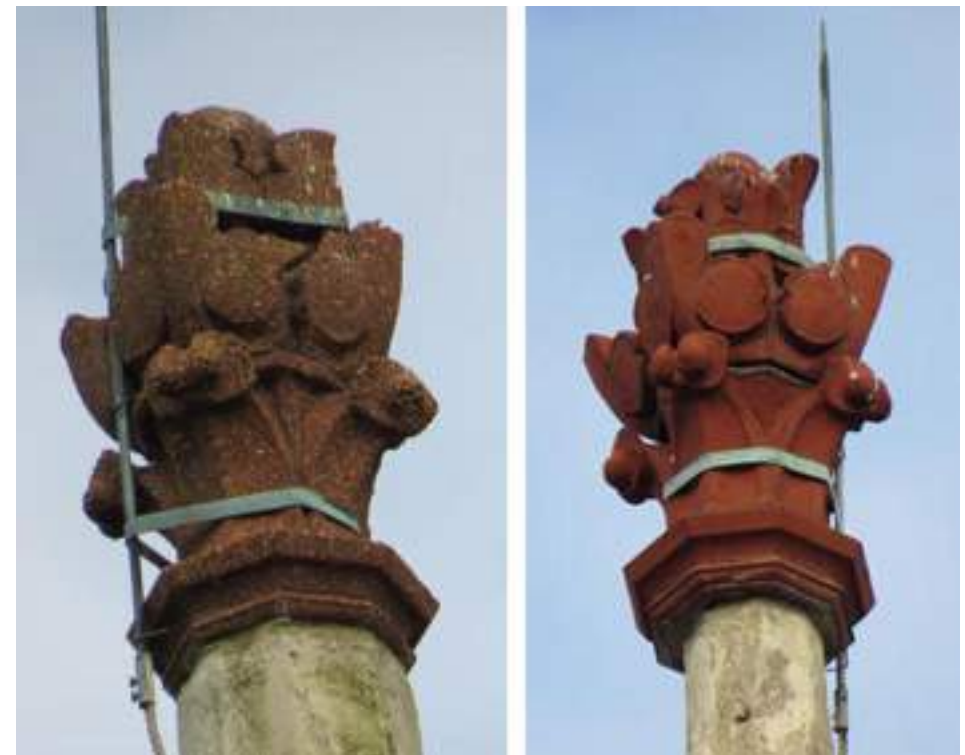
Figure 5.5-5.6 : Tower Finials: in poor condition on the left and fair condition on the right. Photos by Laura Stokley, 2015

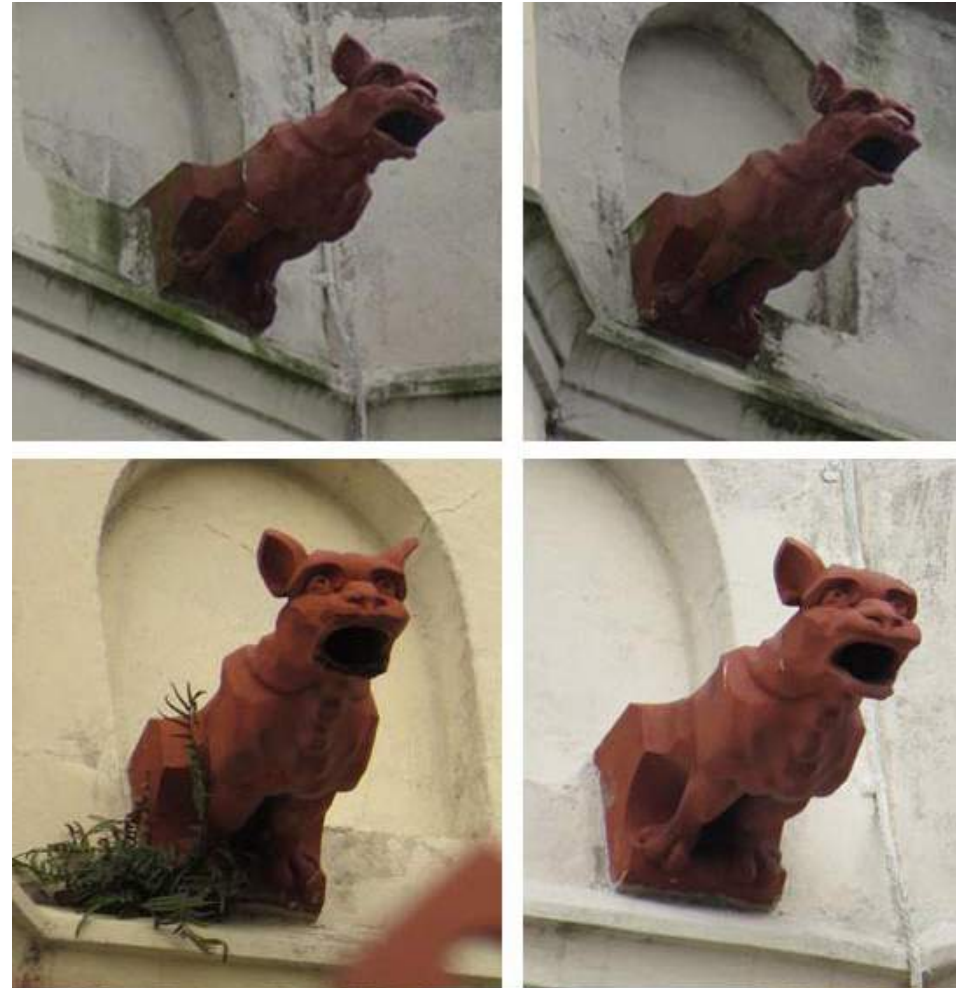
Figure 5.17-5.20 : Tower gargoyles showing bio growth, ferns and staining. Photo by Laura Stokley, 2015

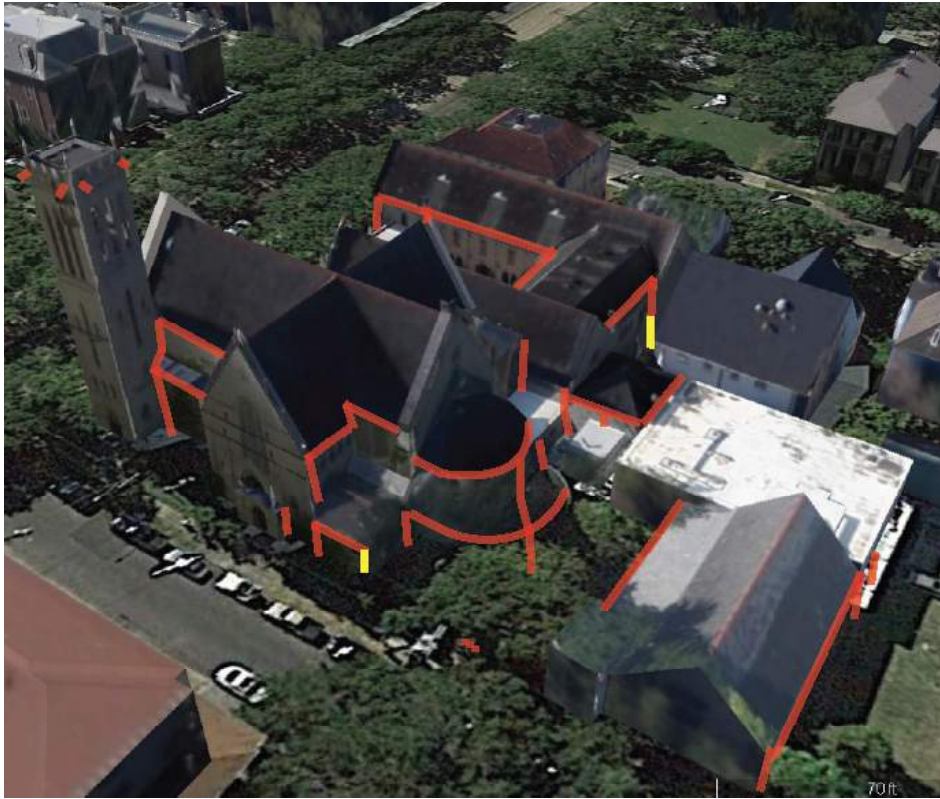
Figure # 6.3: On this aerial view of the church, gutters and downspouts are mapped in red, missing gutters and downspouts in yellow. Photo by Google Earth, Edits by Nathan Lott, 2015

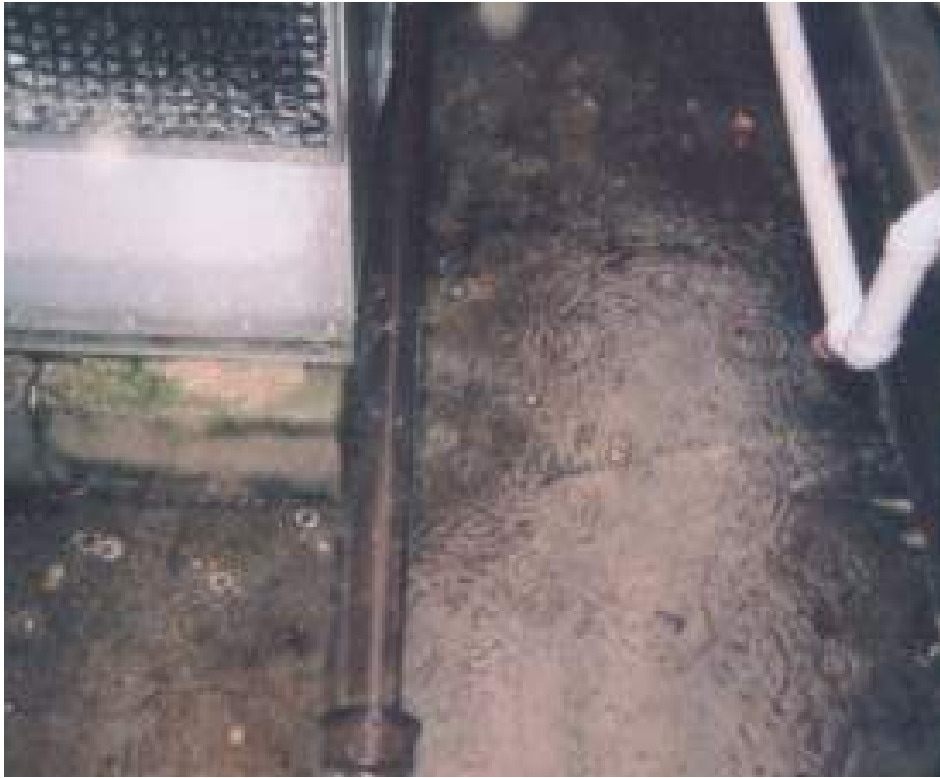
Figure # 6.5: Standing water in the downtown Mechanical Yard. Photo by Dimitri Roby, 2015

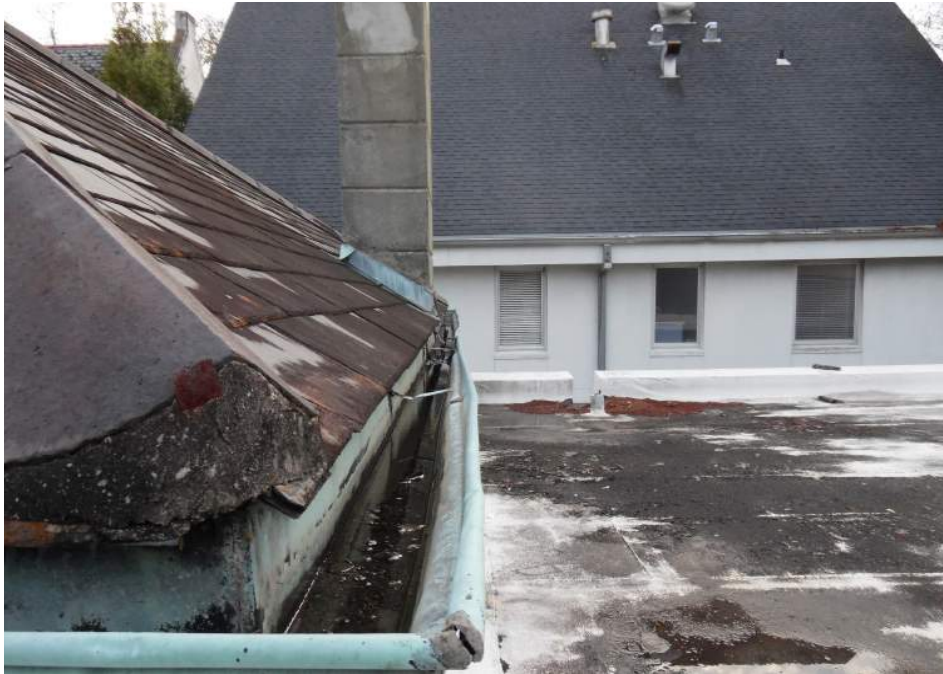
Figure # 6.6: Standing water in the copper gutters on a hipped roof behind the chapel and the adjacent flat roof. Photo by Trudy Andrzejewski, 2015

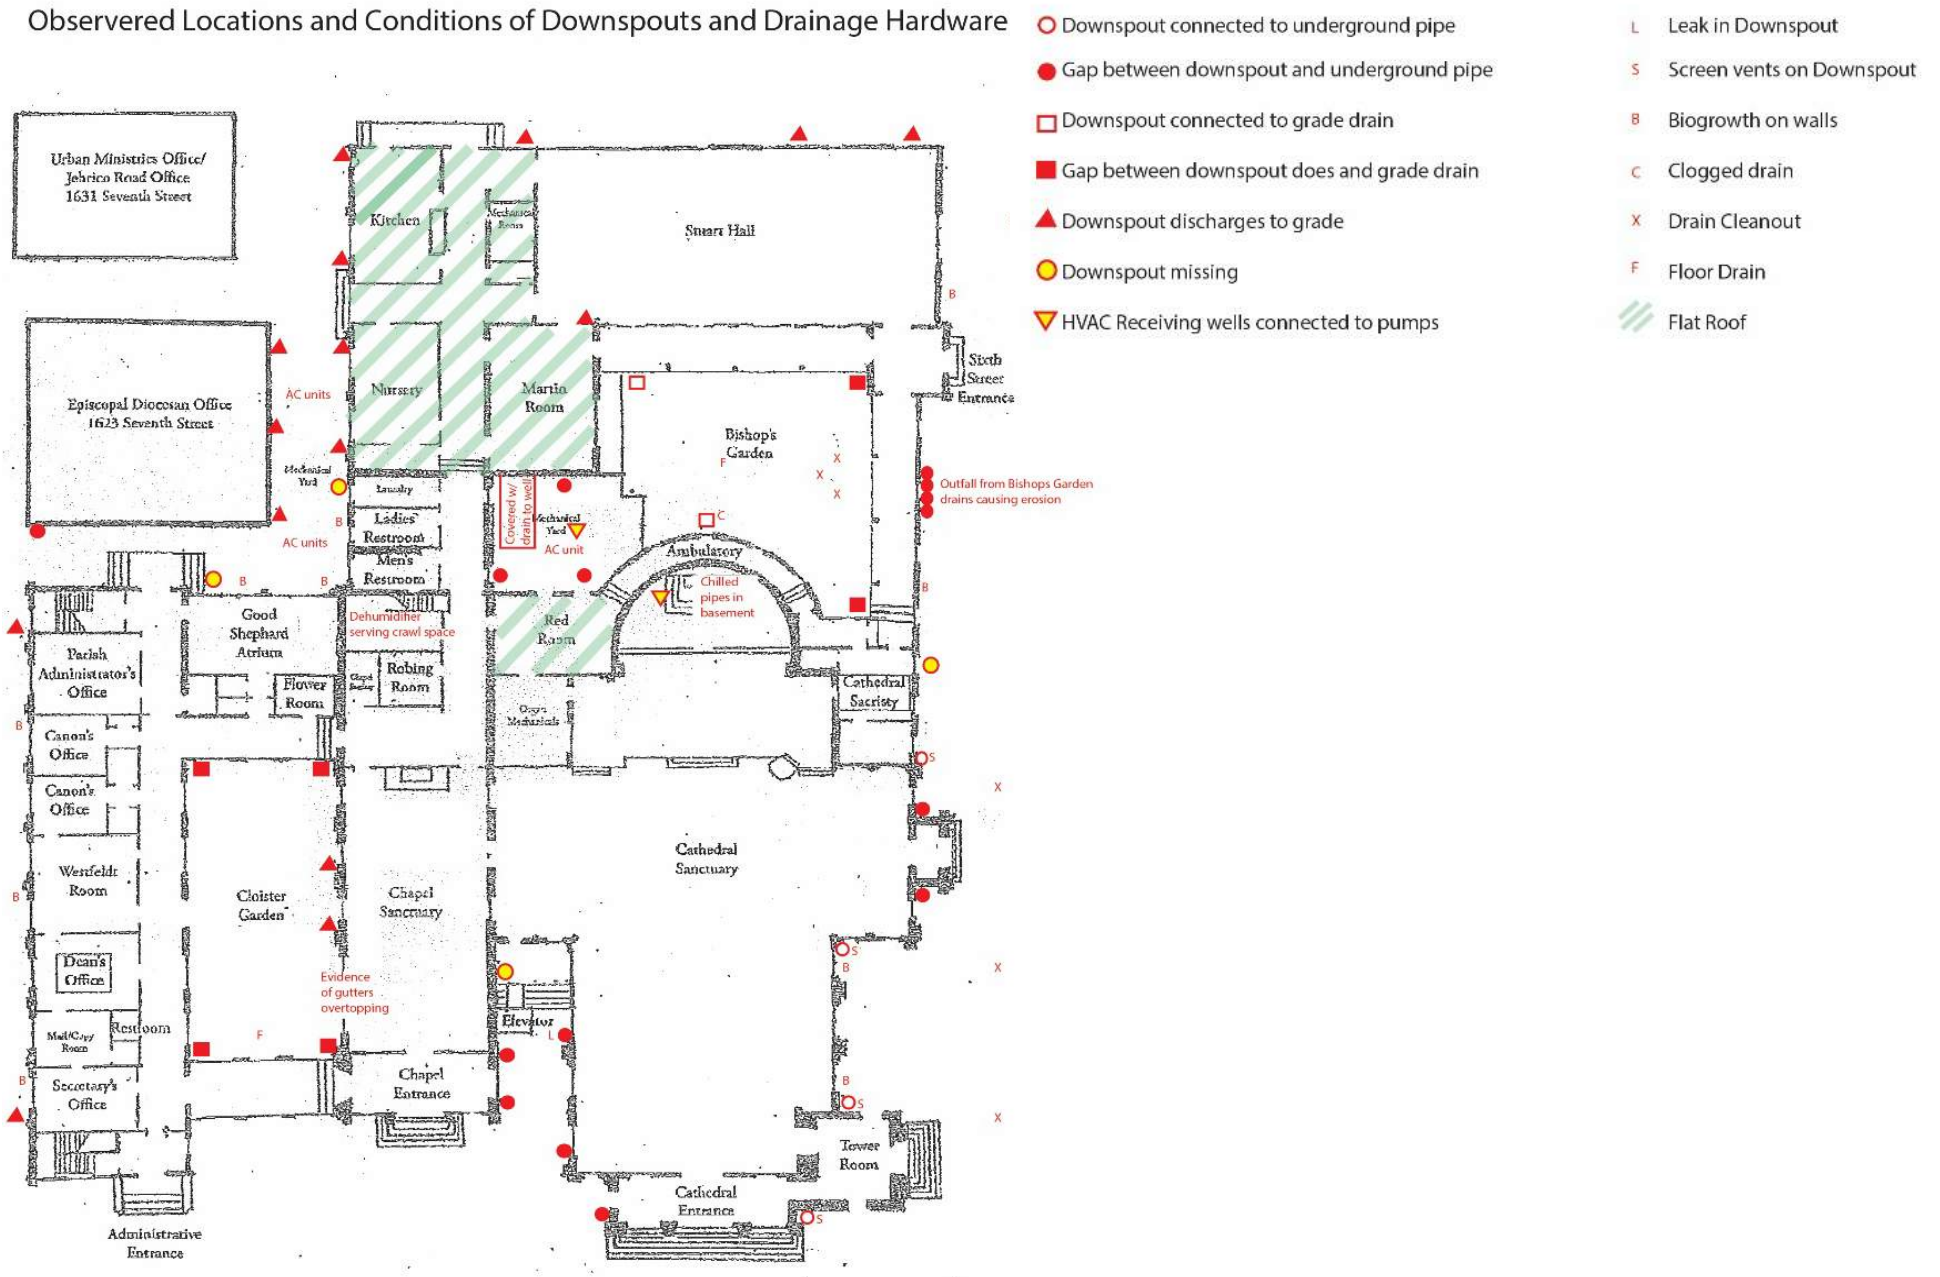
Figure # 6.9: A site map showing observed condition. Image courtesy of Christ Church Cathedral, notations by Nathan Lott, 2015

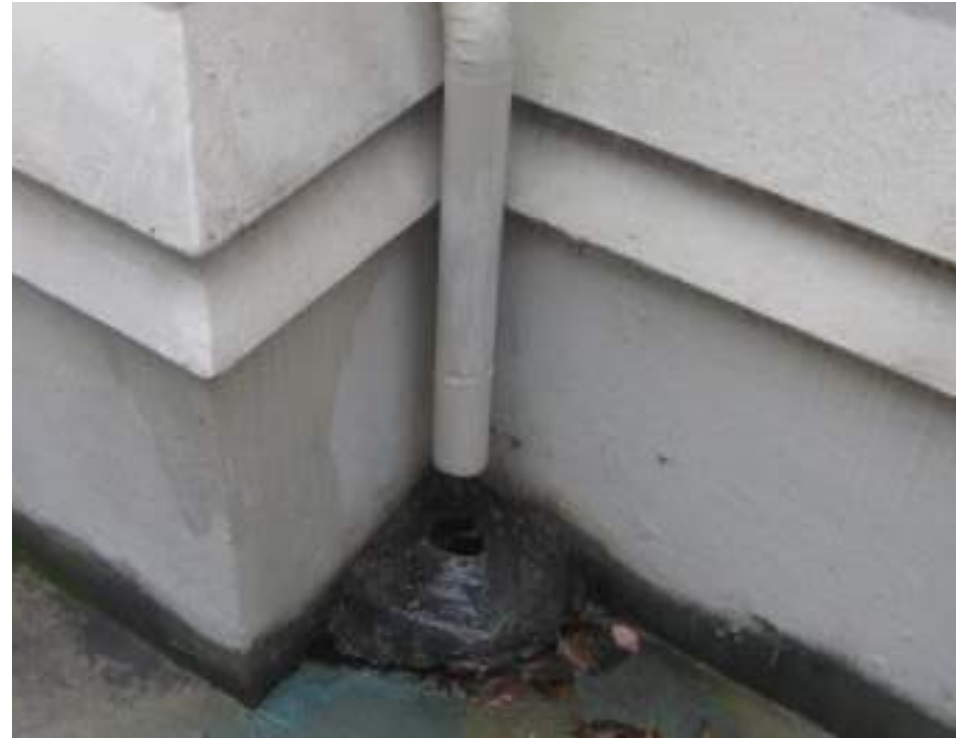
Figure # 6.10: This downspout is inadequately connected to the subterranean drain. Photo by Nathan Lott, 2015

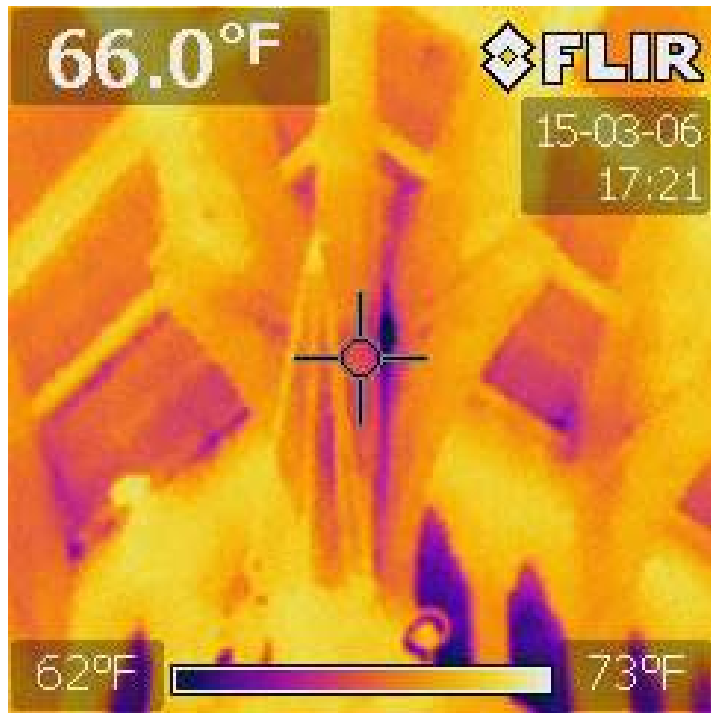
Figure 8.12: Infrared photo of church ceiling showing heat absorption in wooden rafters because of thermal mass. Photograph by author, March 2015.
