Georgia Conference of Home Inspectors

Pre-Closing Property Inspection Report

Client(s): **Ms. Andrea Devries**
Property address: **2049 Hatteras Way NW**
Atlanta, Georgia 30318
Inspection date: **Thursday, December 10, 2015**

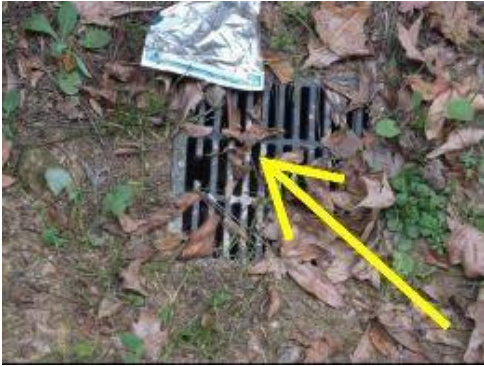
**Photo 3-1**

One or more drains in the yard or landscaped areas appeared to be clogged. Water may accumulate and become a nuisance, or may flow towards the building. Recommend that a qualified person clear drains as necessary.

Yard drain is clogged with leaves and debris. Clean out drain to allow for proper drainage away from the foundation.

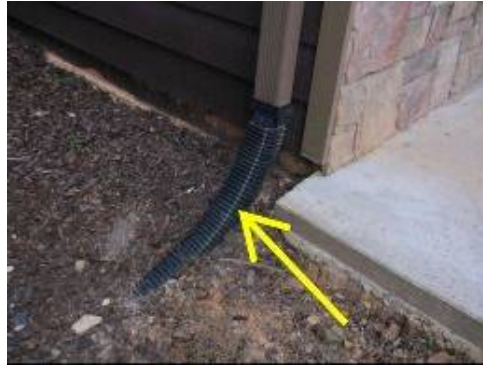
**Photo 3-2**

Downspout extension embedded in the soil. No discharge pipe was located during the inspection.

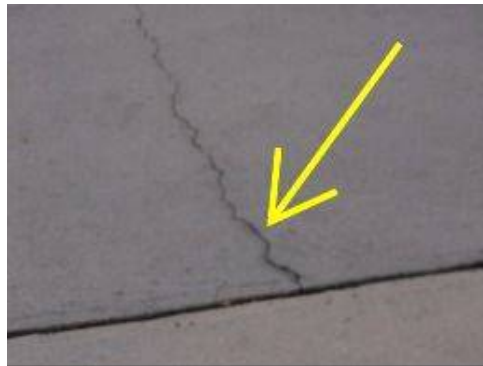
**Photo 3-4**

Minor crack in driveway.

Minor deterioration (e.g. cracks, holes, settlement, heaving) was found in the driveway, but no trip hazards were found. The client may wish to have repairs made for cosmetic reasons.

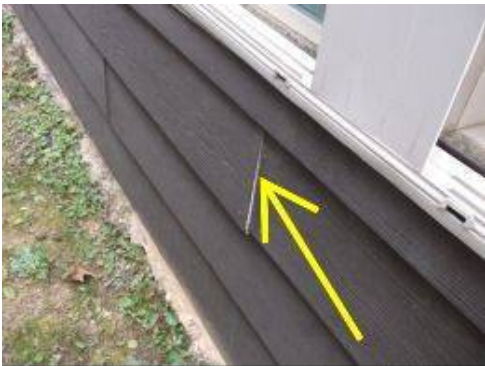
Photo 5-3

Siding butt joints need caulk and sealing with water resistant caulk. Fasteners need to be replaced.

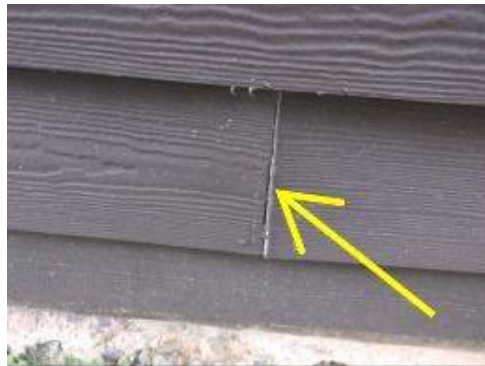
Photo 5-4

Caulk and seal open siding butt joints.

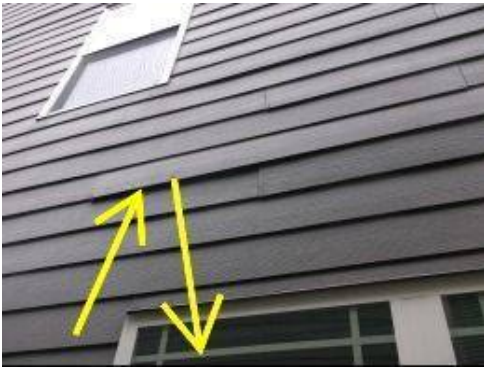
Photo 5-7
Siding member has pulled away from the substrate. It needs re-attached and repaired with the proper fasteners and sealed.

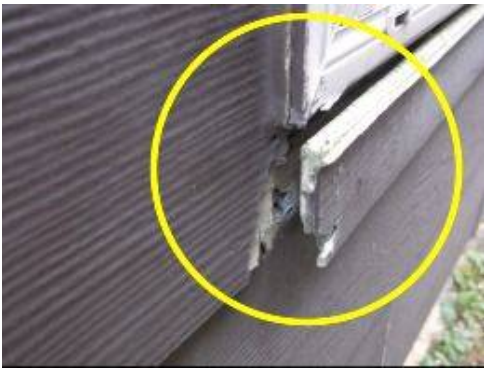
Photo 5-9
Exterior window trim is pulling away from the siding. Repair and re-attach with proper fasteners, caulk and seal joints.

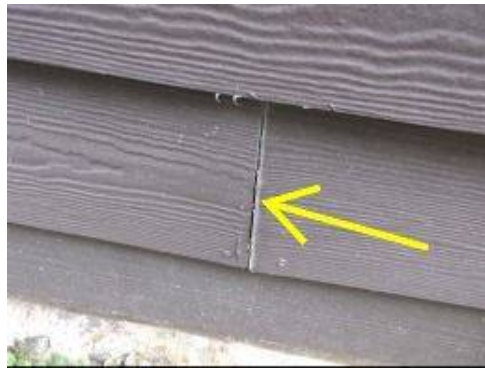
Photo 5-10
Caulk and seal all exterior butt siding joints.

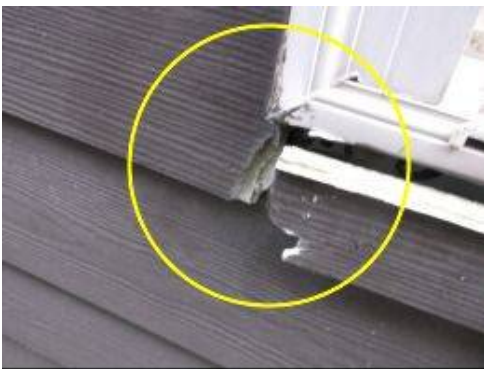
Photo 5-11
Repair and seal all siding butt joints and re-attach loose siding members.

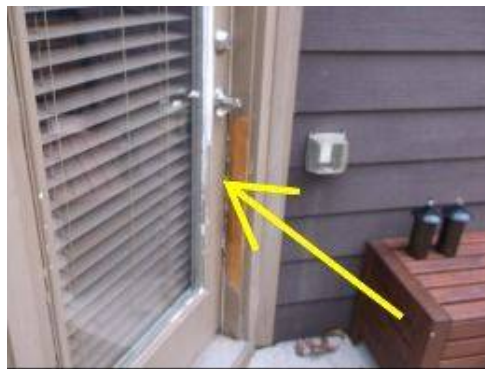
Photo 5-12
Rear patio door is damaged by pets. Repair as necessary.

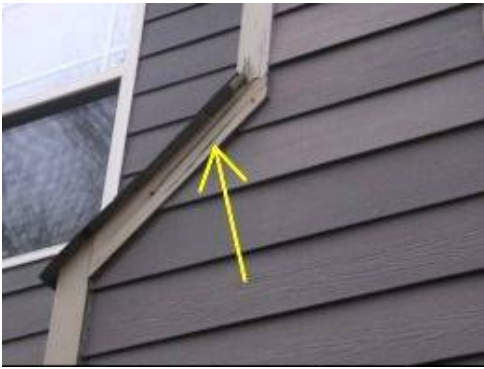
Photo 5-13
Siding trim is moisture damaged and dry-rot. Replace trim wood and re-paint with premium quality paint.

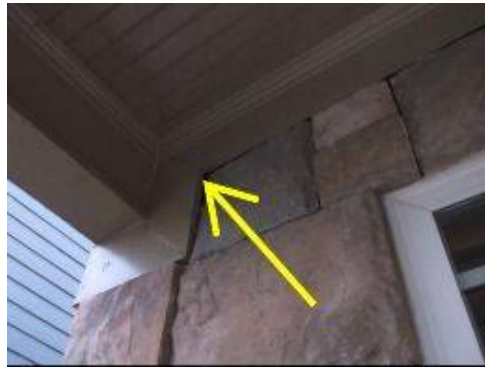
Photo 5-14
Seal all spaces between stone veneer and wood trim and framing.

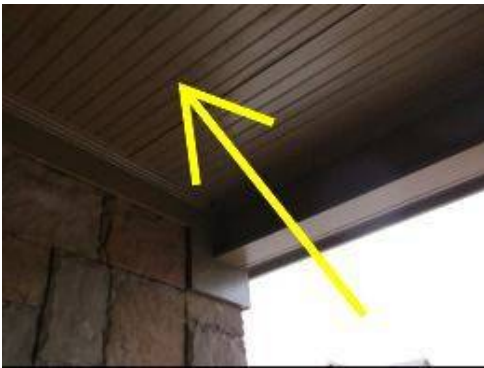
Photo 5-15
Front entrance porch ceiling appears to have mold spores forming. Recommend pressure washing with an anti-mold agent. This should be done periodically.....as the upper porch ceiling may not get adequate sunlight or ventilation to prevent moisture droplets from forming on the ceiling.

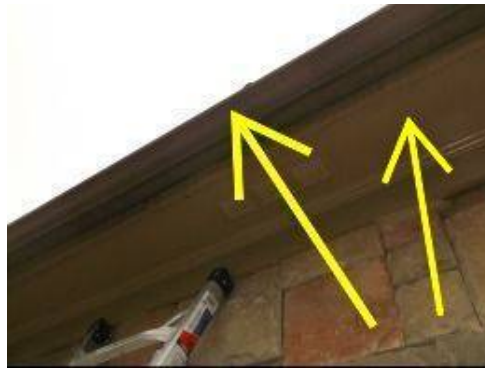
Photo 5-16
Soffit shows signs of moisture intrusion due to water standing inside the gutters.

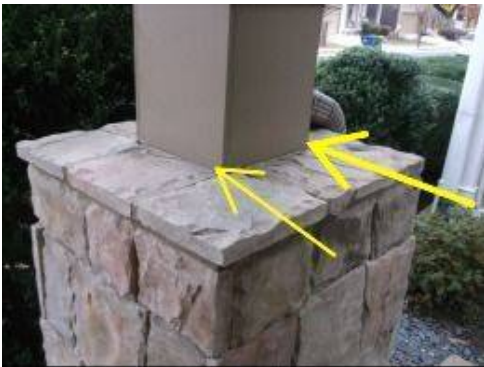
The masonry (brick or stone) veneer was deteriorated or damaged in some areas. Where cracks or openings are exposed, water can enter the wall structure causing mold, fungal growth and structural damage. This is a conducive condition for wood-destroying organisms. Recommend that a qualified contractor repair as necessary. For example, by repointing mortar or replacing broken or missing masonry.

Photo 6-1
Mortar joints cracked at front porch support columns.

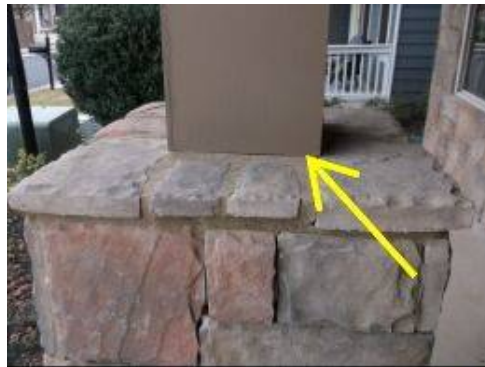
Photo 6-2
Minor cracks in the mortar joints at the front support columns.

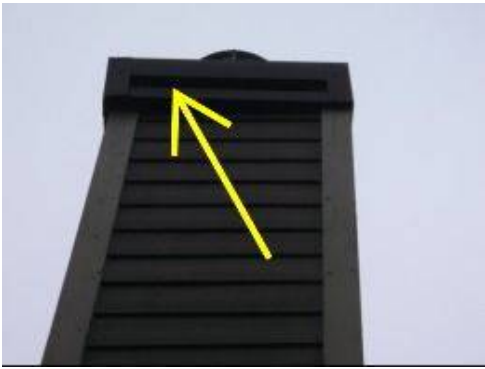
Photo 10-5
Metal chimney cap appears to be improperly installed from ground level. Further evaluation is recommended.

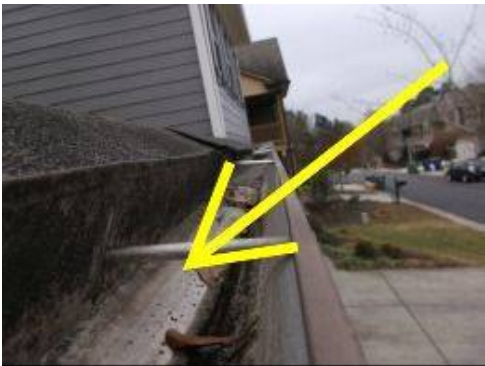
One or more gutters had a substandard slope so that significant amounts of water accumulate in them rather than draining through the downspouts. This has caused debris such as leaves or needles to accumulate in them. Recommend that a qualified person repair as necessary. For example, by correcting the slope in gutters or installing additional downspouts and extensions.

Photo 11-1
Front gutters are improperly sloped such that water is being retained inside the gutters. The standing water is 'wicking' into the soffit causing moisture intrusion.

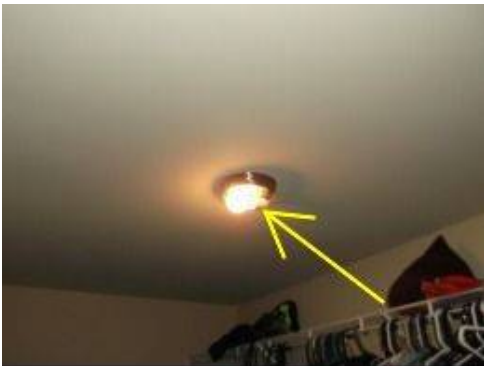
Photo 17-1

Upstairs walk in closet missing diffuser globe.

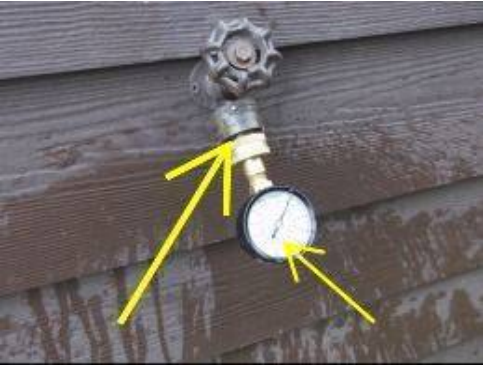
**Photo 18-1**

Water pressure measured at 40 psi. Recommend raising the pressure to a minimum 60 psi to insure all fixtures supply sufficient water. Hose bib is leaking and needs repair.

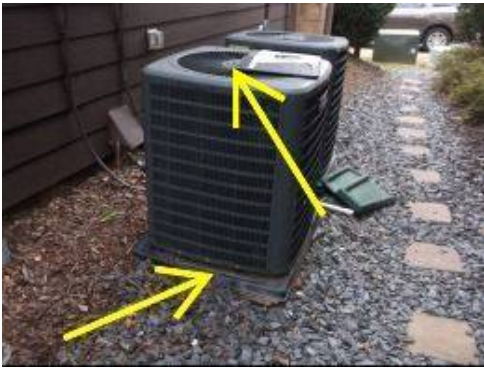
Photo 21-1

Both Air Conditioning compressor/condenser units are not resting level on an anti-vibration pad as required. Units should be raised a minimum of 3" above ground.

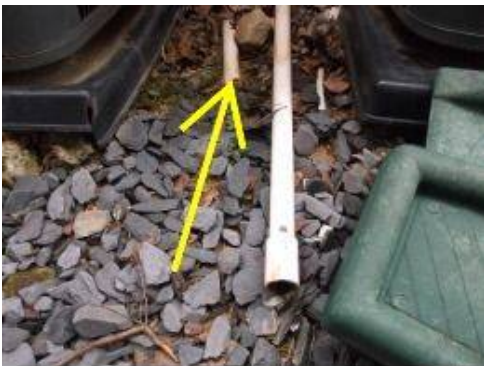
Photo 23-1

Condensate line to compressor/condenser unit was lying on the ground obscured and clogged by dirt and pine needles. This can cause the the excess moisture to back up into the air handler.

Clogged Air Cond. condensate line.

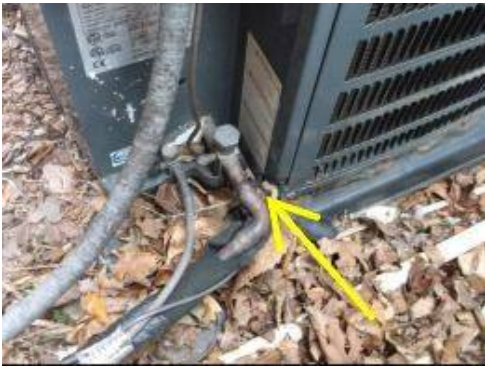
Photo 24-1

Air Conditioning refrigerant lines have insulation deteriorated. Replace as necessary.

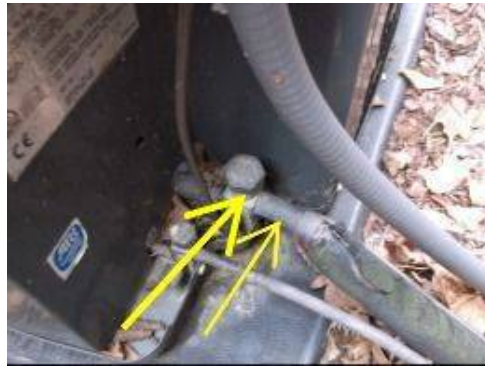
Photo 24-2

Insulation deteriorated at A/C unit refrigerant line.

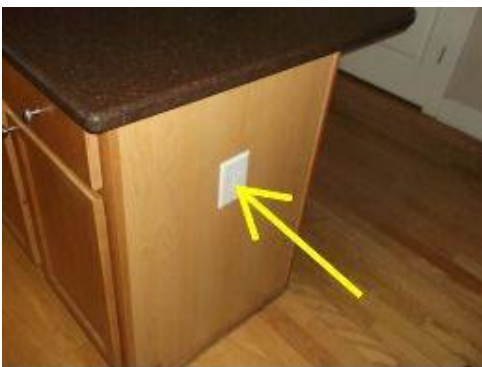
Photo 28-1

Kitchen island is equipped with Ground Fault Circuit Interrupter. It should be labeled 'GFCI Protected'.

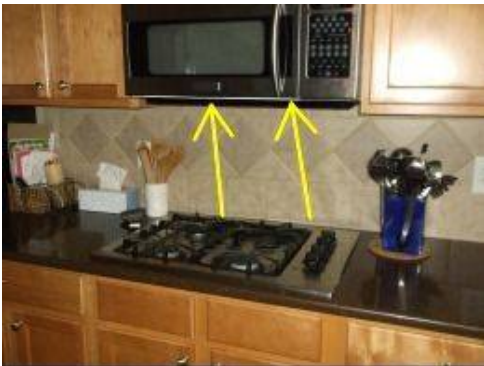
**Photo 28-5**

The distance between the burner elements on the surface unit is approx. 8 inches from the bottom of the microwave and exhaust filters. Exercise due caution when using the surface unit burners. Kitchen fires often start from this area.

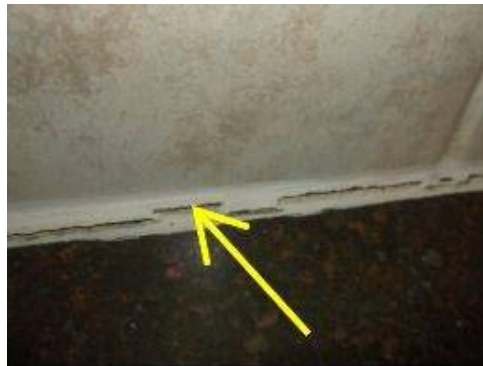
**Photo 28-6**

Gaps, no caulk, or substandard caulking were found between countertops and backsplashes. Water may penetrate these areas and cause damage. Recommend that a qualified person repair as necessary. For example, by installing caulk.

Kitchen counter-top has cracks in the caulking where the counter-top intersects with the back-splash.

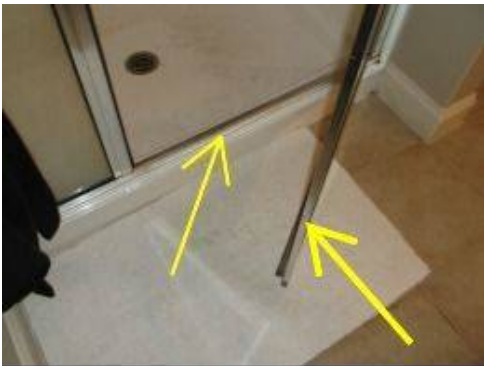
Photo 29-3

Master bathroom shower door is defective and binding and sticking in the frame, making it difficult to open and close. Repair as necessary.

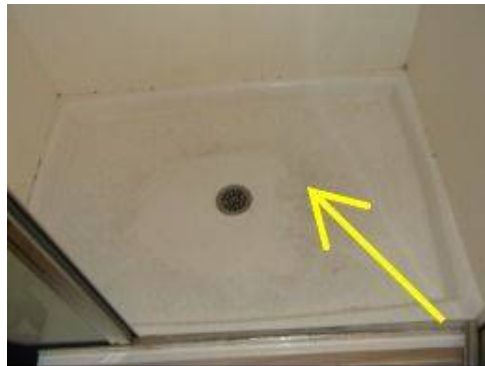
Photo 29-4

Master bath shower needs thorough cleaning, sanitizing and deodorizing prior to use. The shower doors stick inside the frame and is difficult to open and close. Repair door and frame as necessary.

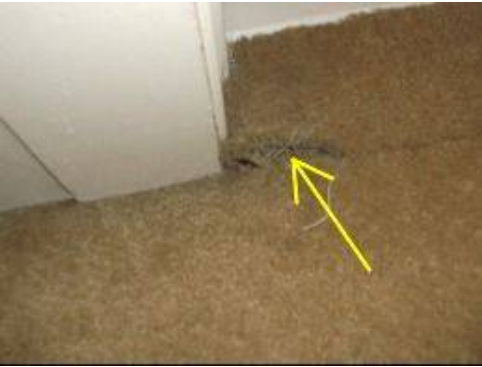
Photo 29-9
Carpet is torn at the seams at entrance to master bathroom. Repair as necessary.

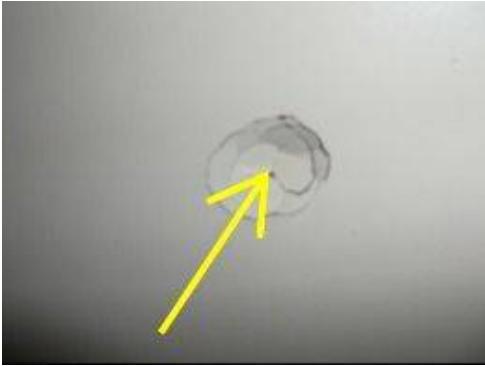
Photo 30-1
Impact damage to bedroom door in master bedroom.

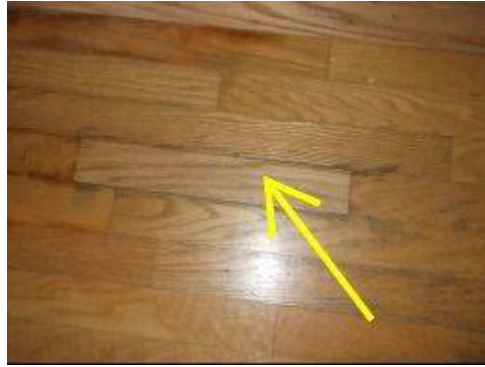
Photo 30-2
Laminate flooring in family room appears to have been repaired or a section replaced. Inquire of current owner or tenant if this is the case.

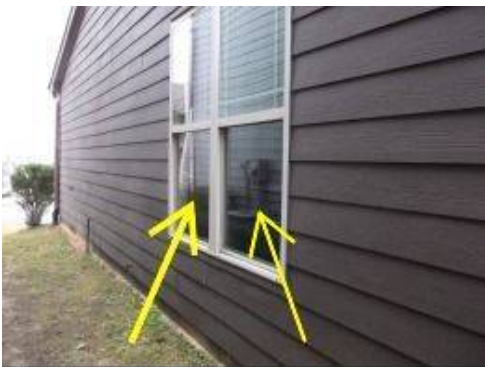
31) **i** Screens were missing from some windows. These windows may not provide ventilation during months when insects are active.

Photo 31-1
Exterior screens missing from several windows.

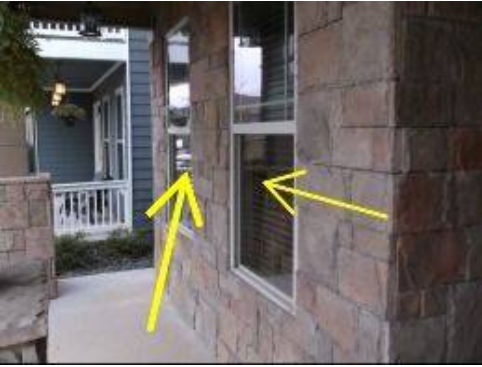
Photo 31-3

Exterior screens missing.

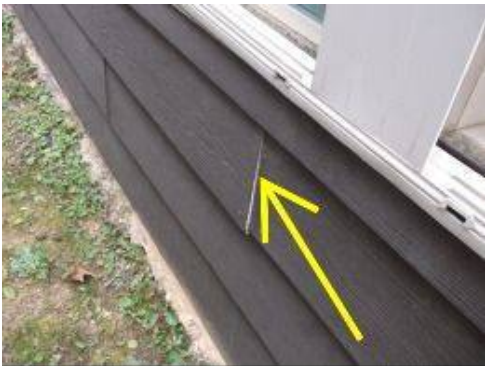
Photo 5-3

Siding butt joints need caulk and sealing with water resistant caulk. Fasteners need to be replaced.

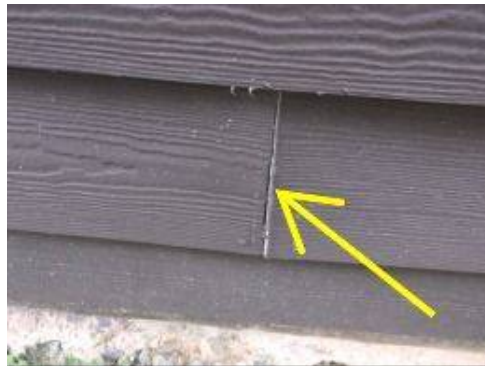
Photo 5-4

Caulk and seal open siding butt joints.

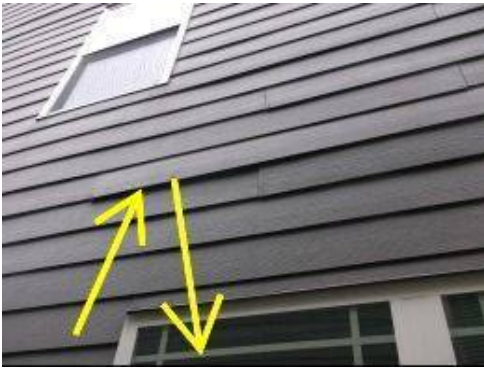
Photo 5-7
Siding member has pulled away from the substrate. It needs re-attached and repaired with the proper fasteners and sealed.

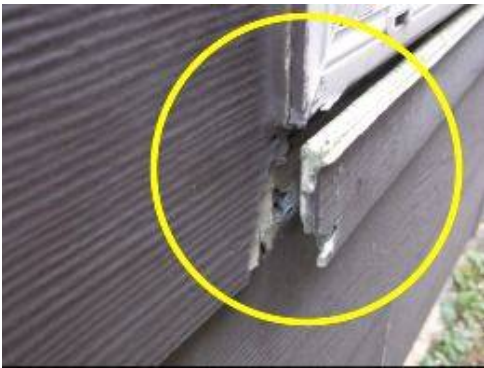
Photo 5-9
Exterior window trim is pulling away from the siding. Repair and re-attach with proper fasteners, caulk and seal joints.

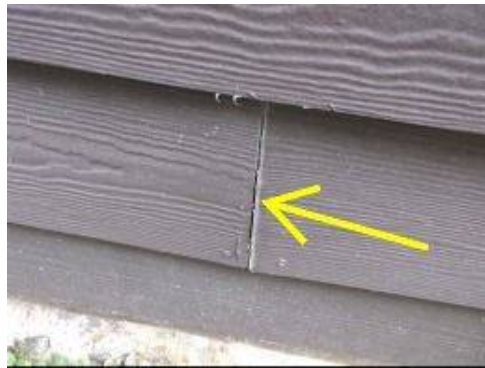
Photo 5-10
Caulk and seal all exterior butt siding joints.

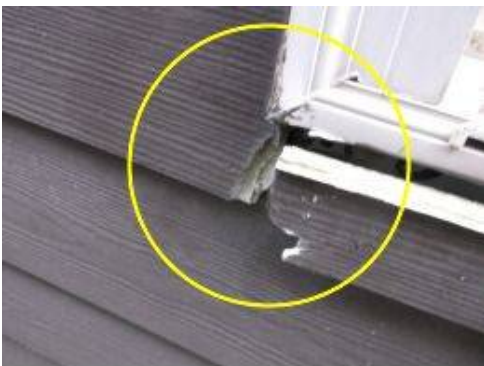
Photo 5-11
Repair and seal all siding butt joints and re-attach loose siding members.

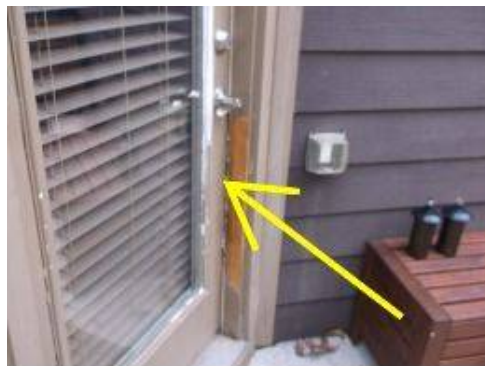
Photo 5-12
Rear patio door is damaged by pets. Repair as necessary.

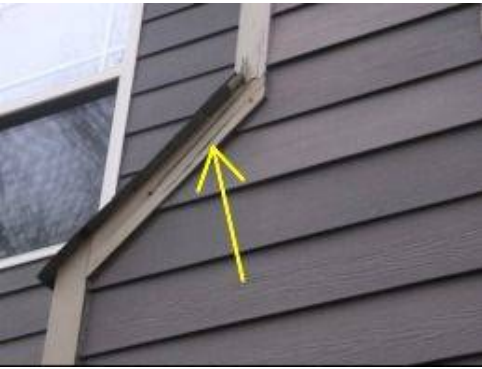
Photo 5-13
Siding trim is moisture damaged and dry-rot. Replace trim wood and re-paint with premium quality paint.

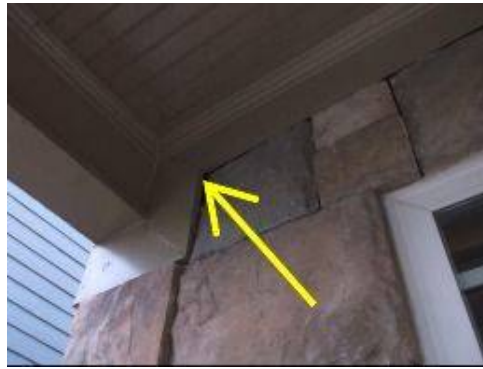
Photo 5-14
Seal all spaces between stone veneer and wood trim and framing.

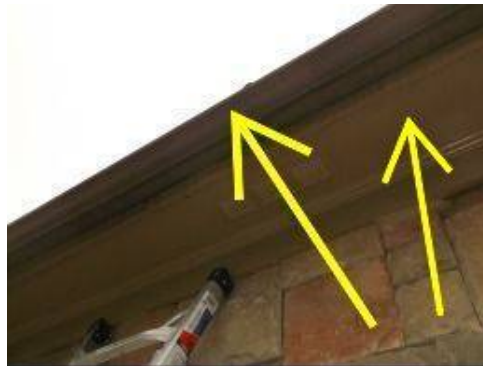
Photo 5-16
Soffit shows signs of moisture intrusion due to water standing inside the gutters.

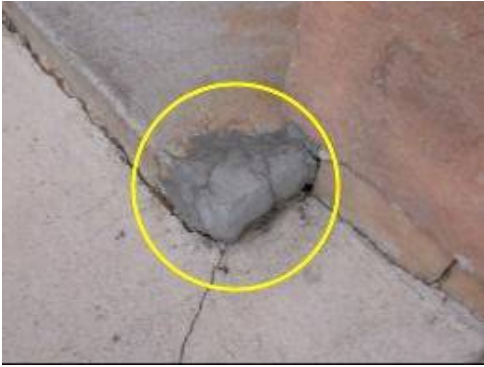
Photo 6-3

Front entrance walkway has been recently repaired at the corner. See photo.

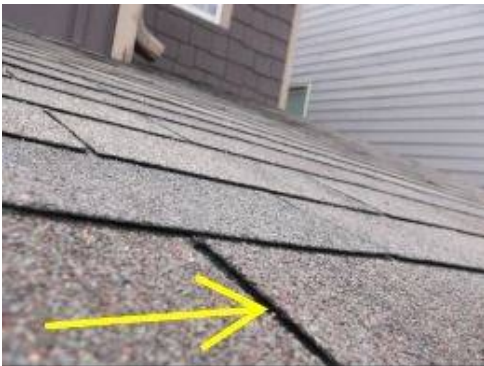
Photo 10-1

- Some composition shingles were cracked and/or broken. Leaks can occur as a result. This is a conducive condition for wood-destroying organisms. Recommend that a qualified contractor repair as necessary. For example, by replacing shingles.

Several shingles above garage gutters are brittle and breaking off. Recommend further evaluation by a qualified roofing company for repair/replacement of broken shingles/

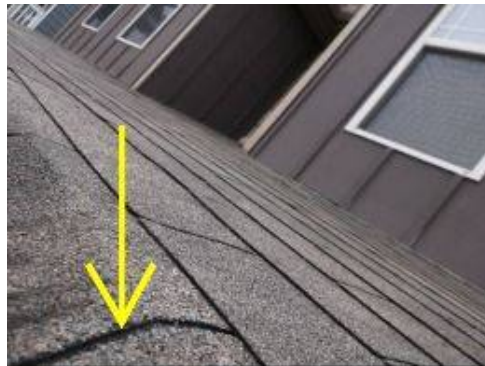
Photo 10-2

Several roofing shingles are brittle and broken. Repair and/or replace.

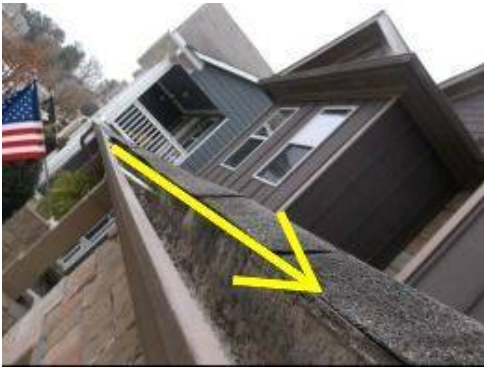
Photo 10-3
Water is standing inside the front gutters. The front gutters are improperly sloped.

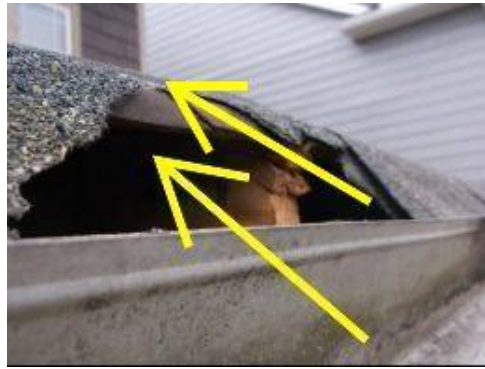
Photo 10-4
Roofing shingle at front entrance above garage has broken off and needs replacement. Contact qualified roofing company.

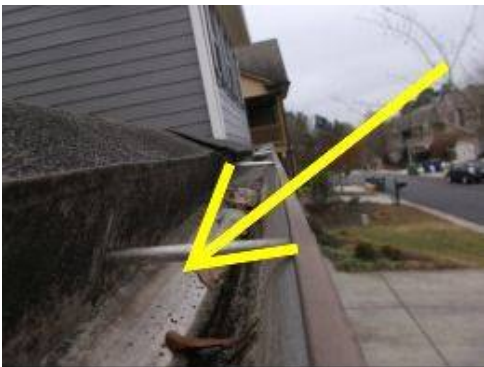
11 🛠️ - One or more gutters had a substandard slope so that significant amounts of water accumulate in them rather than draining through the downspouts. This has caused debris such as leaves or needles to accumulate in them. Recommend that a qualified person repair as necessary. For example, by correcting the slope in gutters or installing additional downspouts and extensions.

Photo 11-1
Front gutters are improperly sloped such that water is being retained inside the gutters. The standing water is 'wicking' into the soffit causing moisture intrusion.

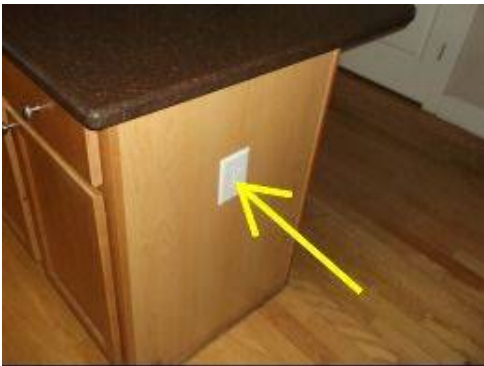
Photo 28-1

Kitchen island is equipped with Ground Fault Circuit Interrupter. It should be labeled 'GFCI Protected'.

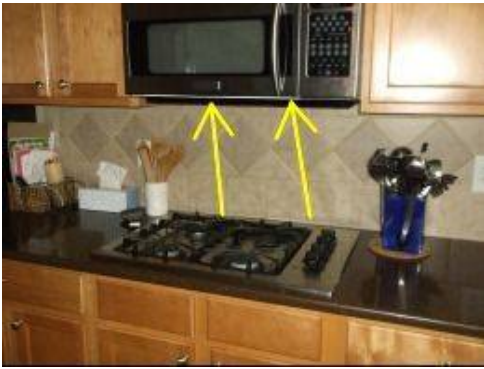
Photo 28-5
The distance between the burner elements on the surface unit is approx. 18 inches from the bottom of the microwave and exhaust filters. Exercise due caution when using the surface unit burners. Kitchen fires often start from this area.

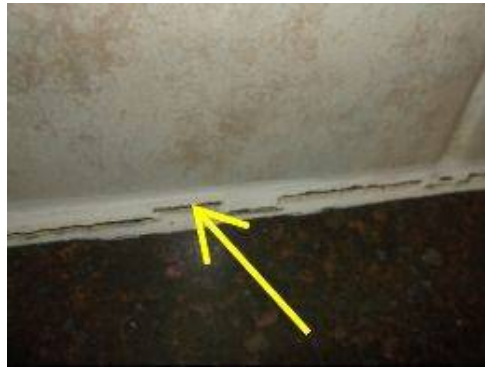
28 🛠️ - Gaps, no caulk, or substandard caulking were found between countertops and backsplashes. Water may penetrate these areas and cause damage. Recommend that a qualified person repair as necessary. For example, by installing caulk.

Photo 28-6
Kitchen counter-top has cracks in the caulking where the counter-top intersects with the back-splash.

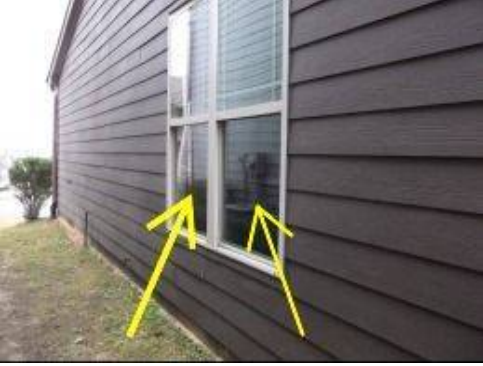
- Screens were missing from some windows. These windows may not provide ventilation during months when insects are active.

Photo 31-1
Exterior screens missing from several windows.

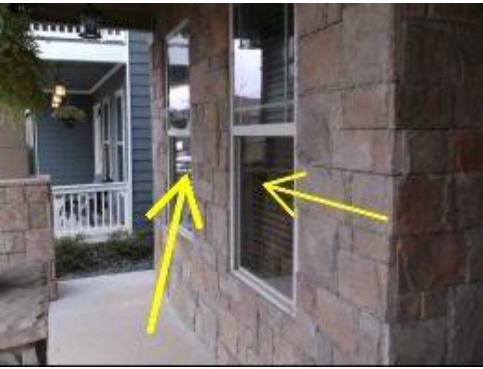
Photo 31-3
Exterior screens missing.
