Georgia Conference of Home Inspectors

Atkins Pre-Closing Property Inspection Report

Client(s): **Tryan E. Atkins**
Property address: **2019 Jebbs Court**
Kennesaw, Georgia 30144
Inspection date: **Saturday, November 21, 2015**

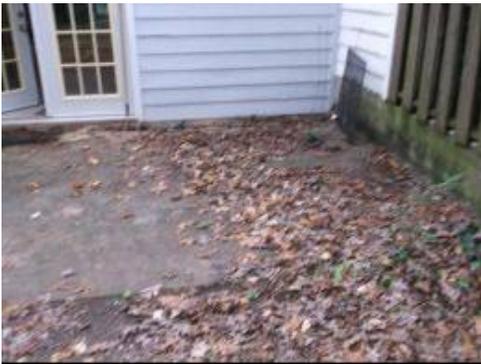
Photo 3-1

3) **i** Minor deterioration (e.g. cracks, holes, settlement, heaving) was found in sidewalks or patios, but no trip hazards were found. The client may wish to have repairs made for cosmetic reasons.

Leaves and twigs have accumulated on the back patio. This could indicate improperly sloping of the concrete patio.

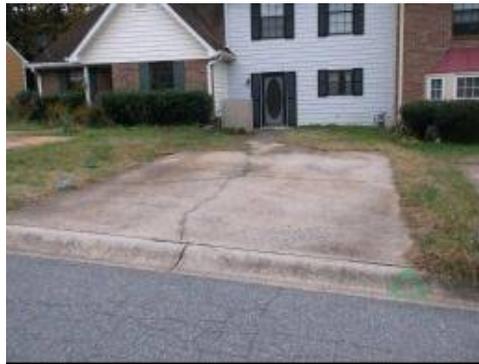
Photo 3-2

Minor cracks and spalling observed from street level in the driveway.

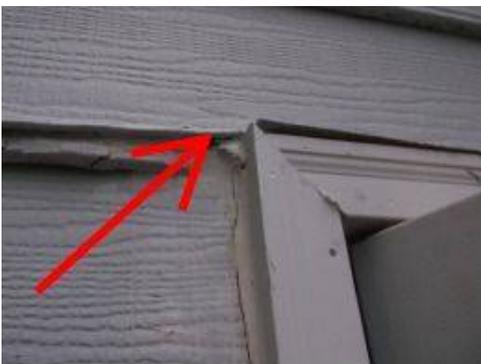
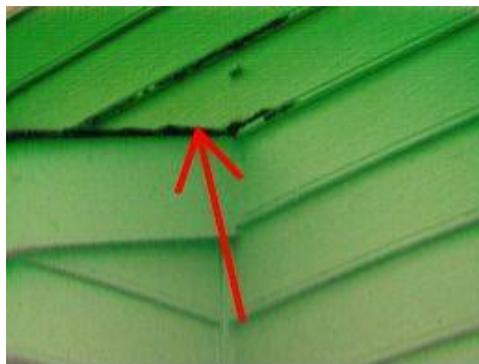
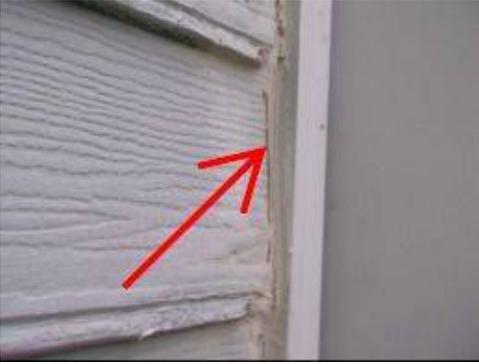
4) **w** Some sections of siding and/or trim were deteriorated. Recommend that a qualified person repair, replace or install siding or trim as necessary.

Masonite wood fiber siding swells and blisters when exposed to moisture. Wood siding members should not be installed closer than 6" from the surface of the ground.

Some areas of siding on this structure showed symptoms described above and need replacement and/or maintenance. Some manufacturers (e.g. Louisiana Pacific) recommend a repair process for this siding where affected areas are sealed with Permanizer Plus, a flexible primer made by Pittsburgh Paint, followed by two coats of 100% acrylic latex paint. This sealant must be applied to the bottom edges using a brush. The face of the siding can be sprayed. The Permanizer Plus sealer isn't required for edges that aren't swollen, cracked or deteriorated, but the acrylic latex should still be brushed on these edges.

Recommend that a qualified contractor evaluate and replace siding as necessary, and/or seal and repaint as necessary. Repairs should be made per the siding and/or sealant manufacturer's installation instructions, and per standard building practices.

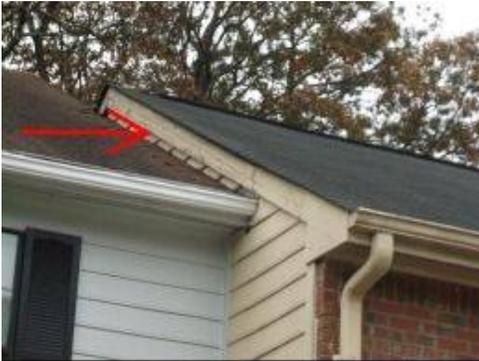
Photo 8-1

Substandard repairs were found at one or more locations on the roof surface. Leaks can occur as a result. This is a conducive condition for wood-destroying organisms. Recommend that a qualified contractor evaluate and repair per standard building practices. See photos

Flashing where the two units roofs meet has substandard flashing where they adjoin. Recommend a qualified roofing contractor make a further evaluation of the entire roof. This roof surface has exceeded its normally expected useful service life and replacement of the current layer of shingles is recommended.

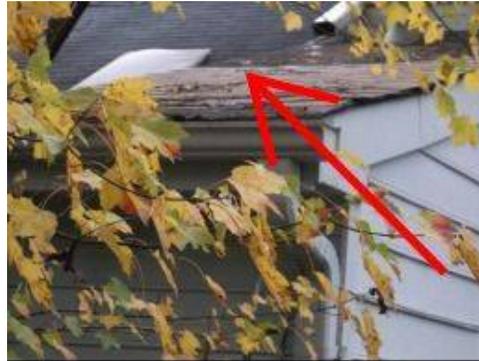
Photo 8-2

Evidence of recent or past roof leak repairs as shown above with different color shingles. This means the age of the shingles does not match the entire covering. Homeowner reports this as a previous repair to the roof leaking into the utility room.

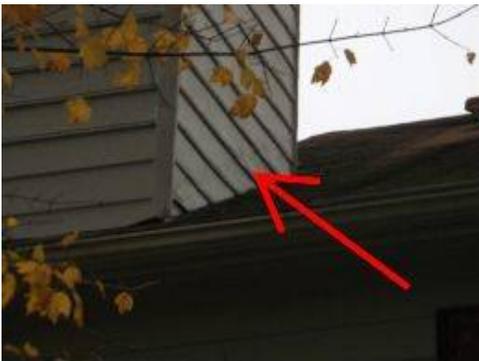
Photo 10-1

One or more roof flashings were substandard. Leaks can occur as a result. This is a conducive condition for wood-destroying organisms. Recommend that a qualified person repair as necessary.

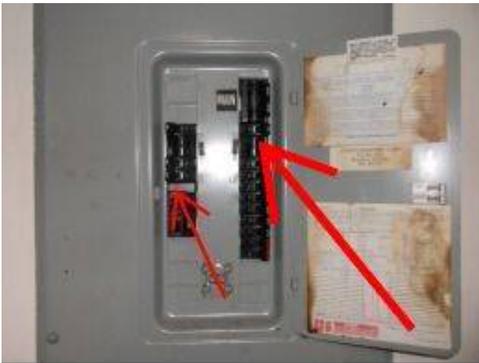
Photo 16-1

One or more slots where circuit breakers are normally installed were open in panel(s) #A. Energized equipment was exposed and is a shock hazard. Recommend that a qualified person install closure covers where missing.

The main electrical panel is not properly labeled, as required by the National Electrical Code. There is also "knock out" cover missing from the panel which exposes live parts.

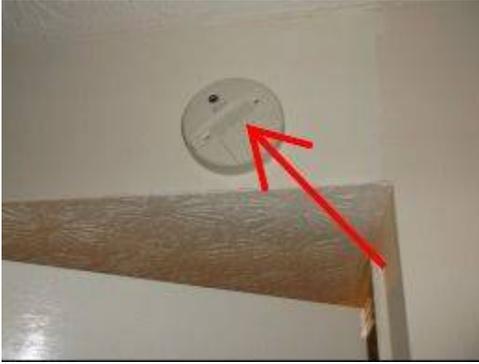
**Photo 17-1**

Carbon-monoxide detector is not properly mounted. It is hanging on screws and is easily shaken loose and falling.

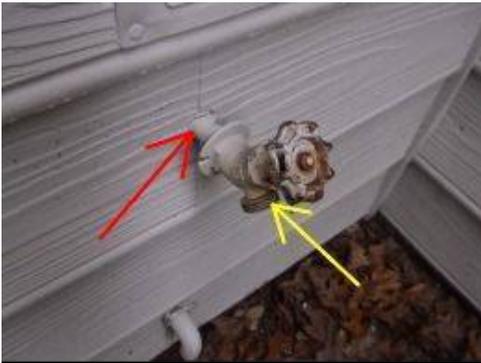
Photo 21-1

Rear hose bib was not fitted with anti-siphon devices. Recommend that a qualified plumber install on one or more hose bibs for convenience, and per standard building practices (e.g. frost-free with anti-siphon device). Install anti-siphon devices to front and rear hose bibs.

A small portion of the exterior hose bib is exposed to cold weather which could result in freezing pipes.

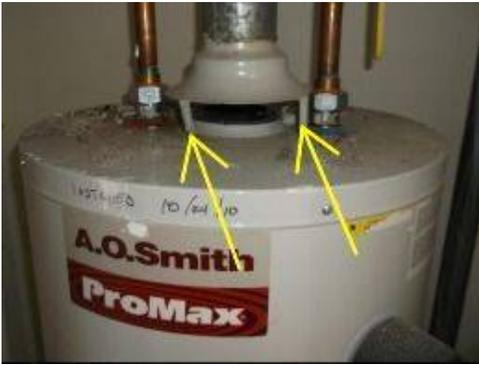
**Photo 23-1**

The draft hood for the water heater flue was loose. This is a potential safety hazard due to the risk of exhaust gases entering living spaces. A qualified person should permanently secure the draft hood with appropriate fasteners per standard building practices.

The flue pipe for the natural gas water heater is not securely attached to the top of the water heater. The capture hood should be attached to the water heater with metal screws.

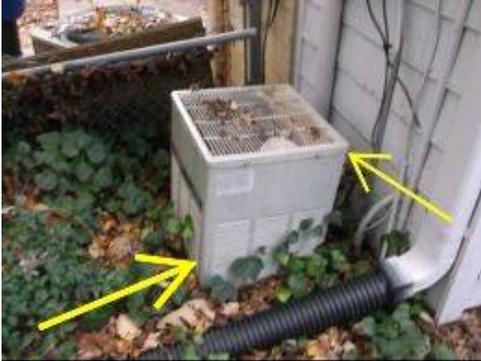
Photo 26-1

Manufactured 1983. 32 Years old. The A/C has far exceeded its normally expected useful service life. The compressor and fins were covered with rust.

The air conditioning compressor/condenser unit is not properly mounted 3" above the ground to keep dirt and debris from collecting inside the housing. The unit is too close to the siding which does not allow proper clearances for free flow of air around the unit. This unit is approx. 32 years old. It has far exceeded its normally expected useful service life and replacement is recommended. The fins and the compressor are rusted completely.

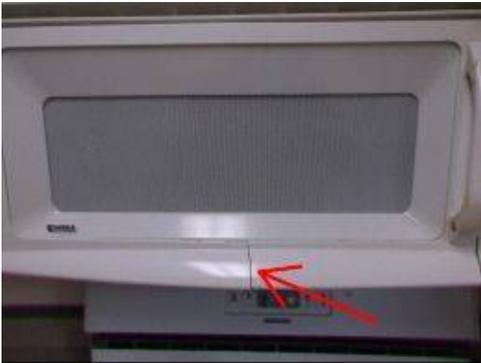
Photo 30-1

The microwave oven was inoperable. Recommend that a qualified person evaluate and repair or replace as necessary.

Built in Microwave oven is inoperable. The bottom of the unit is cracked in the center and the power has been disconnected.

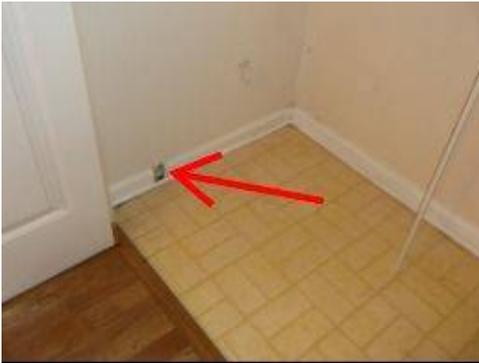
Photo 33-1

33) Overflow drip-pan was not installed in the laundry room. Drip pans should be installed below automatic washers. If the washer overflows or leaks, the water fills the drip pan and is diverted to the outside via the discharge pipe. This prevents water from leaking into the drywall ceilings below and causing moisture damage.

Laundry room should be equipped with a drip pan underneath the washer, so that accidental overflows do not damage the drywall and ceiling below.

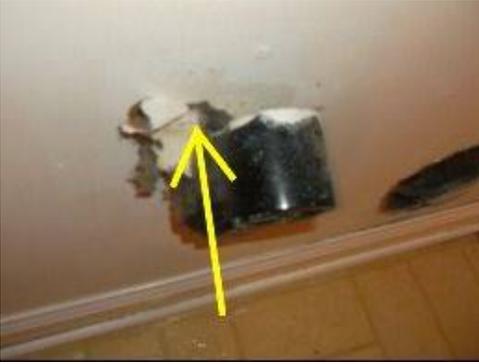
**Photo 34-1**

34) Laundry room electrical dryer receptacle is of the old 'three-prong' type. Newer models of dryers are equipped with 'four-prong'

The three-prong receptacle in the laundry room is the old three-prong type. Newer units have been converted to four prongs. You may want to alert future tenants that the older receptacles will have to be modified or replaced. This should be accomplished by a licensed electrician.

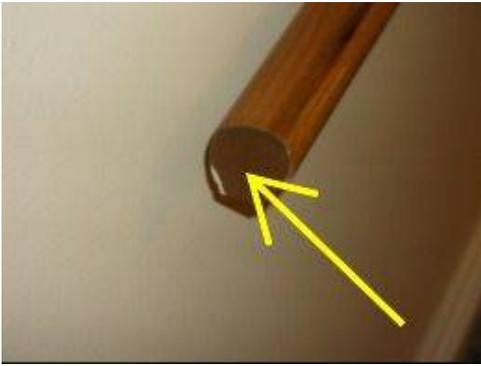
**Photo 35-1**

35) + 🛠️ One or more handrails had no "returns" installed, where ends of handrails turn and connect to adjacent walls so objects or clothing will not catch on the open ends. This is a safety hazard. Recommend that a qualified person install returns per standard building practices.

The ends of handrails should have 'returns' at both ends which prevents occupants from catching their sleeves on the ends and causing potential falls.

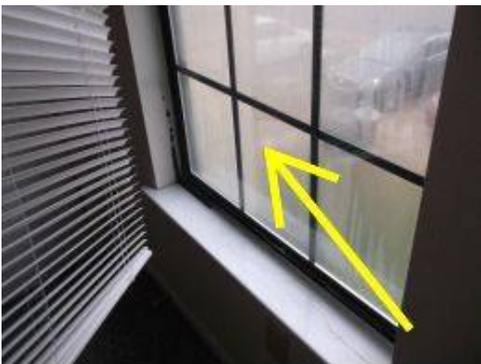
**Photo 36-1**

The double pane seal on the upstairs front bedroom has broken and condensation is building up inside the double panes. These windows have lost their insulation rating.

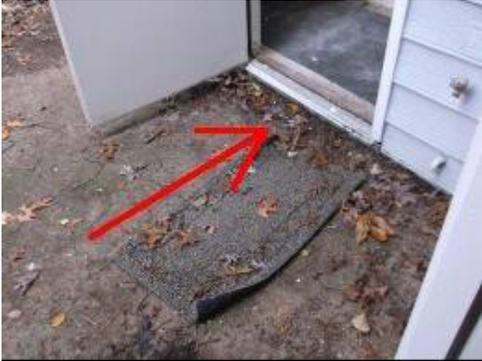
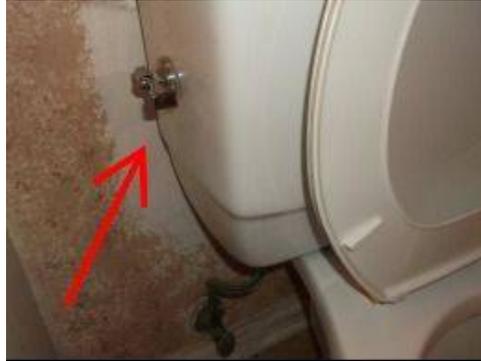
There is evidence of a drywall repair behind the upstairs bathroom toilet bowl. Inquire of the current owner if a recent repair or leak has been repaired.

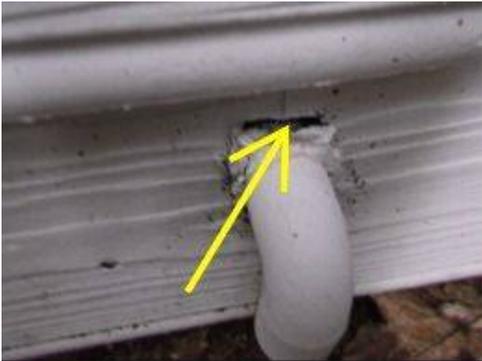
Photo X-3

Caulk and seal around all exterior siding penetrations.

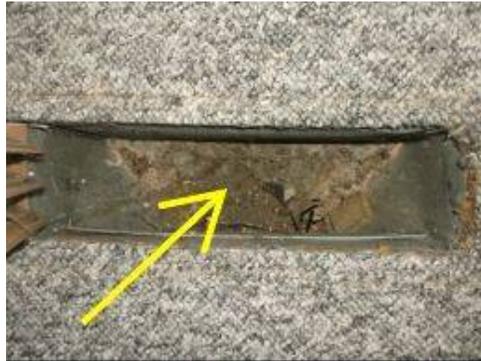
Photo X-4

The supply duct in the rear upstairs bedroom is filled with dust laden debris and needs a thorough cleaning.

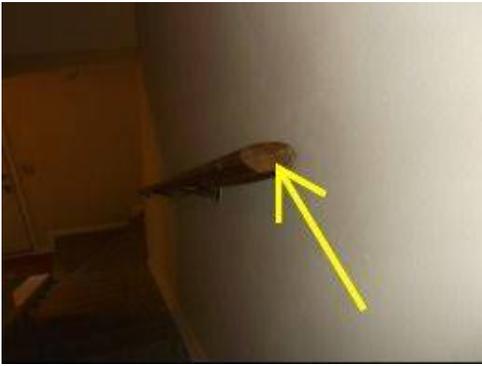
Photo X-5
The ends of stairwell handrails should have 'returns' at either end to prevent sleeves from getting caught on the ends and causing falls.

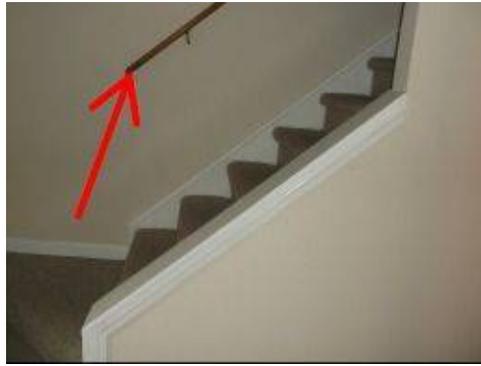
Photo X-6
No returns installed on the upstairs handrails. Open ends of stair handrails could cause sleeves to be caught on the ends and cause potential falls.

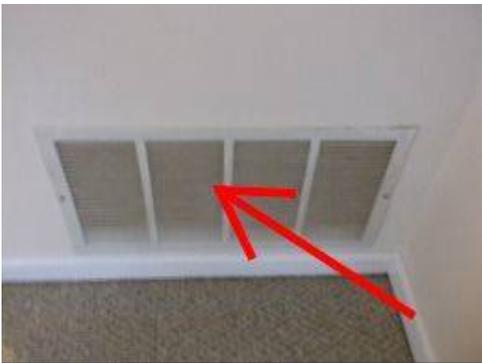
Photo X-7
The furnace air handler grill is dust and grease laden and needs a thorough cleaning.

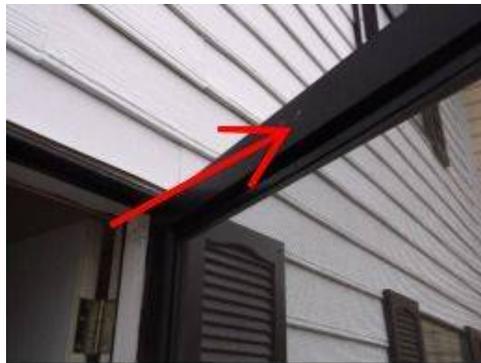
Photo X-8
Pneumatic door closer is missing from the storm door.

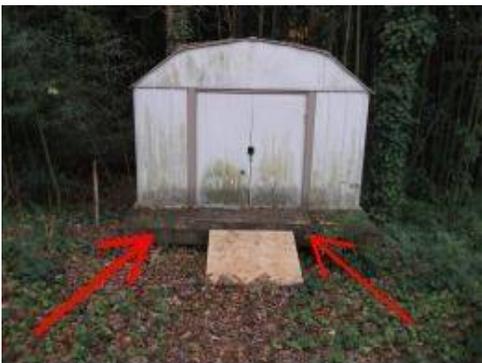
Photo X-9
Outbuildings are excluded from this inspection, however, it should be monitored such that small children do not become entrapped. Also the space underneath is an excellent harbor for rats and snakes. You want to consider installing skirting around the wooden support foundation.

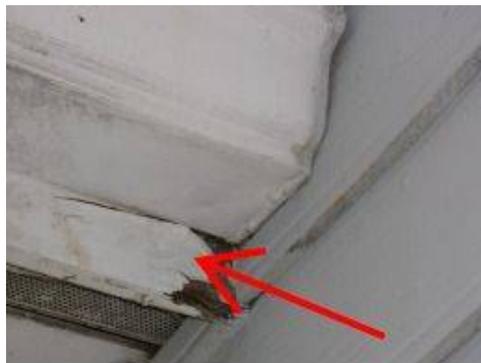
Photo X-10
Gutter is improperly sloped, and water standing inside the gutter is 'wicking' into the wood trim and fascia, causing moisture damage.

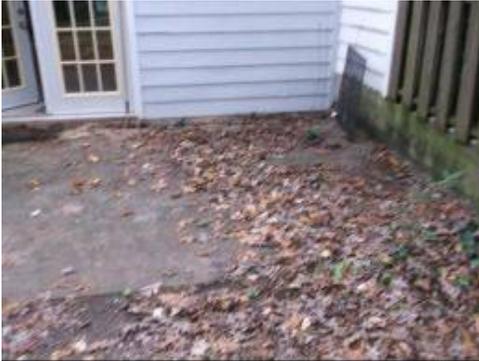
Photo 3-1

- Minor deterioration (e.g. cracks, holes, settlement, heaving) was found in sidewalks or patios, but no trip hazards were found. The client may wish to have repairs made for cosmetic reasons.

Leaves and twigs have accumulated on the back patio. This could indicate improperly sloping of the concrete patio.

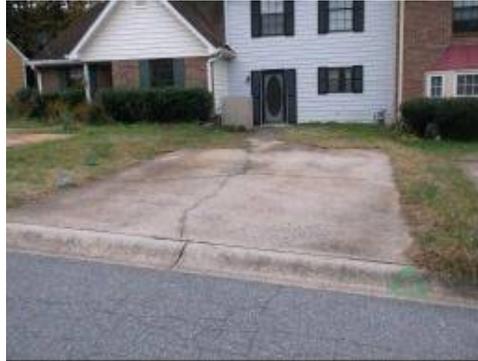
Photo 3-2

Minor cracks and spalling observed from street level in the driveway.

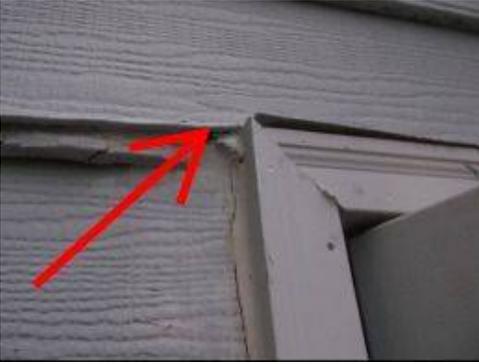
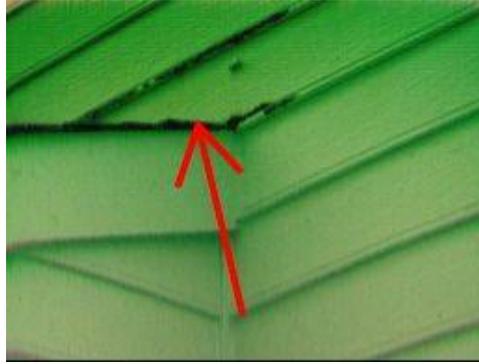
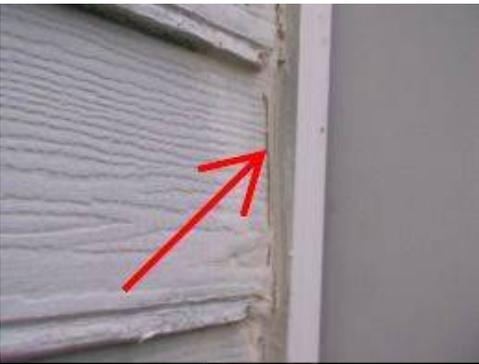
- Some sections of siding and/or trim were deteriorated. Recommend that a qualified person repair, replace or install siding or trim as necessary.

Masonite wood fiber siding swells and blisters when exposed to moisture. Wood siding members should not be installed closer than 6" from the surface of the ground.

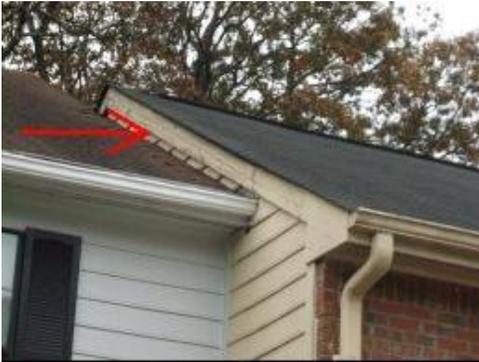
Photo 8-1

- Substandard repairs were found at one or more locations on the roof surface. Leaks can occur as a result. This is a conducive condition for wood-destroying organisms. Recommend that a qualified contractor evaluate and repair per standard building practices. See photos

Flashing where the two units roofs meet has substandard flashing where they adjoin. Recommend a qualified roofing contractor make a further evaluation of the entire roof. This roof surface has exceeded its normally expected useful service life and replacement of the current layer of shingles is recommended.

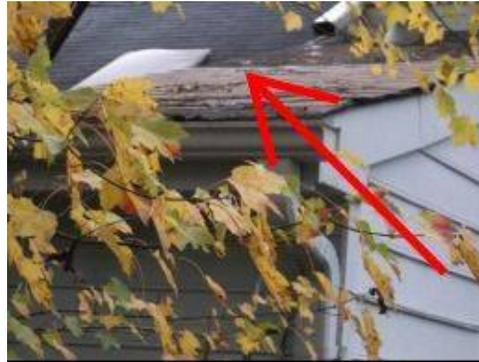
Photo 8-2

Evidence of recent or past roof leak repairs as shown above with different color shingles. This means the age of the shingles does not match the entire covering. Homeowner reports this as a previous repair to the roof leaking into the utility room.

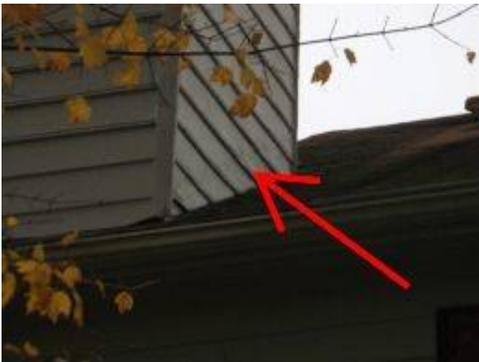
Photo 10-1

- One or more roof flashings were substandard. Leaks can occur as a result. This is a conducive condition for wood-destroying organisms. Recommend that a qualified person repair as necessary.

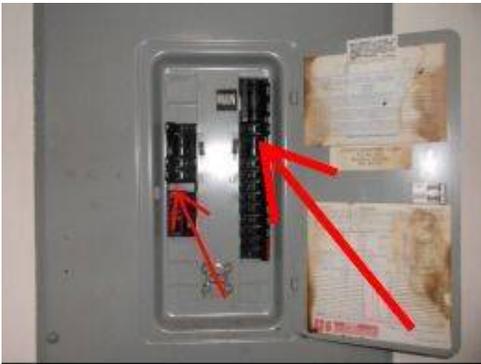
Photo 16-1

- One or more slots where circuit breakers are normally installed were open in panel(s) #A. Energized equipment was exposed and is a shock hazard. Recommend that a qualified person install closure covers where missing.

The main electrical panel is not properly labeled, as required by the National Electrical Code. There is also "knock out" cover missing from the panel which exposes live parts.

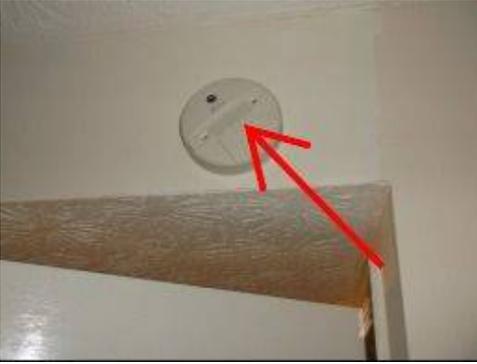
**Photo 17-1**

Carbon-monoxide detector is not properly mounted. It is hanging on screws and is easily shaken loose and falling.

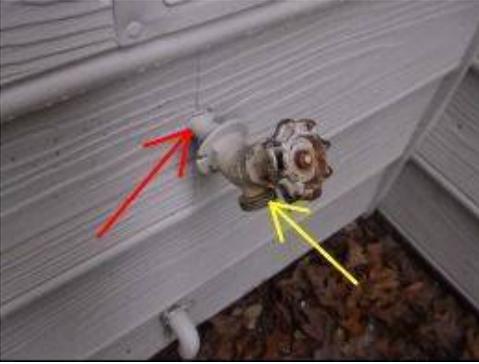
Photo 21-1

- Rear hose bib was not fitted with anti-siphon devices. Recommend that a qualified plumber install on one or more hose bibs for convenience, and per standard building practices (e.g. frost-free with anti-siphon device). Install anti-siphon devices to front and rear hose bibs.

A small portion of the exterior hose bib is exposed to cold weather which could result in freezing pipes.

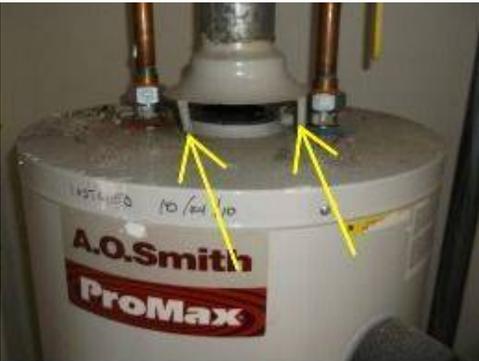
Photo 23-1

- 23** + 🛠️ - The draft hood for the water heater flue was loose. This is a potential safety hazard due to the risk of exhaust gases entering living spaces. A qualified person should permanently secure the draft hood with appropriate fasteners per standard building practices.

The flue pipe for the natural gas water heater is not securely attached to the top of the water heater. The capture hood should be attached to the water heater with metal screws.

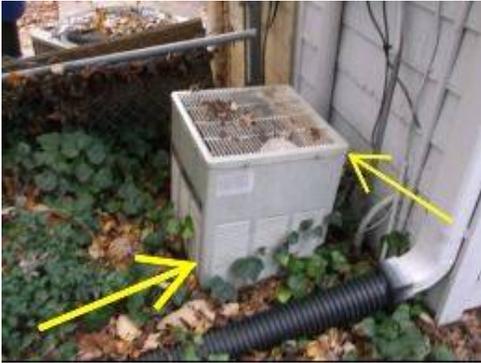
Photo 26-1

Manufactured 1983. 32 Years old. The A/C has far exceeded its normally expected useful service life. The compressor and fins were covered with rust.

The air conditioning compressor/condenser unit is not properly mounted 3" above the ground to keep dirt and debris from collecting inside the housing. The unit is too close to the siding which does not allow proper clearances for free flow of air around the unit. This unit is approx. 32 years old. It has far exceeded its normally expected useful service life and replacement is recommended. The fins and the compressor are rusted completely.

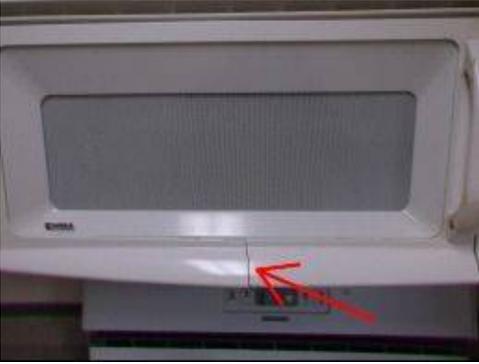
**Photo 30-1**

- The microwave oven was inoperable. Recommend that a qualified person evaluate and repair or replace as necessary.

Built in Microwave oven is inoperable. The bottom of the unit is cracked in the center and the power has been disconnected.

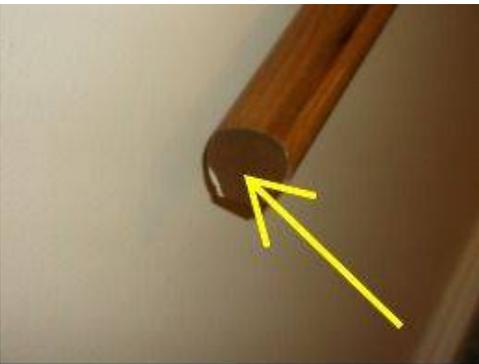
**Photo 35-1**

- One or more handrails had no "returns" installed, where ends of handrails turn and connect to adjacent walls so objects or clothing will not catch on the open ends. This is a safety hazard. Recommend that a qualified person install returns per standard building practices.

The ends of handrails should have 'returns' at both ends which prevents occupants from catching their sleeves on the ends and causing potential falls.

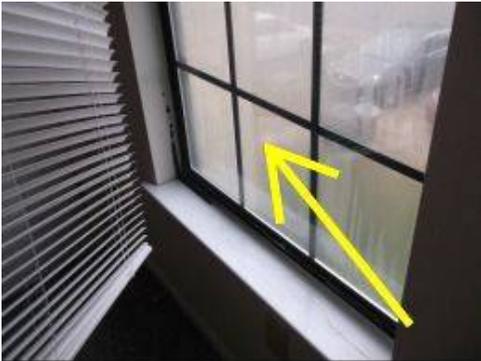
Photo 36-1

The double pane seal on the upstairs front bedroom has broken and condensation is building up inside the double panes. These windows have lost their insulation rating.
