Georgia Conference of Home Inspectors

Mr. Brian Hinton Property Inspection Report Pre-Purchase

Client(s): **Brian Hinton**
Property address: **2685 Ozella Place SW**
Atlanta, Georgia 30331
Inspection date: **Monday, July 21, 2014**

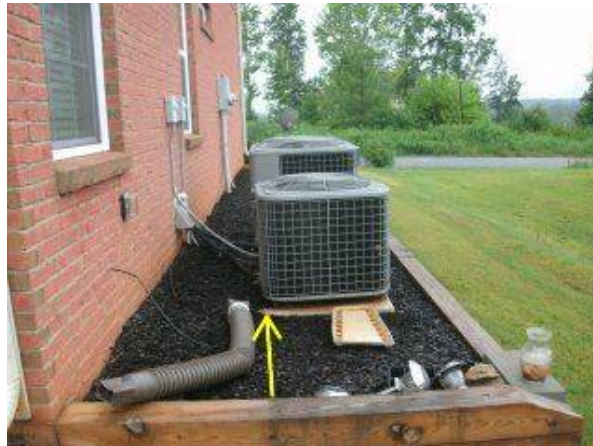
Photo 10-2
 DOWNSPOUT EXTENSION AND SPLASH BLOCK NEED TO BE INSTALLED PROPERLY...TO PREVENT WATER FROM 'POOLING' UP AGAINST FOUNDATION.

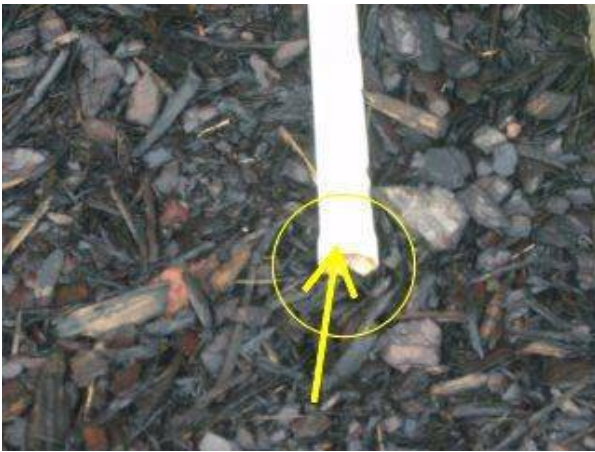
Photo 11-1
CLOGGED CONDENSATE LINES CAN RESULT IN
MOISTURE RETENTION IN THE ATTIC.

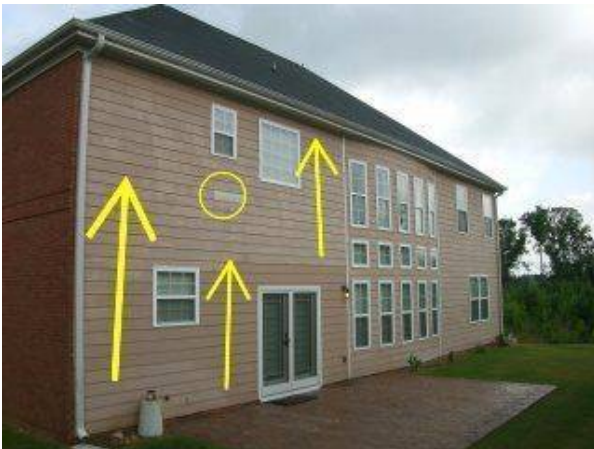
Photo 13-1

VIEW FROM REAR OZELLA PLACE. SEVERAL SIDING MEMBERS HAVE IMPACT DAMAGE AND AREAS WHERE REPAIRS HAVE BEEN RECENTLY

MADE. CAULK AND SEAL ALL JOINTS IN EXTERIOR SIDING.

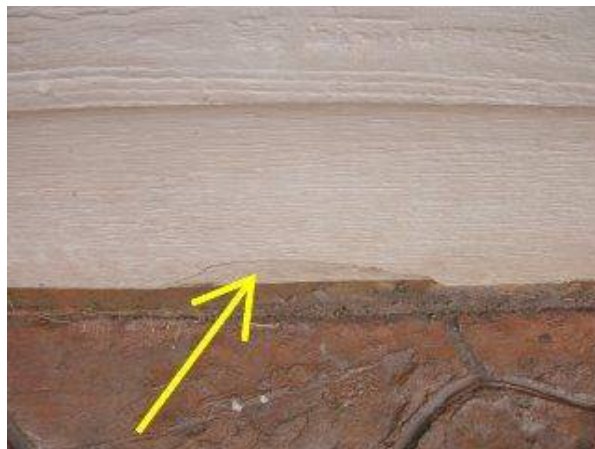
Photo X-4

IMPACT DAMAGE AS VIEWED FROM REAR SIDING.

IMPACT DAMAGE TO SIDING MEMBER AT REAR YARD.

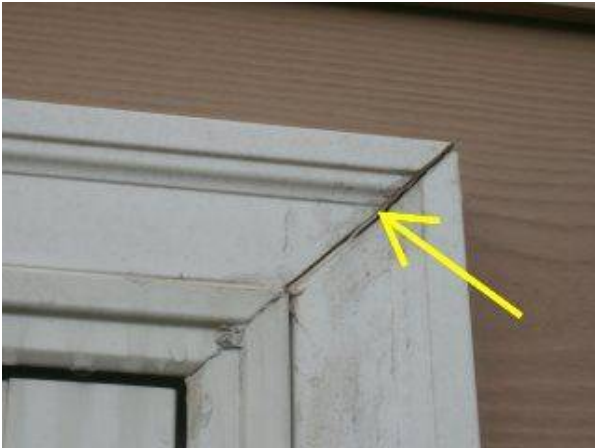
Photo X-5
WINDOW EXTERIOR TRIM ARE PULLING AWAY FROM MITRE JOINTS. CAULK AND SEAL WITH WEATHER-RESISTANT TYPE.

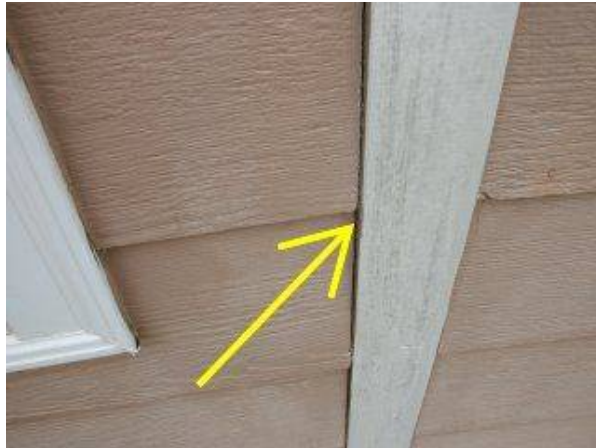
Photo X-6
SEAL ALL EXTERIOR SIDING JOINTS.

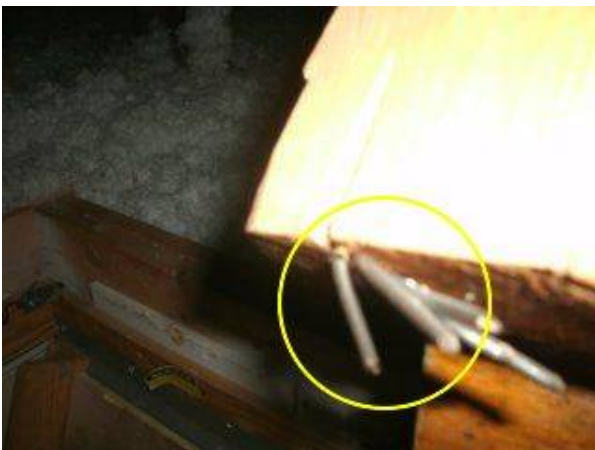
Photo X-7
POTENTIAL SAFETY HAZARD. NAILS ARE PROTRUDING AT ENTRANCE TO ATTIC STAIRS....INVITING INJURIES. EXERCISE CAUTION WHEN ENTERING AT THIS LOCATION. REPAIR AS SOON AS PRACTICABLE.

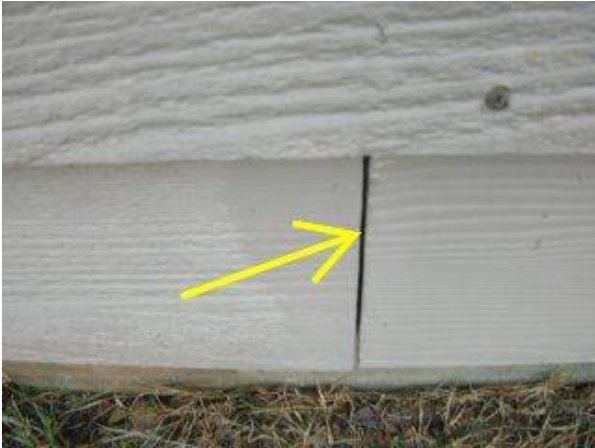
Photo X-11
GAPS IN EXTERIOR SIDING NEED CAULK AND SEALED WITH WEATHER-RESISTANT TYPE CAULK.

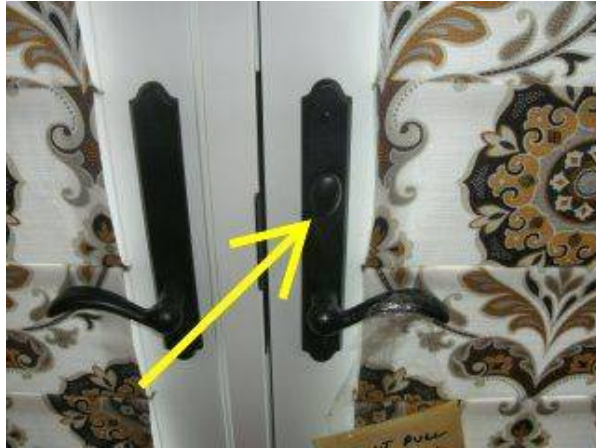
One or more exterior doors had double-cylinder deadbolts installed, where a key is required to open them from both sides. This can be a safety hazard in the event of an emergency because egress can be obstructed or delayed. Recommend replacing double-cylinder deadbolts with single-cylinder deadbolts where a handle is installed on the interior side.

Photo X-12
DOORS SHOULD NOT REQUIRE THE USE OF A TOOL, SPECIAL KNOWLEDGE OR KEY TO GAIN EXIT IN AN EMERGENCY.

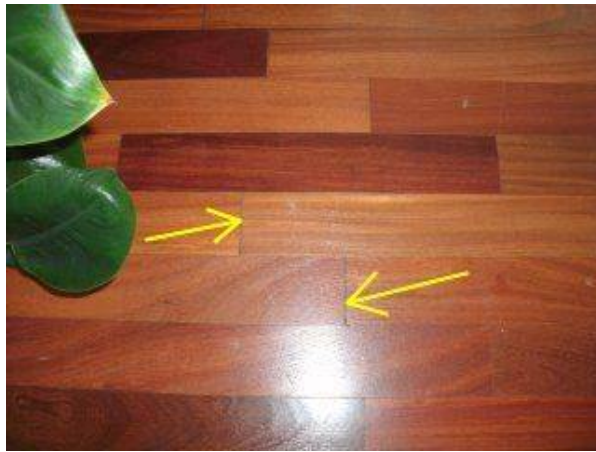
Photo X-16
GAPS OBSERVED IN HARDWOOD JOINTS IN
FAMILY ROOM.

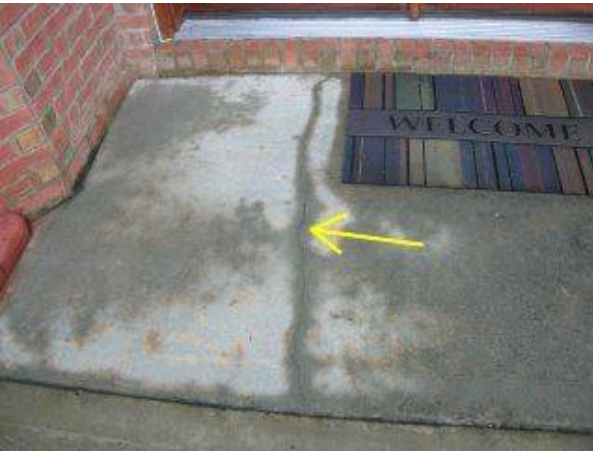
Photo X-17
MINOR CRACKS IN CONCRETE WALKWAY. THESE
ARE COMMON AND DO NOT APPEAR TO BE
SERIOUS.

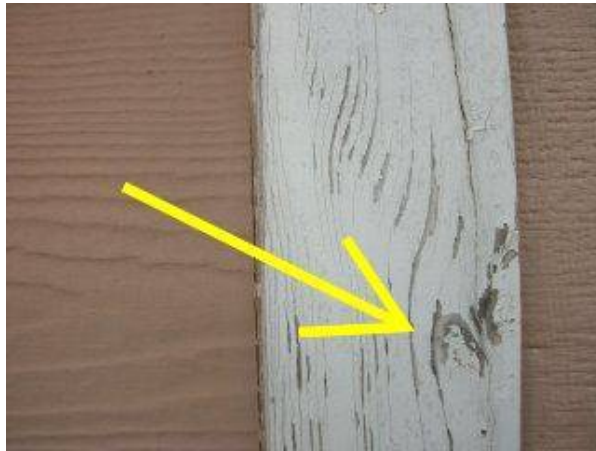
Photo X-18
SIDING TRIM PAINT IS PEELING AND EXPOSING
WOOD TO WEATHER.

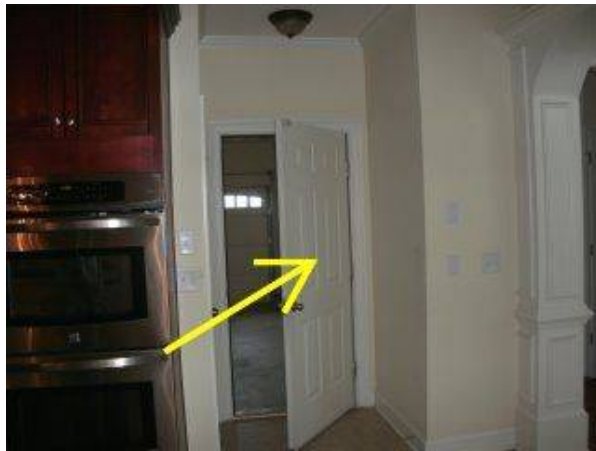
Photo X-20
THE DOOR THAT SEPARATES THE LIVING SPACE
FROM THE GARAGE IS REQUIRED TO BE 'FIRE-
RATED'. THIS DOOR DOES NOT APPEAR TO BE OF
FIRE RATED MATERIAL.

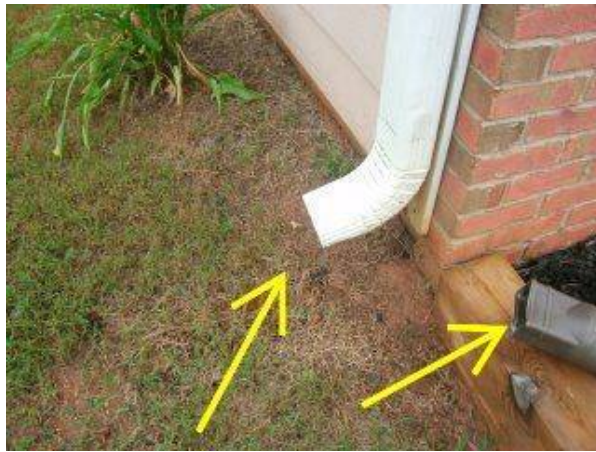
Photo X-22
DOWNSPOUT EXTENSIONS NEED TO BE RE-INSTALLED FOR PROPER DRAINAGE AWAY FROM FOUNDATION.
