Georgia Conference of Home Inspectors

Mr. Brian Hinton Property Inspection Report Pre-Purchase

Client(s): **Brian Hinton**
Property address: **2685 Ozella Place SW**
Atlanta, Georgia 30331
Inspection date: **Monday, July 21, 2014**

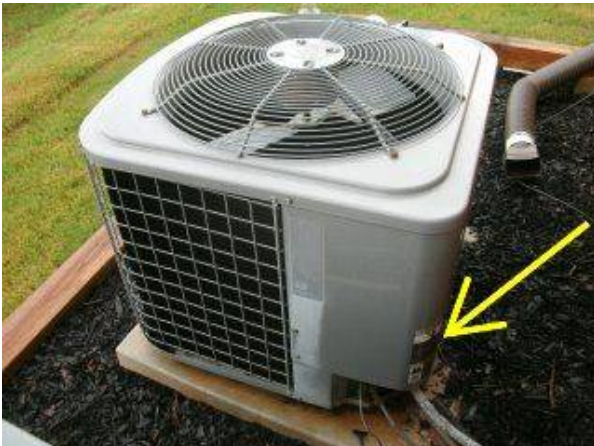
Photo 10-1
 AIR CONDITIONER CONDENSER/COMPRESSOR UNITS SHOULD BE RAISED A MINIMUM OF 3" INCHES ABOVE GROUND AND RESTING LEVEL FOR OPTIMUM OPERATION.

11) Air Conditioning compressor/condenser units should be raised a minimum of 3" above ground to prevent debris and from entering the housing.

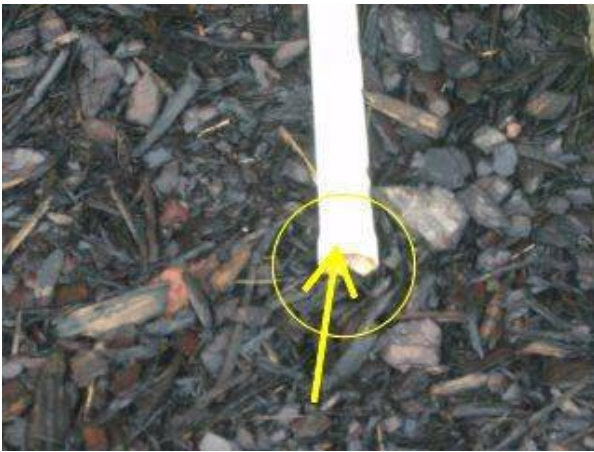
Photo 11-1
CLOGGED CONDENSATE LINES CAN RESULT IN
MOISTURE RETENTION IN THE ATTIC.

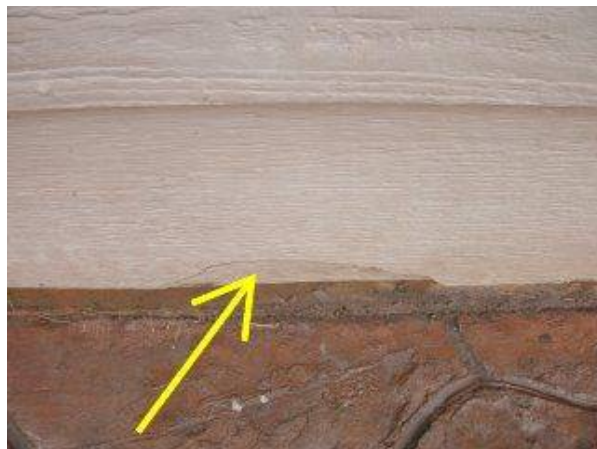
Photo X-4

IMPACT DAMAGE AS VIEWED FROM REAR SIDING.

IMPACT DAMAGE TO SIDING MEMBER AT REAR YARD.

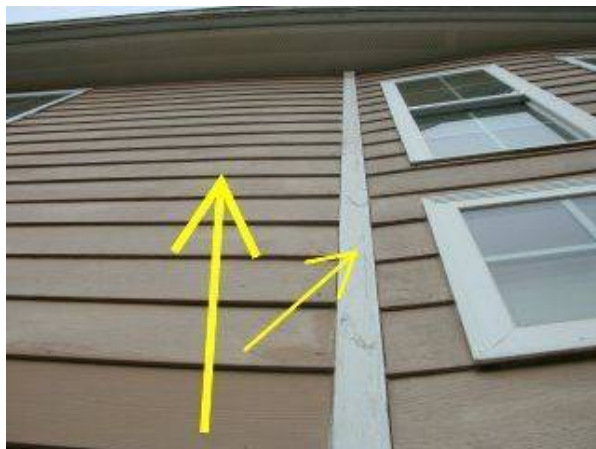
Photo X-10
PAINT IS PEELING ON EXTERIOR WOOD TRIM.

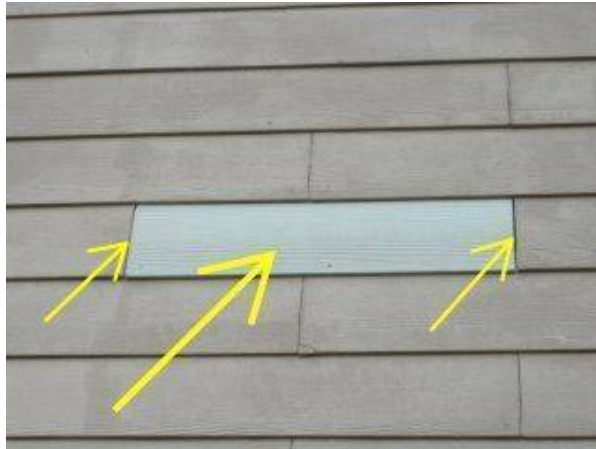
Rear siding members appear to have sections replaced and/or repainted.

Photo X-14
THERE ARE SEVERAL EXTERIOR SIDING MEMBERS WHICH HAVE BEEN REPLACED AND RE-PAINTED AT SEVERAL LOCATIONS.

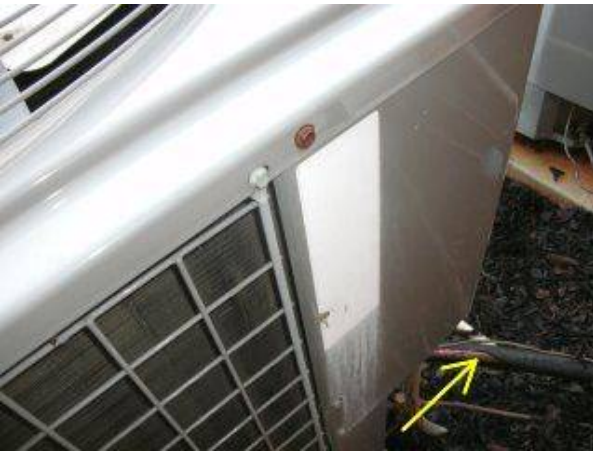
Insulation on the heat pump or air conditioning condensing unit's refrigerant lines was deteriorated or missing in some areas. This may result in reduced efficiency and increased energy costs. Recommend that a qualified person replace or install insulation as necessary.

Photo X-15
AIR CONDITIONING REFRIGERANT LINE INSULATION IS PULLING AWAY FROM PIPES.

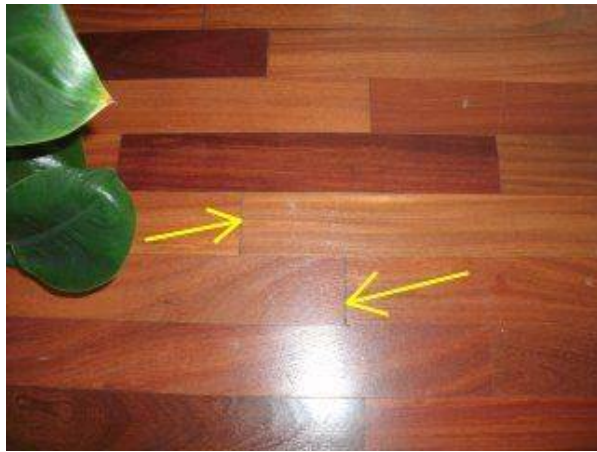
Photo X-16
GAPS OBSERVED IN HARDWOOD JOINTS IN FAMILY ROOM.

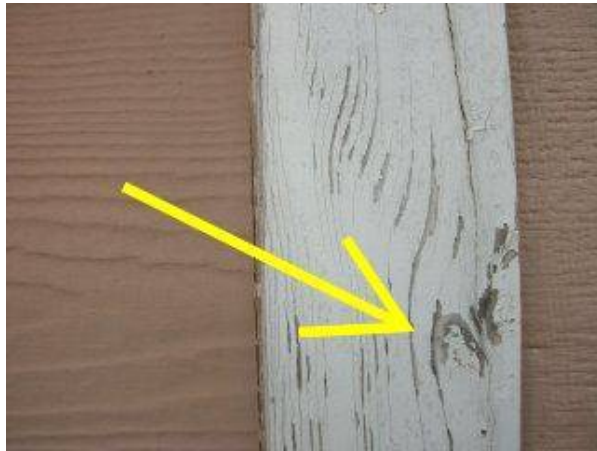
Photo X-18
SIDING TRIM PAINT IS PEELING AND EXPOSING WOOD TO WEATHER.

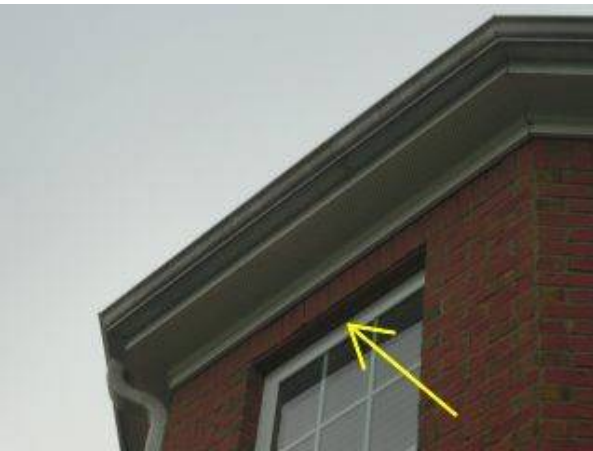
Photo X-19
CAULK AND SEAL ALL EXTERIOR SIDING JOINTS AND WINDOW TRIM TO PREVENT MOISTURE INTRUSION.

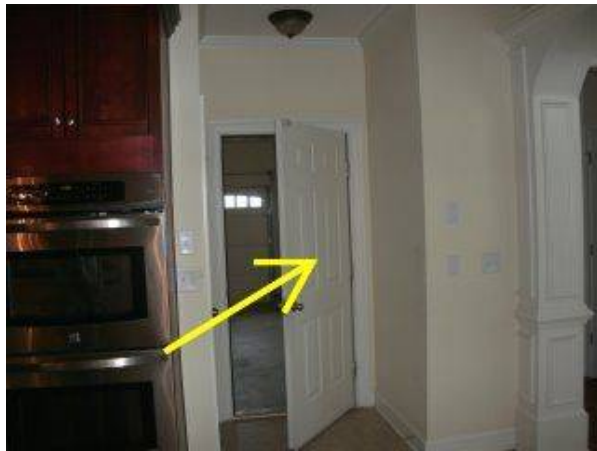
Photo X-20
THE DOOR THAT SEPARATES THE LIVING SPACE FROM THE GARAGE IS REQUIRED TO BE 'FIRE-RATED'. THIS DOOR DOES NOT APPEAR TO BE OF FIRE RATED MATERIAL.

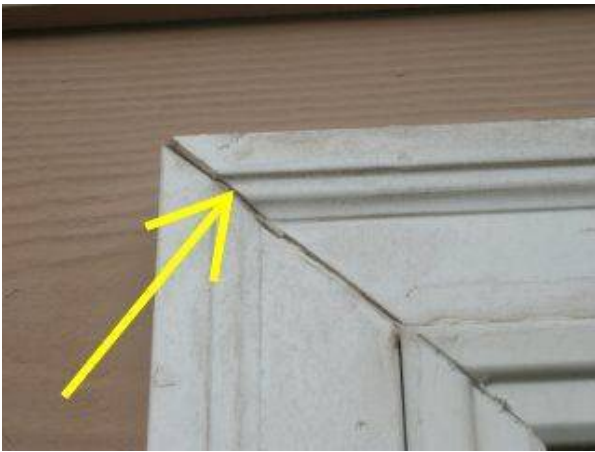
Photo X-21
GAPS BETWEEN TRIM JOINTS EXPOSE WOOD MEMBERS TO WEATHER. CAULK AND SEAL ALL EXTERIOR SIDING AND TRIM JOINTS.
