Pre-Closing Property Inspection Report

Client(s): **Mr. Jesse Shepherd**
Property address: **4070 Dinmont Chase**
Atlanta, Georgia 30349
Inspection date: **Tuesday, August 25, 2015**

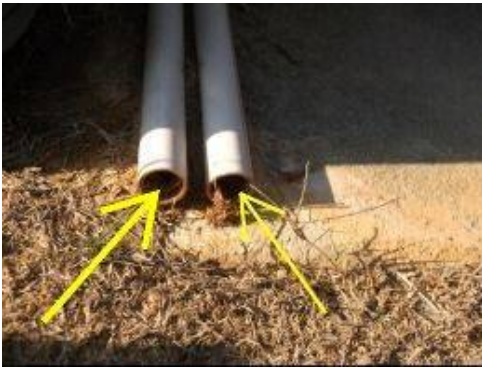
**Photo 13-1**

Condensate lines to both compressor/condenser units was lying on the ground obscured and clogged by dirt and pine needles. This can cause the the excess moisture to back up into the air handler.

Condensate lines for the air conditioning system are lying on the concrete pad and clogged with grass and debris. The condensate lines should remain free of obstructions that might cause water to back-up into the air handler.

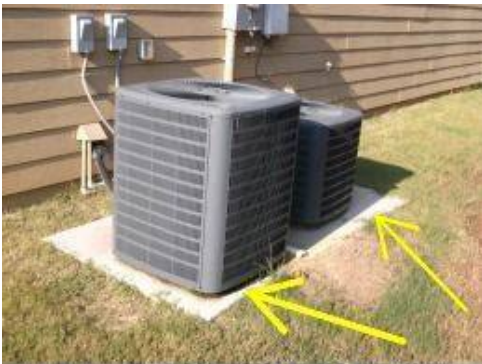
**Photo 15-1**

- 15) Air Conditioning compressor/condenser units should be raised a minimum of 3" above ground and resting on a non-vibration pad to prevent debris and from entering the housing, and resting level to prevent premature wear of fan bushings.

Air conditioning compressor condenser units should be raised a minimum of 3" above ground and resting level on a 'none'vibration' surface.

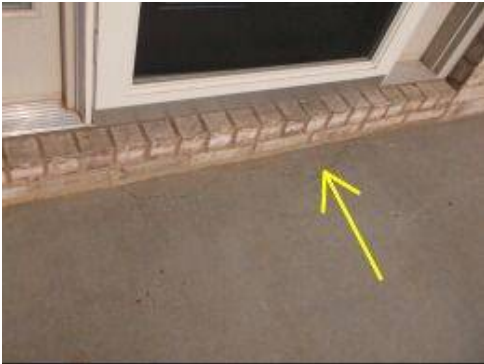
Photo X-3
Hairline cracks on the concrete porch at the entrance.

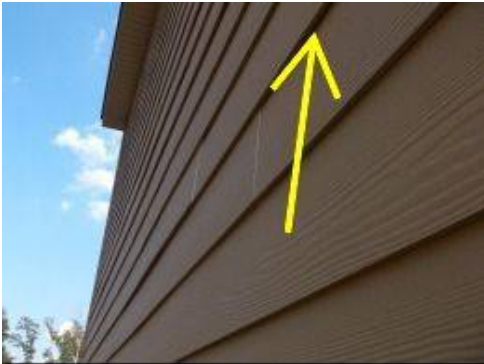
Photo X-7
Several siding members are 'loose' and need fasteners replaced.

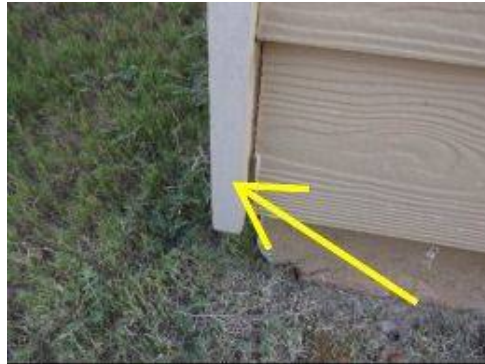
Photo X-8
Caulk and seal all siding and trim joints to prevent moisture intrusion. This corner trim piece is located at the back yard adjacent to the concrete patio. The trim is also split at several locations.

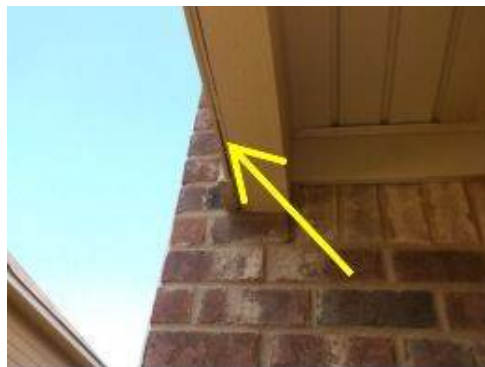
Photo X-10
Trim above front entrance concrete porch is pulling away from the siding.

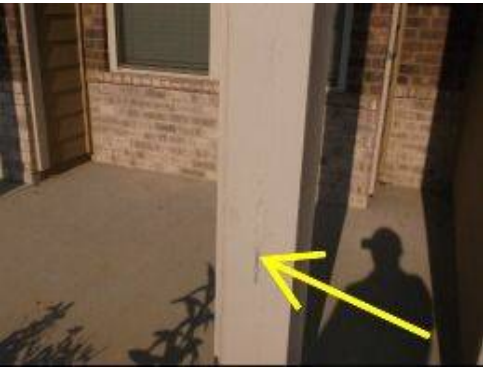
Photo X-11
Front porch support columns need re-painting with prime plus 2 coats of premium quality paint. Wood members are exposed to the weather. Re-paint where necessary.

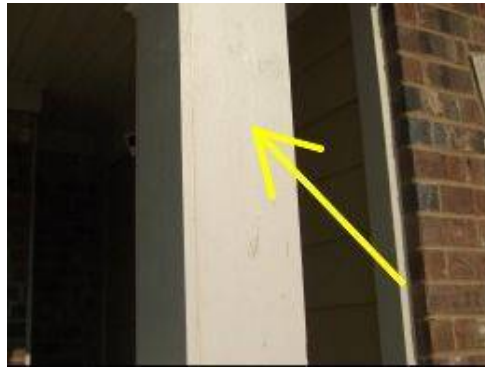
Photo X-12
Front porch support columns have peeling paint and minor splits in the wood members. Recommend re-painting with prime plus 2 coats of premium quality paint.

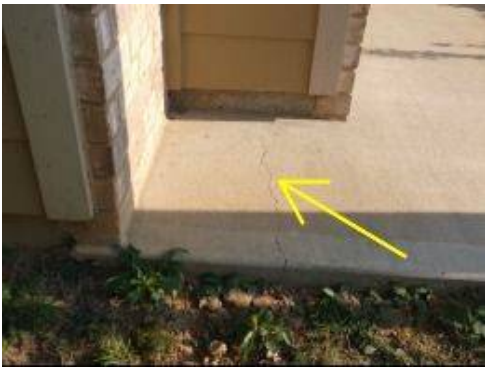
Photo X-19
Hairline cracks in the concrete porch at the front entrance.

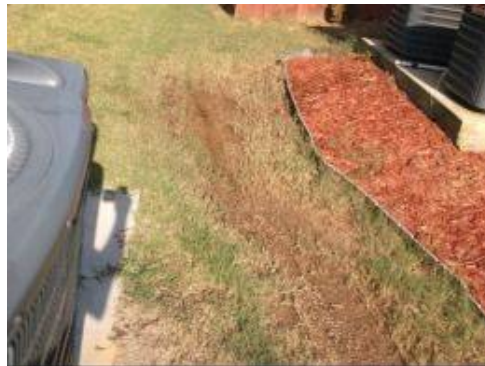
Photo X-30
Water is 'ponding' at the side yard nearest the air conditioning compressor units.

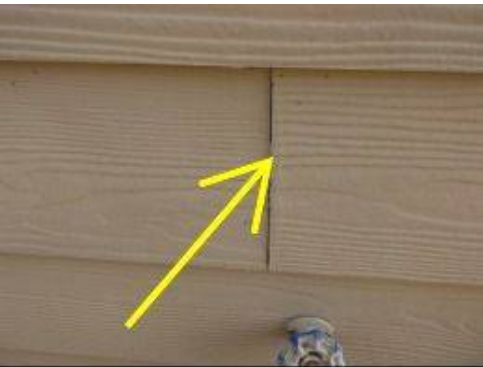
Photo 6-1

- One or more holes or gaps were found in siding or trim. Vermin, insects or water may enter the structure. Recommend that a qualified person repair as necessary. Several siding butt joints were not properly fastened at the joints. These missing fasteners have caused the ends of the butt joints to pull away from the substrate.
