Georgia Conference of Home Inspectors

Pre-Closing Property Inspection Report

Client(s): **Mr. Jesse Shepherd**
Property address: **4070 Dinmont Chase**
Atlanta, Georgia 30349
Inspection date: **Tuesday, August 25, 2015**

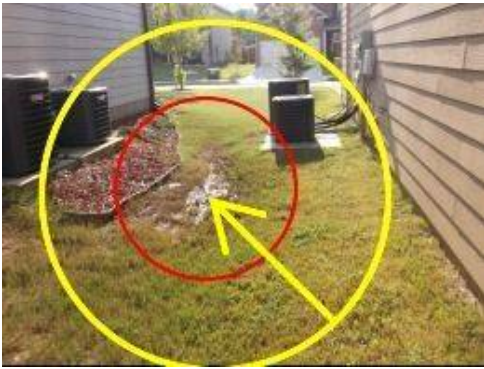
Photo 2-1

Significant amounts of standing water or evidence of past accumulated water were found at one or more locations in the yard or landscaped areas, and no drain was visible. If evidence of past water was found (e.g. silt accumulation or staining), monitor these areas in the future during periods of heavy rain. If standing water exists, recommend that a qualified person repair as necessary. For example, installing one or more drains, or grading soil.

Water is 'ponding' at the swale on the side yard where the air conditioning compressors are located. This area needs further evaluation by a landscaping specialist. Water should not stand for more than 48 hours in one spot after raining. This muddy area invites slips and falls, and standing water attracts mosquitoes.

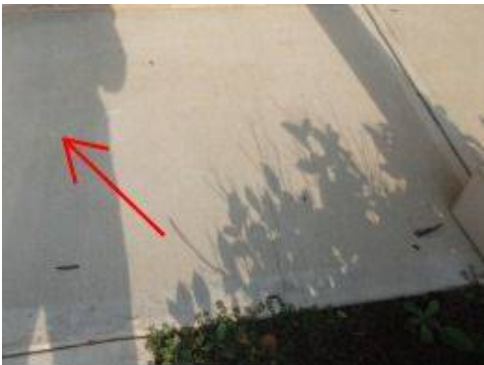
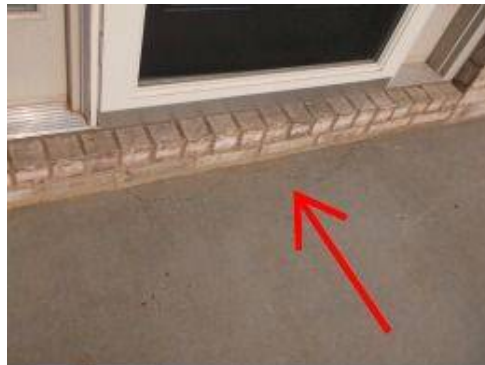
Photo 4-1

4) Front entrance concrete walkway has hairline cracks at several locations near the front entrance. These cracks appear to be minor and do not present a tripping hazard.

Minor hairline cracks observed at front entrance concrete porch.

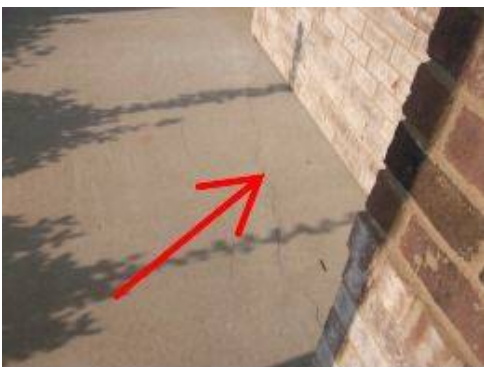
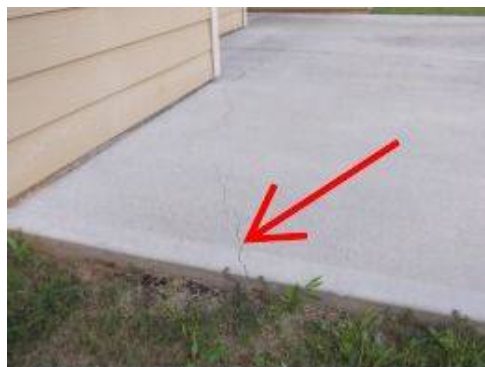
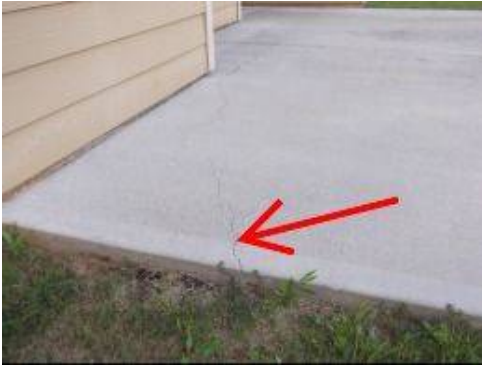
Photo 4-3

Photo 4-5
Hairline cracks observed at rear concrete patio surface.

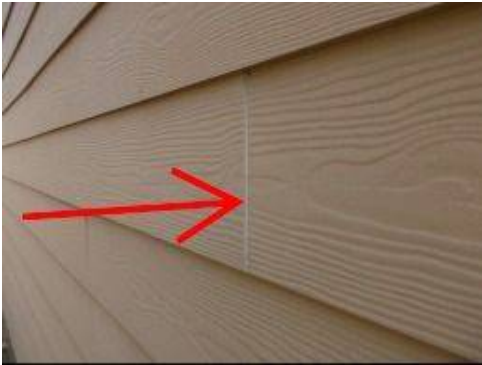
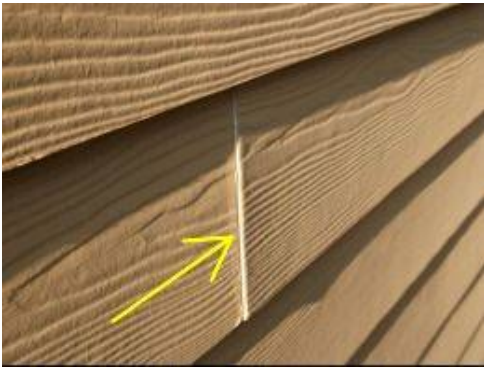
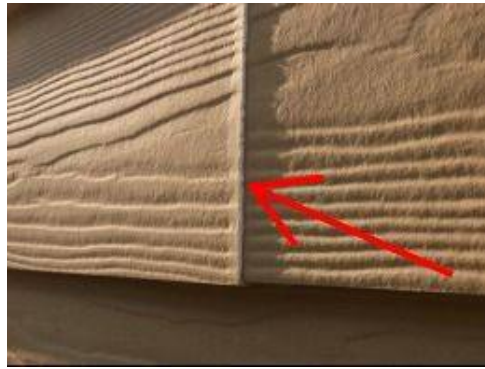
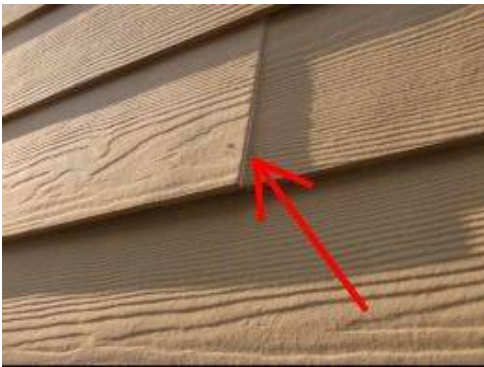
Photo 5-1

Some and/or Many sections of siding and/or trim were loose. Recommend that a qualified person repair, replace or install siding or trim as necessary.

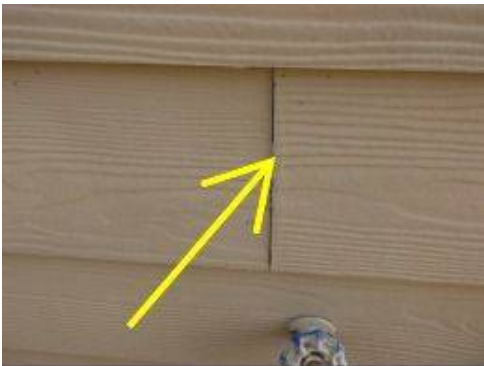
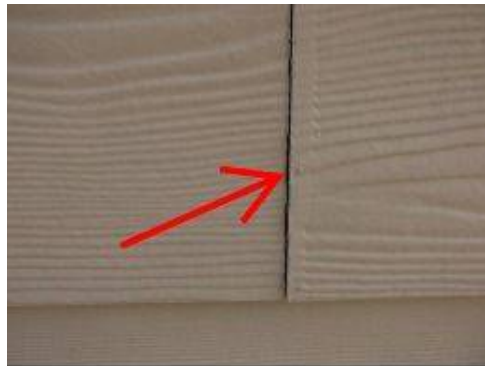
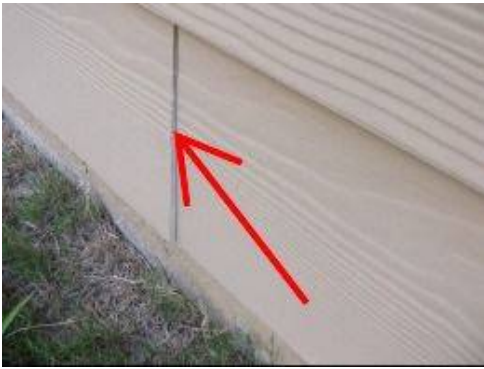
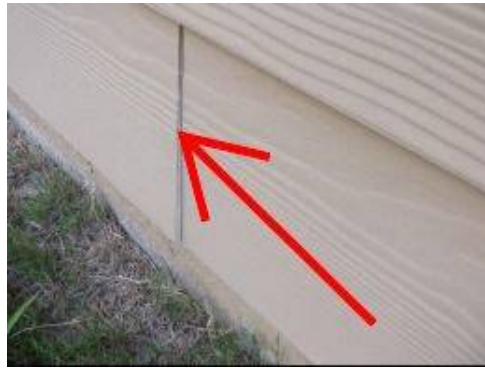
Photo 6-1

One or more holes or gaps were found in siding or trim. Vermin, insects or water may enter the structure. Recommend that a qualified person repair as necessary. Several siding butt joints were not properly fastened at the joints. These missing fasteners have caused the ends of the butt joints to pull away from the substrate.

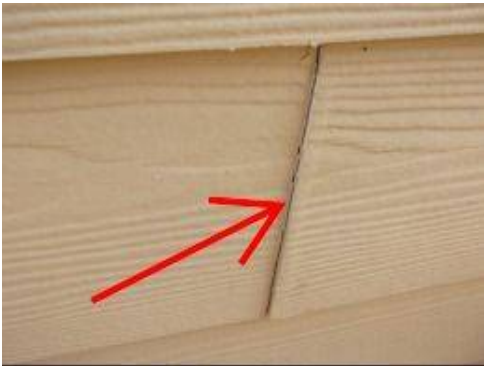
Photo 7-1

Caulk was in some areas. For example, at siding butt joints and/or at siding-trim junctions. Recommend that a qualified person renew or install caulk as necessary. Where gaps are wider than 1/4 inch, an appropriate material other than caulk should be used. For more information, visit:

All exposed ends of siding butt joints should be properly sealed with weather-resistant caulk, to prevent moisture intrusion.

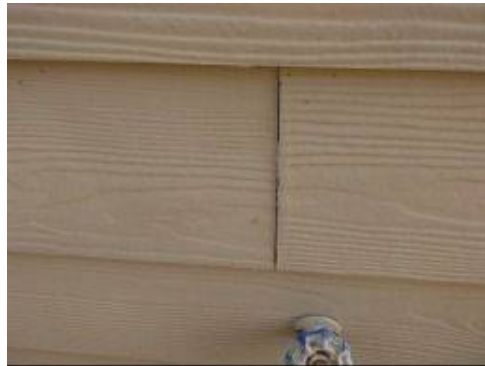
Photo 7-2

Some siding members are pulling away from the sub-strate, due to missing fasteners. Replace and/or properly install fasteners at siding butt joints where needed.

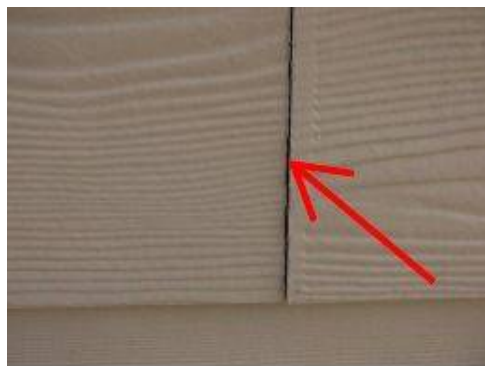
Photo 7-4

Seal all exposed ends of siding butt joints. Some siding members were not properly fastened to the substrate.

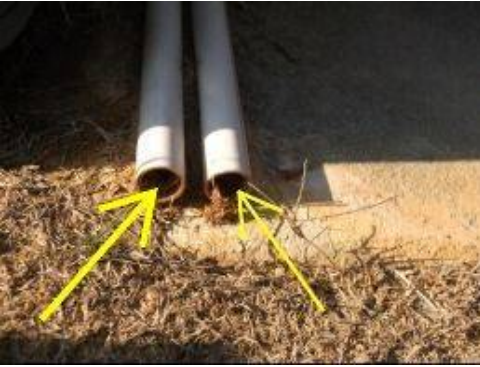
**Photo 13-1**

Condensate lines to both compressor/condenser units was lying on the ground obscured and clogged by dirt and pine needles. This can cause the the excess moisture to back up into the air handler.

Condensate lines for the air conditioning system are lying on the concrete pad and clogged with grass and debris. The condensate lines should remain free of obstructions that might cause water to back-up into the air handler.

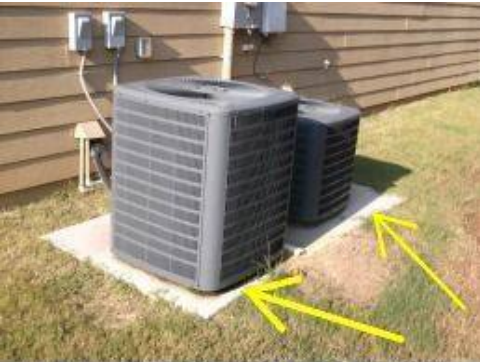
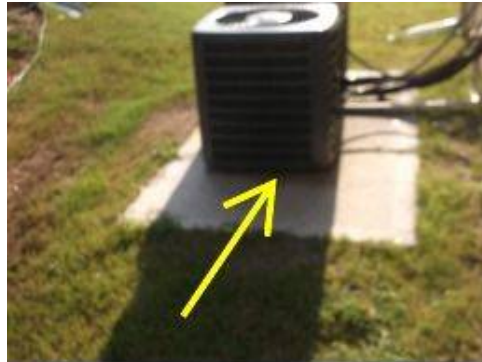
**Photo 15-1**

- 15) Air Conditioning compressor/condenser units should be raised a minimum of 3" above ground and resting on a non-vibration pad to prevent debris and from entering the housing, and resting level to prevent premature wear of fan bushings.

Air conditioning compressor condenser units should be raised a minimum of 3" above ground and resting level on a 'none'vibration' surface.

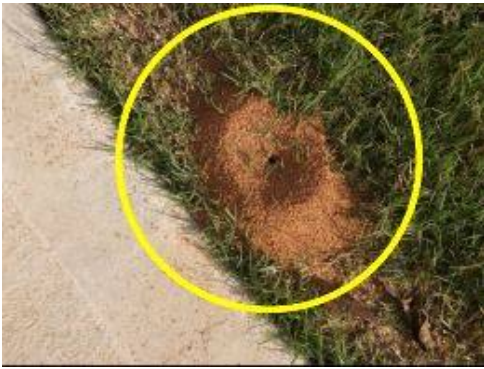
Photo X-5
Fire ant mounds observed adjacent to concrete driveway/walkway.

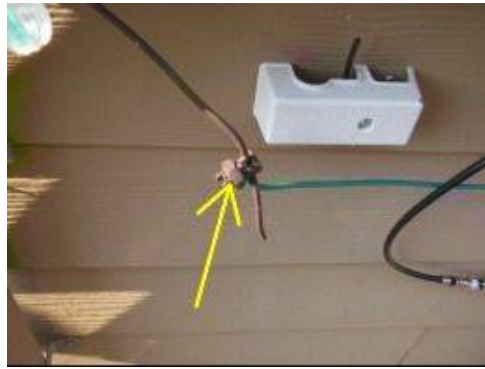
Photo X-6
The electrical ground wire is 'spliced' near the exterior panel box. Ground wires for the electrical system may not be spliced at any point along the wire.

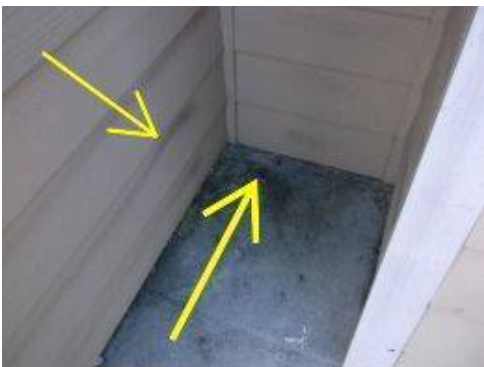
Photo X-9
There is evidence that water is being retained inside the corner of the rear concrete patio. There is suspected mold and algae growth on the siding at this location.

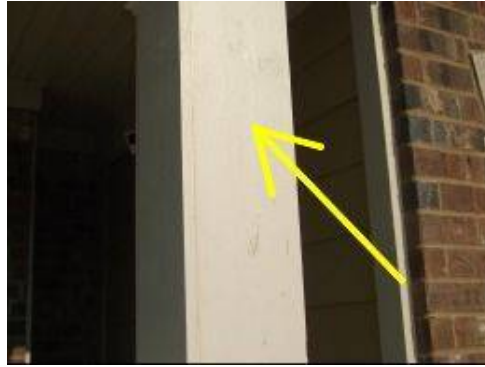
Photo X-12
Front porch support columns have peeling paint and minor splits in the wood members. Recommend re-painting with prime plus 2 coats of premium quality paint.

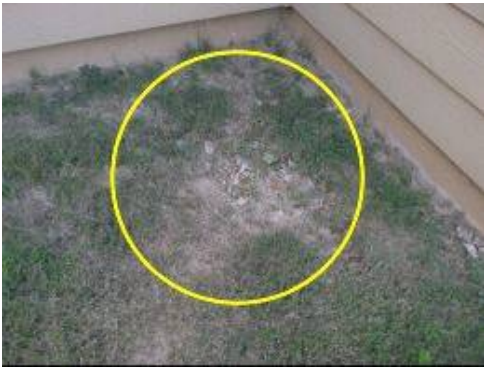
Photo X-33

There is evidence that water is pooling at the corner underneath the overhang. There are no gutters or downspouts installed at this location.

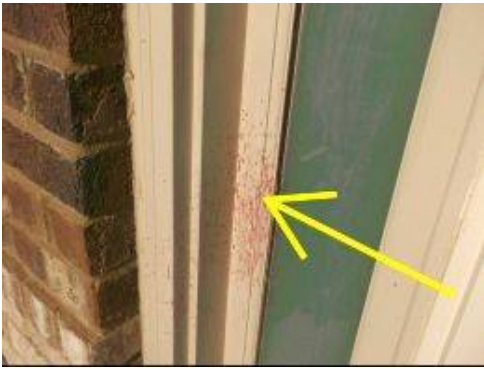
Photo X-39
There is a 'red' paint stain at the front entrance door trim.

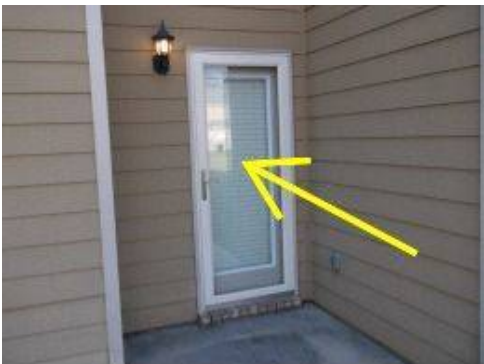
Photo X-43
Glass storm door could potentially be a hazard of persons colliding with the door when lighting is poor.

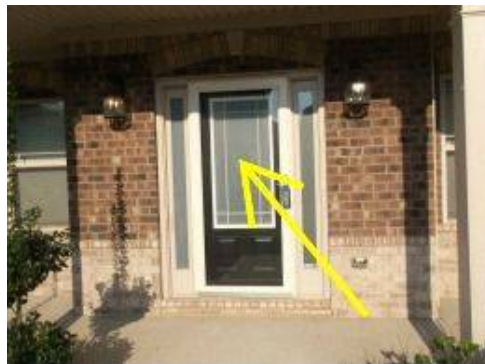
Photo X-44
Front entrance with glass storm door. The glass storm door could be a potential hazard of persons colliding with the door when lighting is poor.

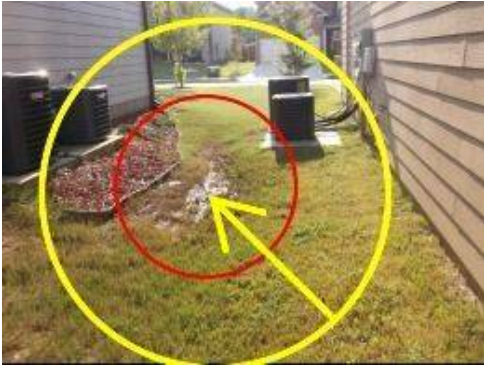
Photo 2-1

- Significant amounts of standing water or evidence of past accumulated water were found at one or more locations in the yard or landscaped areas, and no drain was visible. If evidence of past water was found (e.g. silt accumulation or staining), monitor these areas in the future during periods of heavy rain. If standing water exists, recommend that a qualified person repair as necessary. For example, installing one or more drains, or grading soil.

Water is 'ponding' at the swale on the side yard where the air conditioning compressors are located. This area needs further evaluation by a landscaping specialist. Water should not stand for more than 48 hours in one spot after raining. This muddy area invites slips and falls, and standing water attracts mosquitoes.

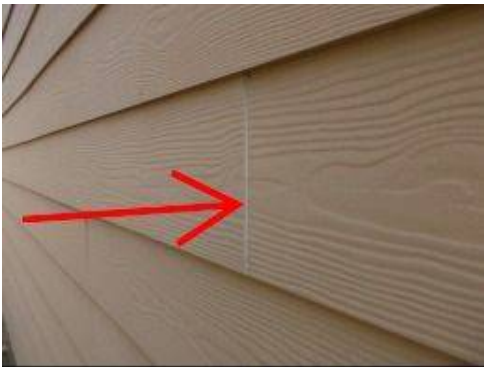
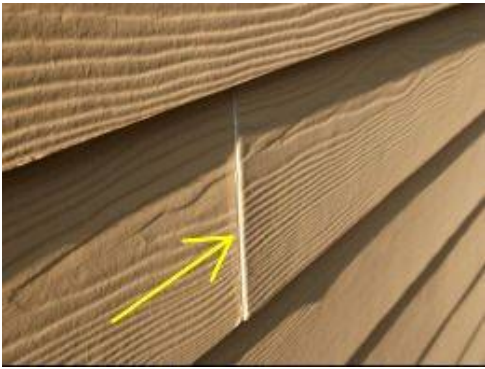
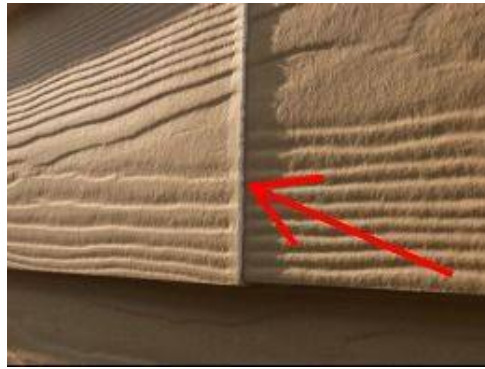
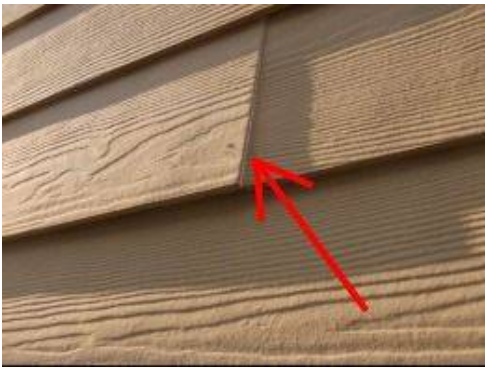
Photo 5-1

- Some and/or Many sections of siding and/or trim were loose. Recommend that a qualified person repair, replace or install siding or trim as necessary.

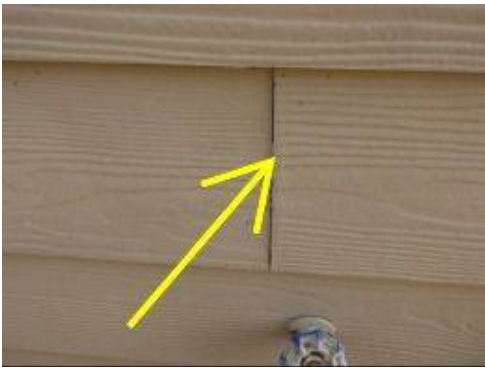
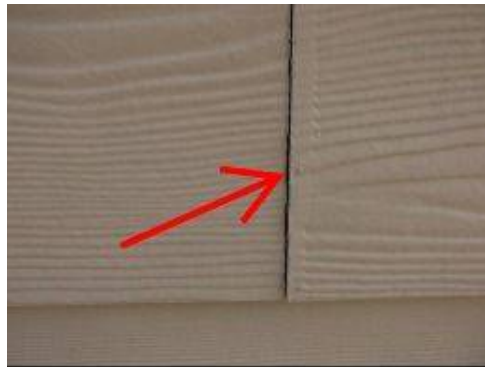
Photo 6-1

- One or more holes or gaps were found in siding or trim. Vermin, insects or water may enter the structure. Recommend that a qualified person repair as necessary. Several siding butt joints were not properly fastened at the joints. These missing fasteners have caused the ends of the butt joints to pull away from the substrate.

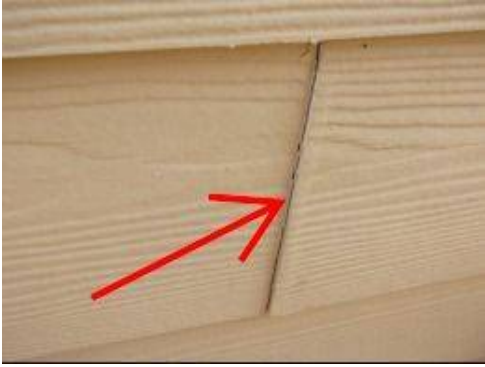
Photo 7-1

- Caulk was in some areas. For example, at siding butt joints and/or at siding-trim junctions. Recommend that a qualified person renew or install caulk as necessary. Where gaps are wider than 1/4 inch, an appropriate material other than caulk should be used. For more information, visit:

All exposed ends of siding butt joints should be properly sealed with weather-resistant caulk, to prevent moisture intrusion.

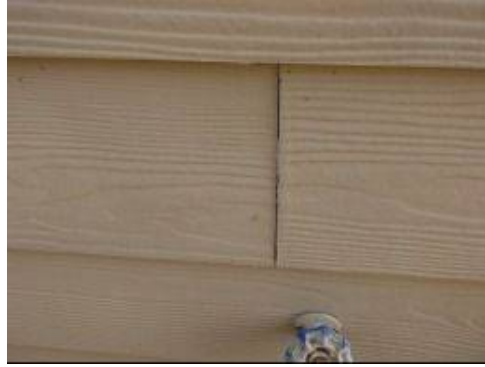
Photo 7-2

Some siding members are pulling away from the sub-strate, due to missing fasteners. Replace and/or properly install fasteners at siding butt joints where needed.

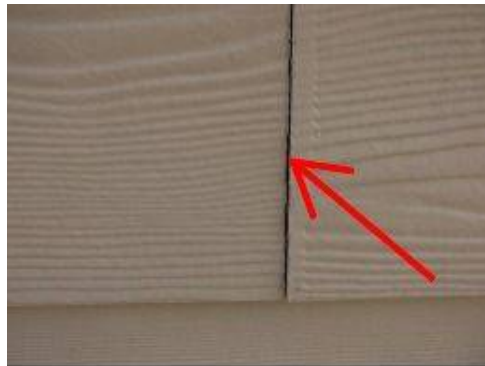
Photo 7-4

Seal all exposed ends of siding butt joints. Some siding members were not properly fastened to the substrate.

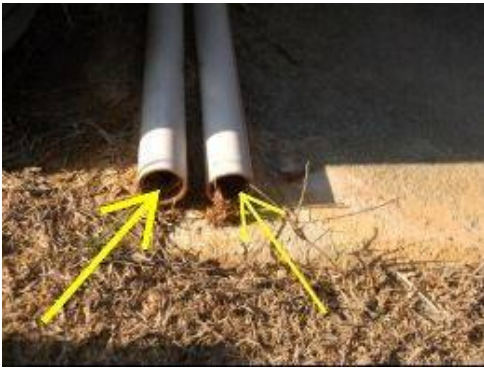
**Photo 13-1**

- Condensate lines to both compressor/condenser units was lying on the ground obscured and clogged by dirt and pine needles. This can cause the the excess moisture to back up into the air handler.

Condensate lines for the air conditioning system are lying on the concrete pad and clogged with grass and debris. The condensate lines should remain free of obstructions that might cause water to back-up into the air handler.
