Georgia Conference of Home Inspectors

Summary

Client(s): **Ms. Greta Brotherton**
Property address: **24` Alexander Top Place**
Grayson, Georgia 30017
Inspection date: **Tuesday, December 08, 2015**

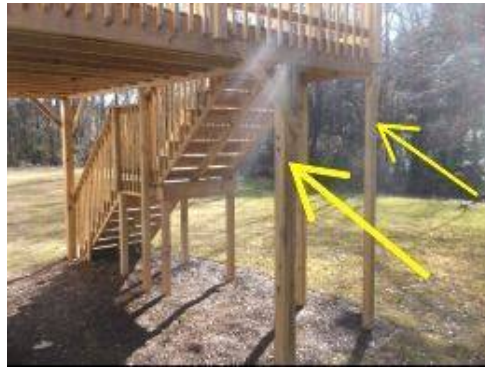
Photo 5-2

- Soil was in contact with one or more wooden deck, porch or balcony support posts. This is a conducive condition for wood destroying organisms. Even if posts are made of treated wood, the cut ends below soil may not have been field treated. Recommend grading soil or repairing as necessary to prevent wood-soil contact.

Support columns at rear deck. A mixture of 4x4 and 4x6.

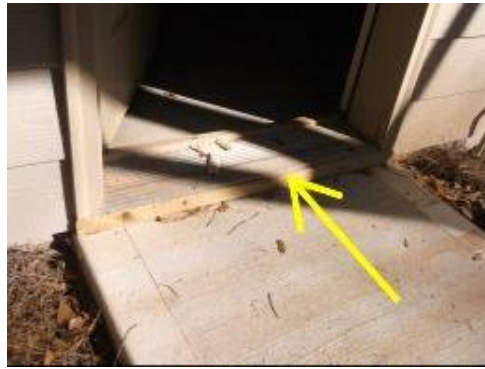
- Untreated wood siding and/or trim was in contact with concrete or masonry at the rear basement door kick-plate. Moisture collected between the two materials or wicking up into the wood is a conducive condition for wood-destroying organisms. Wood siding or trim should be installed with a minimum clearance of 1-2 inches between it and concrete or masonry below it at building exteriors. Monitor these areas for rot or infestation in the future and repair if needed. Recommend that a qualified person repair per standard building practices. For example, by trimming siding or trim as needed.

Photo 10-2
Wood kick plate in contact with concrete landing. Untreated lumber should not be in direct contact with concrete surfaces, due to the potential for rot.

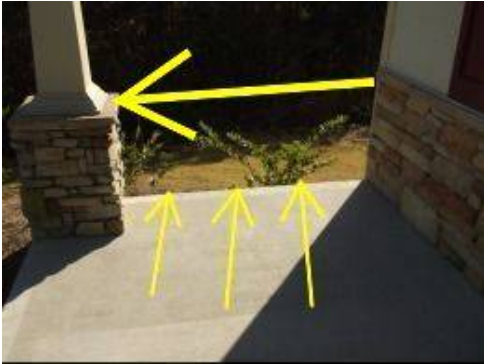
- 13 - Guardrails at one or more locations with drop-offs higher than 30 inches were missing components, and pose a fall hazard. Recommend that a qualified person repair guardrails as necessary.

Photo 13-1
All unenclosed surfaces 30 inches or higher requires guardrails to prevent occupants from falling off and potential injury. Recommend guardrails be installed at the side entrance porch.

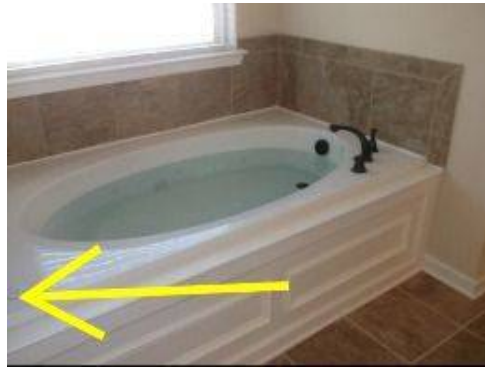
Photo 18-6
 Master bathroom jetted tub does not respond to normal operating controls. The spring loaded on/off switch is defective.

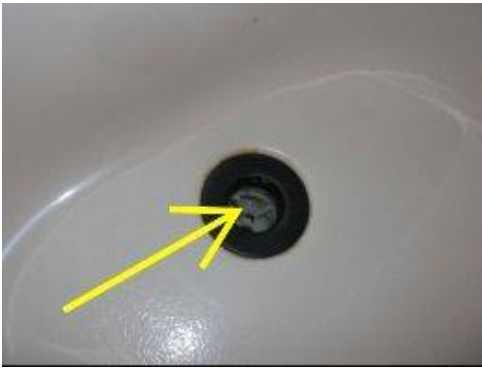
Photo 26-3
Bathroom stopper is missing from upstairs bathroom.

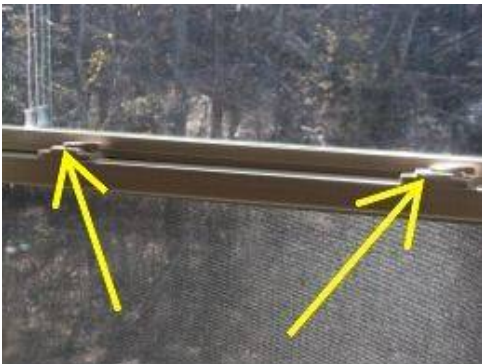
- One or more windows that were designed to open and close were difficult to open and close. Recommend that a qualified person repair windows as necessary so they open and close easily.

Photo 28-1
Rear upstairs bedroom window is improperly installed. The locking mechanism does not latch properly.

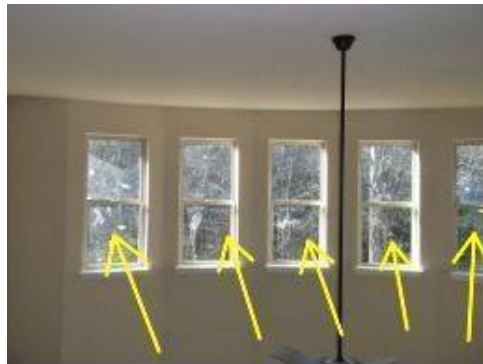
Photo 28-2
Windows above family room need cleaning. Paint or mortar stains visible from floor level.
