Georgia Conference of Home Inspectors

Summary

Client(s): **Ms. Greta Brotherton**
Property address: **24` Alexander Top Place**
Grayson, Georgia 30017
Inspection date: **Tuesday, December 08, 2015**

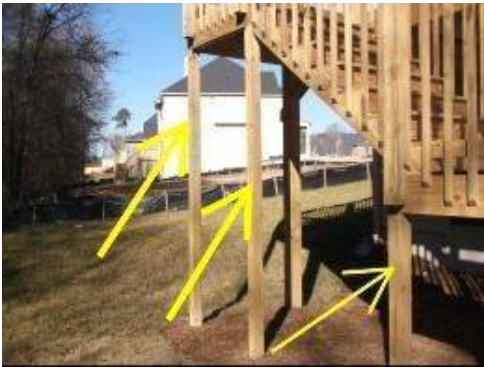
Photo 5-1

- Soil was in contact with one or more wooden deck, porch or balcony support posts. This is a conducive condition for wood destroying organisms. Even if posts are made of treated wood, the cut ends below soil may not have been field treated. Recommend grading soil or repairing as necessary to prevent wood-soil contact.

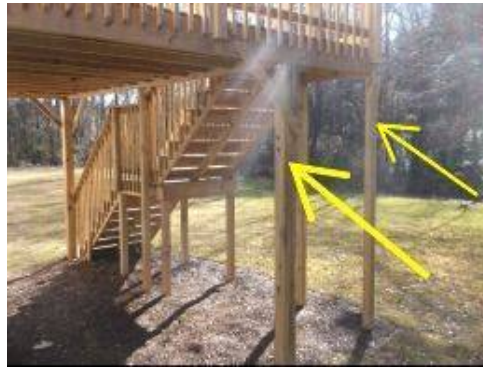
Photo 5-2

Support columns at rear deck. A mixture of 4x4 and 4x6.

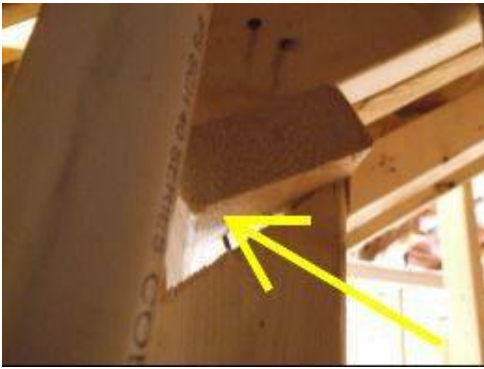
Photo 5-3

Rear deck supporting members are not fully bearing on the support posts. Repair as necessary.

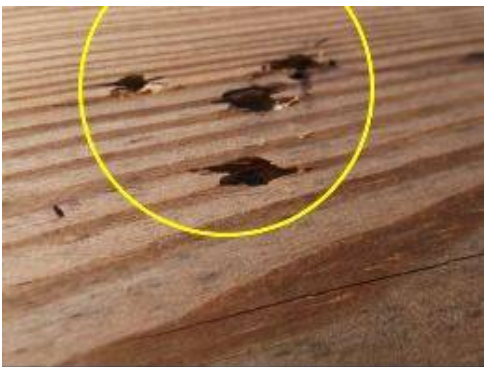
Photo 7-1

- Some nails securing decking boards were loose and were not flush with the surfaces of boards. Boards are more likely to loosen and warp. This may pose a safety hazard to those with bare feet. Recommend that a qualified person repair as necessary. For example, by replacing nails or installing screws. Note that existing nails that are simply pounded back in will be likely to loosen again.

Nails at rear deck are 'over-driven' at several locations.

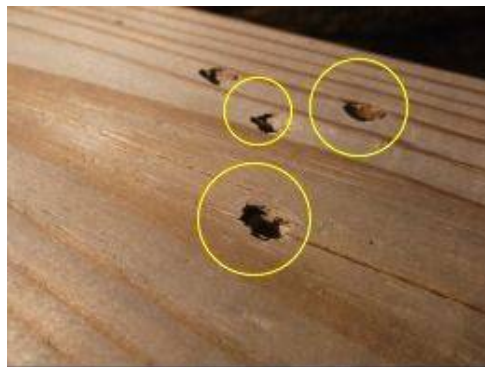
Photo 7-2

Nail heads are over-driven and have sunk into the deck top rail. Water can settle into the holes exposing the wood member to moisture. Recommend filling the over-sunk nails with epoxy or some other weather-resistant caulk or sealant.

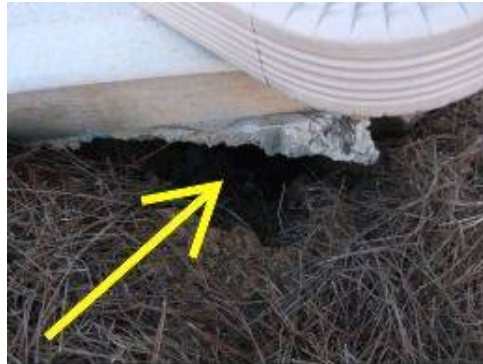
Photo 9-2
A portion of the concrete driveway base and footing is not fully supported by the ground. There is a large hole where the concrete meets the ground surface. The unsupported concrete could potentially collapse and break off affecting the remaining concrete surfaces. This area appears to not be properly and fully back-filled.

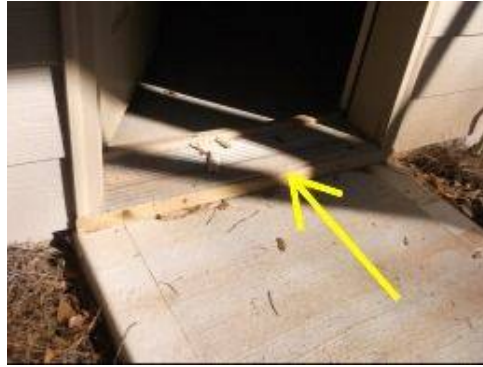
**Photo 10-2**

- Untreated wood siding and/or trim was in contact with concrete or masonry at the rear basement door kick-plate. Moisture collected between the two materials or wicking up into the wood is a conducive condition for wood-destroying organisms. Wood siding or trim should be installed with a minimum clearance of 1-2 inches between it and concrete or masonry below it at building exteriors. Monitor these areas for rot or infestation in the future and repair if needed. Recommend that a qualified person repair per standard building practices. For example, by trimming siding or trim as needed.

Wood kick plate in contact with concrete landing. Untreated lumber should not be in direct contact with concrete surfaces, due to the potential for rot.

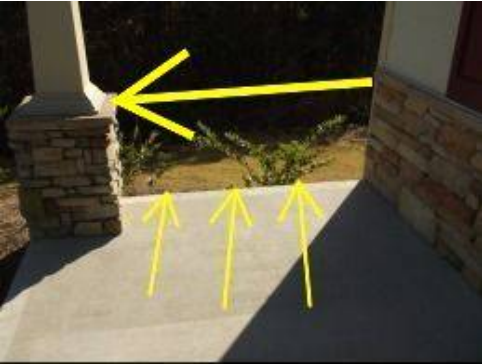
**Photo 13-1**

- Guardrails at one or more locations with drop-offs higher than 30 inches were missing components, and pose a fall hazard. Recommend that a qualified person repair guardrails as necessary.

All unenclosed surfaces 30 inches or higher requires guardrails to prevent occupants from falling off and potential injury. Recommend guardrails be installed at the side entrance porch.

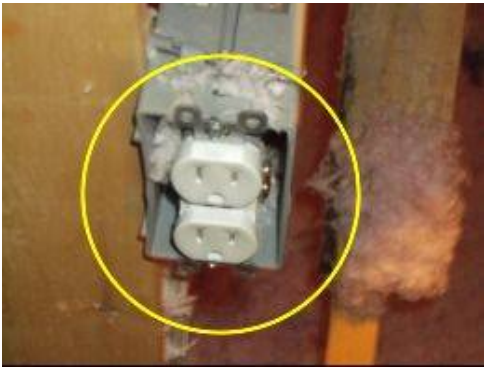
- One or more cover plates installed outside were missing components. This is a potential shock and/or fire hazard. Recommend that a qualified electrician repair as necessary.

Photo 16-1
Cover plate missing from attic duplex receptacle exposing live energized parts.

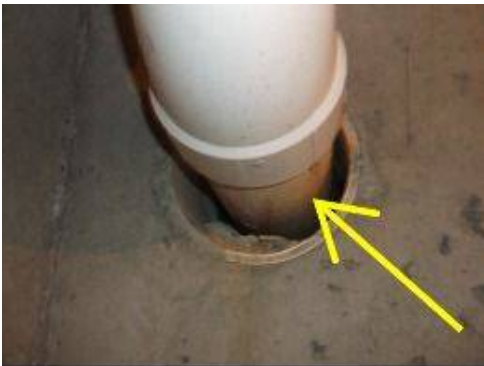
Photo 18-1
Recommend caulking and sealing of all wall penetrations from the basement walls.

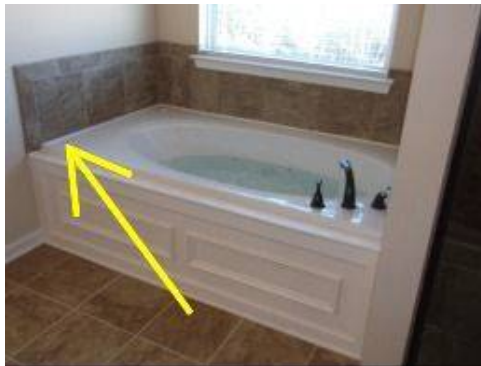
Photo 18-2
Jetted tub motor does not respond to normal operating. The switch is defective and the motor does not engage. Repair and test as necessary.

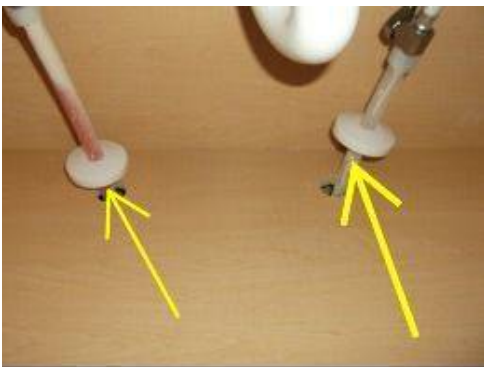
Photo 18-3
Escutcheon plates underneath bathroom sink are not properly installed. The water supply lines are not securely anchored.

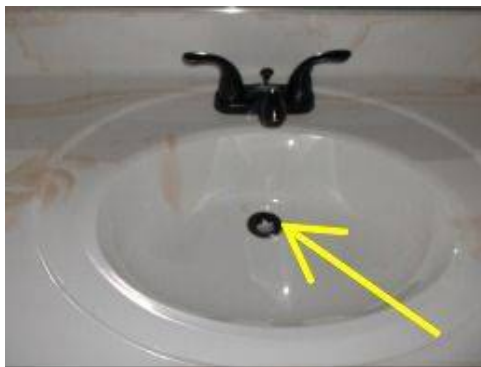
Photo 18-4
Upstairs bathroom sink stopper is missing. Replace as necessary.

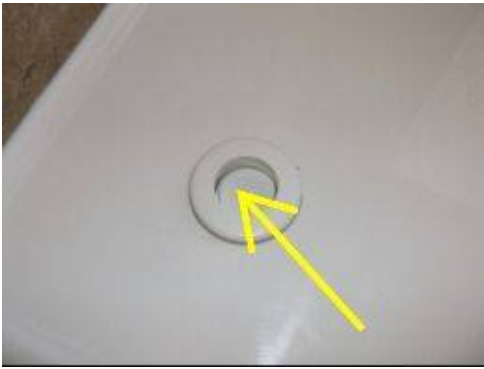
Photo 18-5
 Jetted tub switch motor does not engage. The spring loaded switch is defective. Repair and/or replace and test as necessary.

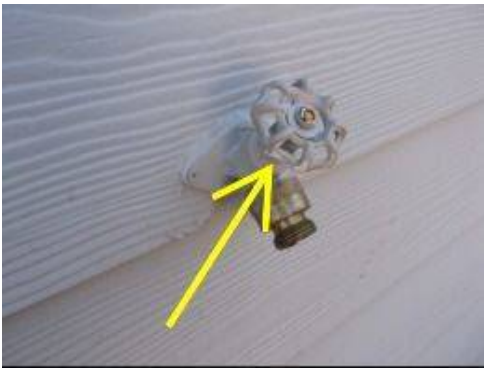
Photo 18-7
 Exterior hose bib is split and leaking when valve is opened.

19 - One or more hose bibs (outside faucets) leaked when tested. When hose bibs leak while turned off, it's often caused by a worn valve seat or a loose bonnet. When hose bibs leak while turned on, it may be due to worn "packing" around the stem or a defective backflow prevention device. Recommend that a qualified plumber repair as necessary.

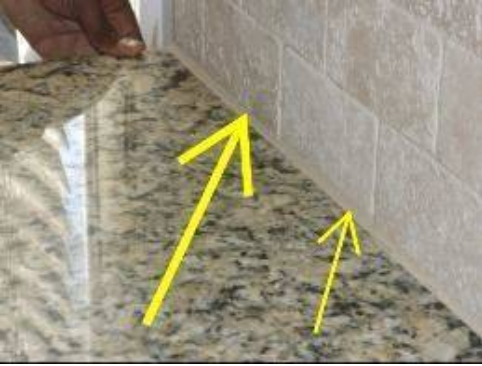
Photo 23-1

- Gaps, no caulk, or substandard caulking were found between countertops and backsplashes. Water may penetrate these areas and cause damage. Recommend that a qualified person repair as necessary. For example, by installing caulk.

Kitchen counter-top grout has a seam where the tile grout has settled.

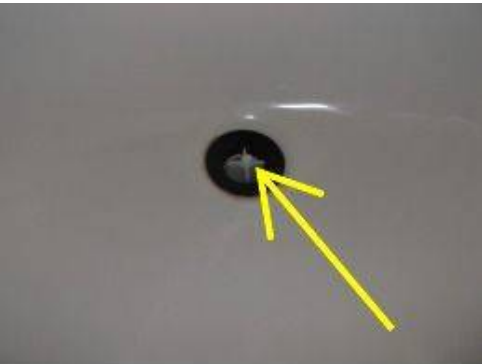
Photo 26-1

- The bathtub drain stopper mechanism at location(s) #A and B was missing. Recommend that a qualified person repair or replace as necessary.

Sink stopper missing at hallway upstairs bathroom.

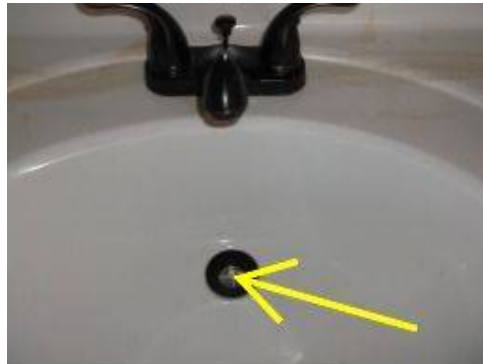
Photo 26-2

Sink stopper missing from bathroom lavatory sink.

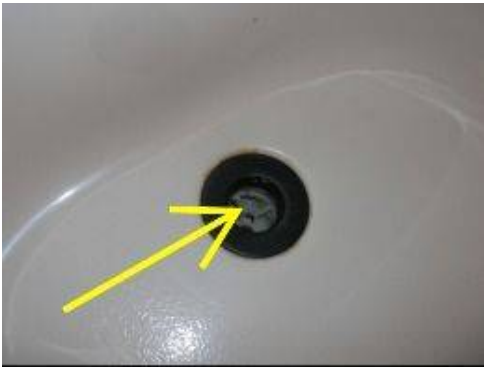
Photo 26-3
Bathroom stopper is missing from upstairs bathroom.

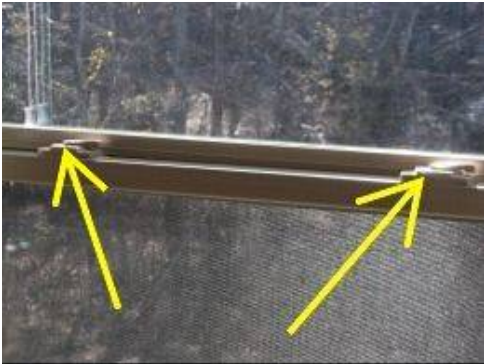
- One or more windows that were designed to open and close were difficult to open and close. Recommend that a qualified person repair windows as necessary so they open and close easily.

Photo 28-1
Rear upstairs bedroom window is improperly installed. The locking mechanism does not latch properly.

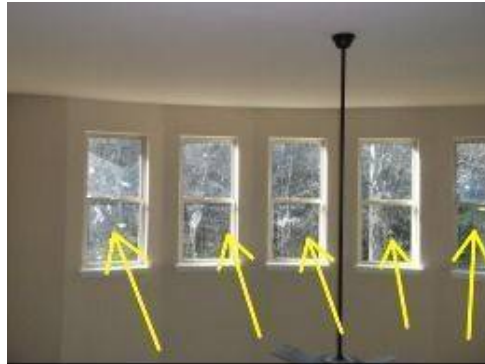
Photo 28-2
Windows above family room need cleaning. Paint or mortar stains visible from floor level.
