Case Study

Grout Wall Effectiveness Study

Willowstick tracked seepage around a grout wall and along an old diversion pipe

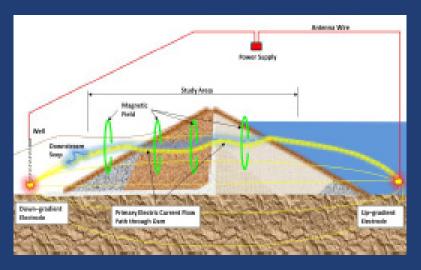
The Willowstick investigation identified two discrete seepage flow paths. One flow path travelled around the installed grout wall along the top of rock. The second flow path followed the alignment of an old diversion pipe. The surveys identified both the location and the depth of these seepage flow paths.

3D model showing the results of Willowstick seepage flow survey. Seepage Flow path (yellow tube) flowing around the grout wall (red tubes) before passing under the dam near top of rock.

The groundwater investigation provided the client with new insights and intelligence about the subsurface conditions at the site. The dam owner will likely use this intelligence to design a new grout wall and investigate the area around the old pipeline.
