# THE USE OF INNOVATIVE GROUNDWATER SEEPAGE DETECTION TECHNIQUES

DR. ANDY HUGHES

## THE SAMANALAWEWA DAM

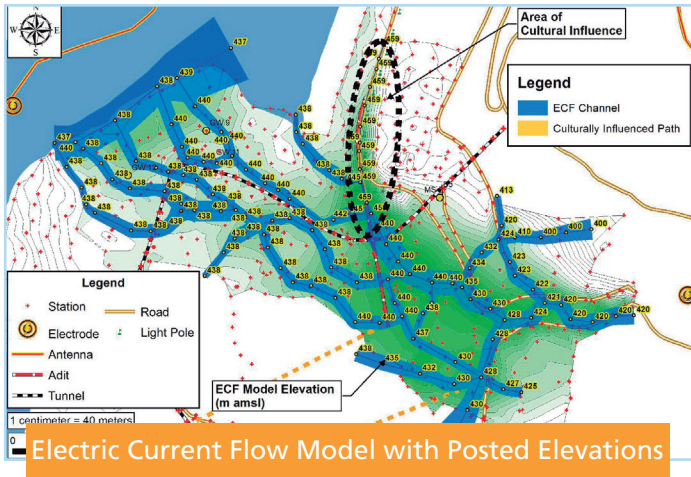
The above figure shows an interpretation of the results from Survey 1—which shows the positions of the modelled flow paths (vertical and horizontal alignment).

The model suggests that seepage north of the tunnel occurs above the tunnel and finds an opening in the adit's grout curtain at the 440m elevation.

The results of the investigation suggest that there are a series of braided seepage flow paths, north and south of the tunnel, that run beneath the right abutment study area. Seepage appears to concentrate around the right side of the dam, rather than underneath or through the dam's earthen embankment. There is

some seepage occurring along the right rim within the grout curtain, but not to the extent that it is flowing through the right abutment study area. It has been recommended, any seepage through karst topography needs to be carefully characterized, monitored and possibly remediated, to ensure the integrity of the reservoir as well as the safety of those residing downstream of the dam.

The Willowstick survey has confirmed two main areas where the cutoff wall is compromised – one on the bend of the tunnel and the other where the original cutoff wall crosses the tunnel. Having identified the location of what we believed to be the two largest sources of leakage through the right abutment area, it is possible to undertake cost effective remedial works at The Samanalawewa Dam. These remedial works will to ensure the safety and integrity of the dam and bring the reservoir back to its proposed top water level and; retaining its ability to generate energy.

- 1) Close two significant gaps in the existing supplementary grout curtain
- 2) Locate and fill major karstic features at approximate elevation of 438m.
